LESSONS LEARNED AND IMPROVEMENTS TO VIRGINIA'S CONCRETE PATCHING

VDOT Concrete Program Manager

February 28, 2020

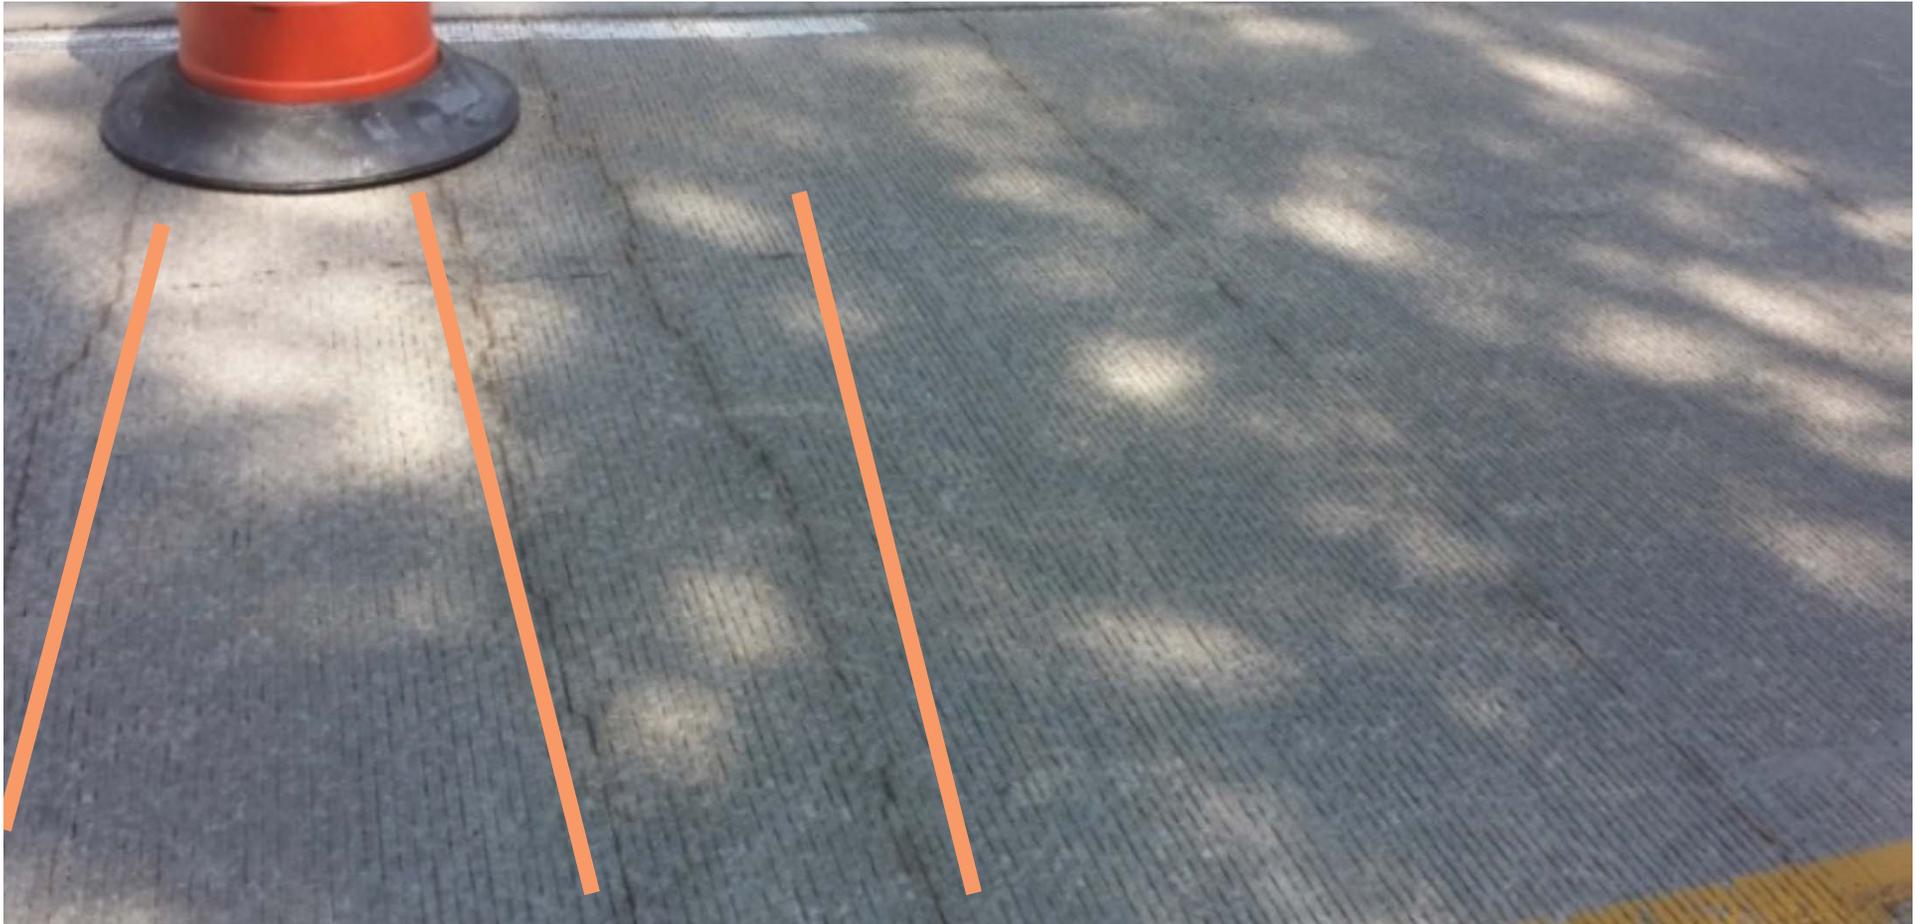
**Five-Year-Old Patch on I-85 with Cracks Close Together.
The cracks were caused by the use of concrete with a
high cement content.**

- *One of the most significant causes of premature failures of patches was the use of high early strength concrete mixtures with high cement contents (as high as 800 lb) that cause excessive shrinkage cracking.*

1. VDOT's Materials Division and Construction Division should require in future special provisions that concrete patching mixtures include much less cement (as in the regular paving concrete) and include fly ash or slag when longer lane closures can be specified. In a single project, multiple mixture designs with varying cementitious materials could be used for achieving the required strength.
2. Chapter 6 of the VDOT Materials Division Manual of Instructions should be revised to indicate that the VDOT districts should require preliminary engineering prior to patching to consider the condition of the existing pavement, future traffic, and the need for patching and placing an overlay to improve the structural capacity.

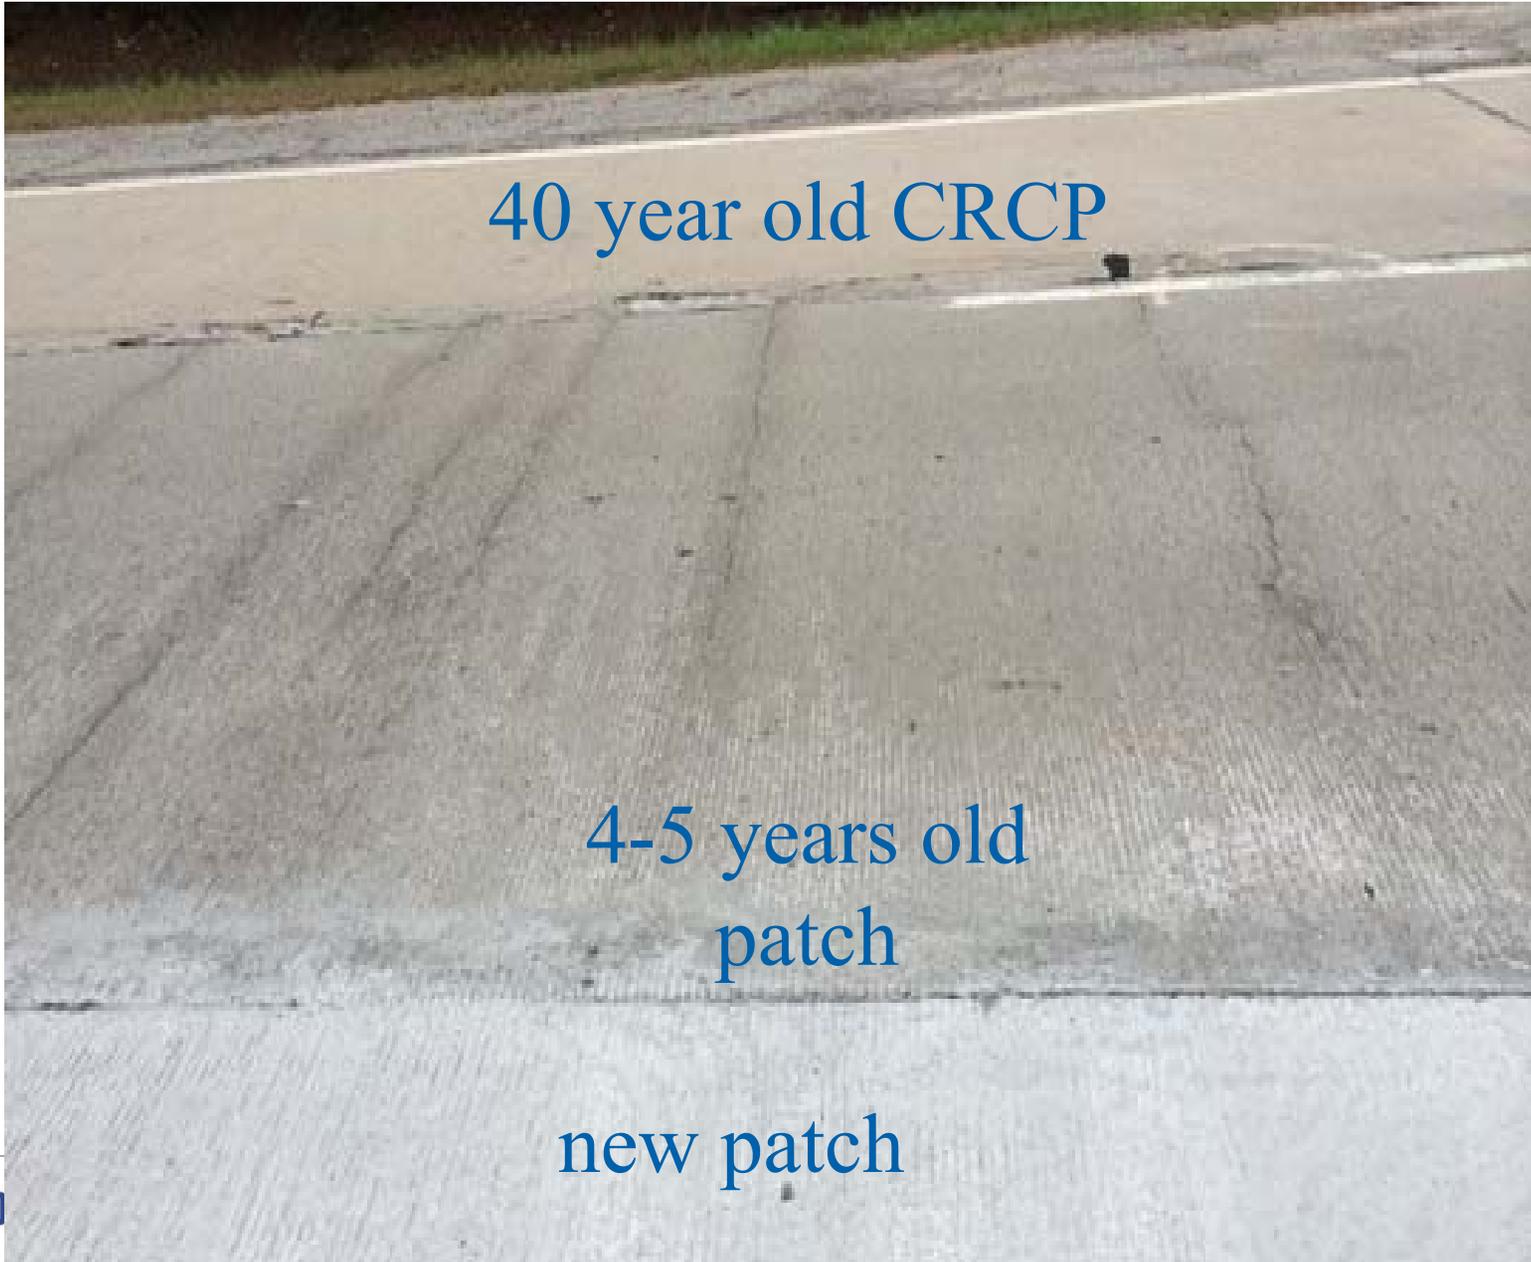
4-5 years old patch with many cracks

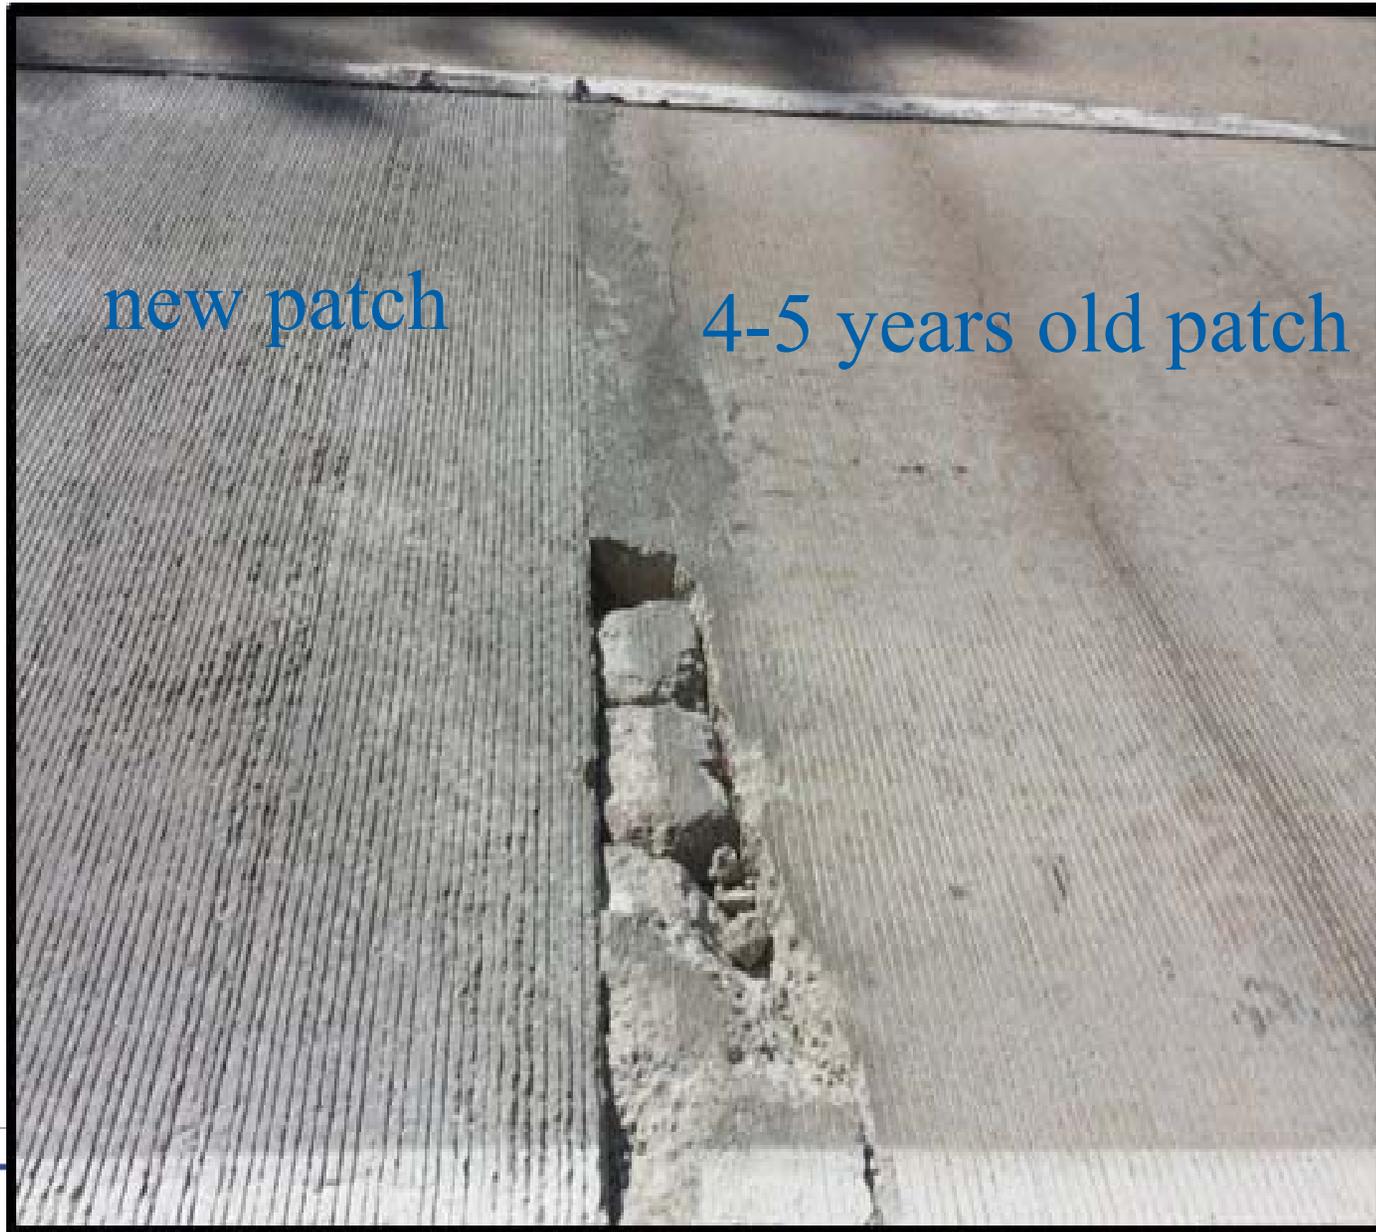
Failure adjacent to new patch
