Appendix D
Detailed Safety Assessment

Study Area Safety Review

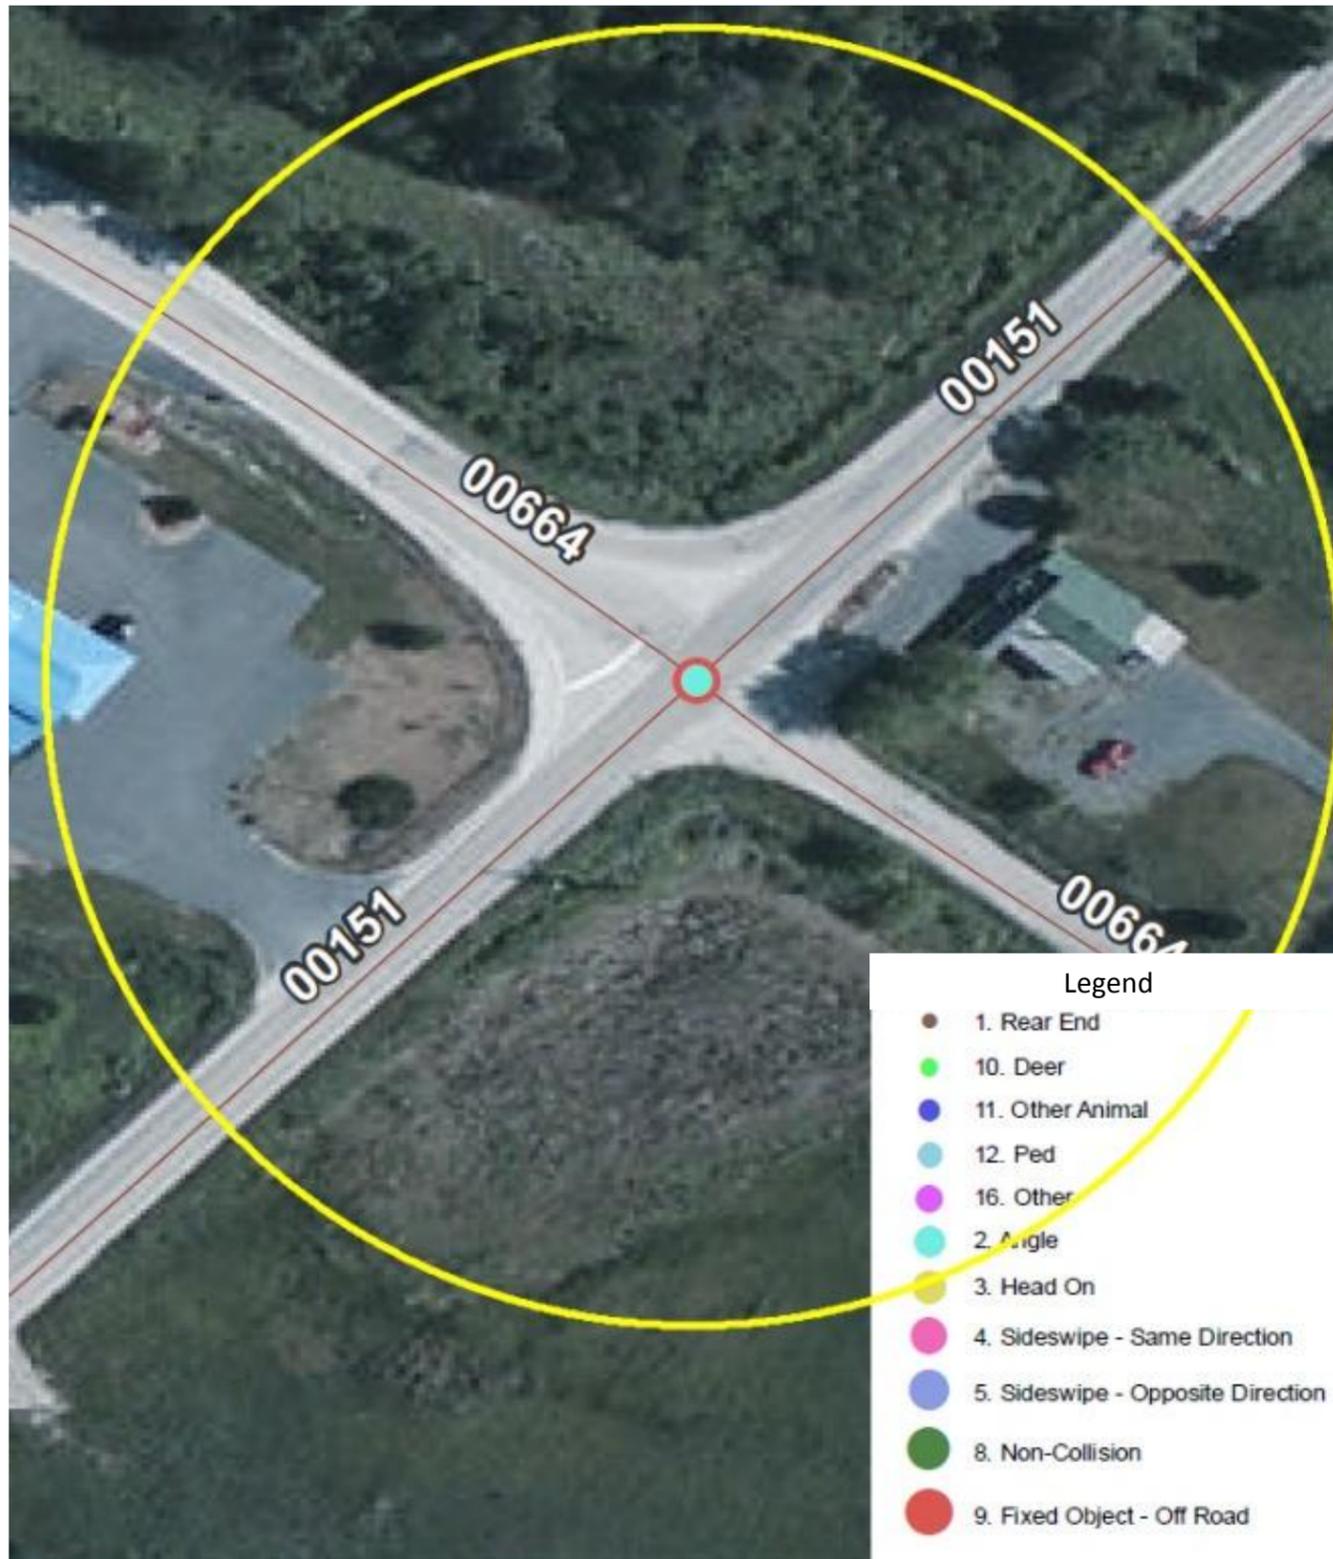
1. Route 664 (Beech Grove Road)/(Glenthorne Loop) at Route 151

Type	# of Crashes	Severity	Day/ Night
Angle	1	Property Damage	Day
Fixed Object - Off-Road	1	Property Damage	Night

- Route 151 southbound right turning traffic onto Beech Grove Road.
 - Slow turning movements. The slow turning vehicles may obstruct the view for the vehicles turning from eastbound Beech Grove Road.
 - Some vegetation in northwest quadrant impedes sight distance.
 - Impatient Route 151 southbound through vehicles may clip right-turning vehicles.
 - Some southbound Route 151 traffic may be intending to turn into “Ski Barn” parking lot but may have turn signal on when passing Beech Grove Road.
 - This may confuse Beech Grove Road eastbound left turning traffic, causing this traffic to turn in front of Route 151 southbound through traffic.
- Signage on northbound Route 151 may be confusing; current location of Route 664-ahead sign could direct traffic into Devils Backbone business.
- Conditions are worse during ski season.

Improvements	Short/Long Term	Potential Safety Benefits
Trim vegetation in northwest quadrant	On-going	<ul style="list-style-type: none"> • Increases sight distance for turning vehicles • Eliminates obstacle within the sight distance triangle
Adjust signage along northbound Route 151	Short-Term	<ul style="list-style-type: none"> • Helps drivers prepare early for turning
Add southbound offset right turn bay, or	Mid-Term	<ul style="list-style-type: none"> • Prevents stopped vehicles from blocking the through movements • Expect 14 percent reduction in crashes based on Highway Safety Manual (HSM)¹

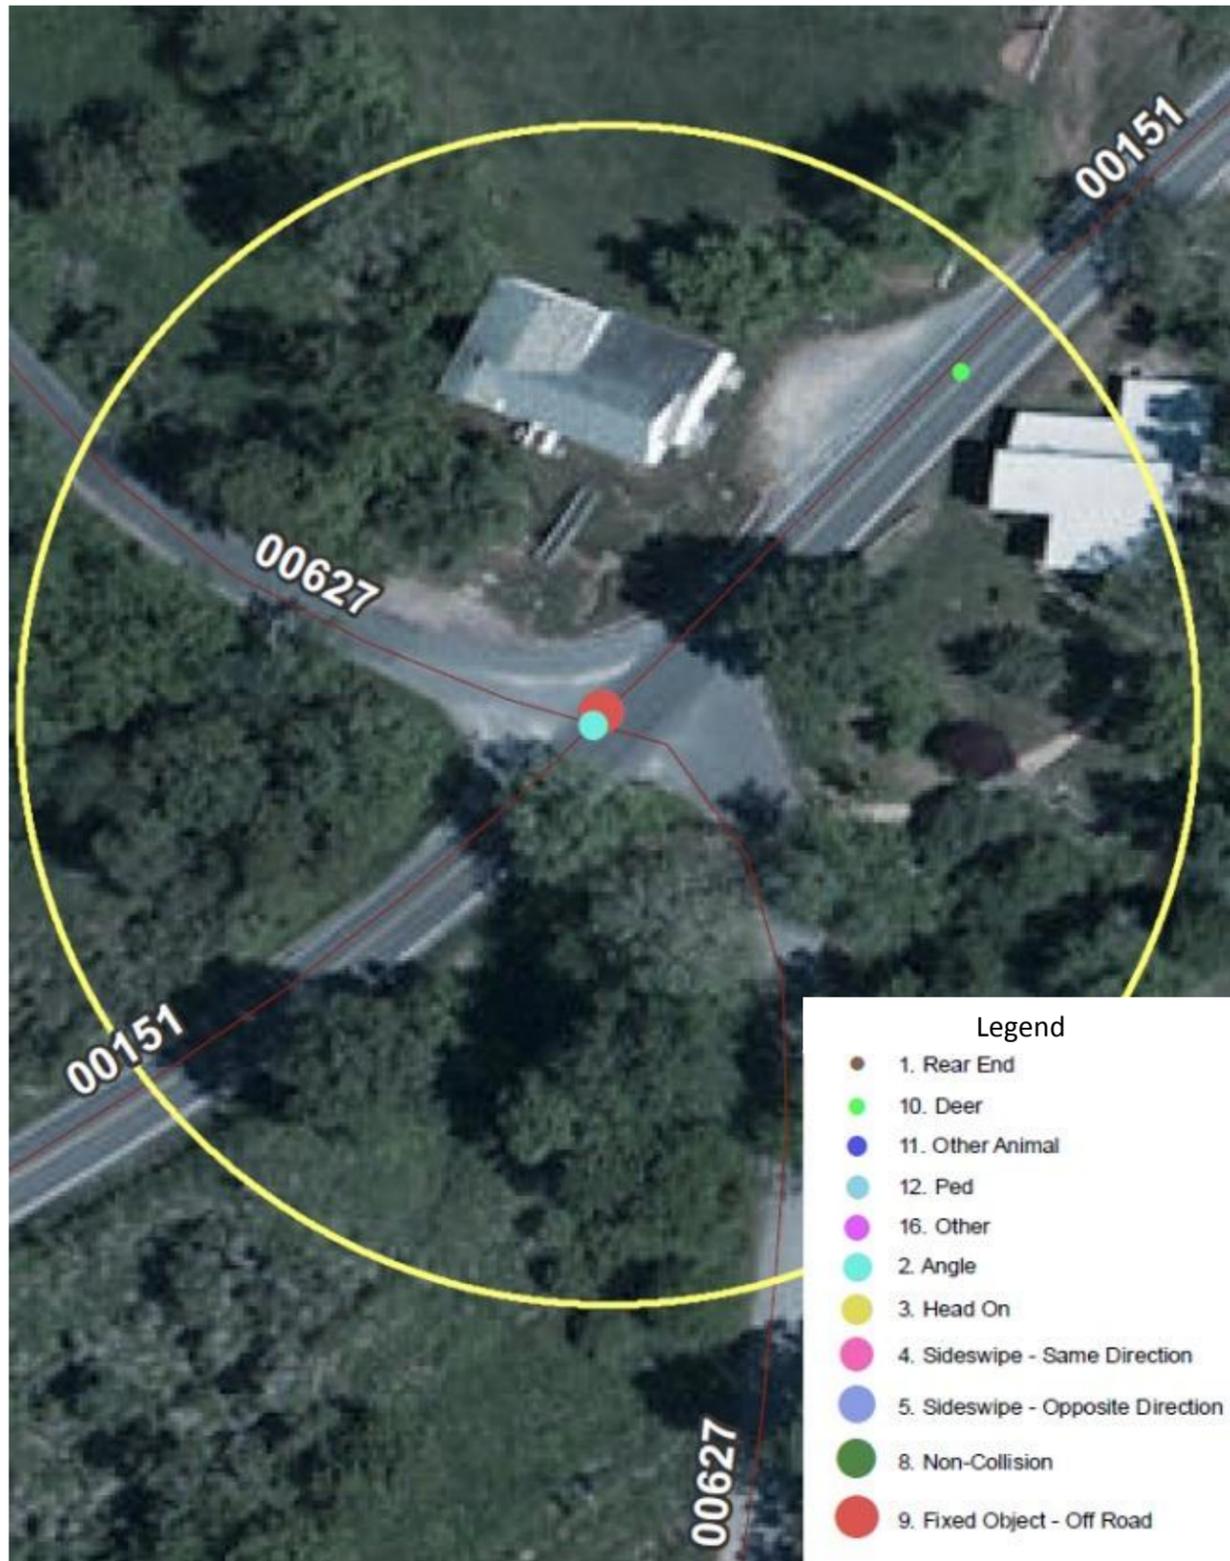
2. Route 627 (Spruce Creek Lane and Glenthorne Loop) at Route 151

Type	# of Crashes	Severity	Day/ Night
Angle	1	Injury	Day
Fixed Object - Off-Road	1	Injury	Night
Wildlife	1	Property Damage	Night

- Skewed alignment due to foundation of a former mill in the southeast quadrant.
- Approximately 100-150 people reside along Spruce Creek Lane; ongoing development is currently adding 25 homes (some may already be occupied).
- Per comments from the Sherriff's Deputy, when eastbound vehicles turn left to travel northbound, often they will turn into the southbound lane (in the wrong lane), get up to roadway travel speed, then move over into the northbound lane.
- Location has a perceived high left turning truck traffic volume. Note, a cidery is located to the east.
- Spruce Creek Lane eastbound left turning onto Route 151 northbound has very poor line of sight:
 - Embankment in southwest quad limits sight distance.
 - Often left turning traffic will turn and drive in the southbound lane (i.e. wrong way traffic) until they can move over into the northbound lane.

Improvements	Short/Long Term	Potential Safety Benefits
Add intersection-ahead signage with flashers on the northbound approach, include actuation when vehicles approach intersection on minor approaches	Short-Term	<ul style="list-style-type: none"> • Enhances the visibility of intersection and increases motorists' awareness of traffic on the minor approaches
Realign Route 627 to reduce skew (by 25 degrees) and improve sight distance	Mid-Term	<ul style="list-style-type: none"> • Improves sight distance • Reduces the chance of left turn vehicles to turn onto wrong way on Route 151 • Expect 9 percent reduction in crashes based on HSM
Regrade embankment in the southwest quadrant	Mid-Term	<ul style="list-style-type: none"> • Increases sight distance for side street vehicles • Eliminates obstacle within the sight distance triangle
Monitor traffic volumes and crashes to determine if signal is warranted	On-going	<ul style="list-style-type: none"> • Signalization will provide safe opportunities for minor road traffic to turn onto Route 151

Monitor need for a southbound left turn bay to accommodate turning traffic	On-going	<ul style="list-style-type: none"> • Will provide a separate lane for left turning traffic as they wait for a safe gap in the opposing through lane to turn

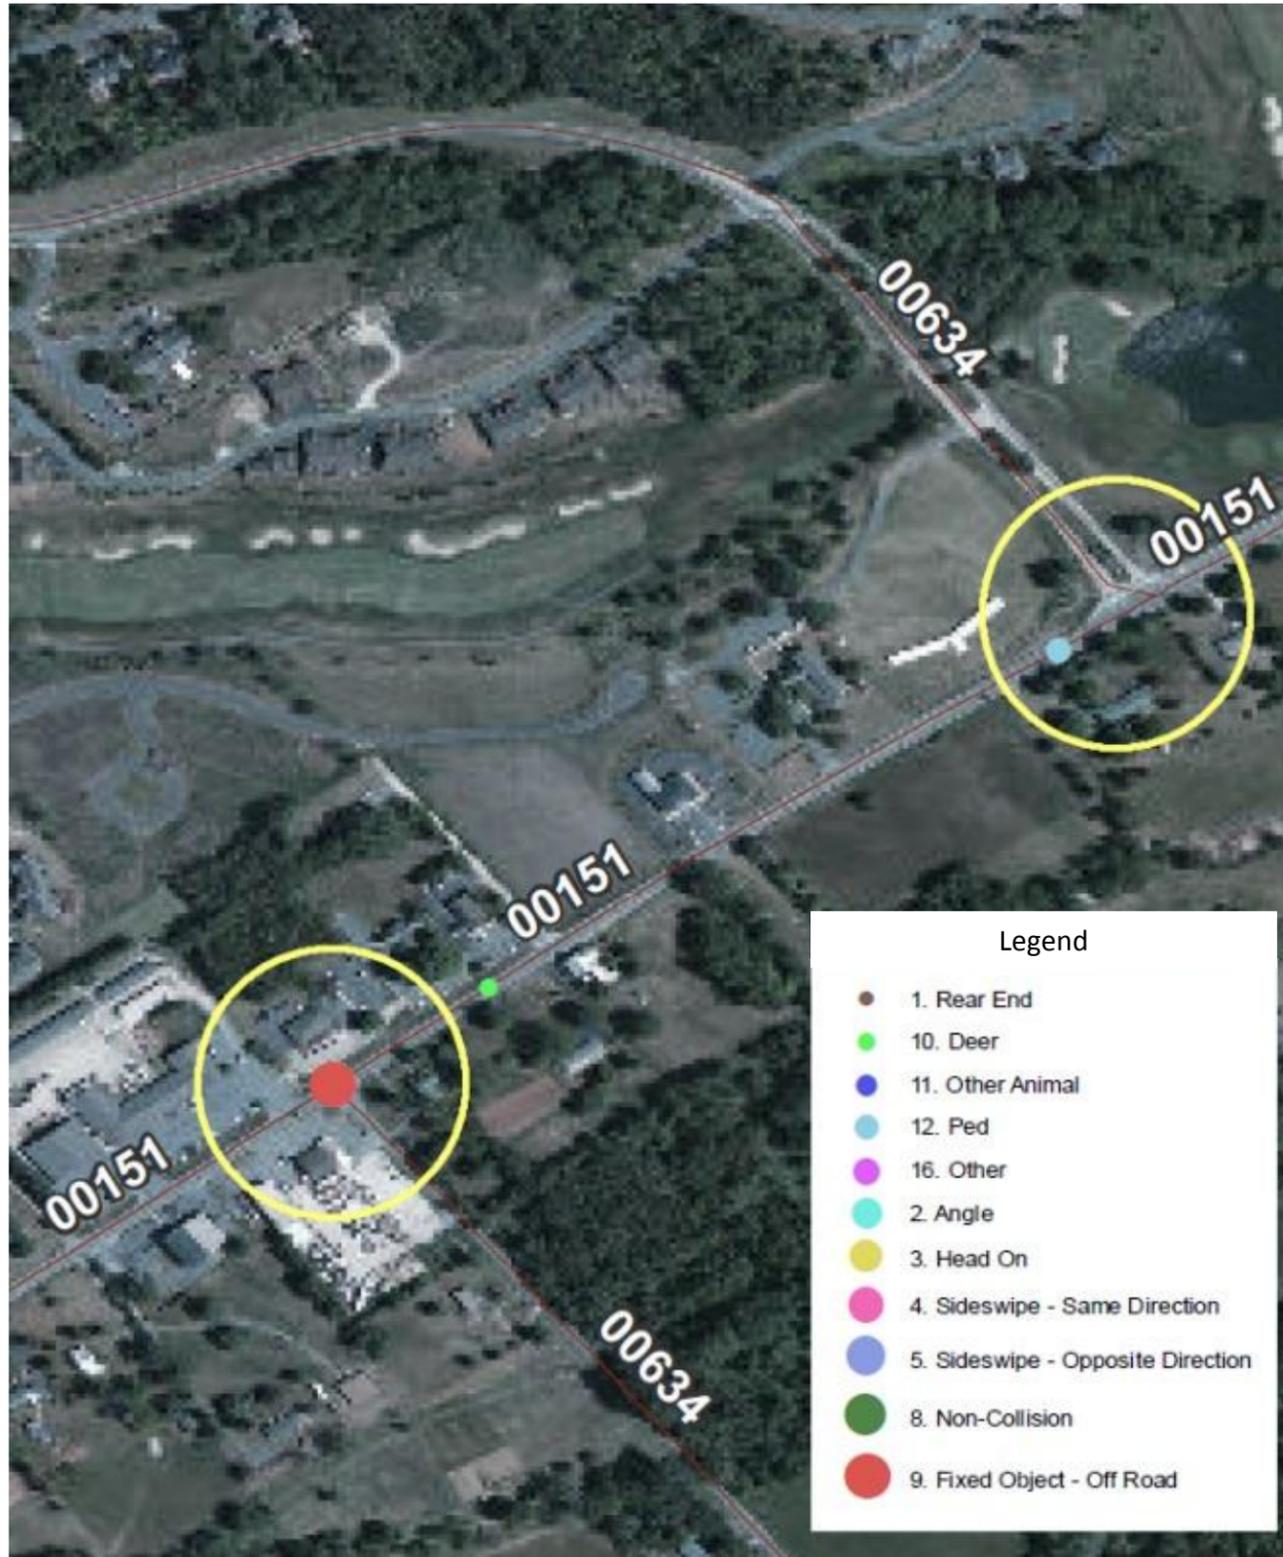
3. Route 634 (Adial Road)/Nellysford area at Route 151

Type	# of Crashes	Severity	Day/ Night
Pedestrian	1	Fatal	N.A.
Fixed Object – Off Road	1	Property Damage	Day
Wildlife	1	N.A.	N.A.

- Lack of stop bar and end-of-road treatment.
- Vegetation along the side of the roadway can block view of the stop sign.
- Lack of pedestrian facilities.
- Poor Access Management/poor inter-parcel connectivity.

Improvements	Short/Long Term	Potential Safety Benefits
Add sidewalks and crosswalks for pedestrians	Short-Term	<ul style="list-style-type: none"> • Separates pedestrian and vehicular traffic flow • Provides protection to pedestrian and enhances their safety
Along Adial Road, trim vegetation and relocate stop sign	Short-Term	<ul style="list-style-type: none"> • Increases sight distance for turning vehicles • Eliminates obstacles within the sight distance triangle
As new development or re-development occurs, improve access management and inter-parcel connectivity	Long-Term	<ul style="list-style-type: none"> • Limits disturbances from driveways and reduces inter-parcel traffic's usage of mainline • Expect 25 percent reduction in crashes based on HSM
Explore potential to reduce speed limit to 35 mph within the Nellysford commercial area	Long-Term	<ul style="list-style-type: none"> • Reduces both crash potential and collision severity

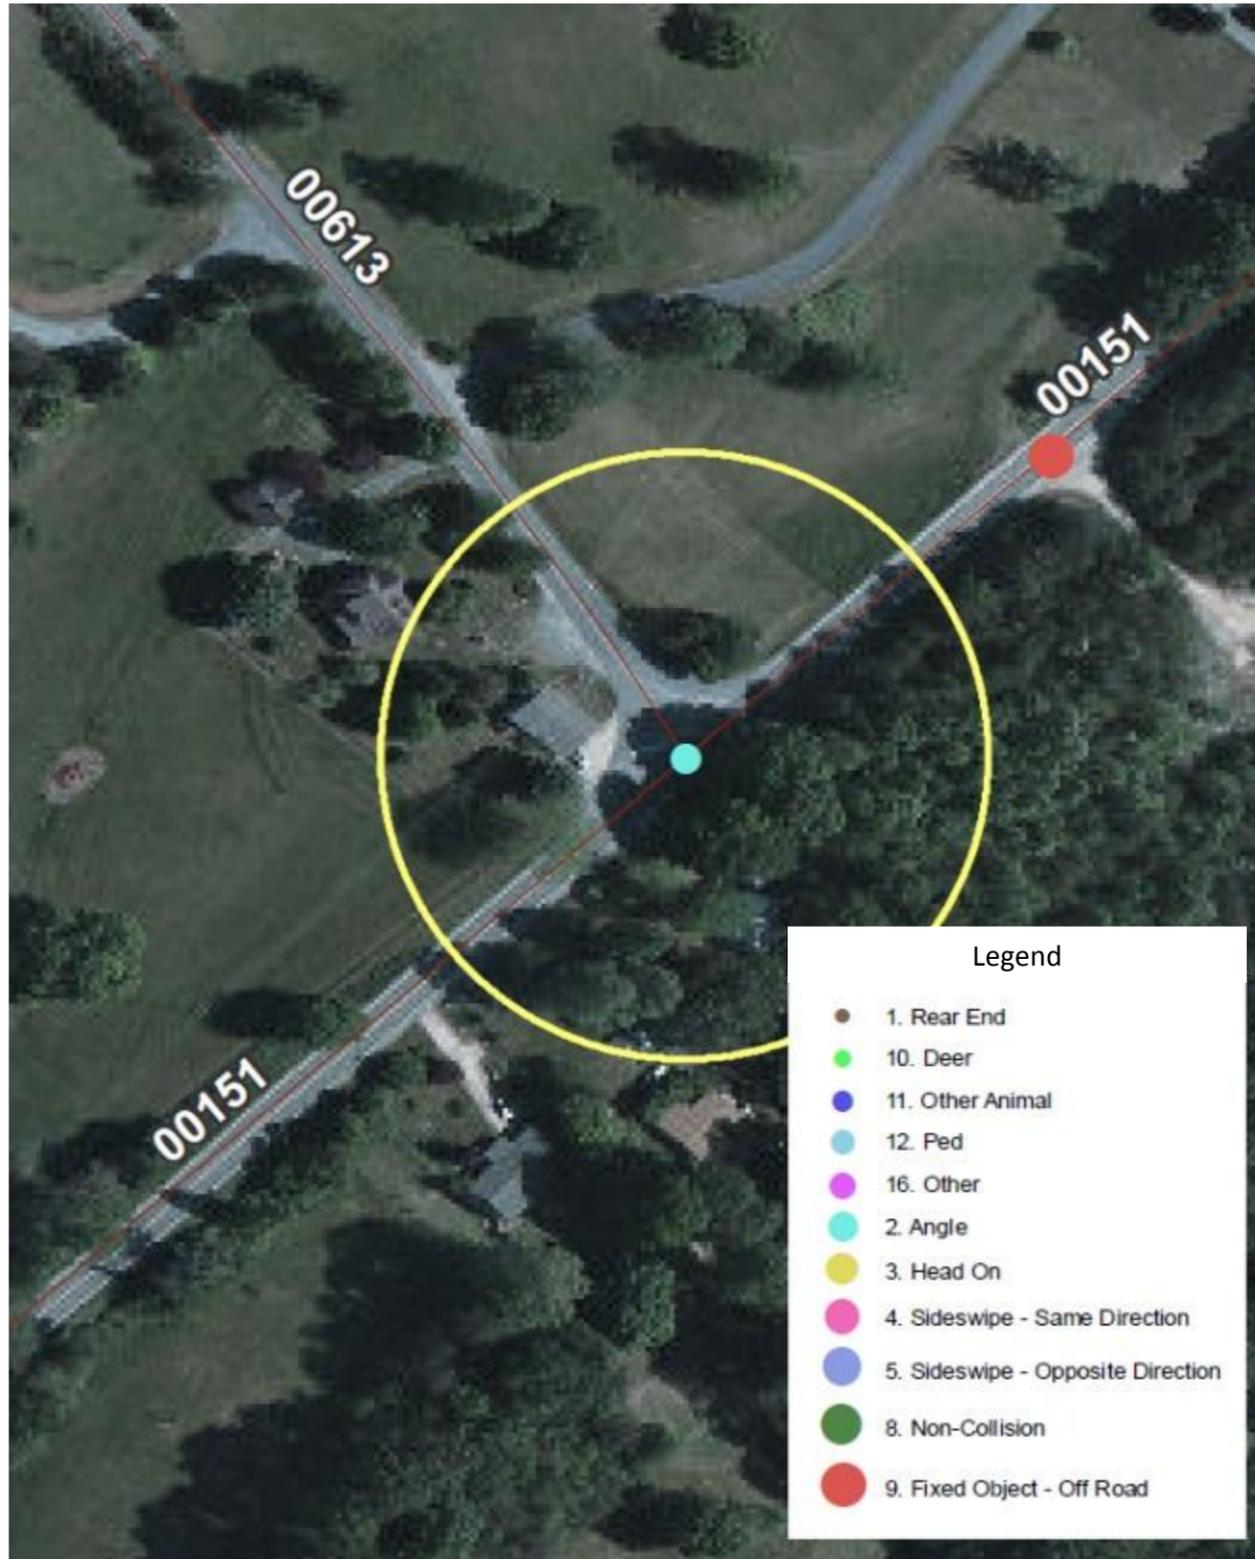
4. Route 613 (Rodes Farm Drive and Lodebar Estate) at Route 151

Type	# of Crashes	Severity	Day/ Night
Angle	1	Injury	Night
Fixed Object – Off Road	1	Injury	N.A.

- Crest in hill and embankments between the two (2) intersections limits sight distance for turning vehicles from minor roadways and driveways.

Improvements	Short/Long Term	Potential Safety Benefits
Regrade roadway in area to improve sight distance <ul style="list-style-type: none"> ○ Reduce crest of hill ○ Regrade embankment 	Long-Term	<ul style="list-style-type: none"> • Increases sight distance for side street vehicles • Eliminates obstacle within the sight distance triangle
Review signage to ensure compliance with State Code	Short-Term	<ul style="list-style-type: none"> • Increases sight distance for side street vehicles and reduces driver distraction

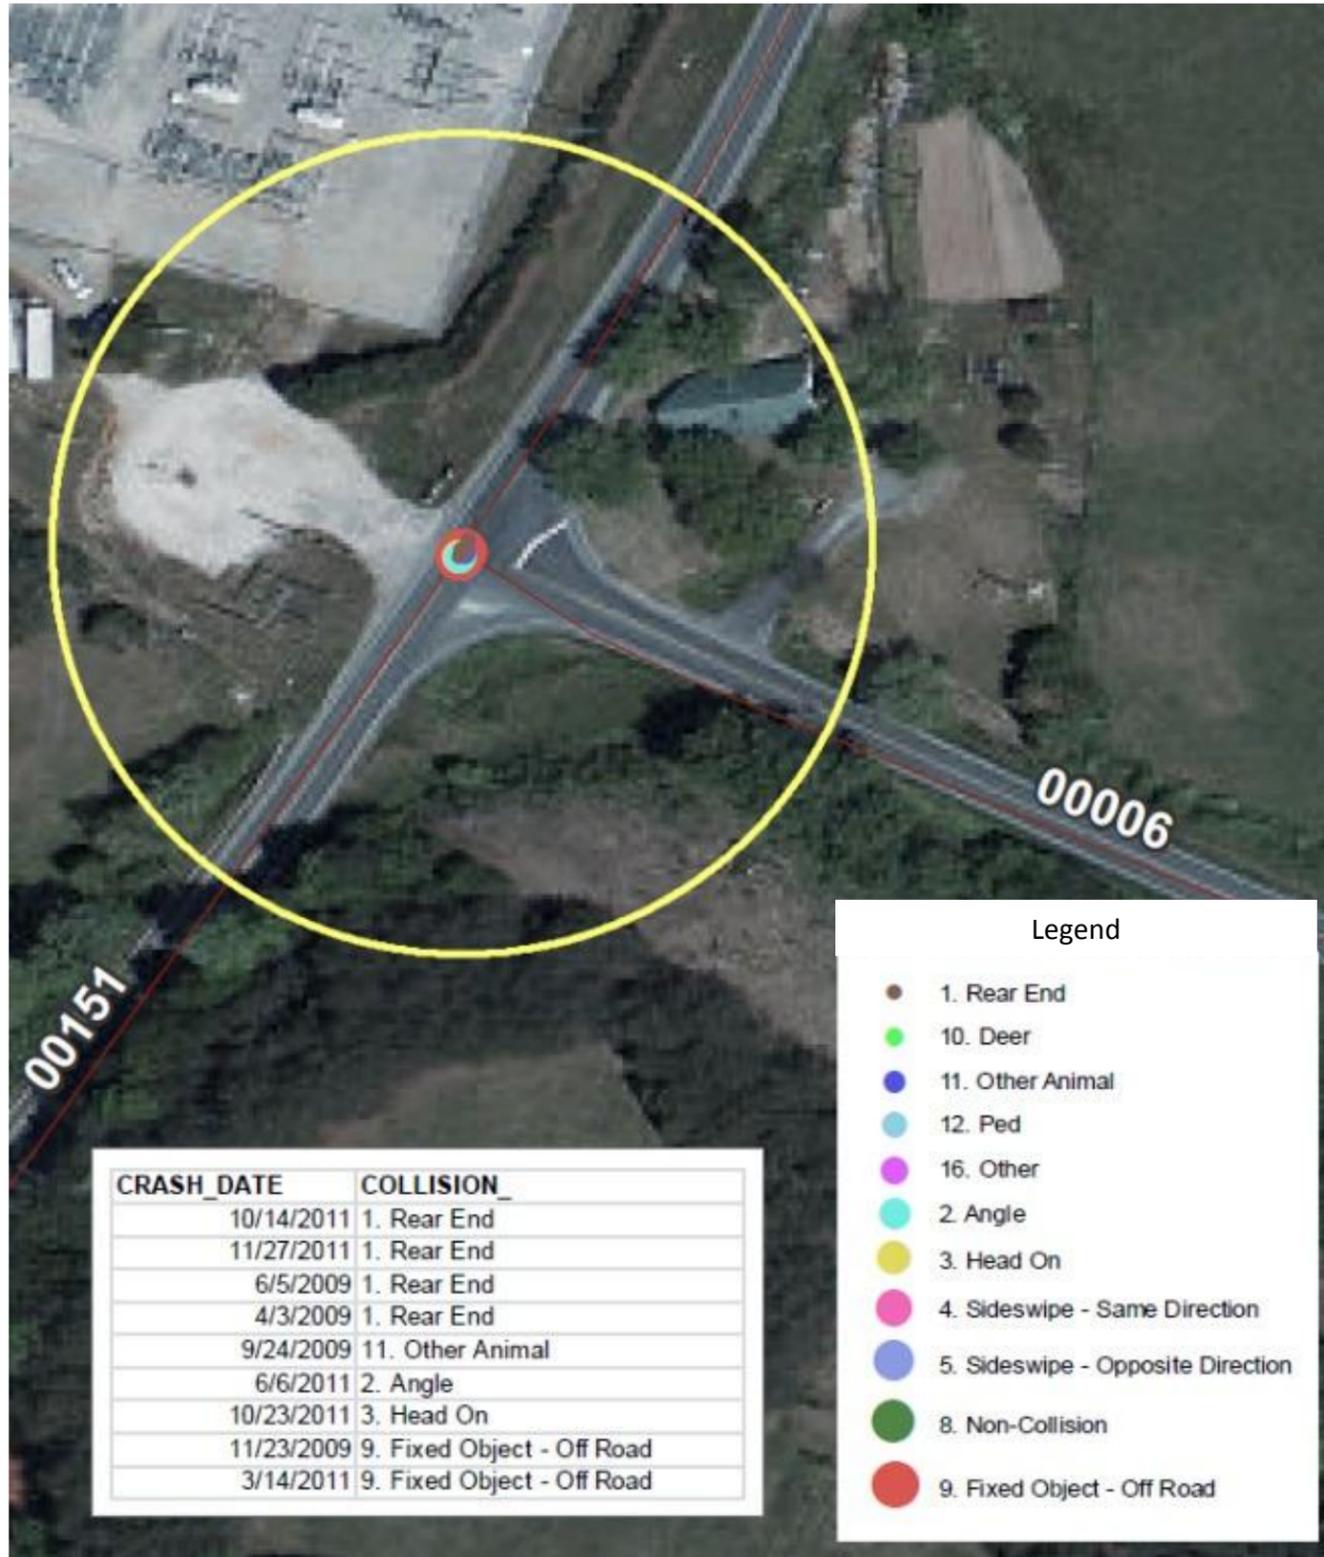
5. Route 6 (River Road) at Route 151

Type	# of Crashes	Severity	Day/ Night
Read-end	1	Injury	Day
	2	Property Damage	Day
	1	Property Damage	Night
Angle	1	Injury	Day
Fixed Object – Off Road	1	Injury	Night
	1	Property Damage	Night
Other Types	1	Property Damage	Night

- Stop bar on River Road fairly close to edge of travel way of Route 151 northbound.
 - Route 151 southbound left turning traffic crosses over double-yellow of both Route 151 and River Road, which may cause them to conflict with River Road traffic queued at the stop bar.
 - Buses and tractor trailers have little room to make left turn if a vehicle is stopped, as there is little receiving room for the departing leg.
 - Cannot move stop bar back due to embankment in southeast quad.
- Lack of southbound left turn lane.

Improvements	Short/Long Term	Potential Safety Benefits
Widen east leg of intersection for wider receiving area to accommodate turning vehicles	Short-Term	<ul style="list-style-type: none"> • Provides better radius for easy turning movements of heavy vehicles and buses
Consider roundabout (Option A)	Mid-Term	<ul style="list-style-type: none"> • Relatively low traffic circulation speed • Reduces conflict points and angles • Reduces collision potentials and severity • Expect 44 percent reduction in crashes based on HSM
When upgrading bridge to the north, widen structure to accommodate a southbound left turn bay (close proximity of bridge may preclude a left turn bay under current configuration)	Mid-Term	<ul style="list-style-type: none"> • Reduces the collision potentials between through vehicles and turning vehicles stopped at the intersection • Expect 44 percent reduction in crashes based on HSM

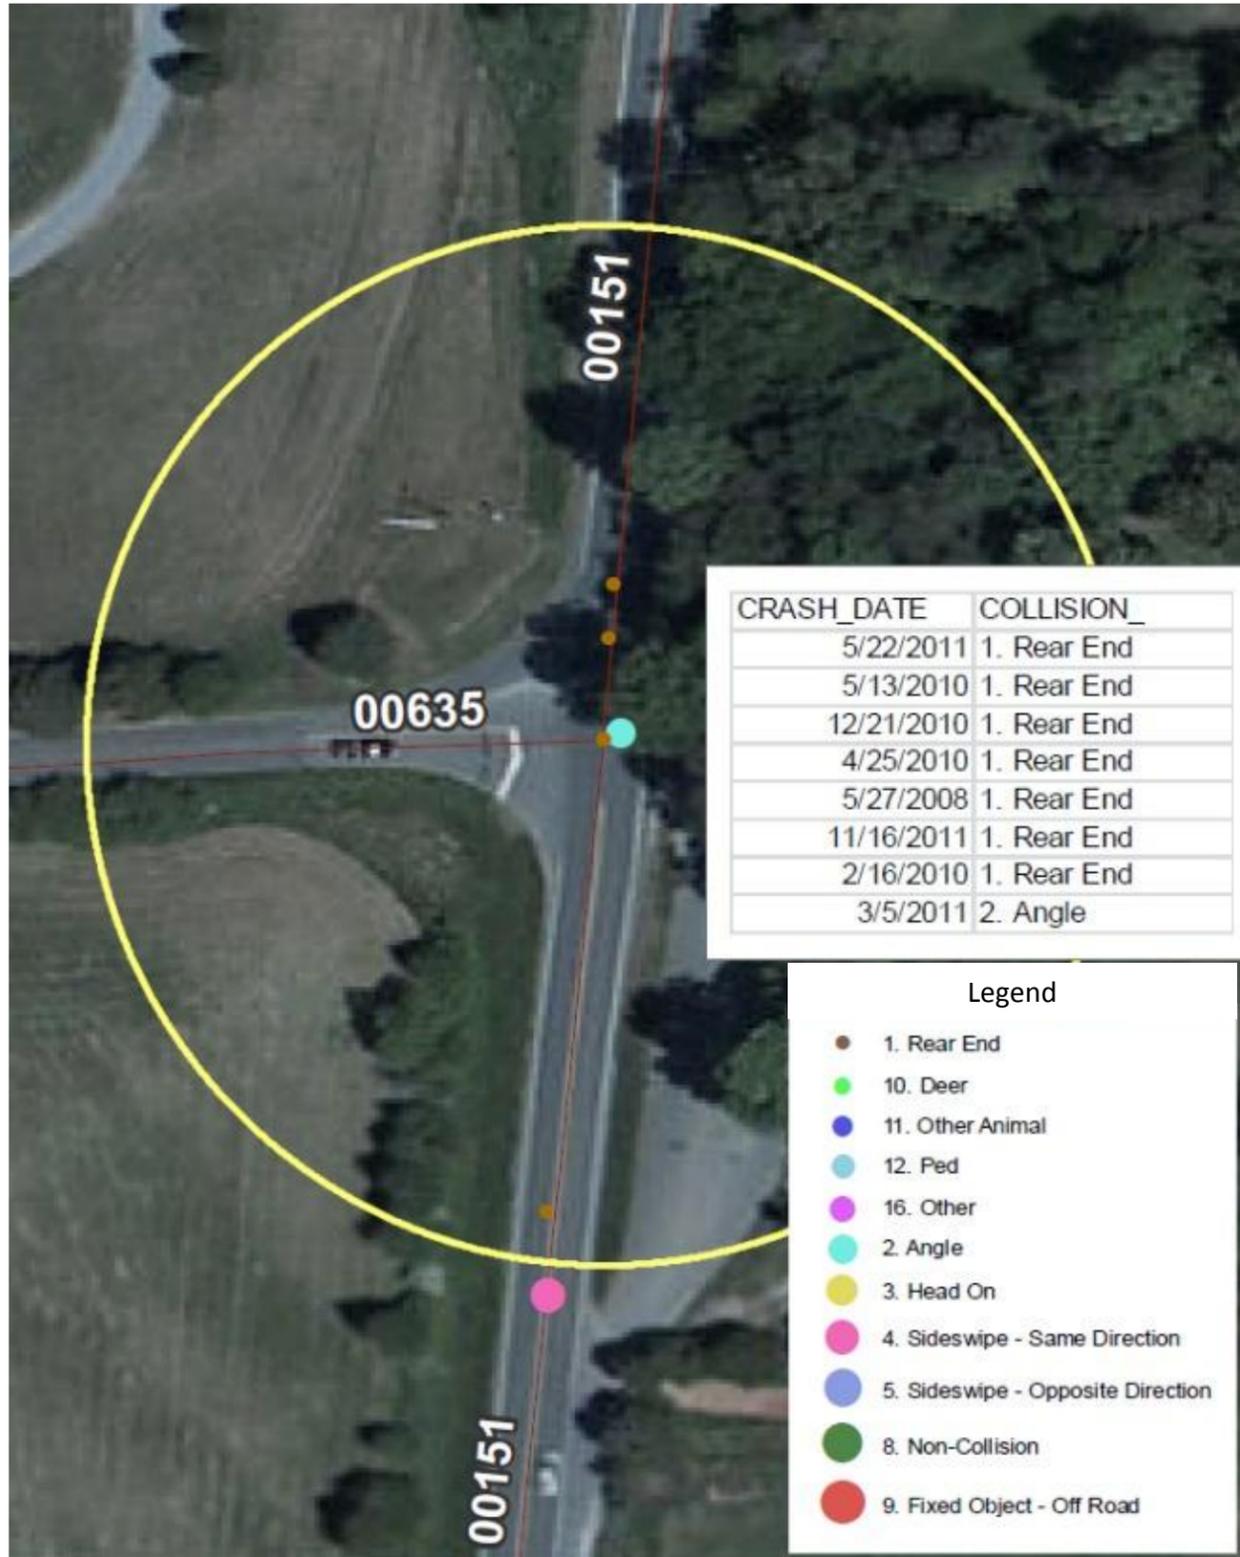
6. Route 635 (Rockfish School Lane) at Route 151

Type	# of Crashes	Severity	Day/ Night
Read-end	4	Injury	Day
	3	Property Damage	Day
Angle	1	Injury	Day

- Most crashes have occurred in 2010 and 2011:
 - Due to addition of Recycling Drop-off at Community Center.
 - Park activities generate high traffic: soccer fields, horse and dog shows.
- Lack of turn lanes.

Improvements	Short/Long Term	Potential Safety Benefits
Add a northbound left turn lane*	Short-Term	<ul style="list-style-type: none"> • Reduces the collision potential between through vehicles and turning vehicles stopped at the intersection • Expect 44 percent reduction in crashes based on HSM

* VDOT has approved an HSIP grant to construct a northbound left turn lane. Preliminary start date for construction is October 2015.

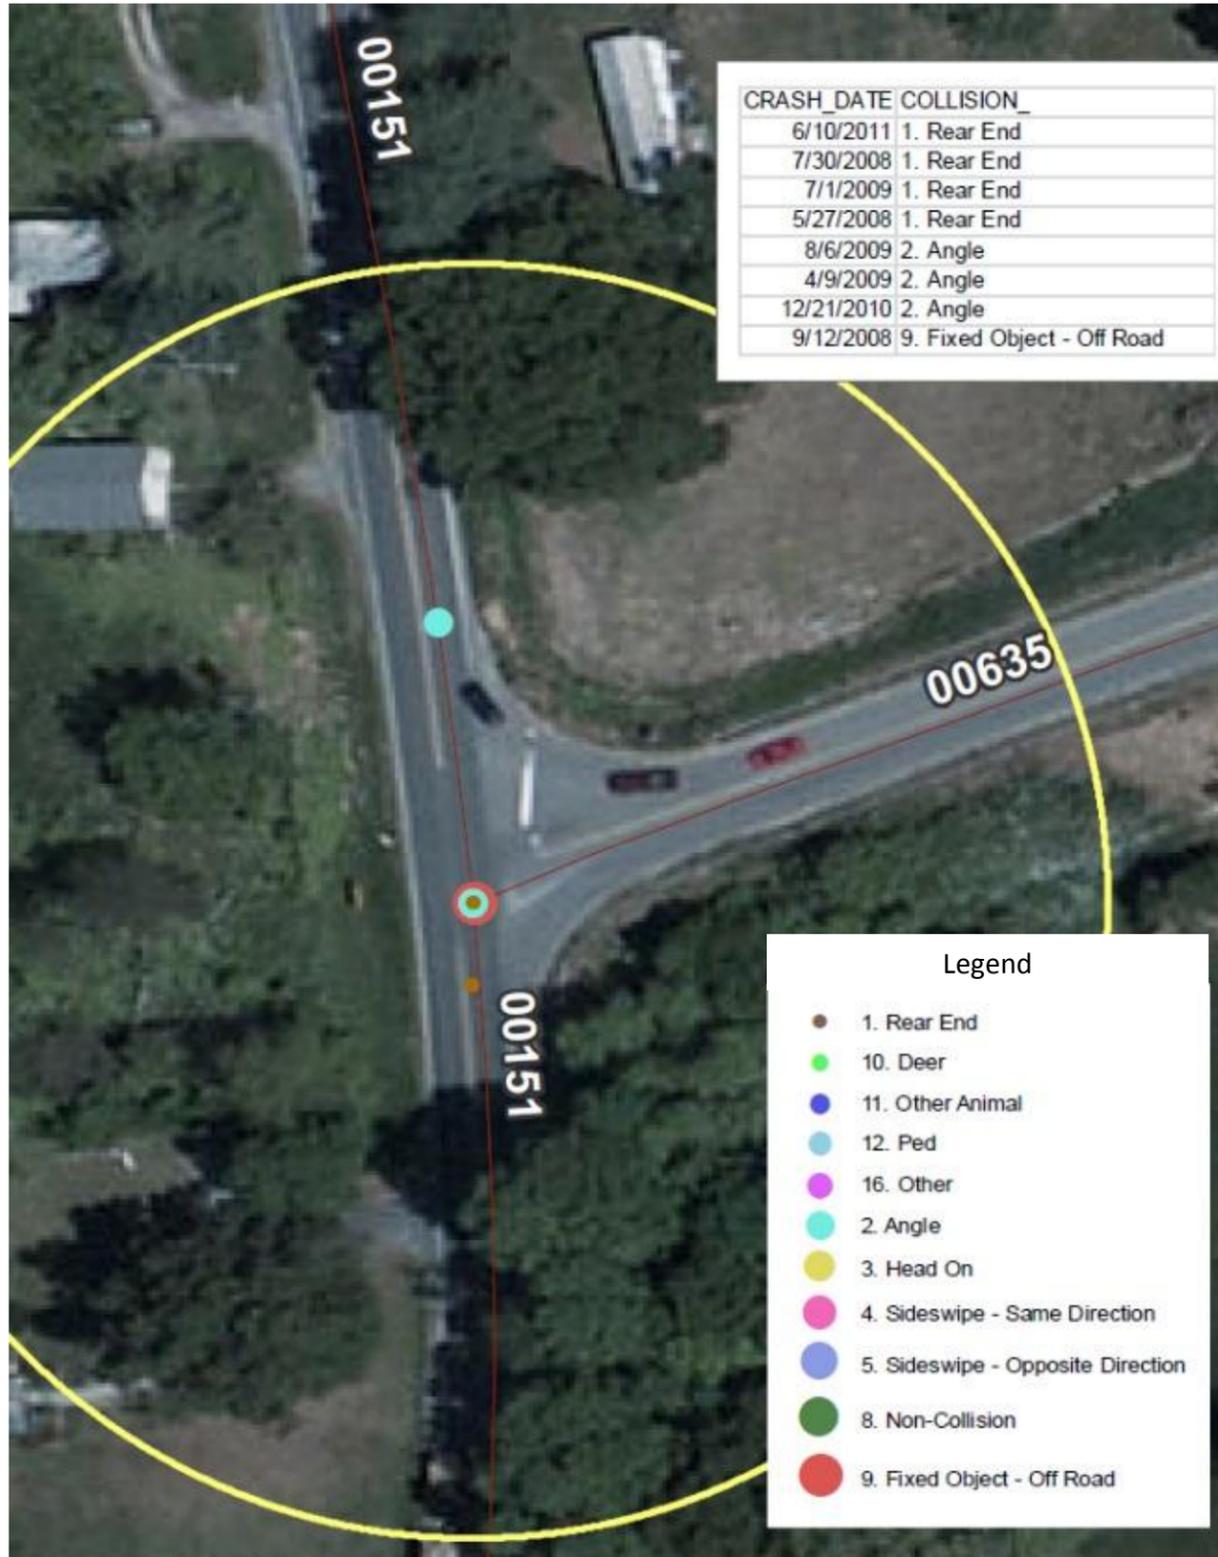
7. Route 635 (Greenfield Road) at Route 151

Type	# of Crashes	Severity	Day/ Night
Read-end	4	Property Damage	Day
Angle	1	Injury	Day
	2	Property Damage	Day
Fixed Object -Off-road	1	Injury	Night

- Most crashes occurred in 2008 and 2009.
 - Note that this location was reconstructed in 2010-2011 timeframe.
- The northbound right turn bay is short.

Improvements	Short/Long Term	Potential Safety Benefits
Extend northbound right turn bay by utilizing (restriping) the existing shoulder prior to the start of the turn bay	Short-Term	<ul style="list-style-type: none"> • Reduces the collision potential between through vehicles and turning vehicles stopped at the intersection • Expect 14 percent reduction in crashes based on HSM

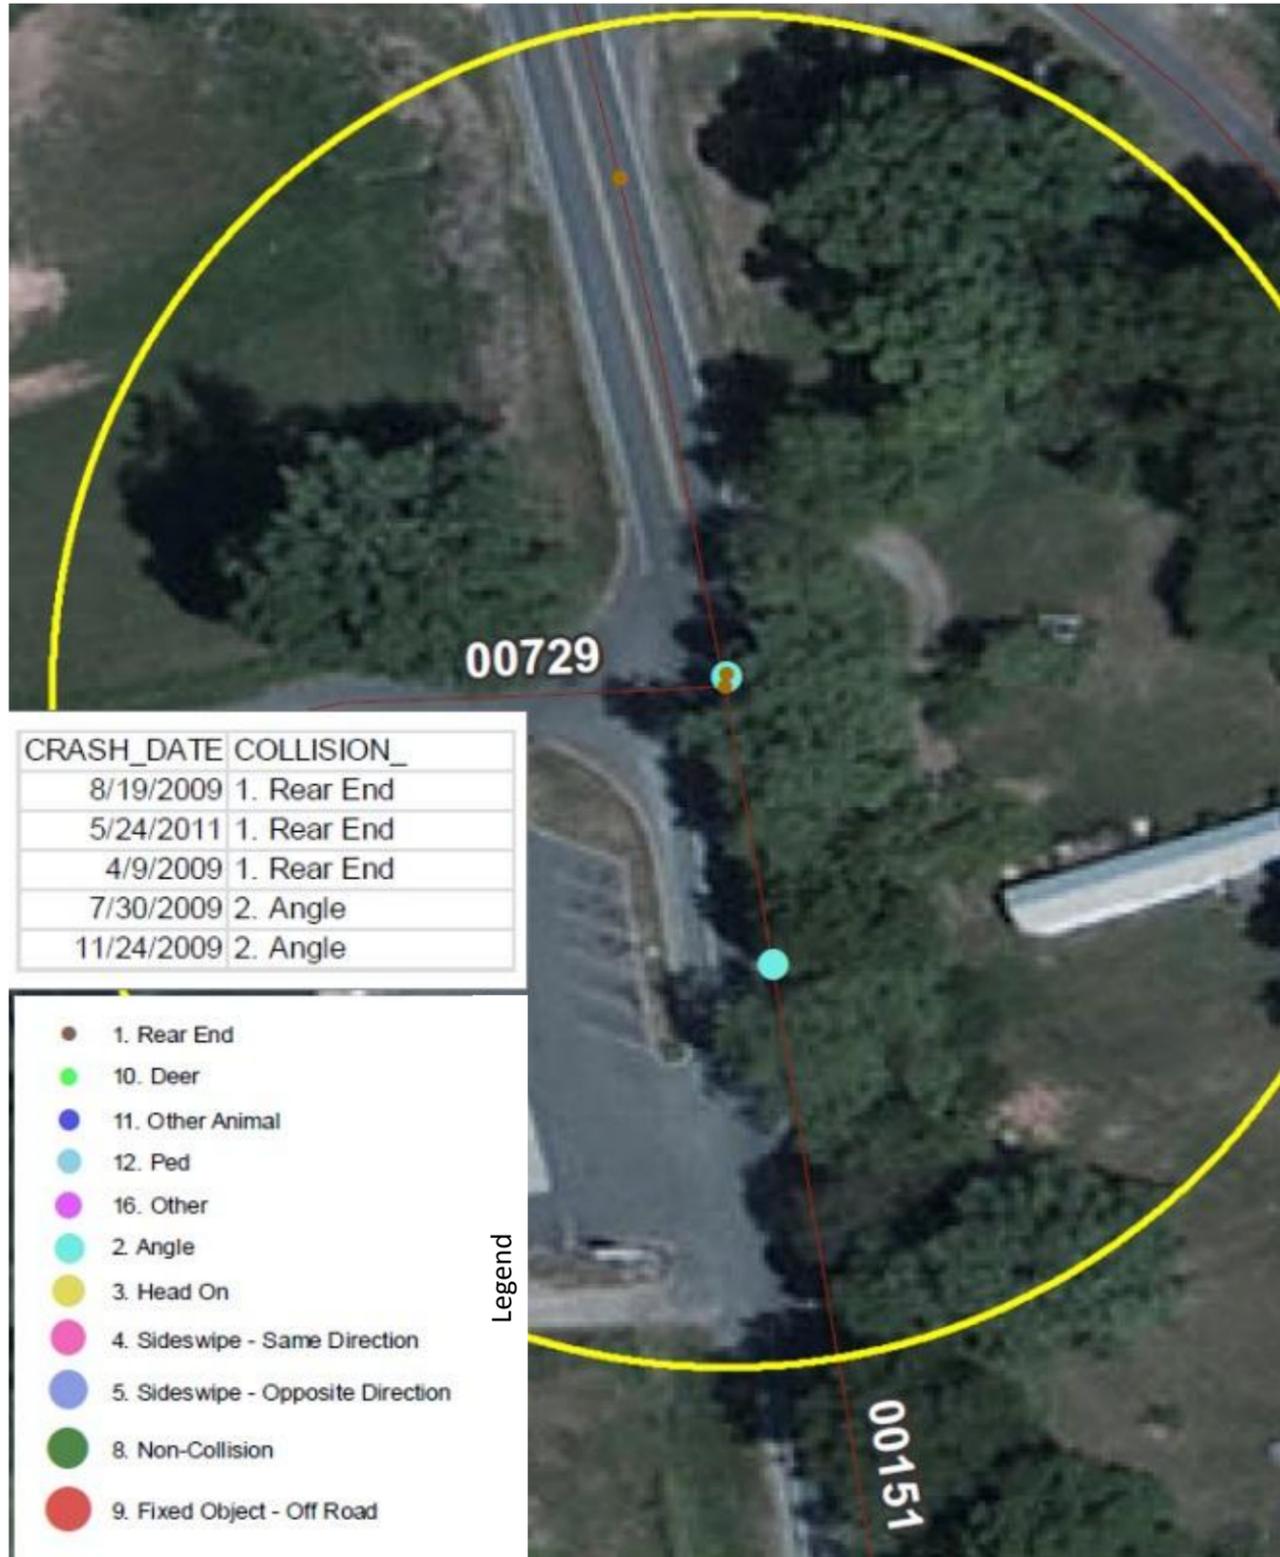
8. Route 729 (Creek Road) at Route 151

Type	# of Crashes	Severity	Day/ Night
Read-end	2	Injury	Day
	1	Property Damage	Day
Angle	2	Injury	Day

- Line of sight issues for Creek Road.
- Lack of left turn bay into the southern entrance of the store, primary access point for vehicles from the south.
 - Many drivers already using hatched median as a turning area.
- Lack of southbound right turn bay.
- Presence of underground utilities may hinder improvements.

Improvements	Short/Long Term	Potential Safety Benefits
Restripe roadway to provide northbound left turn into the store's southern access	Short-Term	<ul style="list-style-type: none"> • Reduces the collision potential between through vehicles and turning vehicles stopped at the intersection • Expect 44 percent reduction in crashes based on HSM
Add a southbound right turn bay onto Creek Road, move minor road stop bar further towards the southbound through lane	Mid-to Long-Term	<ul style="list-style-type: none"> • Reduces the collision potential between through vehicles and turning vehicles stopped at the intersection • Expect 14 percent reduction in crashes based on HSM

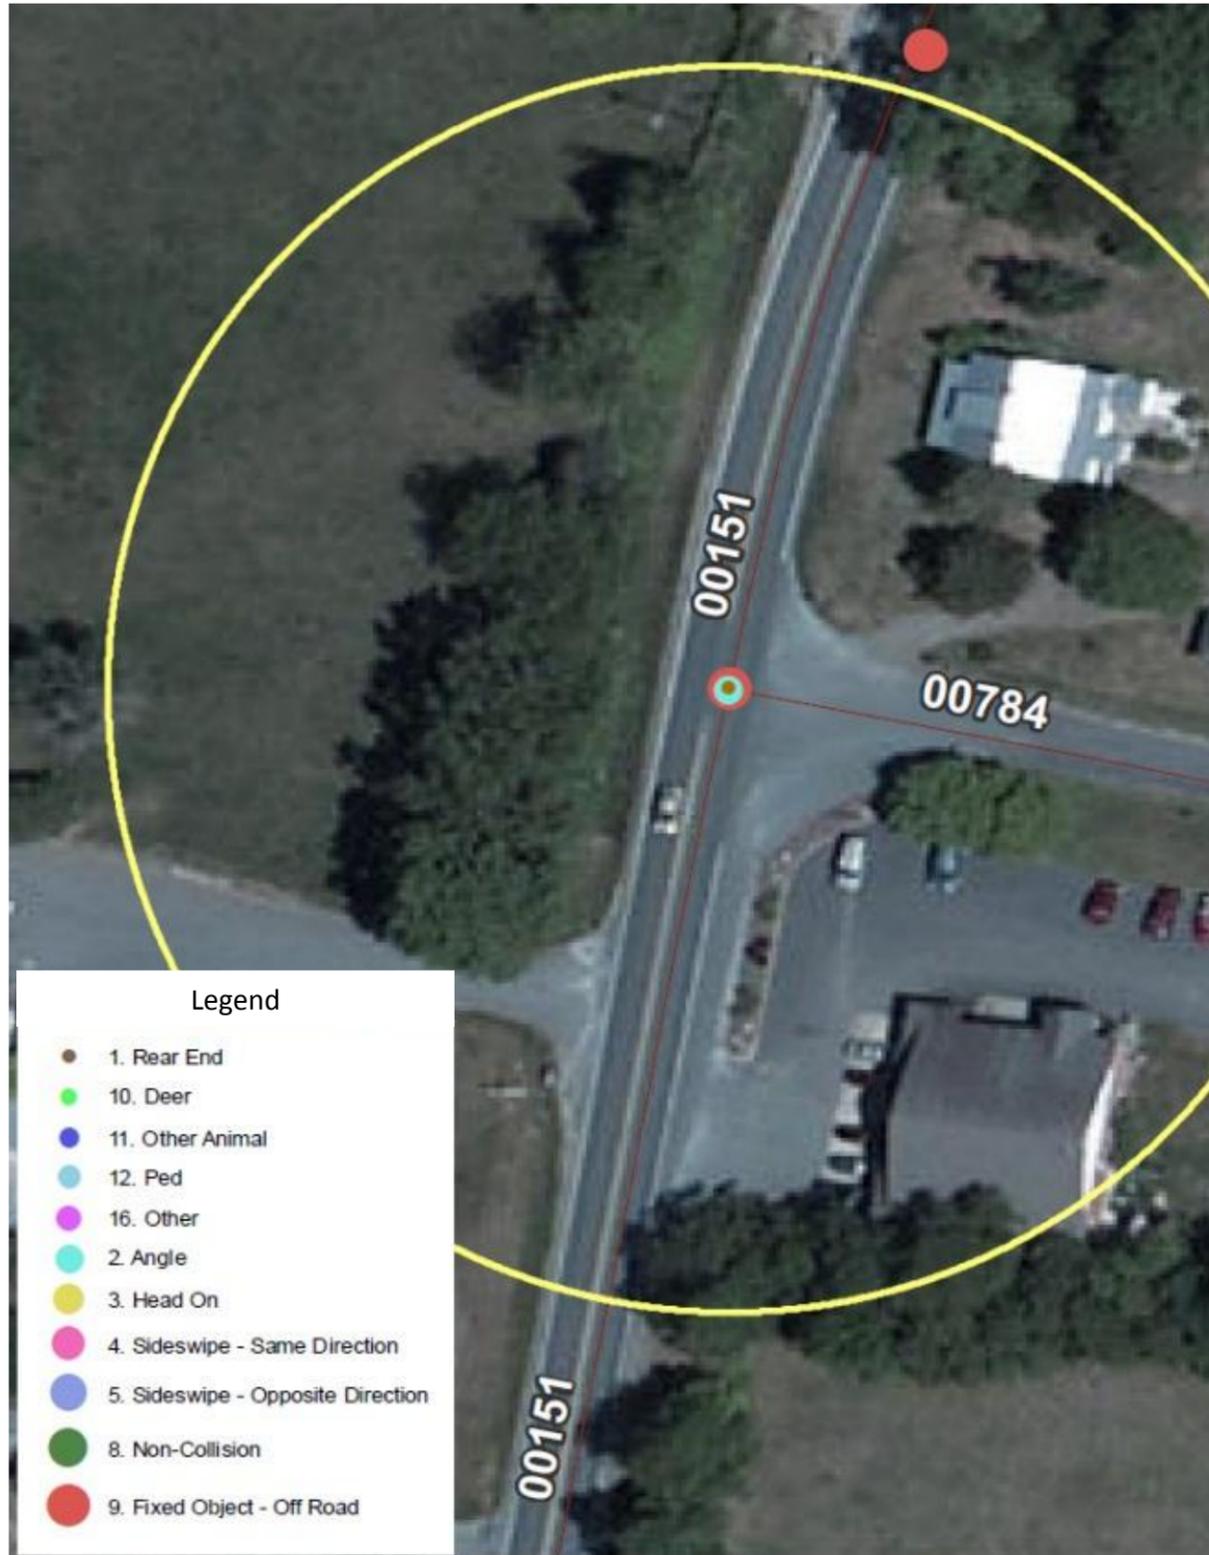
9. Route 784 (Bland Wade Lane) at Route 151

Type	# of Crashes	Severity	Day/ Night
Read-end	1	Injury	Day
Angle	1	Injury	Day
Fixed Object -Off-road	1	Injury	Day
	1	Injury	N.A.

- Limited sight distance to the north, less than 200 feet, affects southbound left turns and Bland Wade traffic.
- Route 151 dips to the south, limiting sight distance.
 - Traffic from 784 cuts through the gym lot to turn left when destined to the south – gets better line of sight.
- Lack of advance signage for Route 784 in the northbound direction, and signage for Route 784 is on the far side of the intersection.
- There is already a constant flashing 35 mph advisory speed sign.

Improvements	Short/Long Term	Potential Safety Benefits
Consider changing flashers to be demand responsive, so that they flash only when a vehicle present (35 mph advisory speed sign with flashers already present)	Short-Term	<ul style="list-style-type: none"> • Increases motorists’ awareness of the speed limit in this section • Alerts speeding drivers and reduces collision potentials and severity
Add a northbound right turn bay	Mid-Term	<ul style="list-style-type: none"> • Reduces the collision potential between through vehicles and turning vehicles stopped at the intersection • Expect 14 percent reduction in crashes based on HSM
Regrade roadway to improve sight distance and eliminate dip in road, or relocate Bland Wade Lane south of the Fitness Center	Long-Term	<ul style="list-style-type: none"> • Increases sight distance in mountain terrain
