Appendix D
Detailed Safety Assessment

Study Area Safety Review

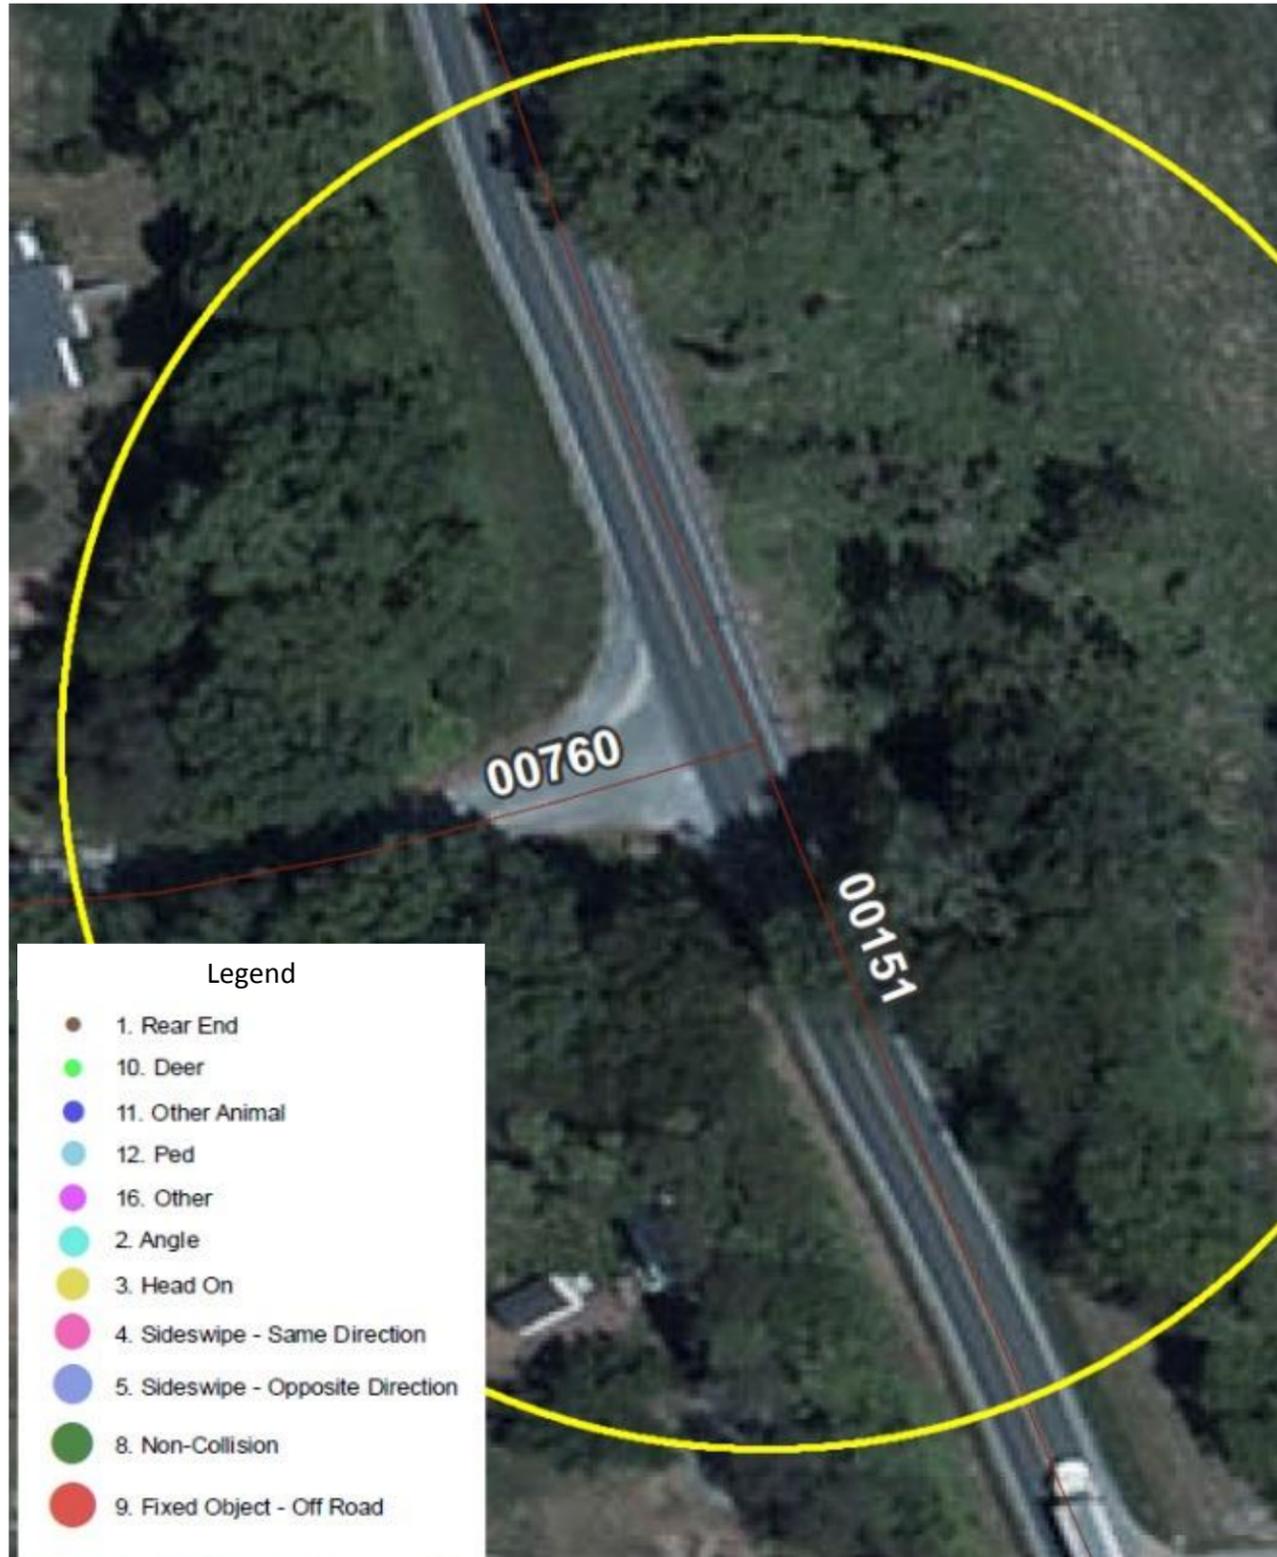
10. Route 760 (Sunrise Drive) at Route 151

- No reported crashes for analysis years
- Crash debris present south of intersection during site visit
- Guardrail condition indicates two (2) off-road accidents
- Frequent deer collisions in the vicinity of the intersection

- Due to crest of hill to the south, left turning traffic is limited in sight distance of northbound vehicles.
 - Regrade hill.
- Guardrail needs rehabilitation, due to recent crashes; note that there is a steep drop-off.
- Crash debris at crest of hill.

Improvements	Short/Long Term	Potential Safety Benefits
Rehabilitate guardrail and improve drainage	Short-Term	<ul style="list-style-type: none"> • Protects off-road vehicles and reduce collision severity
Add Deer Crossing signs	Short-Term	<ul style="list-style-type: none"> • Raises driver awareness of frequent deer crossing the roadway in the vicinity of the intersection
Modify embankment in southwest quadrant	Mid- to Long-Term	<ul style="list-style-type: none"> • Increases sight distance for side street vehicles • Eliminates obstacle within the sight distance triangle
Regrade roadway to reduce crest	Long-Term	<ul style="list-style-type: none"> • Increases sight distance in mountain terrain

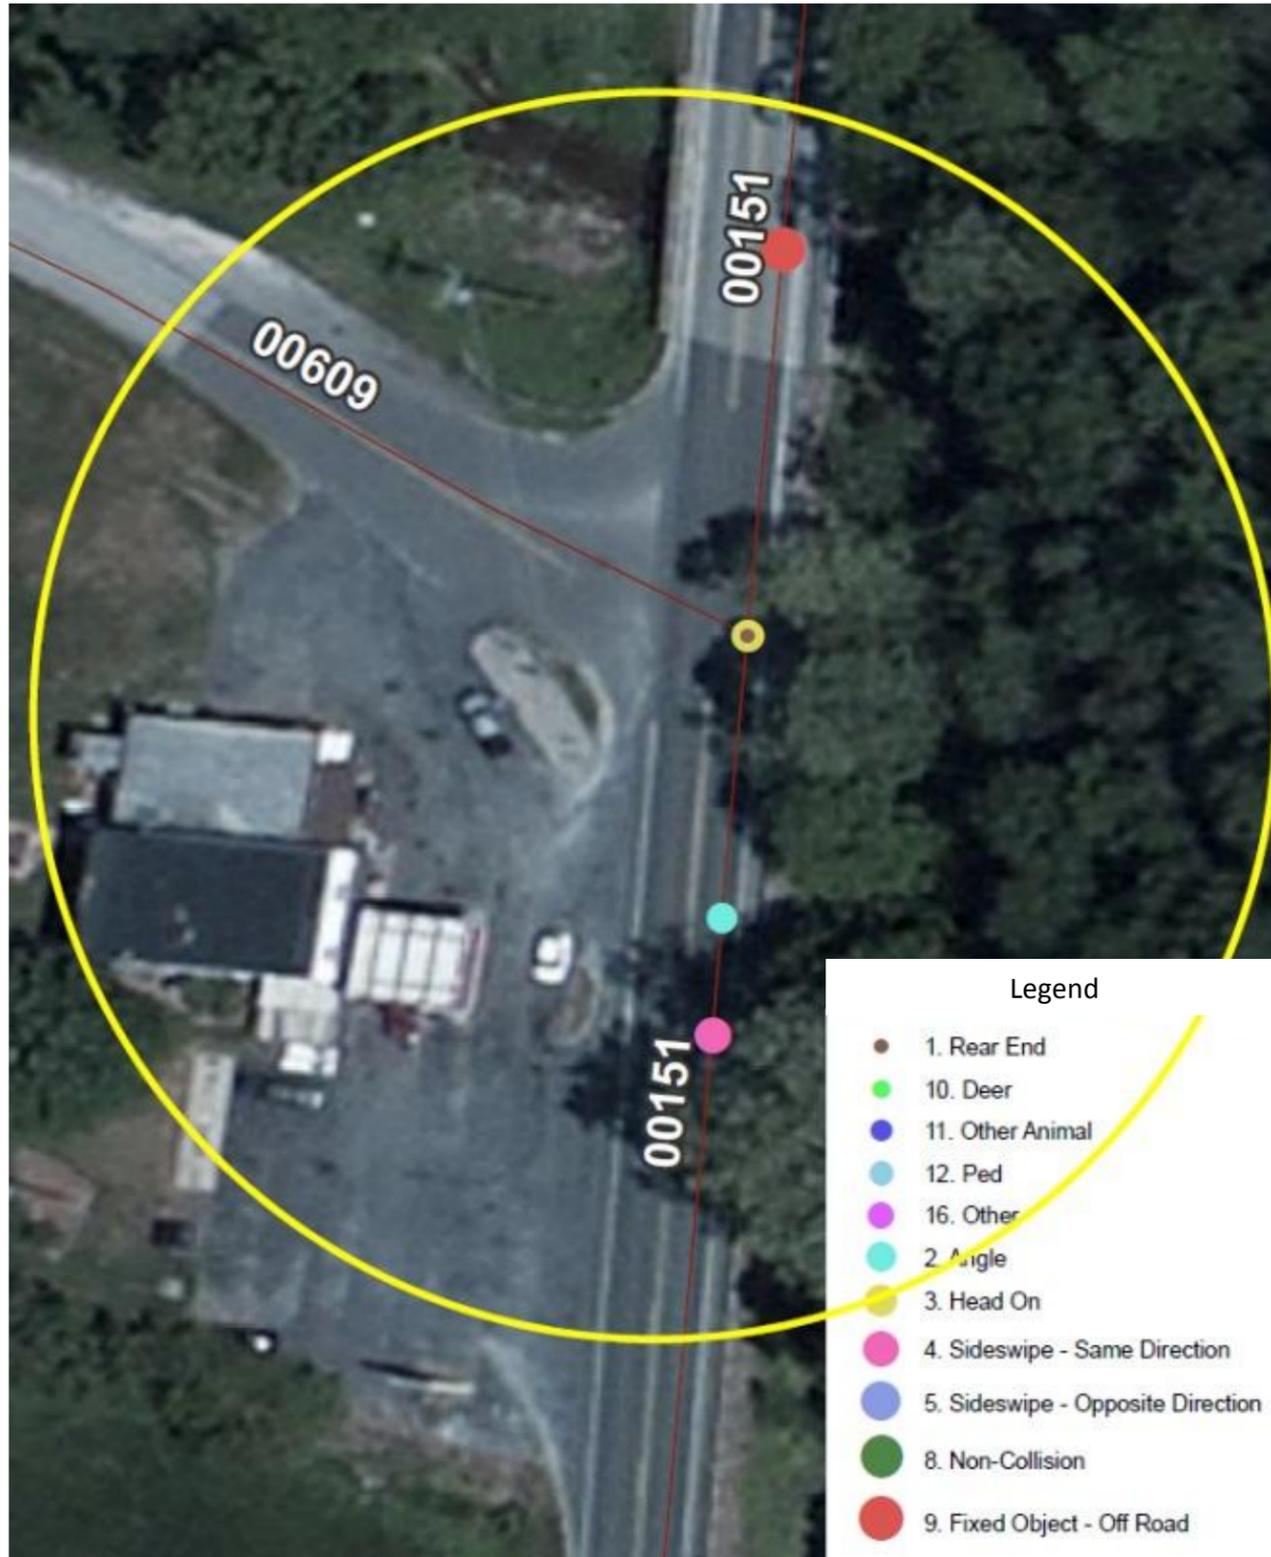
11. Route 609 (Mill Lane) at Route 151

Type	# of Crashes	Severity	Day/ Night
Read-end	1	Property Damage	Night
Angle	1	Property Damage	Day
Fixed Object -Off-road	1	Property Damage	Night
Side-swipe	1	Property Damage	Day
Head-on	1	Injury	Day

- Poor sight distance:
 - The parapet wall of the Goodwins Creek Bridge can restrict sight distance for Mill Road traffic looking north.
 - Overgrown vegetation
- Poor access management: driveways of gas station are in close proximity of the intersection.

Improvements	Short/Long Term	Potential Safety Benefits
Trim vegetation along the west side of Route 151	On-going	<ul style="list-style-type: none"> • Increases sight distance • Eliminates obstacle within the sight distance triangle
Improve signage on Route 151 for Route 609	Short-Term	<ul style="list-style-type: none"> • Increases intersection visibility and motorists' awareness
Improve access management	Mid-Term	<ul style="list-style-type: none"> • Limits disturbances from driveways and reduce inter-parcel traffic's usage of mainline
Widen bridge structure	Long-Term	<ul style="list-style-type: none"> • Increases sight distance for traffic on Mill Road

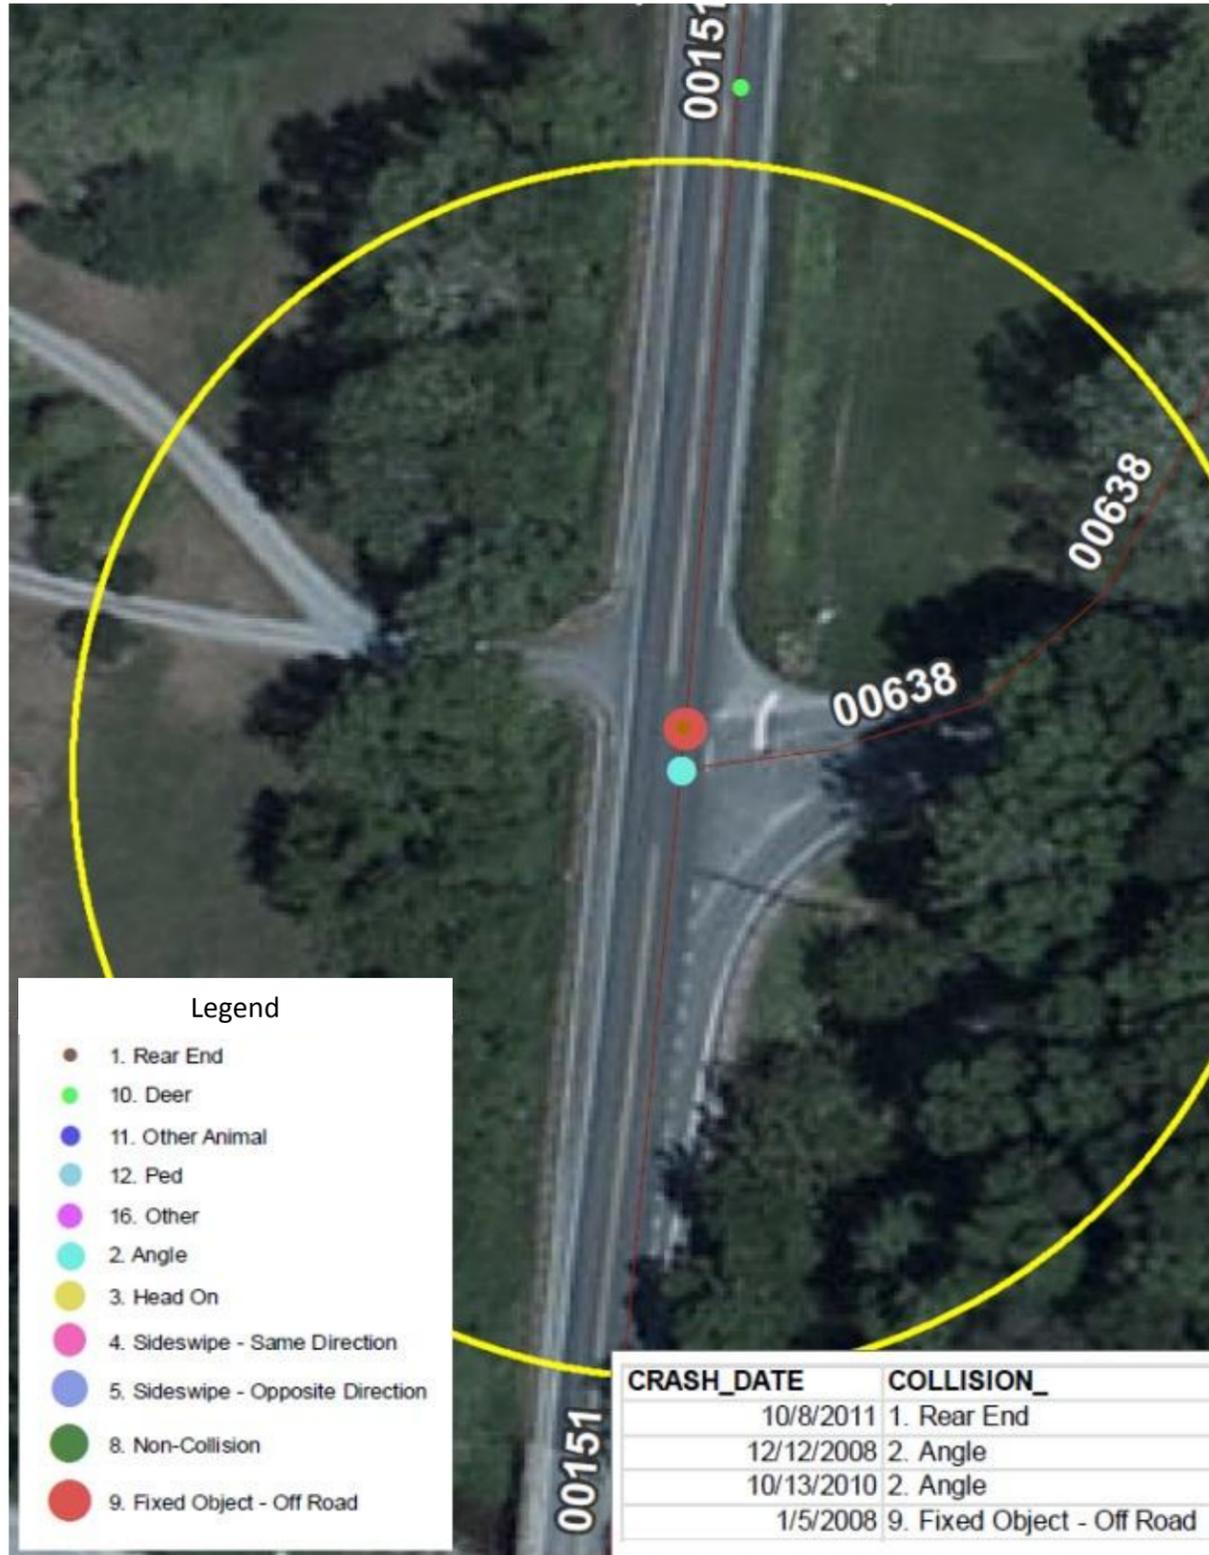
12. Route 638 S (Avon Road) at Route 151

Type	# of Crashes	Severity	Day/ Night
Read-end	1	Injury	Day
Angle	1	Injury	Day
	1	Property Damage	Day
Fixed Object -Off-road	1	Property Damage	Day

- Overgrown vegetation on the eastside of the roadway can restrict sight distance for Avon Road traffic looking south.
- Stop bar is to far back from roadway.
- Frequent deer collisions north if intersection

Improvements	Short/Long Term	Potential Safety Benefits
Move stop bar closer to roadway to improve sight distance	Short-Term	<ul style="list-style-type: none"> • Increases sight distance for turning vehicles
Add Deer Crossing signs	Short-Term	<ul style="list-style-type: none"> • Raises driver awareness of frequent deer crossing the roadway in the vicinity of the intersection
Trim vegetation along the east side of Route 151	On-going	<ul style="list-style-type: none"> • Increases sight distance • Eliminates obstacle within the sight distance triangle

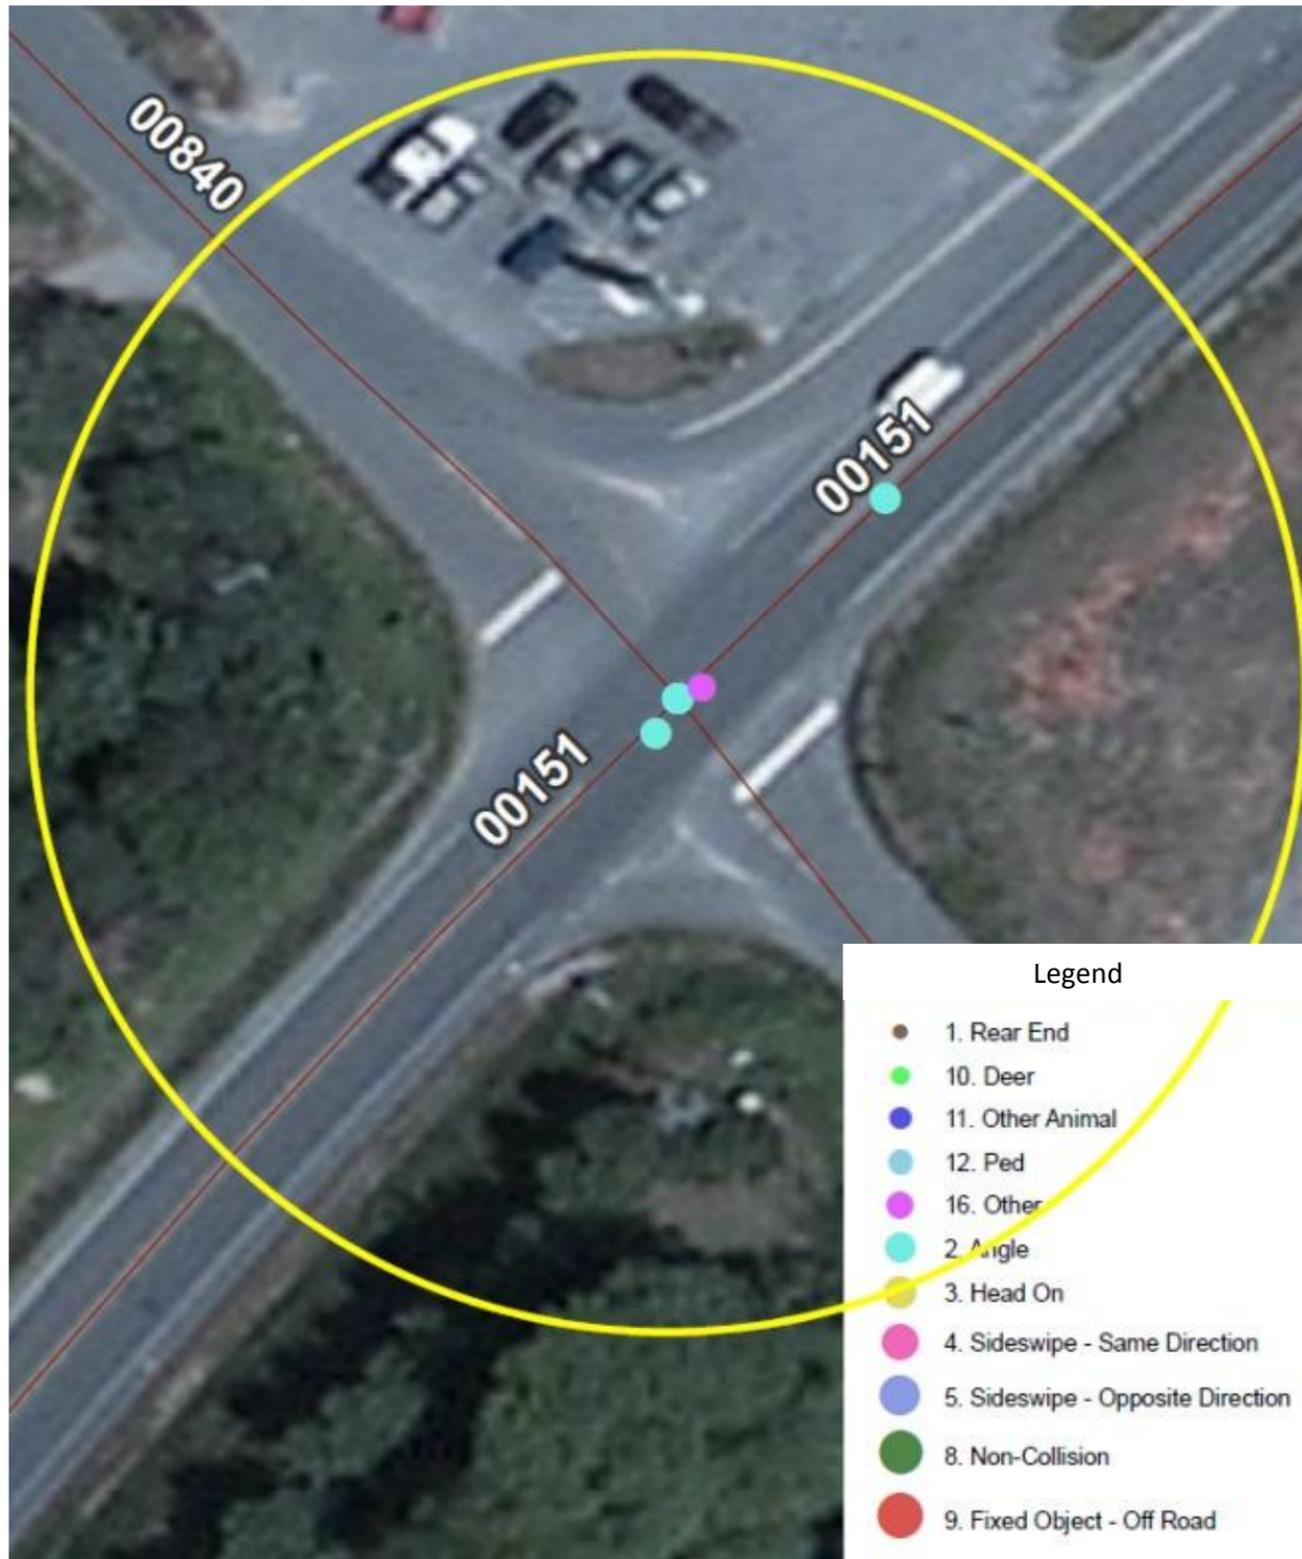
13. Route 840 (Tanbark Drive) at Route 151

Type	# of Crashes	Severity	Day/ Night
Read-end	1	Property Damage	Day
Angle	1	Injury	Day
	2	Injury	Night
	1	Property Damage	Day
	1	Property Damage	Night
Other	1	Property Damage	N.A.

- Yellow and stop bar pavement markings are faded on both minor approaches.
- The eastbound approach (Tanbark Drive) dips as the roadway approaches Route 151, which hides the view of Route 151 until the vehicle is immediately near the intersection.
- Embankment in southwest quadrant limits sight distance to the south for eastbound Tanbark Drive.
- Embankment in southeast quadrant limits sight distance to the south for westbound Tanbark Drive. Utilities/trees are present at the edge of the embankment's top which may limit opportunities to regrade embankment, appears to have been regraded in the past 5 years.

Improvements	Short/Long Term	Potential Safety Benefits
Refresh yellow lines and stop bars and relocate stop sign	Short-Term	<ul style="list-style-type: none"> • Increases intersection visibility and motorists' awareness
Add intersection ahead signs on Route 840	Short-Term	<ul style="list-style-type: none"> • Increases intersection visibility and motorists' awareness
Add 45mph advisory sign to the existing Intersection Warning Sign	Short-Term	<ul style="list-style-type: none"> • Encourages drivers to reduce speed • Reduces collision potentials and severity
Consider rumble strips for Route 840 approaches to Route 151	Short-Term	<ul style="list-style-type: none"> • Increases motorists' awareness of upcoming intersection
Regrade Tanbark Road to improve visibility to Route 151	Long-Term	<ul style="list-style-type: none"> • Increases sight distance • Eliminates obstacle within the sight distance triangle

Regrade embankment in the southwest and southeast quadrants	Long-Term	<ul style="list-style-type: none"> • Increases sight distance • Eliminates obstacle within the sight distance triangle

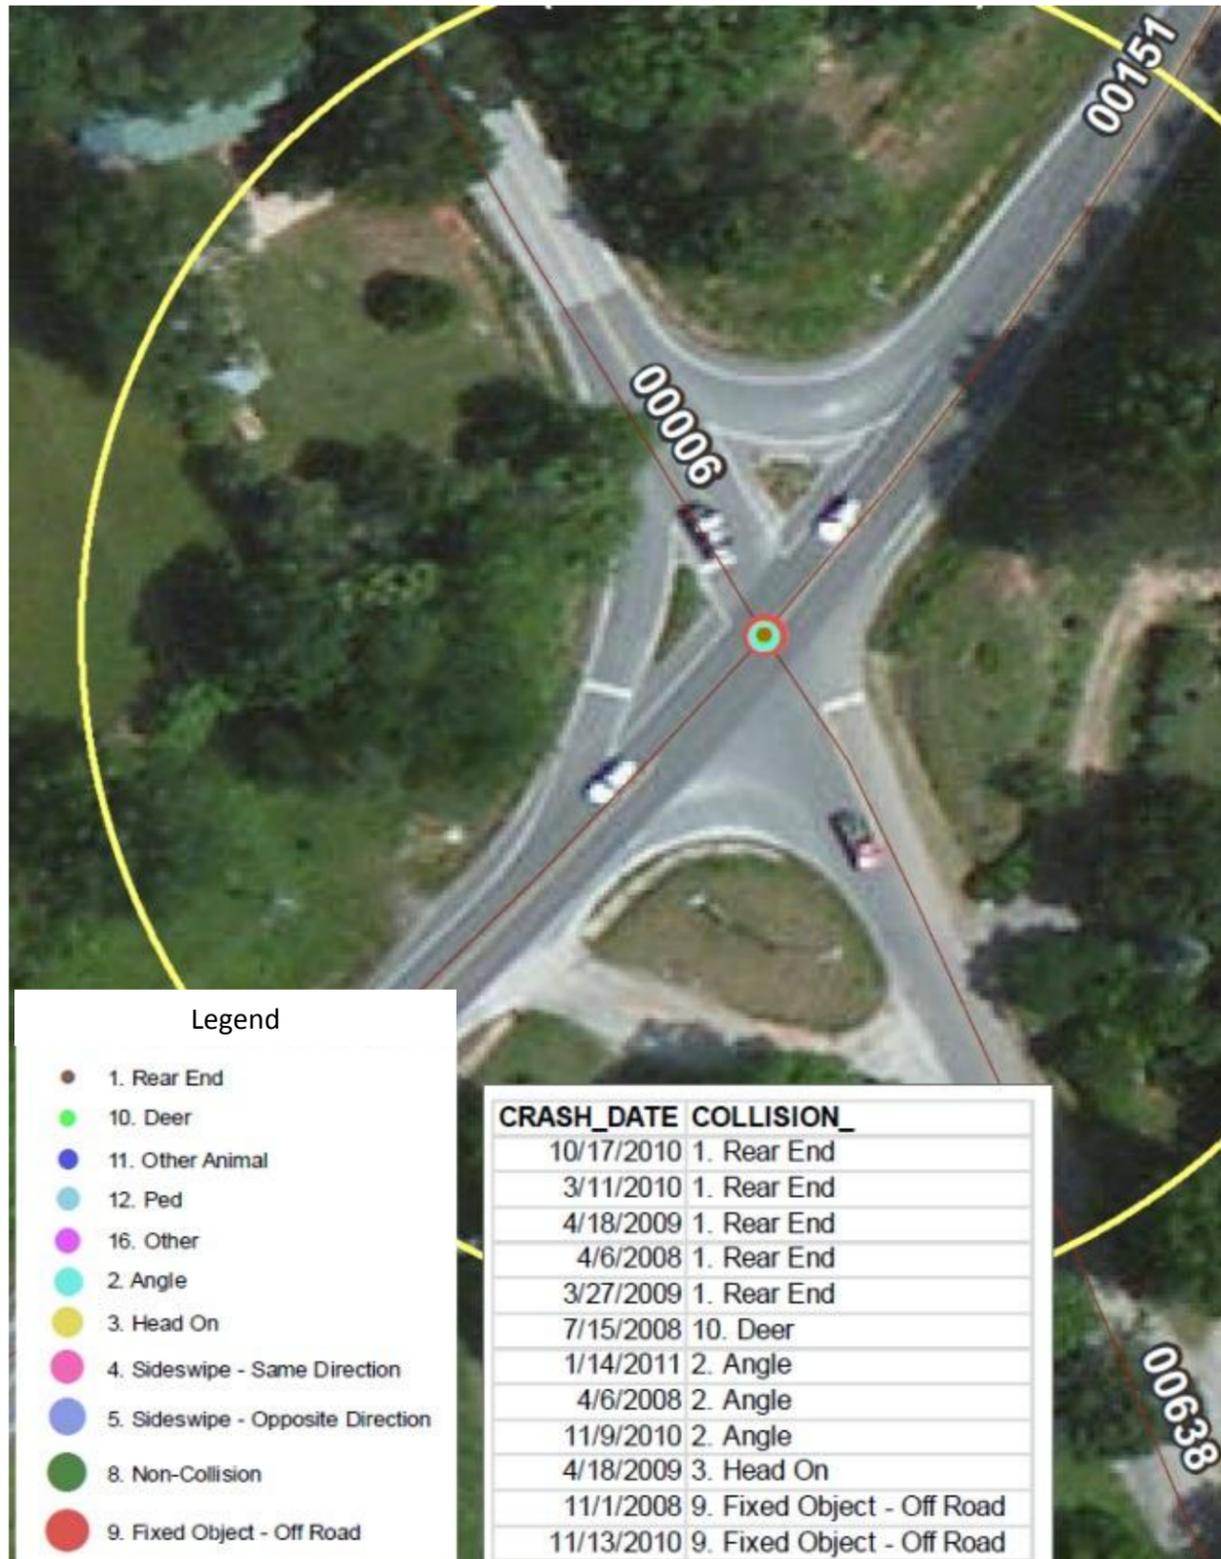
14. Route 6 (Afton Mountain Road) and Route 638 North (Avon Road) at Route 151

Type	# of Crashes	Severity	Day/ Night
Rear-end	2	Injury	Day
	2	Injury	Night
	1	Property Damage	Day
Angle	1	Injury	Night
	2	Property Damage	Day
Other Types	1	Injury	Day
	3	Property Damage	Night

- Route marker sign and vegetation block view of the stop sign on Route 6 eastbound approach.
- Stop signs are not consistent in size on the eastbound approach.
- Eastbound right turning angle is poor, forcing drivers to really look over their shoulder, curvature of roadway increases issue.
- Sight distance for vehicles looking to the south is also an issue as Route 151 dips.

Improvements	Short/Long Term	Potential Safety Benefits
Add left turn lanes for the northbound and southbound approaches *	Short-Term	<ul style="list-style-type: none"> • Reduces the collision potentials between through vehicles and turning vehicles stopped at the intersection • Expect 48 percent reduction in crashes based on HSM
Reconfigure eastbound right turn lane to reduce skew by 20 percent	Short-Term	<ul style="list-style-type: none"> • Improve sights distance • Reduces the chance of left turn vehicles to turn onto wrong way on Route 151 • Expect 8 percent reduction in crashes based on HSM
After the above improvements implemented, monitor need to add rumble strips on Route 6 and Route 638 approaches to Route 151	Mid-Term	<ul style="list-style-type: none"> • Increases motorists' awareness of upcoming intersection
After the above improvements implemented, monitor need to add acceleration lane to assist eastbound right turning vehicles to merge into southbound traffic	Mid-Term	<ul style="list-style-type: none"> • Improves merging conditions and reduces merging conflicts

Regrade Routes 6 and 638 approaches to the intersection	Long-Term	<ul style="list-style-type: none"> • Increases sight distance
VDOT recently reviewed Route 151 to the north, improved signage	Completed	<ul style="list-style-type: none"> • Increases intersection visibility and motorists' awareness

* VDOT has approved an HSIP grant to construct a northbound left turn lane. Preliminary start date for construction is March 2016.

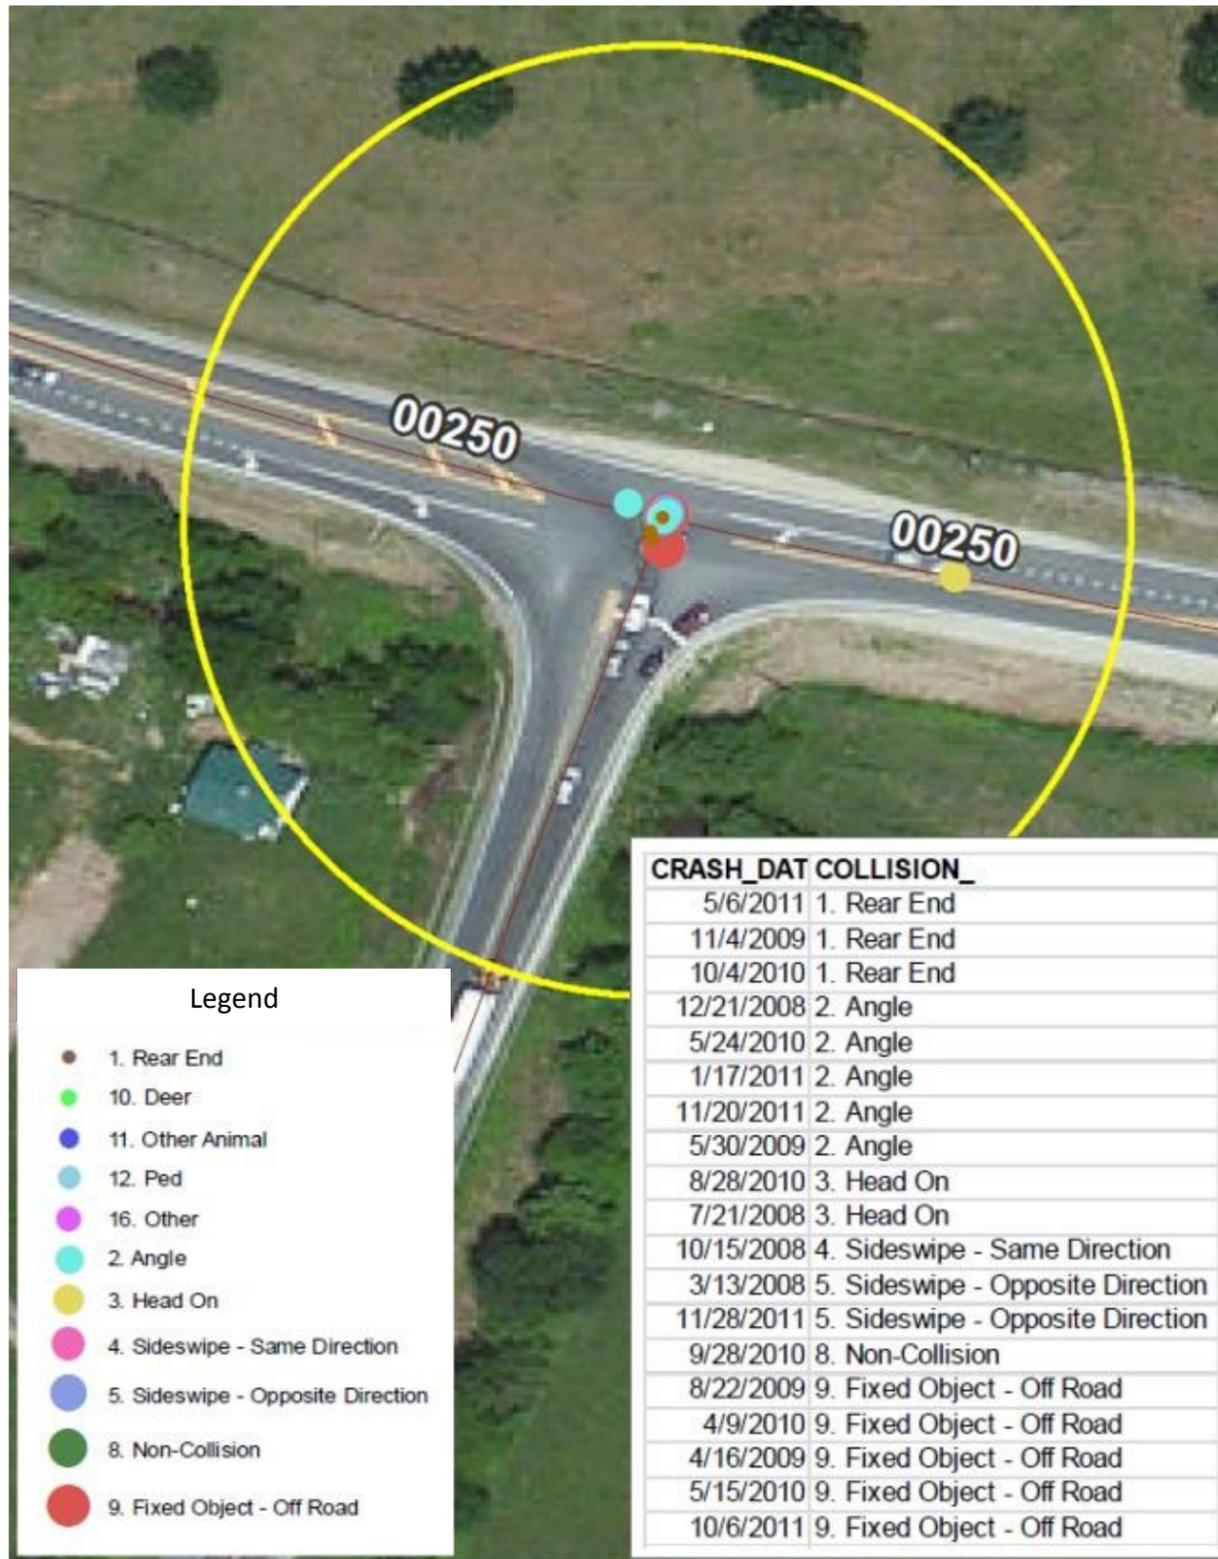
15. US Route 250 (Rockfish Gap Turnpike) at Route 151

Type	# of Crashes	Severity	Day/ Night
Rear-end	3	Injury	Day
Angle	3	Injury	Day
	2	Property Damage	Day
Head-on	1	Injury	Day
	1	Property Damage	Day
Fixed Object – Off Road	1	Injury	Day
	4	Property Damage	Night
Other Types	1	Injury	Day
	2	Property Damage	Day
	1	Property Damage	Night

- U.S. Route 250 eastbound right turning traffic blocks line of sight of eastbound through traffic for Route 151 turning traffic. The curve on U.S. Route 250 makes it difficult to differentiate eastbound rights from eastbound through movement vehicles.
- The westbound left turn queue often spills into the westbound through lane, as the turn bay is insufficient in length. U.S. Route 250 westbound through traffic is driving around the queued vehicles, by driving on the shoulder and the grass.

Improvements	Short/Long Term	Potential Safety Benefits
Extend the westbound left turn lane	Short- to Mid-Term	<ul style="list-style-type: none"> • Reduces the chance of queuing vehicles spilling back to the through lanes • Reduces the collision potential between through vehicles and turning vehicles stopped at the intersection
Offset the eastbound right turn bay by 12 feet to improve visibility of eastbound through vehicles	Mid-Term	<ul style="list-style-type: none"> • Improves visibility of eastbound through vehicles
Add a northbound right turn lane. If a signal or roundabout will not be installed, add an acceleration lane on US Route 250	Mid-Term	<ul style="list-style-type: none"> • Reduces the collision potential between through vehicles and turning vehicles stopped at the intersection • Expect 14 percent reduction in crashes based on HSM
Consider street lighting	Mid-term	<ul style="list-style-type: none"> • Increases visibility of the intersection at night time, would reduce off-road crashes

Consider a roundabout (Option A)	Mid-Term	<ul style="list-style-type: none"> • Relatively low traffic circulation speed • Reduces conflicting points and angles • Reduces collision potential and severity • Expect 44 percent reduction in crashes based on HSM
Consider a traffic signal (Option B)	Mid-Term	<ul style="list-style-type: none"> • Eliminates conflicting points • Reduces collision potentials and severity • Expect 44 percent reduction in crashes based on HSM
