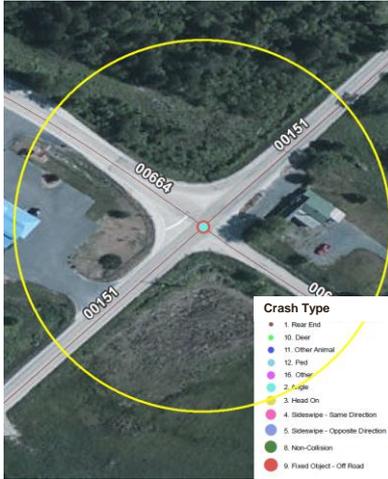
## 1) Rte. 151 at Rte. 664 (Beech Grove Road)

- Angle
- Off-road

- Heavy southbound right turn traffic
- Overgrown vegetation
- Confusing signage

- Add southbound offset right turn bay
- Trim vegetation in northwest quadrant
- Adjust signage along northbound Rte. 151

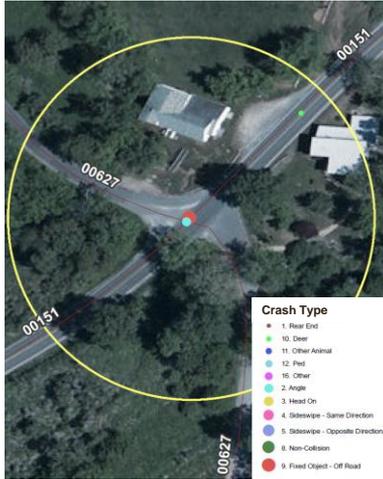
## 2) Rte. 151 at Rte. 627 (Spruce Creek Lane)

- Angle
- Off-road
- Wildlife

- Poor sight distance
- Odd alignment of Rte. 627 affects turning traffic
- Location of driveways within intersection area
- Potential historic structure (mill foundation)

- Modify embankment in southwest quadrant
- Realign Rte. 627 to improve sight distance
- Add intersection-ahead signage with flashers on the northbound approach

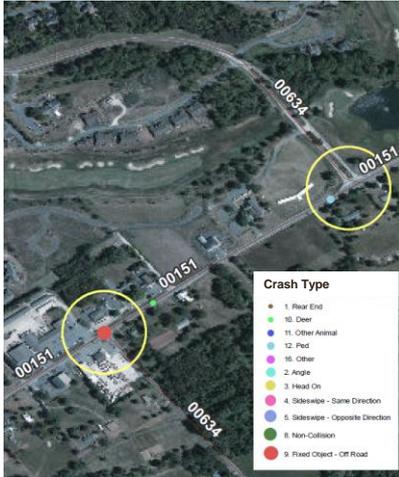
### 3) Rte. 151 at Rte. 634 (Nellysford area)

- Pedestrian
- Off-road
- Wildlife

- Lack of pedestrian facilities
- Access Management/Poor inter-parcel connectivity
- Vegetation on Rte. 634 (Adial Road) limits sight distance approaching Rte. 151

- Add sidewalks for pedestrians
- As new development or re-development occurs, improve access management and inter-parcel connectivity
- On Adial Road, trim vegetation and relocate stop sign
- Reduce speed limit to 35 mph through Nellysford

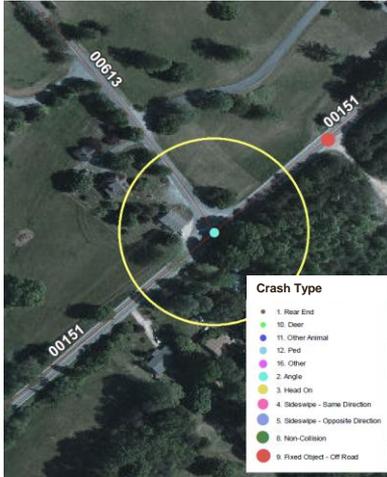
## 4) Rte. 151 at Rte. 613 (Rodes Farm and Lodebar Estates)

- Angle
- Off-road

- Crest in road between Rodes Farm Road and Lodebar Estates limits sight distance
- Embankment along east side of Rte. 151 also contributes to sight distance issues
- Drivers have to be aggressive turning onto Rte. 151

- Regrade roadway in area to improve sight distance
  - Reduce crest of hill
  - Regrade embankment

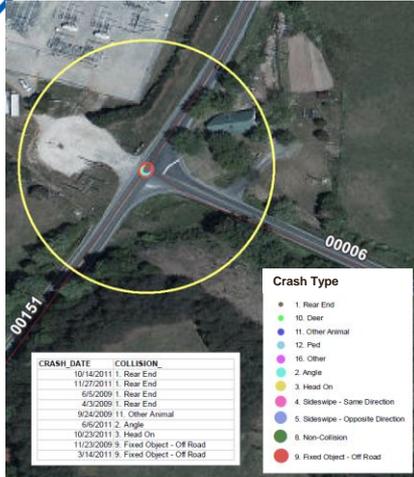
## 5) Rte. 151 at Rte. 6 (River Road)

- 4 Rear-end
- 1 Angle
- 2 Off-road

- Heavy turning truck traffic
- Lack of turn lane
- Narrow receiving area, vehicles are crossing yellow lines (traveling into opposite lane)

- Widen east leg of intersection for wider receiving area to accommodate turning vehicles
- Consider roundabout

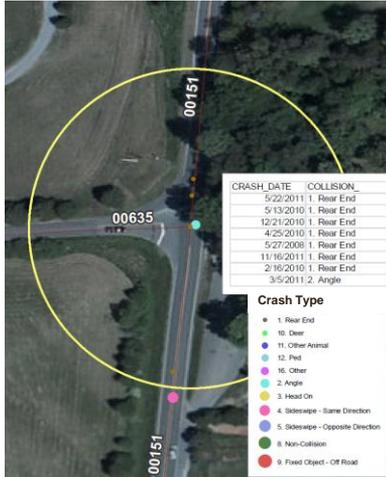
## 6) Rte. 151 at Rte. 635 (Rockfish School Lane)

- 7 Rear-end
- 1 Angle

- **Increased in crashes last two years**
  - Due to addition of Recycling Drop-off at Community Center
  - Park activities generate high traffic: soccer fields, horse and dog shows
- **Lack of turn lanes**

- **VDOT is currently in process to obtain HSIP grant to add a northbound turn lane**

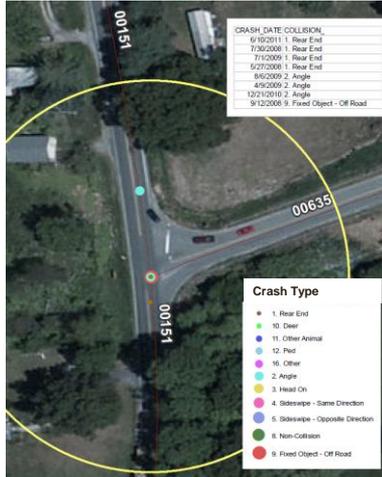
## 7) Rte. 151 at Rte. 635 (Greenfield Road)

- 4 Rear-end
- 3 Angle
- 1 Fixed object/off-road
- Most in 2008 & 2009

- Location recently improved
- Short northbound right turn bay

- Extend northbound right turn bay

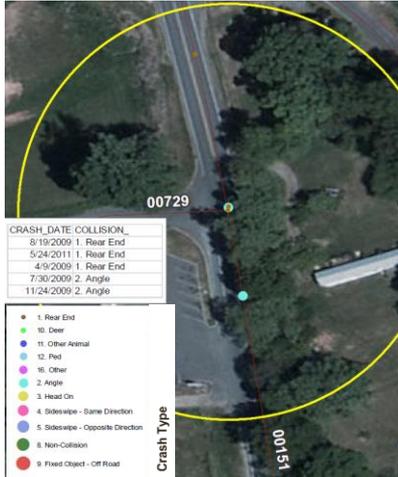
## 8) Rte. 151 at Rte. 729 (Creek Road)

- 3 Rear-end
- 2 Angle

- Turning traffic and lack of turn bays
- Heavy traffic generator (store)

- Restripe roadway to provide northbound left turn into the store's southern access
- Add a southbound right turn bay onto Creek Road

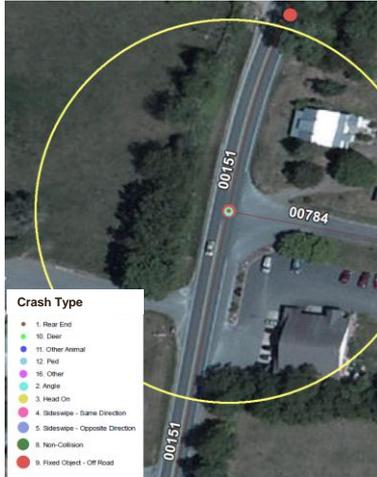
## 9) Rte. 151 at Rte. 784 (Bland Wade Lane)

- 1 Rear-end
- 1 Angle
- 2 Off-road

- Limited sight distance due to hill in northeast quadrant
- Limited sight distance due to dip in road to the south
- **Businesses (Fitness Center, former Doctor's office) at intersection**
  - Traffic cuts through Fitness Center lot

- Regrade hill to improve sight distance and eliminate dip in road
- Add a northbound right turn bay
- 35 mph advisory speed sign with flashers already present

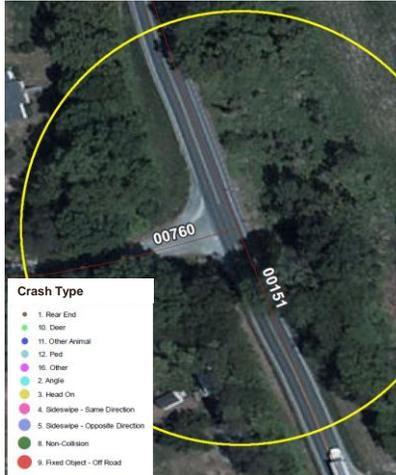
## 10) Rte. 151 at Rte. 760 (Sunrise Drive)

- Crash debris present south of intersection during site visit
- Guardrail condition indicates two accidents

- Limited sight distance due to crest in roadway to the south
- Portion of guardrail in poor condition

- Regrade roadway to reduce crest
- Modify embankment in southwest quadrant
- Rehabilitate guardrail and improve drainage

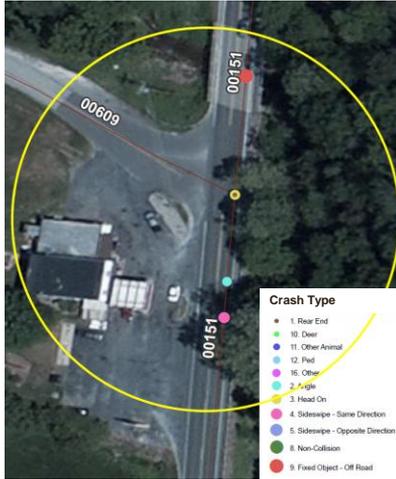
## 11) Rte. 151 at Rte. 609 (Mill Lane)

- 1 Rear-end
- 1 Angle
- 1 Fixed Object/Off-road
- 1 Sideswipe

- **Poor sight distance**
  - Goodwins Creek bridge
  - Overgrown vegetation
- **Driveways of gas station in close proximity of intersection**

- **Trim vegetation**
- **Improve access management**
- **Improve signage on Rte. 151 for Rte. 609**
- **Widen bridge structure**

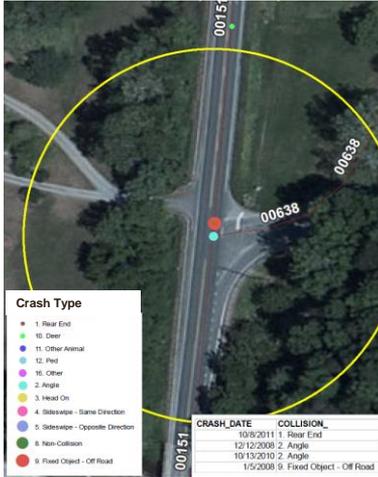
## 12) Rte. 151 at Rte. 638 (Avon Road - south)

- 1 Rear-end
- 1 Angle
- 1 Fixed Object/Off-road

- Driver inattention
- Overgrown vegetation in southeast quadrant limits sight distance
- Stop bar too far back

- Move stop bar closer to roadway to improve sight distance
- Trim vegetation

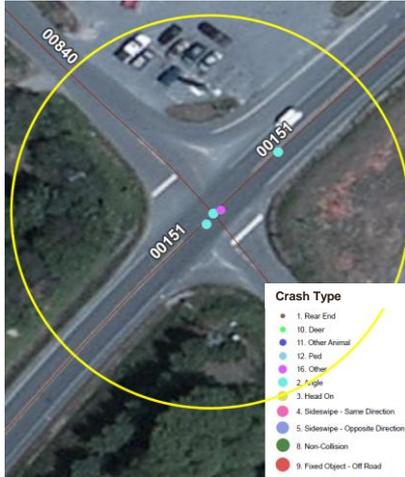
## 13) Rte. 151 at Rte. 840 (Tanbark Road)

- 3 Angle
- 1 other

- Site of two fatalities in a 2012 crash
- Yellow lines and stop bars faded on Tanbark Road
- Crest on Tanbark Road limits approach sight distance
- Embankments limits sight distance

- Refresh yellow lines and stop bars and relocate stop sign
- Add intersection ahead signs on Rte. 840
- Add 45mph advisory sign to the existing Intersection Warning Sign
- Regrade Tanbark Road to improve visibility to Rte. 151
- Improve Tanbark Road at Greenberry Road
- Cut embankment back in southwest quadrant
  - Not possible to cut embankment in southeast quadrant

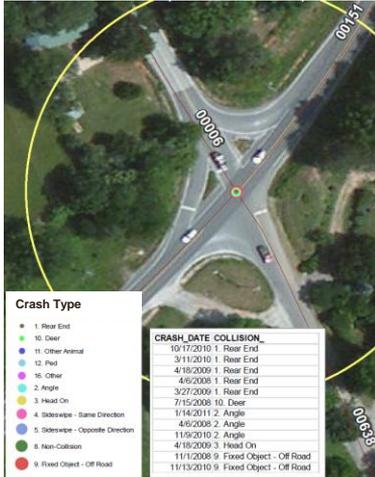
## 14) Rte. 151 at Rte. 6 (Afton Mountain Road)

- 5 Rear-end
- 3 Angle
- 4 other types

- Minor road dips on approach to Rte. 151, hiding view until vehicles near intersection
- Vegetation in southwest quadrant limits sight distance
- Stop signs not consistent in size
- Eastbound right turn approach is at an awkward angle, drivers looking over shoulder to see southbound vehicles
- Dip on Rte. 151 to the south limits sight distance
- Heavy turning volume during tourist season

- Regrade Rte. 6, and make stop signs a consistent size
- Reconfigure eastbound right turn lane or add acceleration lane
- VDOT is currently in process to obtain HSIP grant to add turn lanes
- VDOT recently reviewed Rte. 151 to the north, improved signage

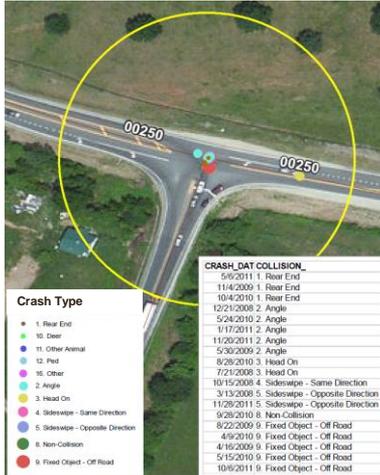
## 15) Rte. 151 at US 250 (Rockfish Gap Turnpike)

- 3 Rear-end
- 5 Angle
- 2 Head-on
- 5 Fixed Object/Off-road
- 4 other types

- **Heavy turn movements with short turn bays**
  - Eastbound US 250 right turning vehicles block Rte. 151 traffic's view of the through movement
  - Westbound US 250 left turning traffic queue extends into through lane, through vehicles driving around on grass area

- **Offset the eastbound right turn bay by 12 feet to improve visibility of eastbound through vehicles**
- **Extend the westbound left turn lane**
- **Add a northbound right turn lane with an acceleration lane**
- **Consider a traffic signal or a roundabout**
