**ROUTE 120 (NORTH GLEBE ROAD) OVER PIMMIT RUN
BRIDGE REHABILITATION
ARLINGTON COUNTY
PROJECT NO. 0120-000-870, P101; UPC 114105
PROJECT NO. 0120-000-867, B623; UPC 111691**

Shahrad Behboodi, PE – Project Manager, Structure & Bridge

July, 2020

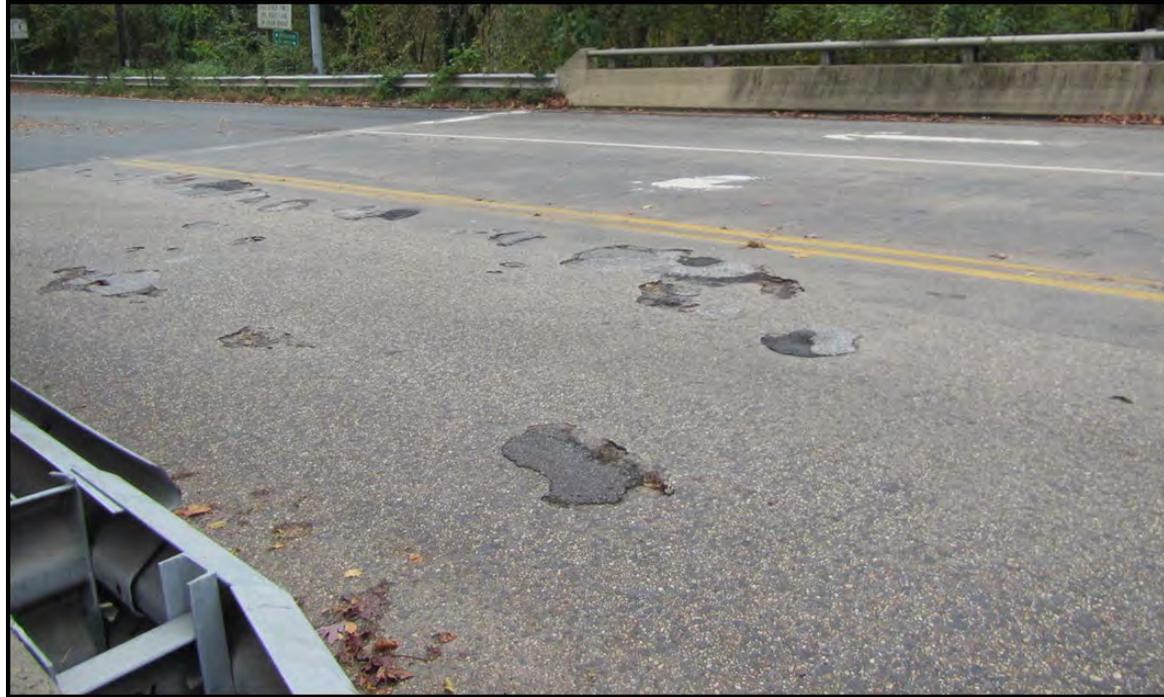
BRIDGE DECK

Numerous potholes in bridge deck deteriorating surface
Condition Rating of 5 of 9 (Fair)

- **Proposed work: Replace the entire bridge deck and supporting beams**

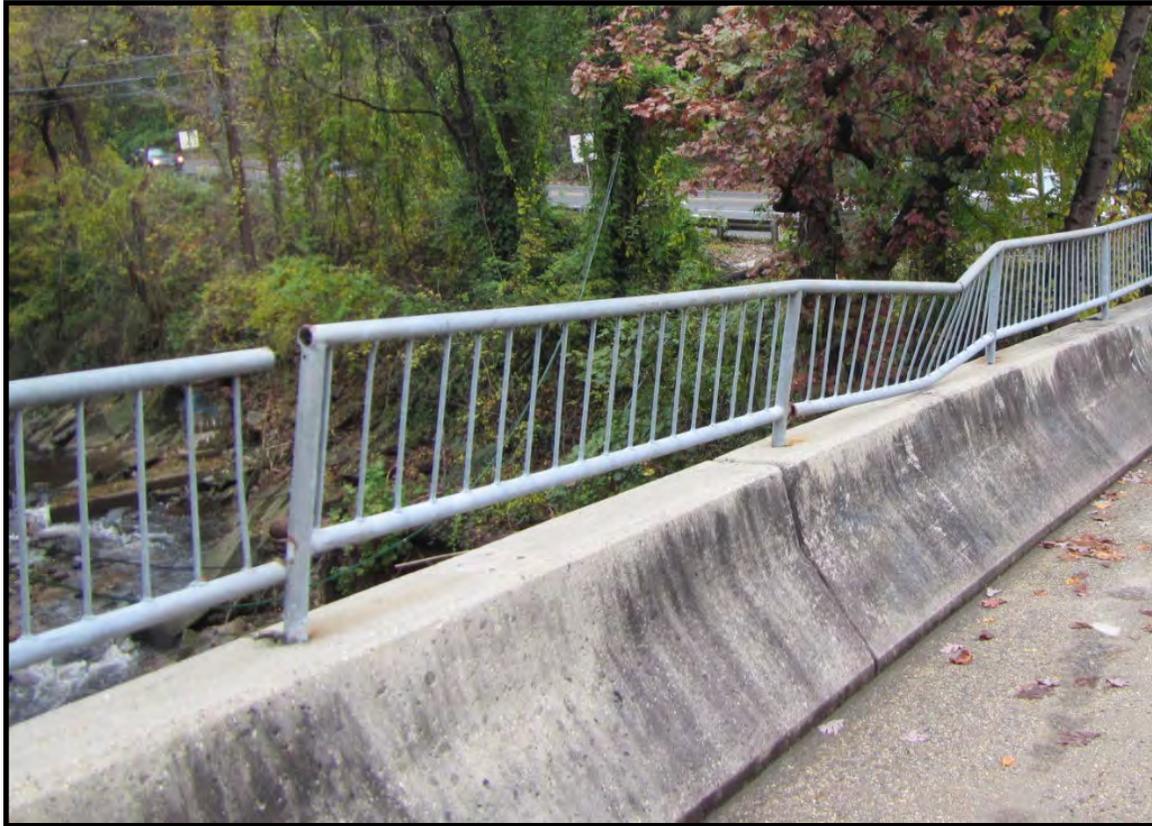
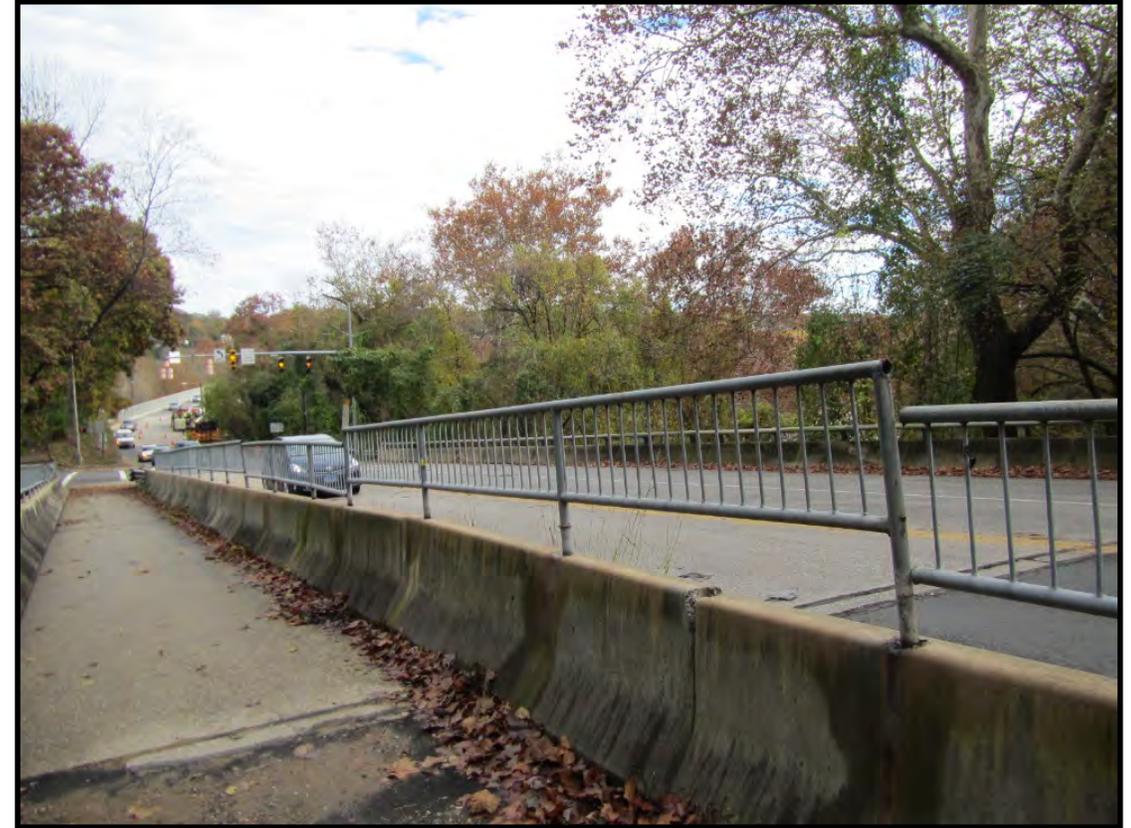
BRIDGE RAILINGS

Damaged and misaligned handrails

➤ **Proposed work: Replace the barriers and handrails**

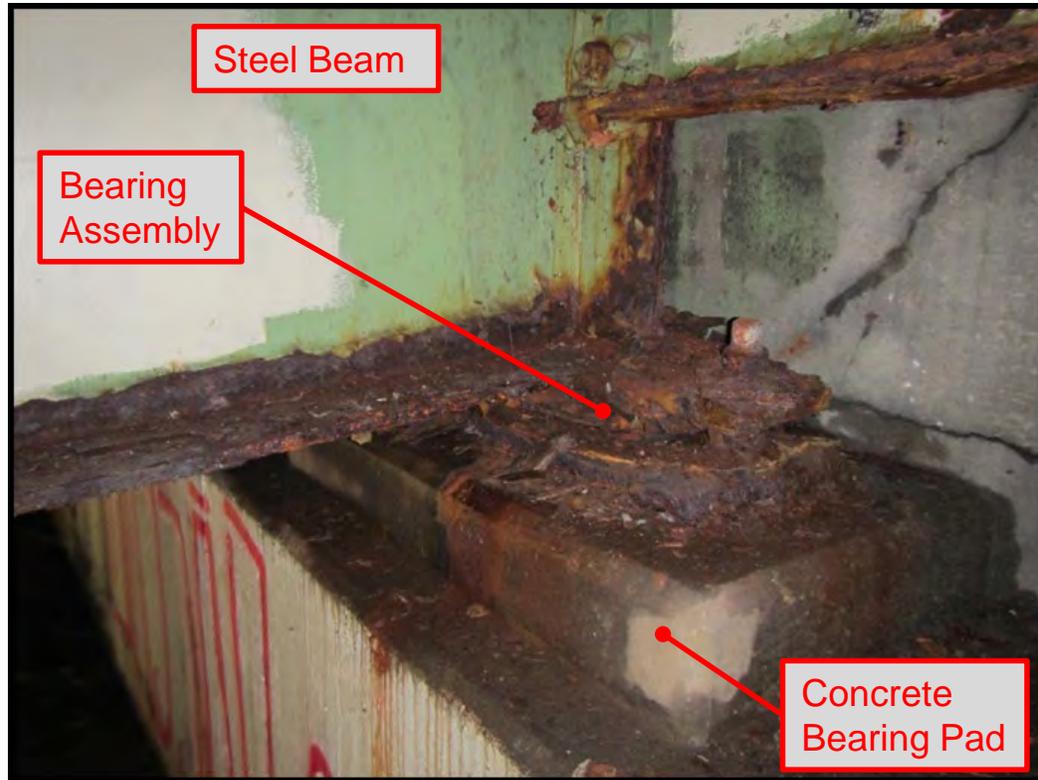
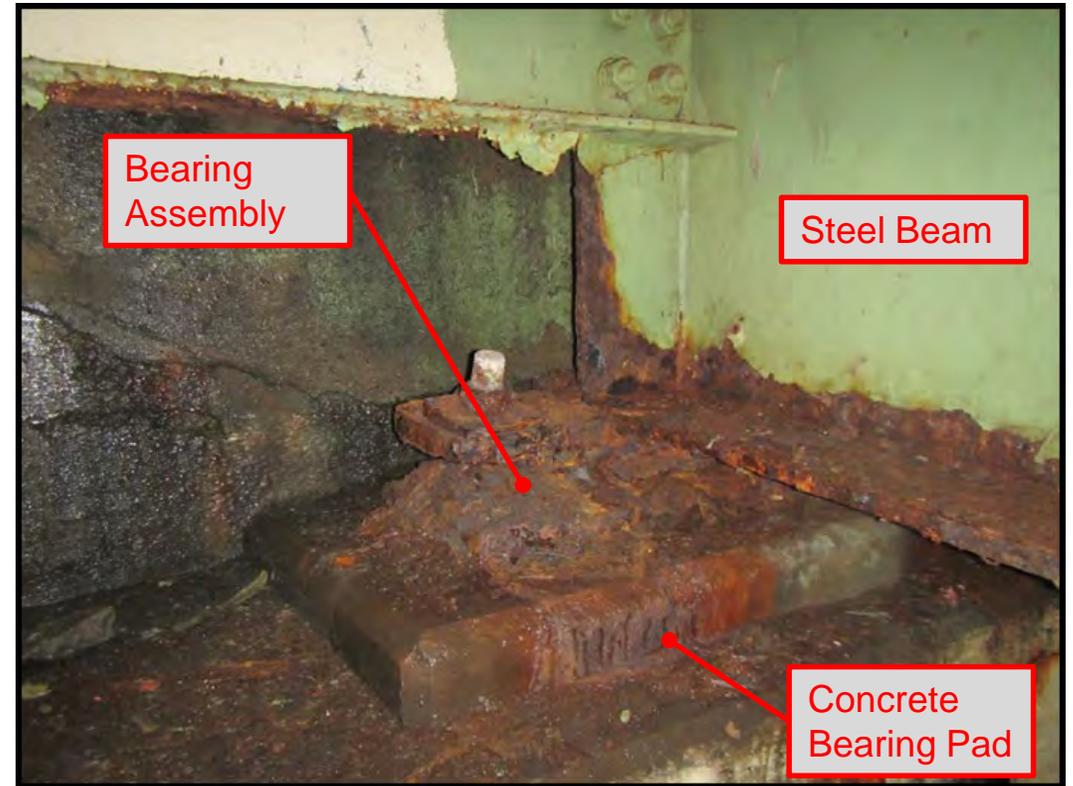
BEAMS AND BEARINGS

Heavily corroded beams and bearings

Condition Rating 4 of 9 (Poor, Structurally Deficient)

- **Proposed work: Replace bearings and steel beams supporting the deck**

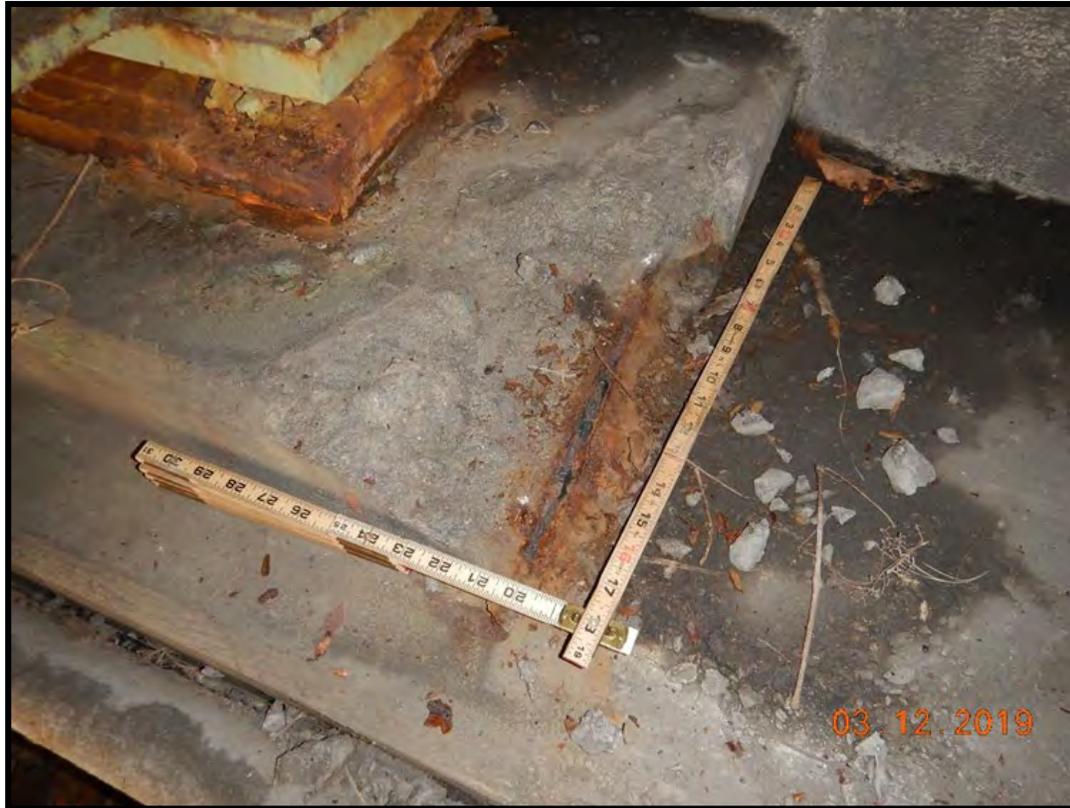
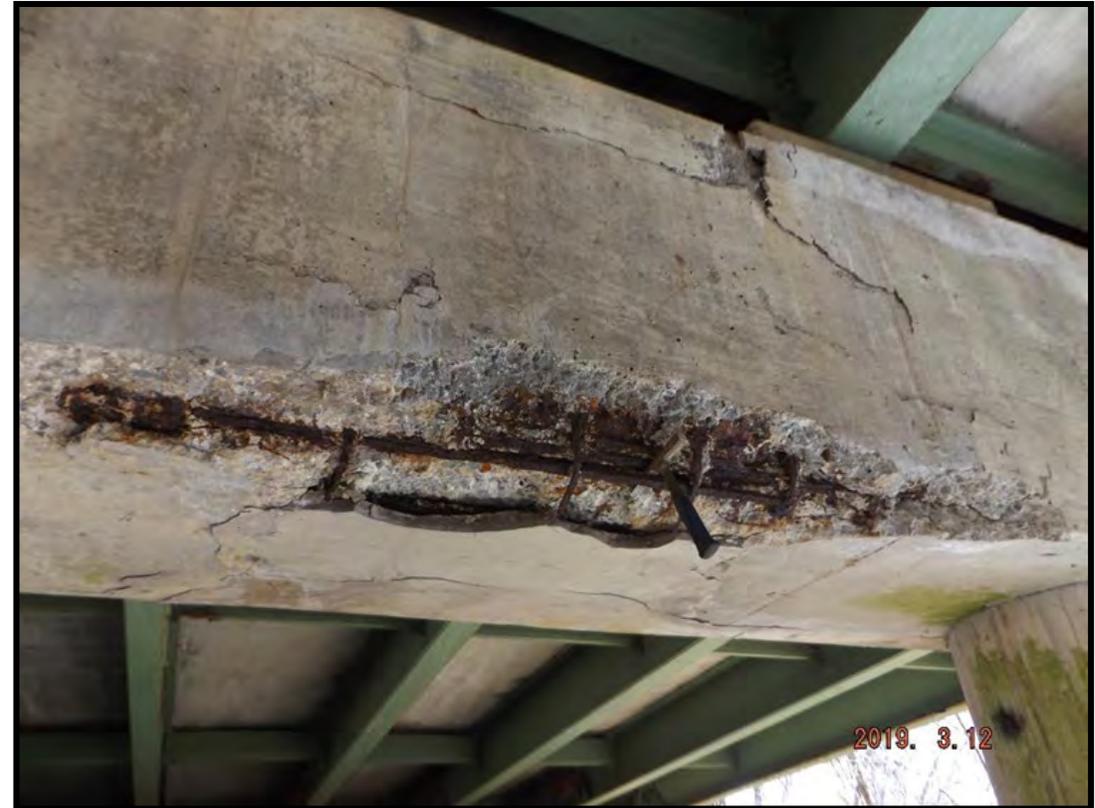
BRIDGE ABUTMENTS AND PIERS

Abutments/Piers exhibit deteriorated concrete and exposed reinforcing bars
Condition Rating 5 of 9 (Fair)

➤ **Proposed work: Concrete will be repaired and receive waterproofing coating**

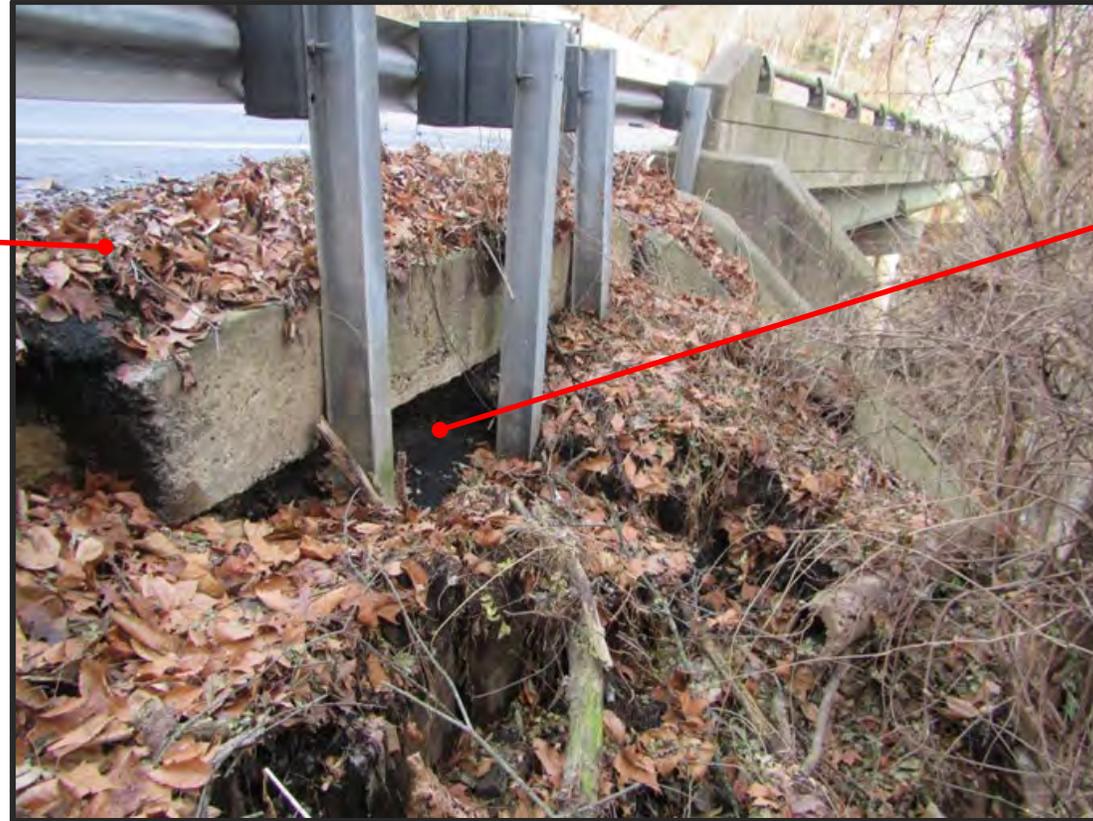
DRAINAGE

No Drainage Provisions to Collect Pavement Runoff

Soil Erosion

Erosion at southwest approach due to lack of drainage inlet to collect water

➤ **Proposed work: Install drainage inlet; build retaining wall**
