Subject: Route 28 Corridor Safety and Operations Study (South of I-66 to Liberia Avenue)
Summary of Data Collection

Technical Memorandum

Subject: Route 28 Corridor Safety and Operations Study
From South of I-66 to Liberia Avenue
Summary of Data Collection

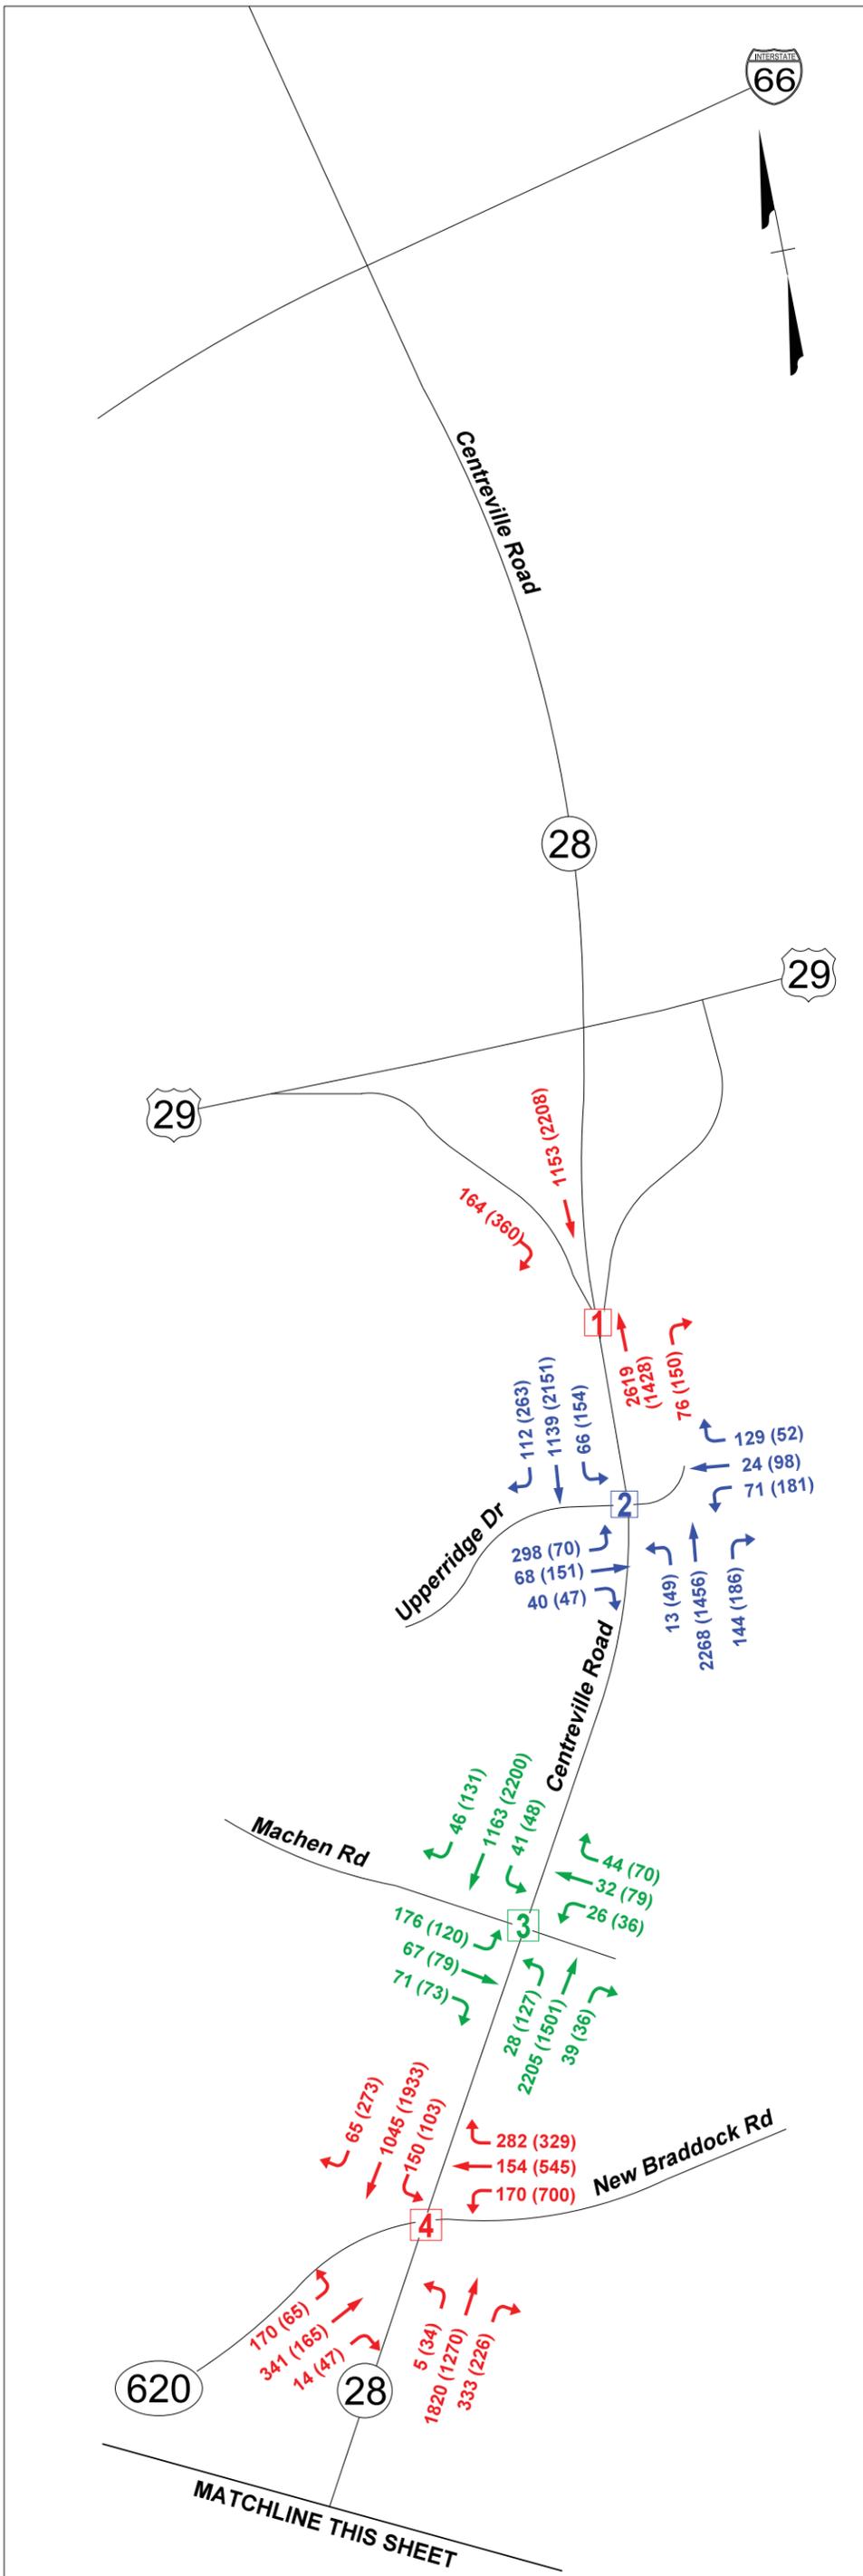
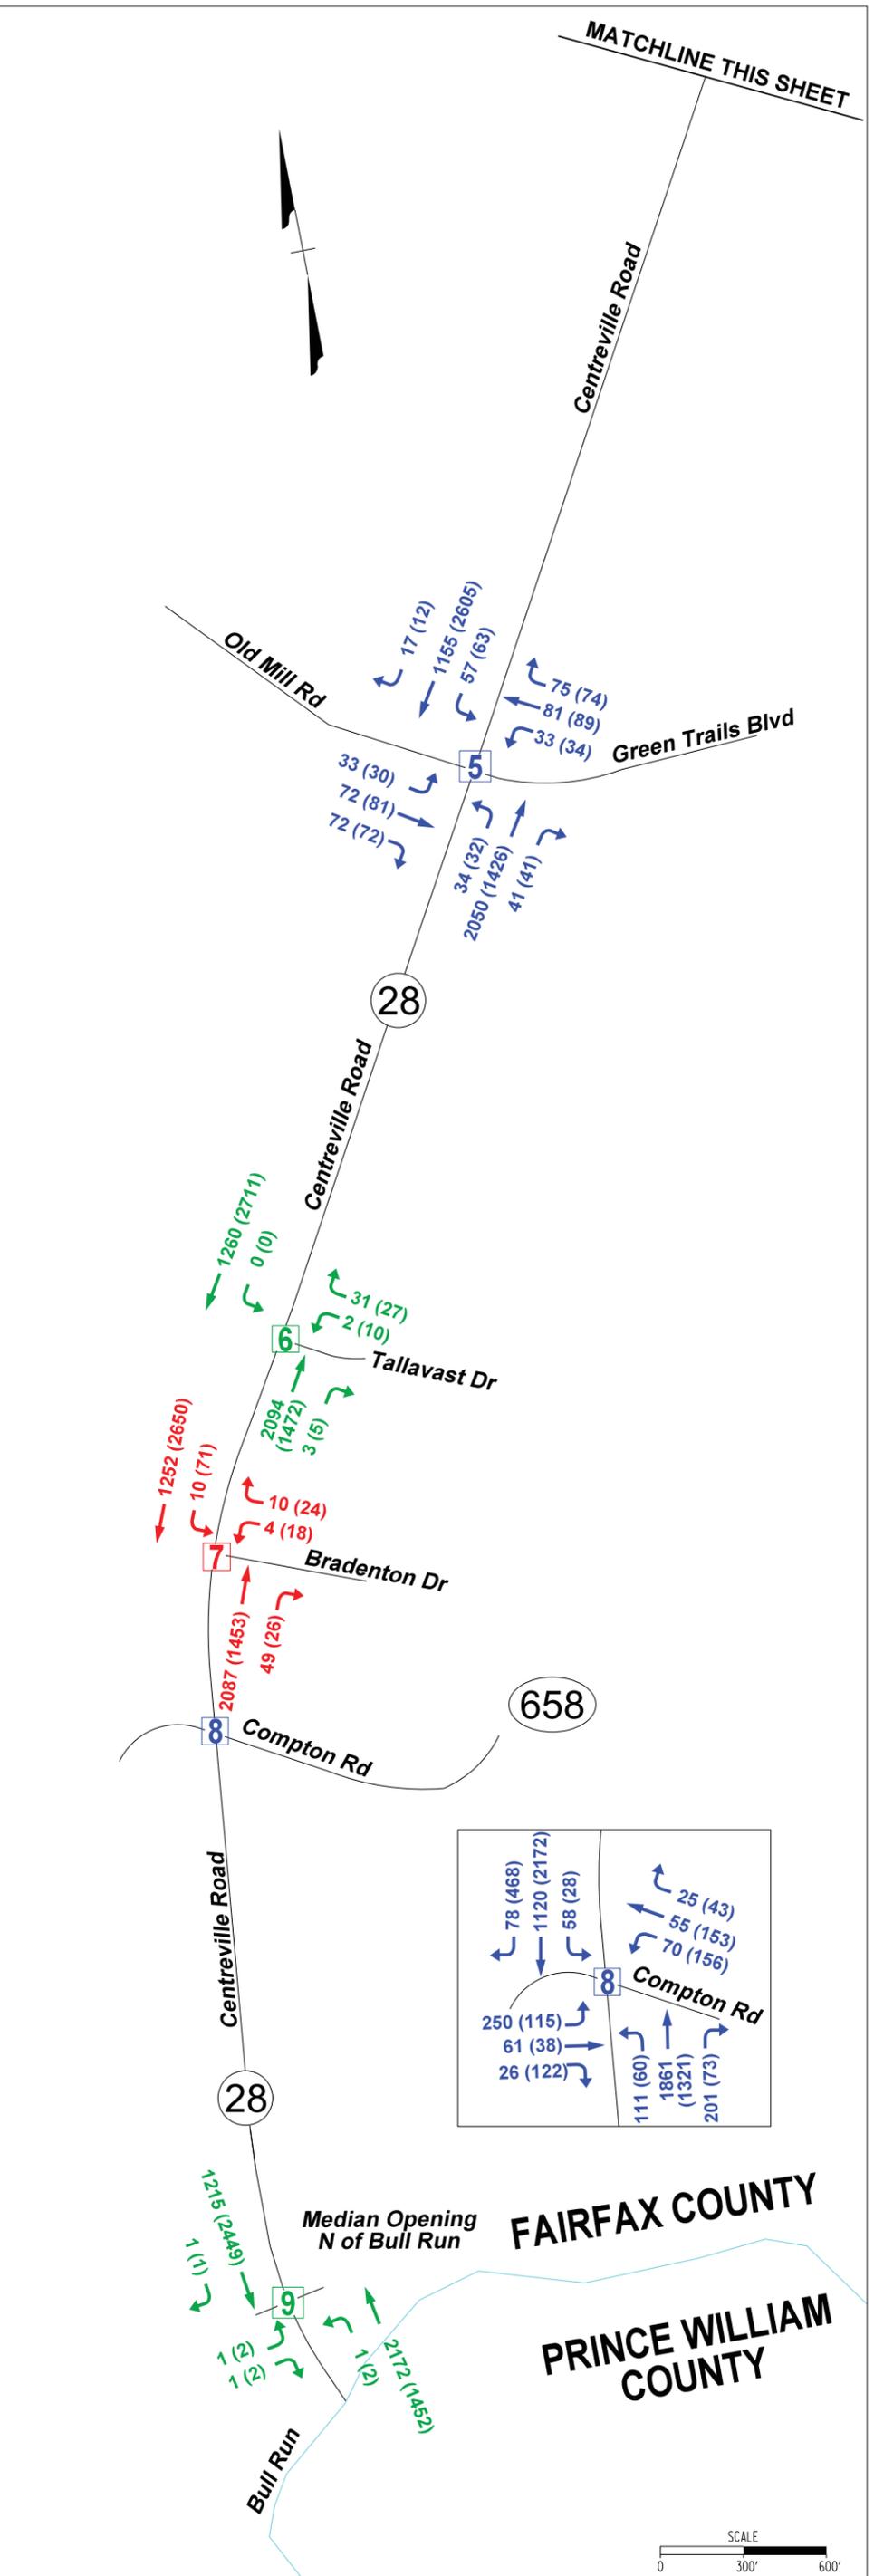
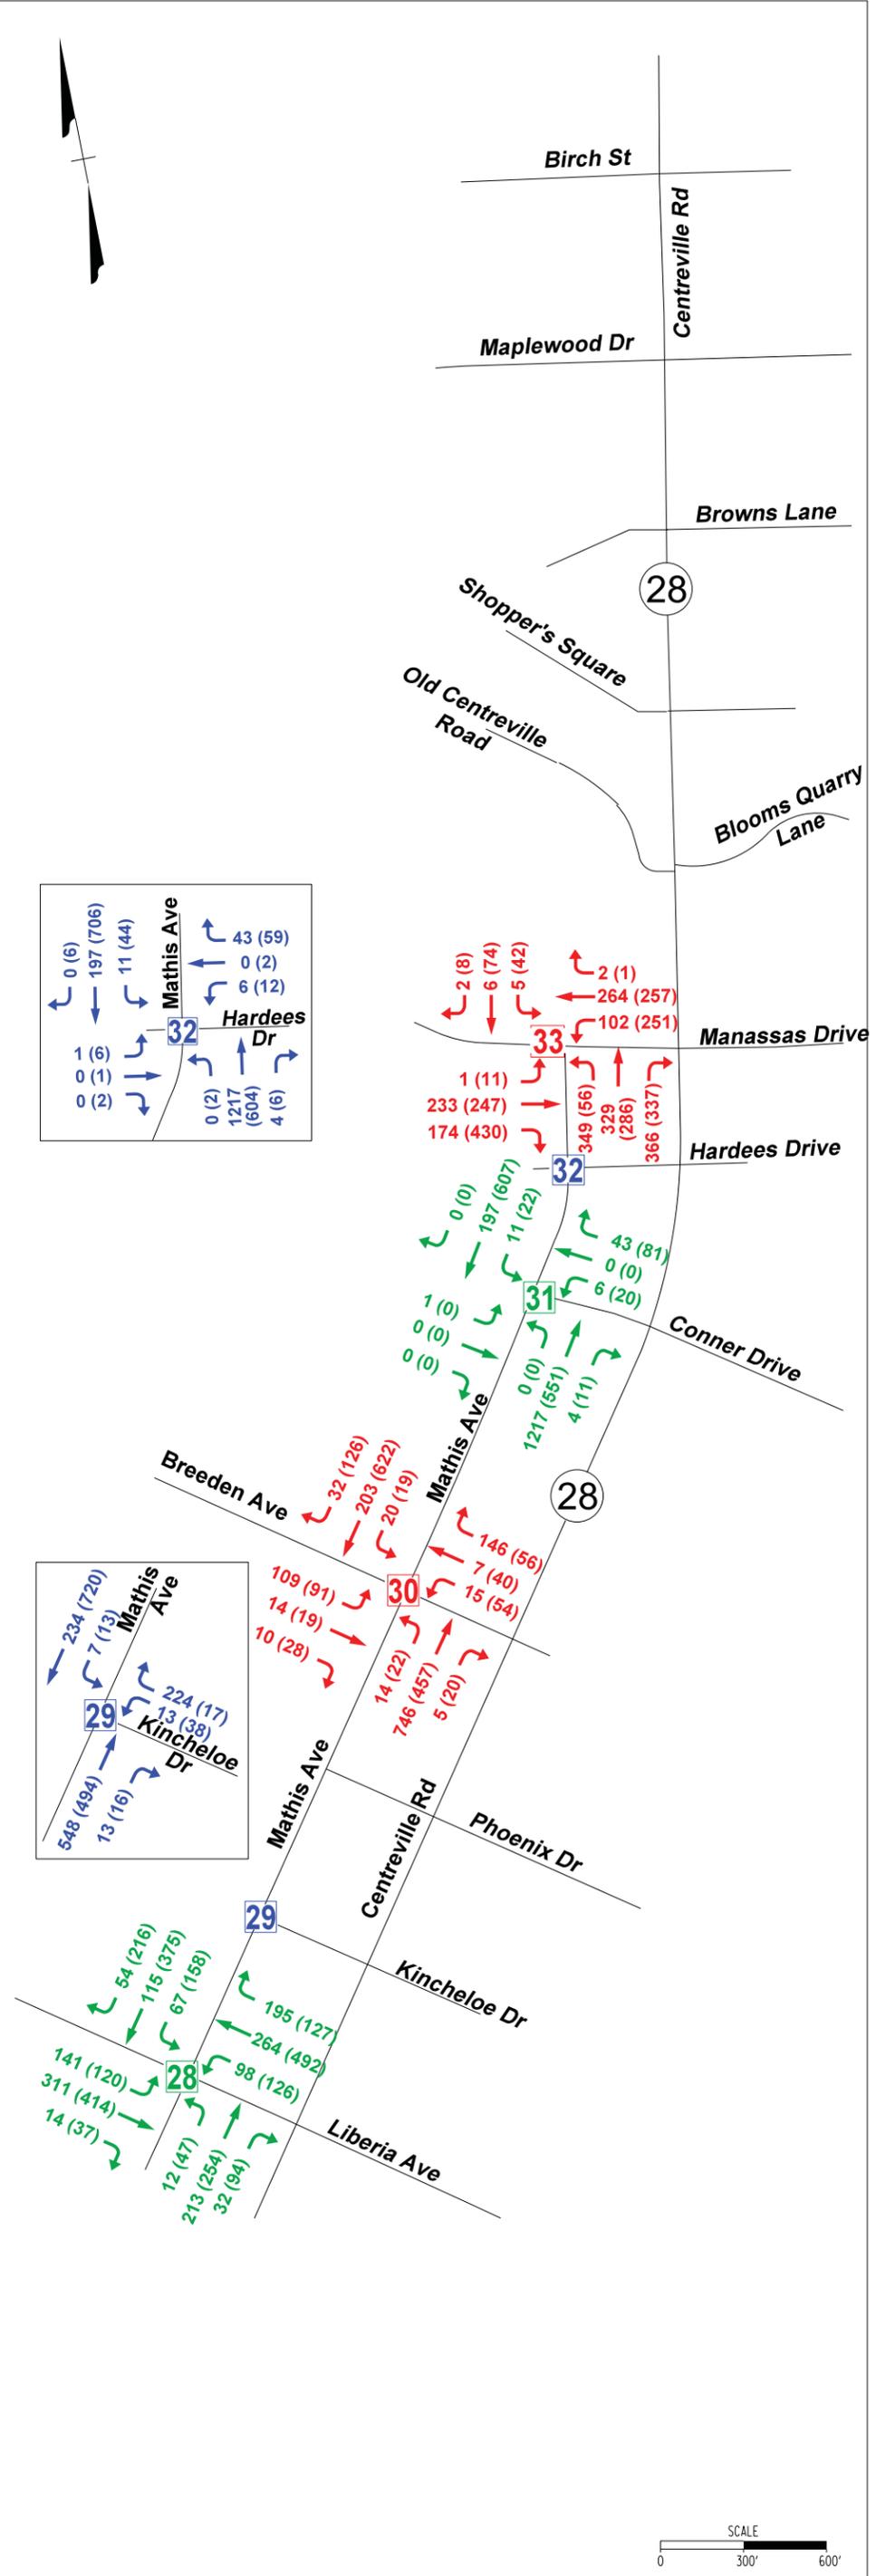
FIGURE 1: PEAK HOUR TRAFFIC VOLUMES (SHEET 1 OF 3)

Turning movement counts were collected for 33 intersections over a three-hour AM and PM weekday peak period in May 2014. In order to provide a comprehensive set of traffic volumes for the corridor, traffic volumes were balanced across the network.

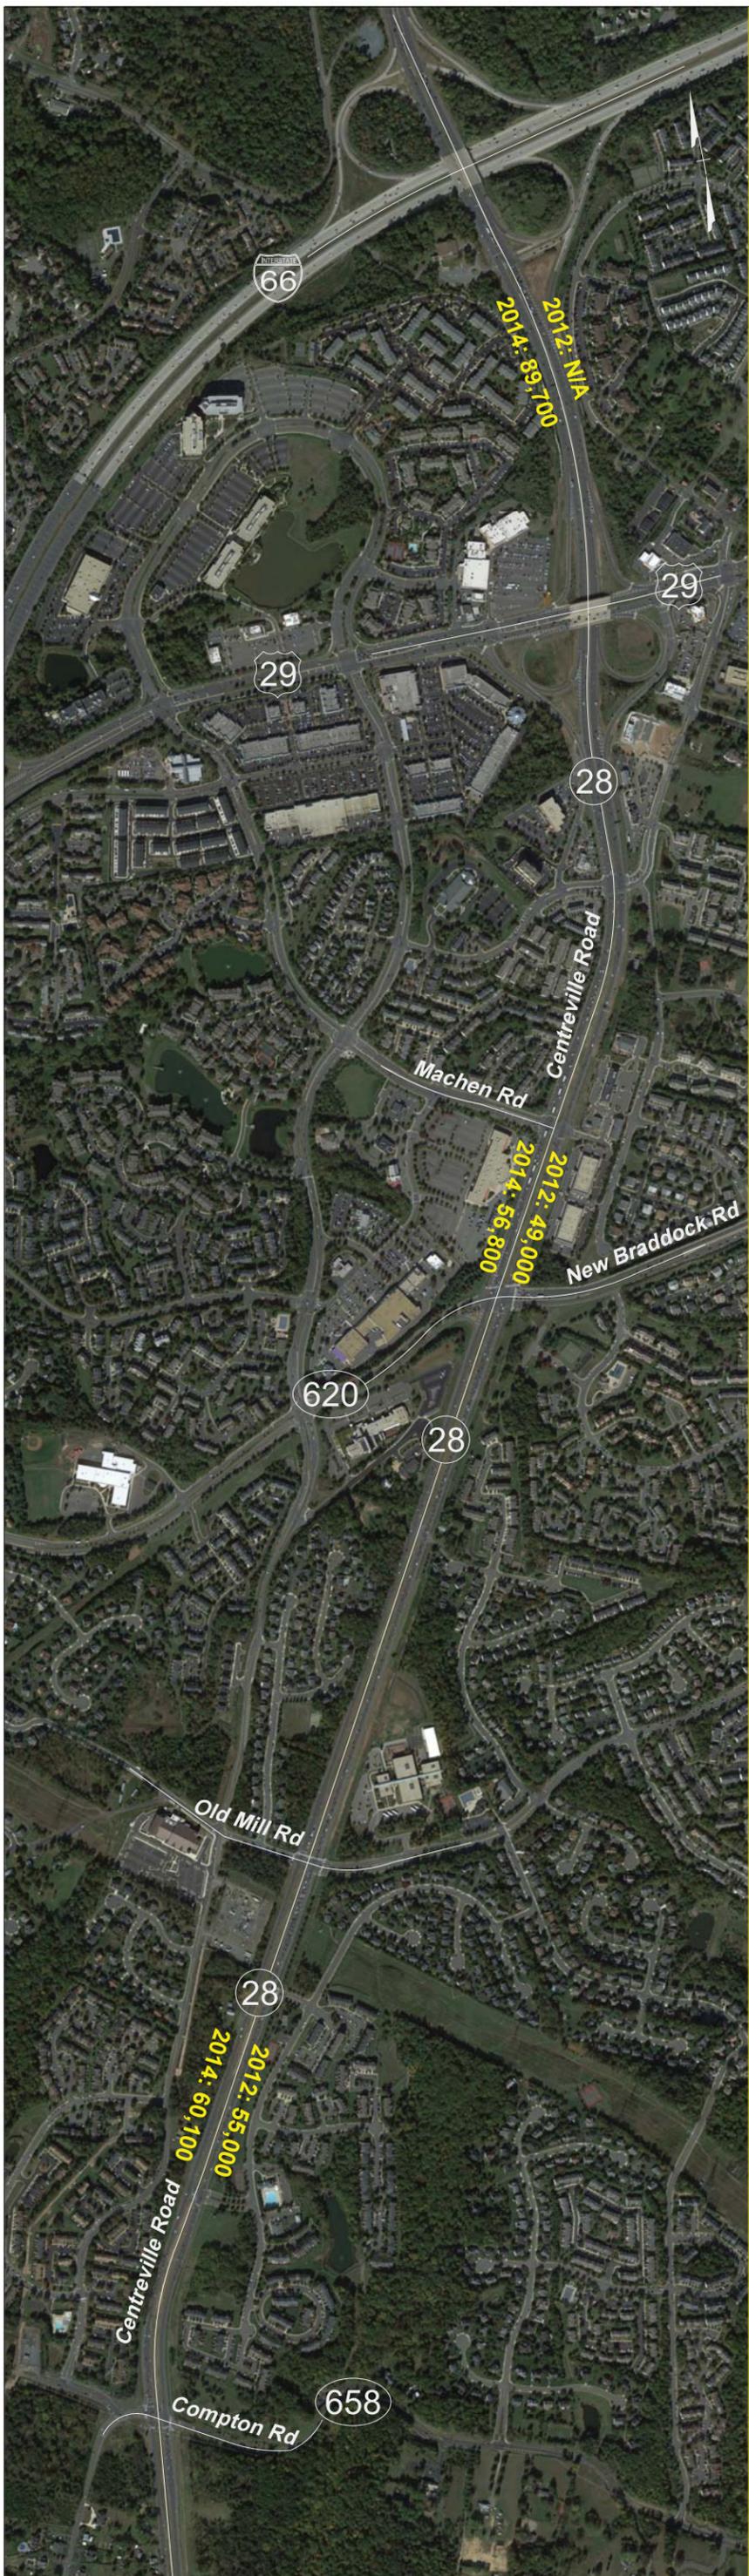
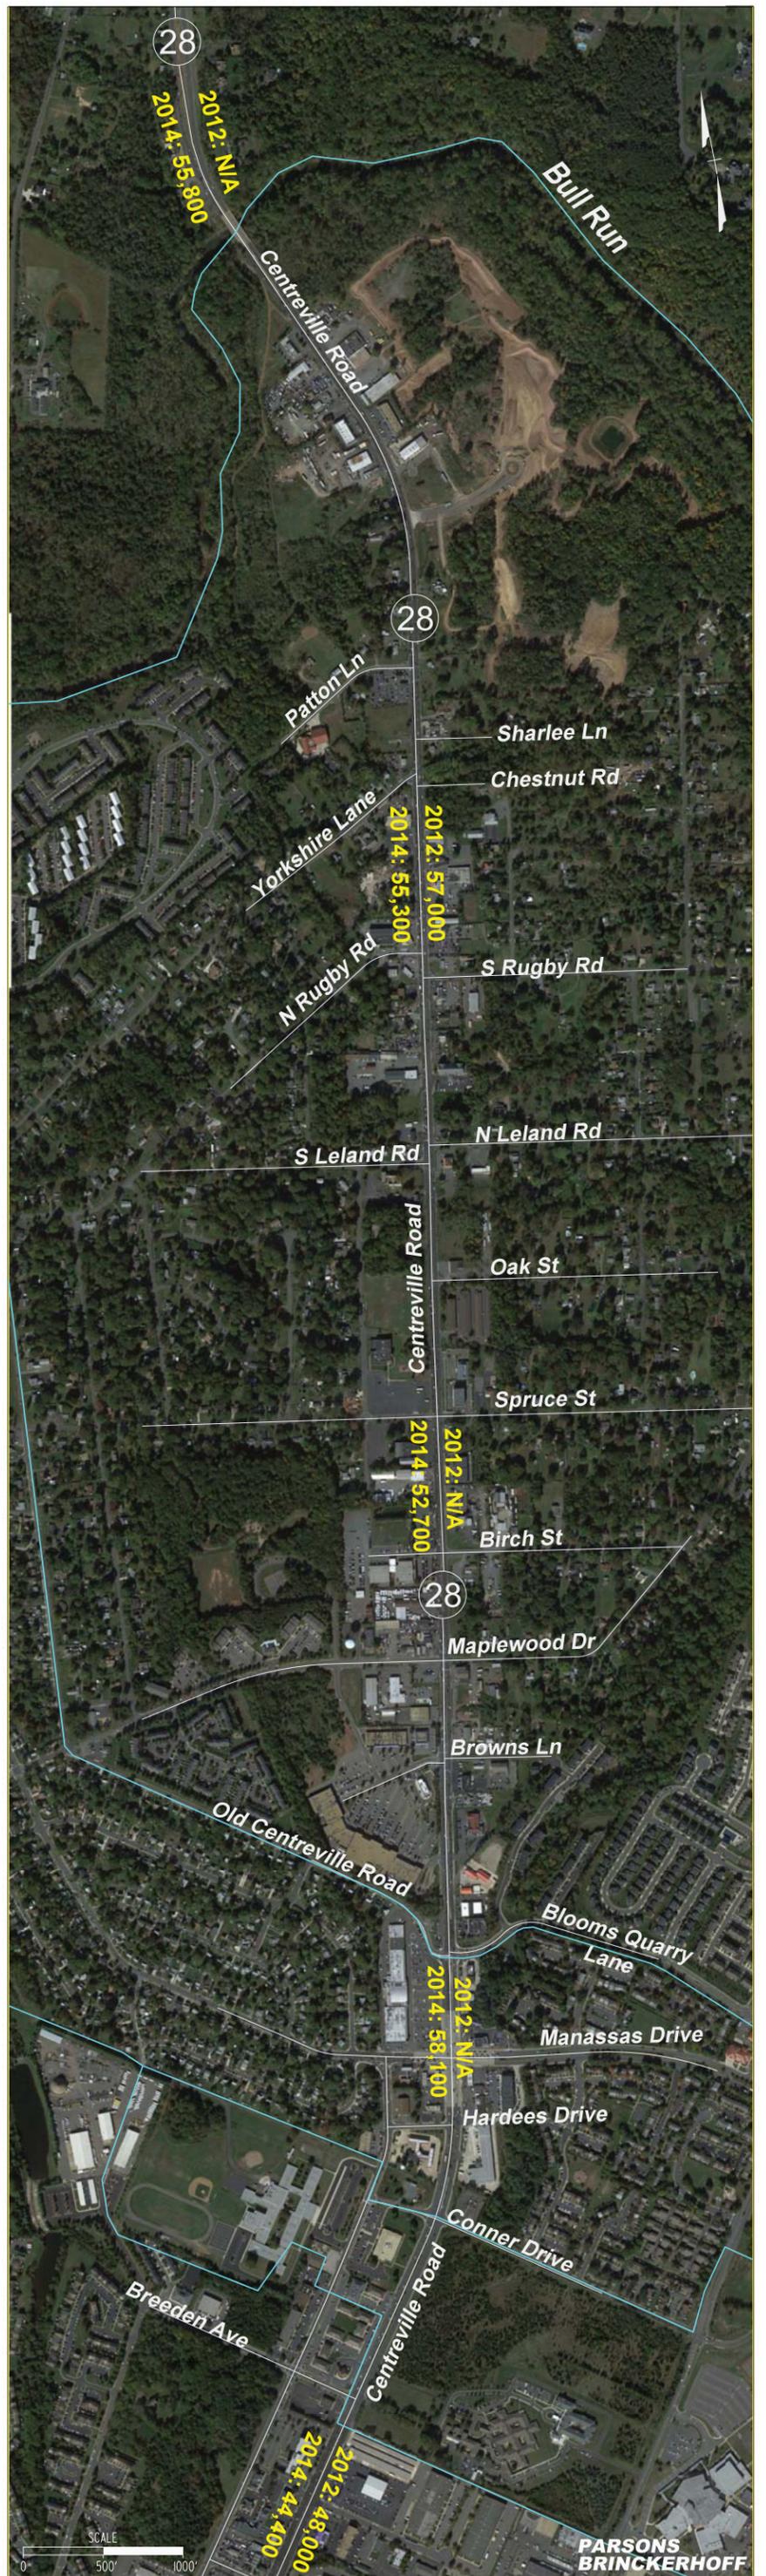
FIGURE 2: ADT VOLUMES

Average Daily Traffic (ADT) volumes (from 24 hour tube counts) were collected at 8 locations on a weekday in May 2014. Traffic conditions associated with significant congestion in the corridor created a situation whereby vehicles would traverse the tubes very slowly, creating an irregular pattern; thereby improperly classifying & counting some vehicles. To develop daily traffic volumes, the intersection counts were used to develop daily volumes.

2012: SOURCE-VDOT COUNT INFORMATION
2014: CALCULATED FROM 2014 HOURLY COUNTS

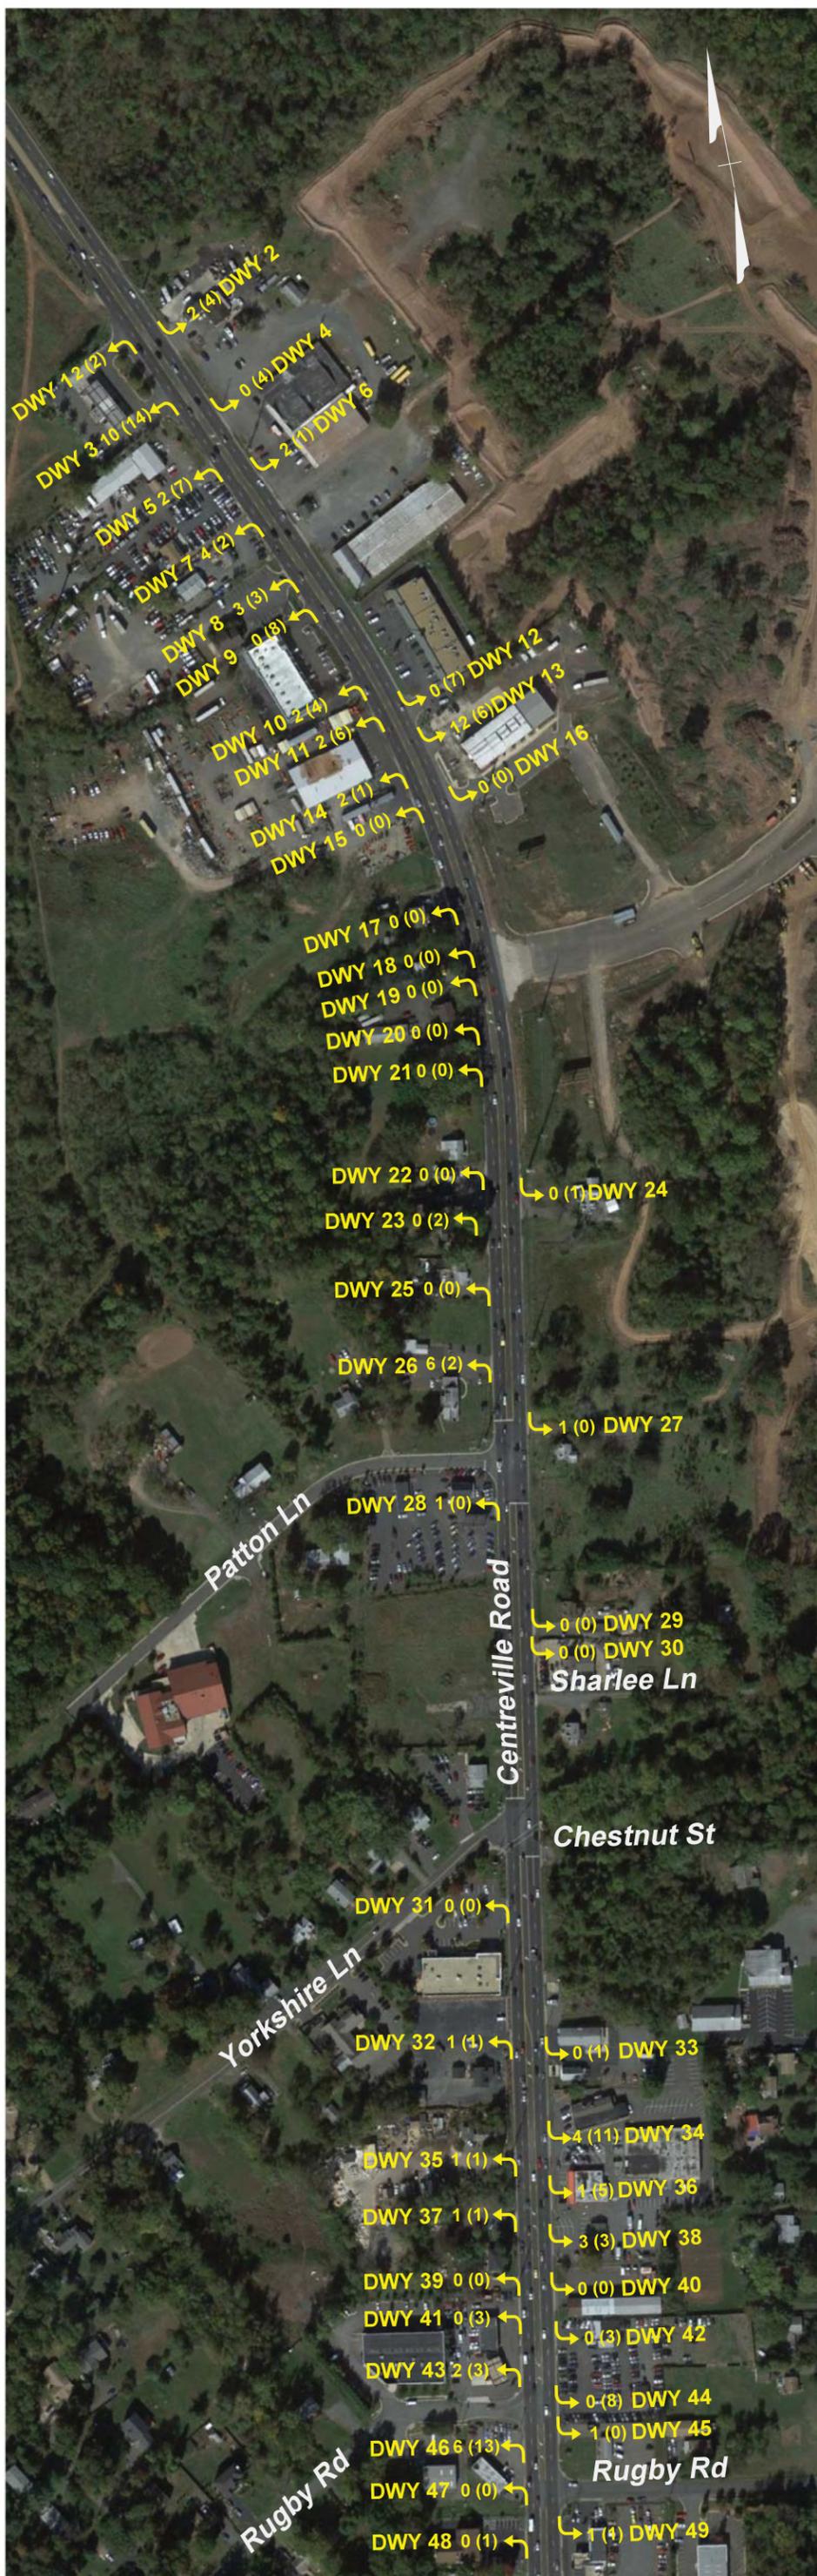
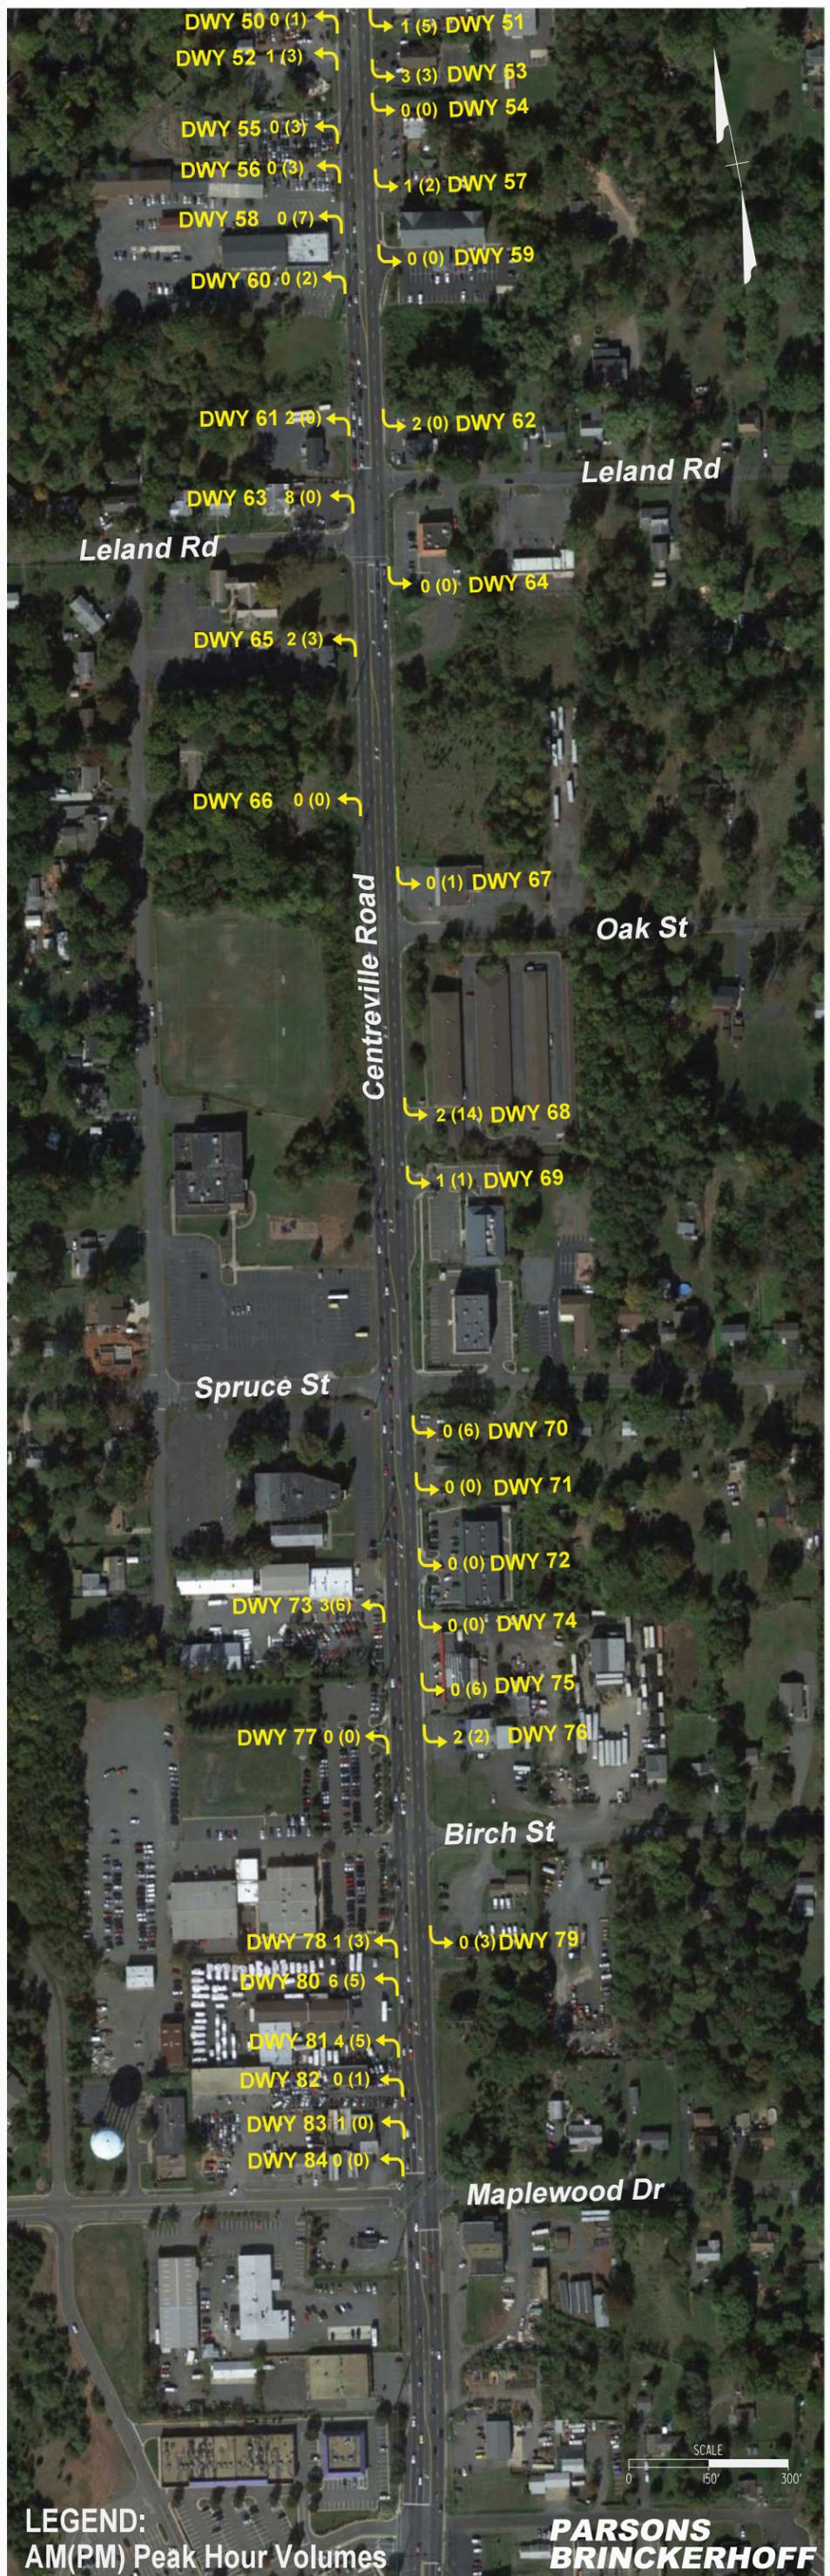
FIGURE 3: LEFT TURN MOVEMENTS INTO DRIVEWAYS

In order to determine the level of use of the existing two-way-left-turn-lane (TWLTL) section in the corridor, peak period left turn movements into the 84 driveways were counted. The data indicates that during the AM and PM peak periods (6 hours total):

- 24 driveways had zero inbound left turn vehicles
- 33 driveways had less than 5 inbound left turn vehicles
- 21 driveways had between 5 to 10 inbound left turn vehicles
- 6 driveways had more than 10 inbound left turn vehicles (maximum observed was 24 inbound left turn vehicles during the 6-hour period).
