Subject: Route 28 Corridor Safety and Operations Study (South of I-66 to Liberia Avenue)
Summary of Data Collection

Technical Memorandum

Subject: Route 28 Corridor Safety and Operations Study
From South of I-66 to Liberia Avenue
Summary of Data Collection

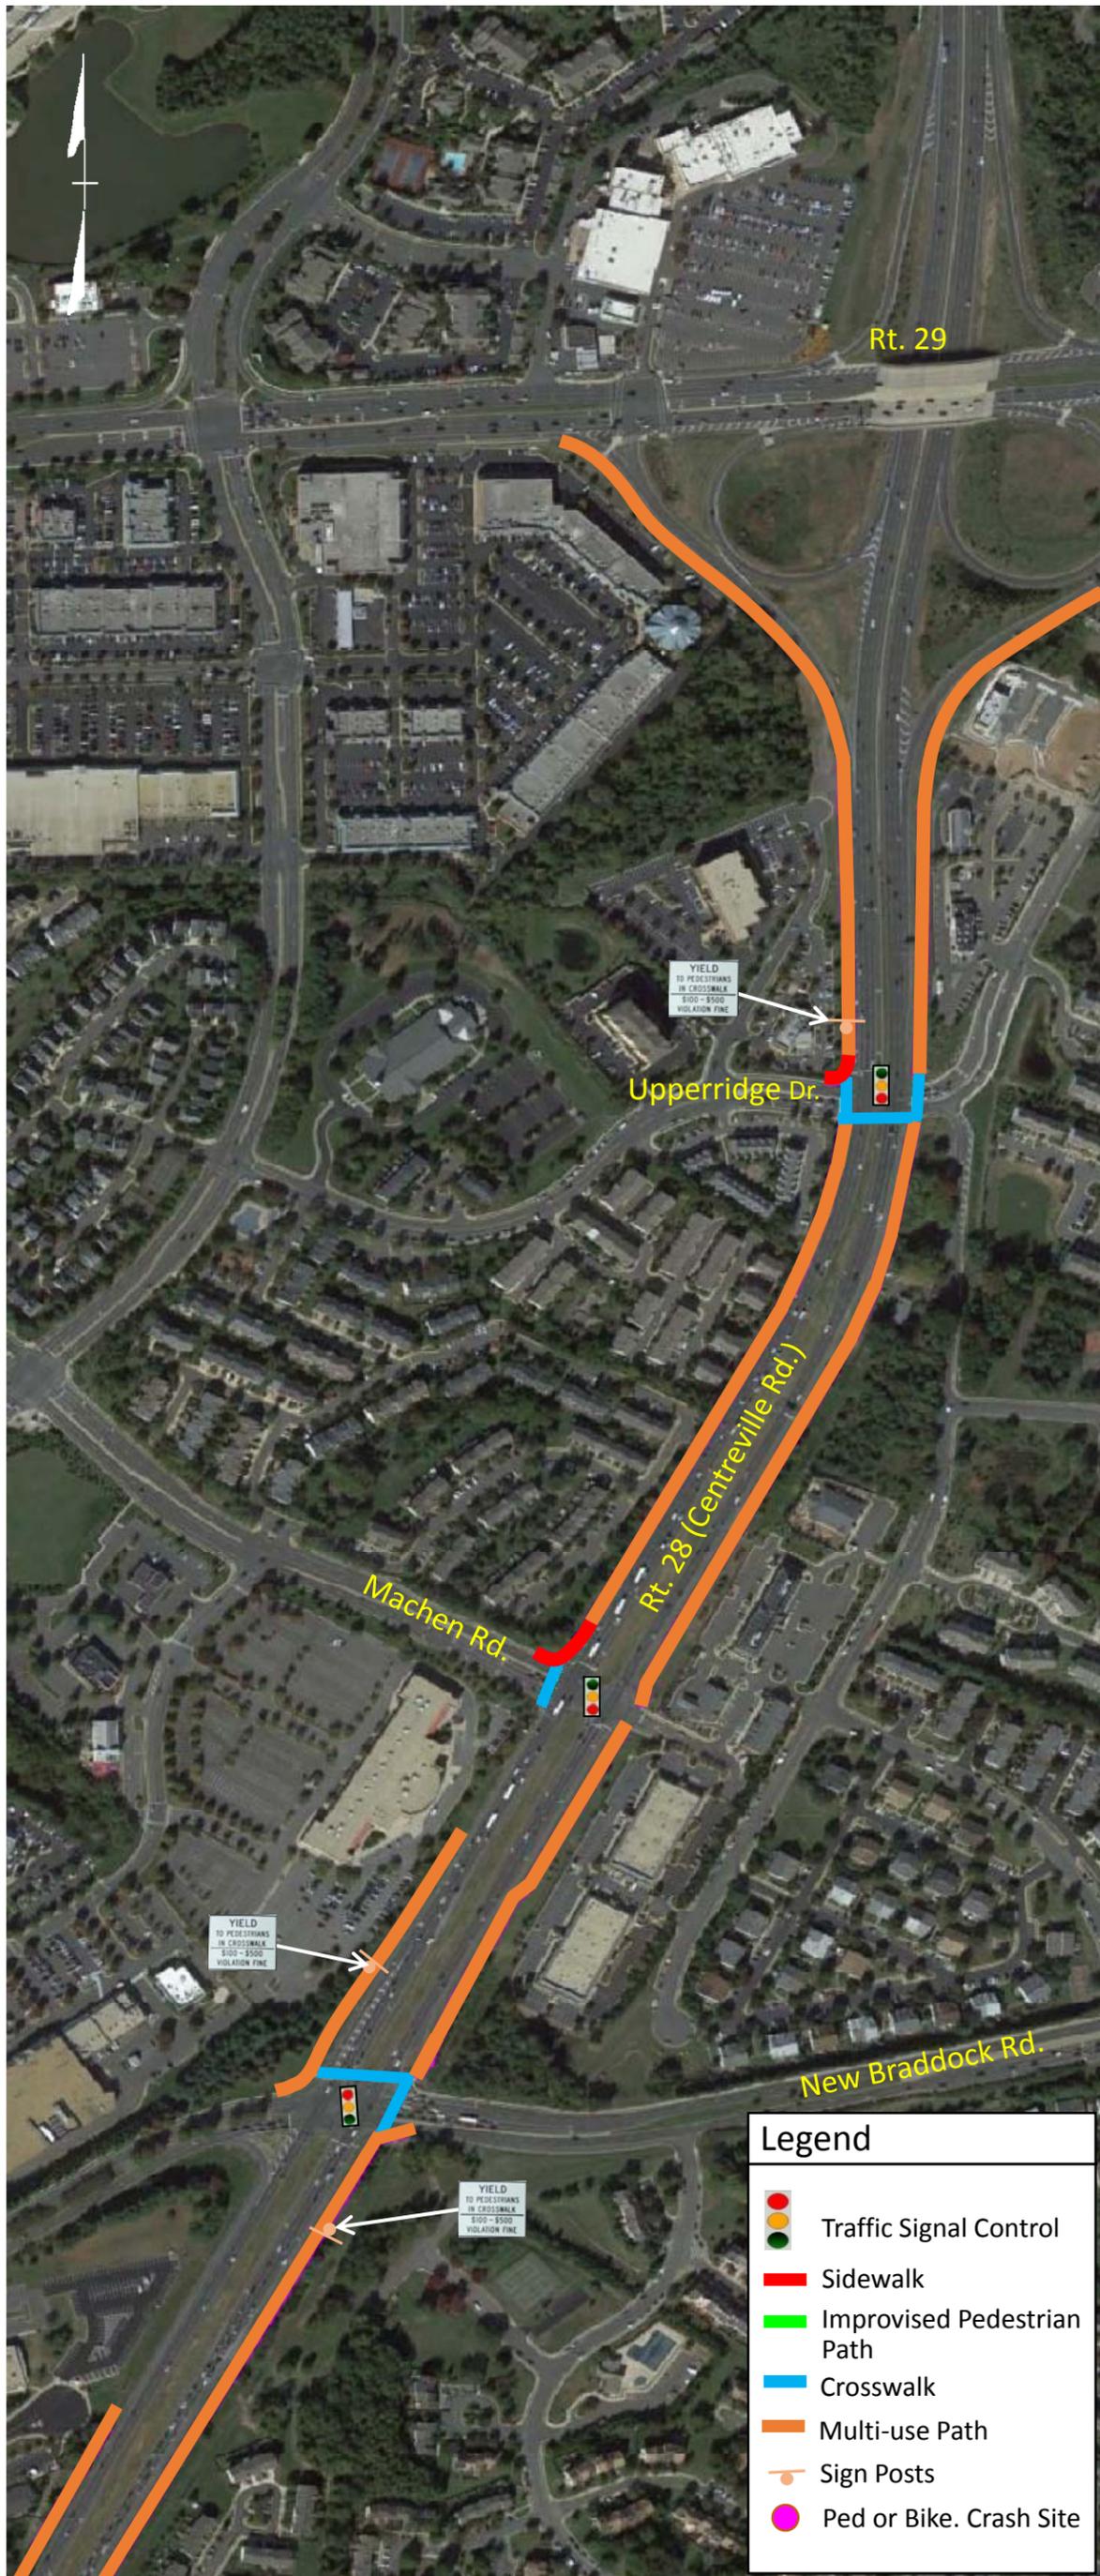
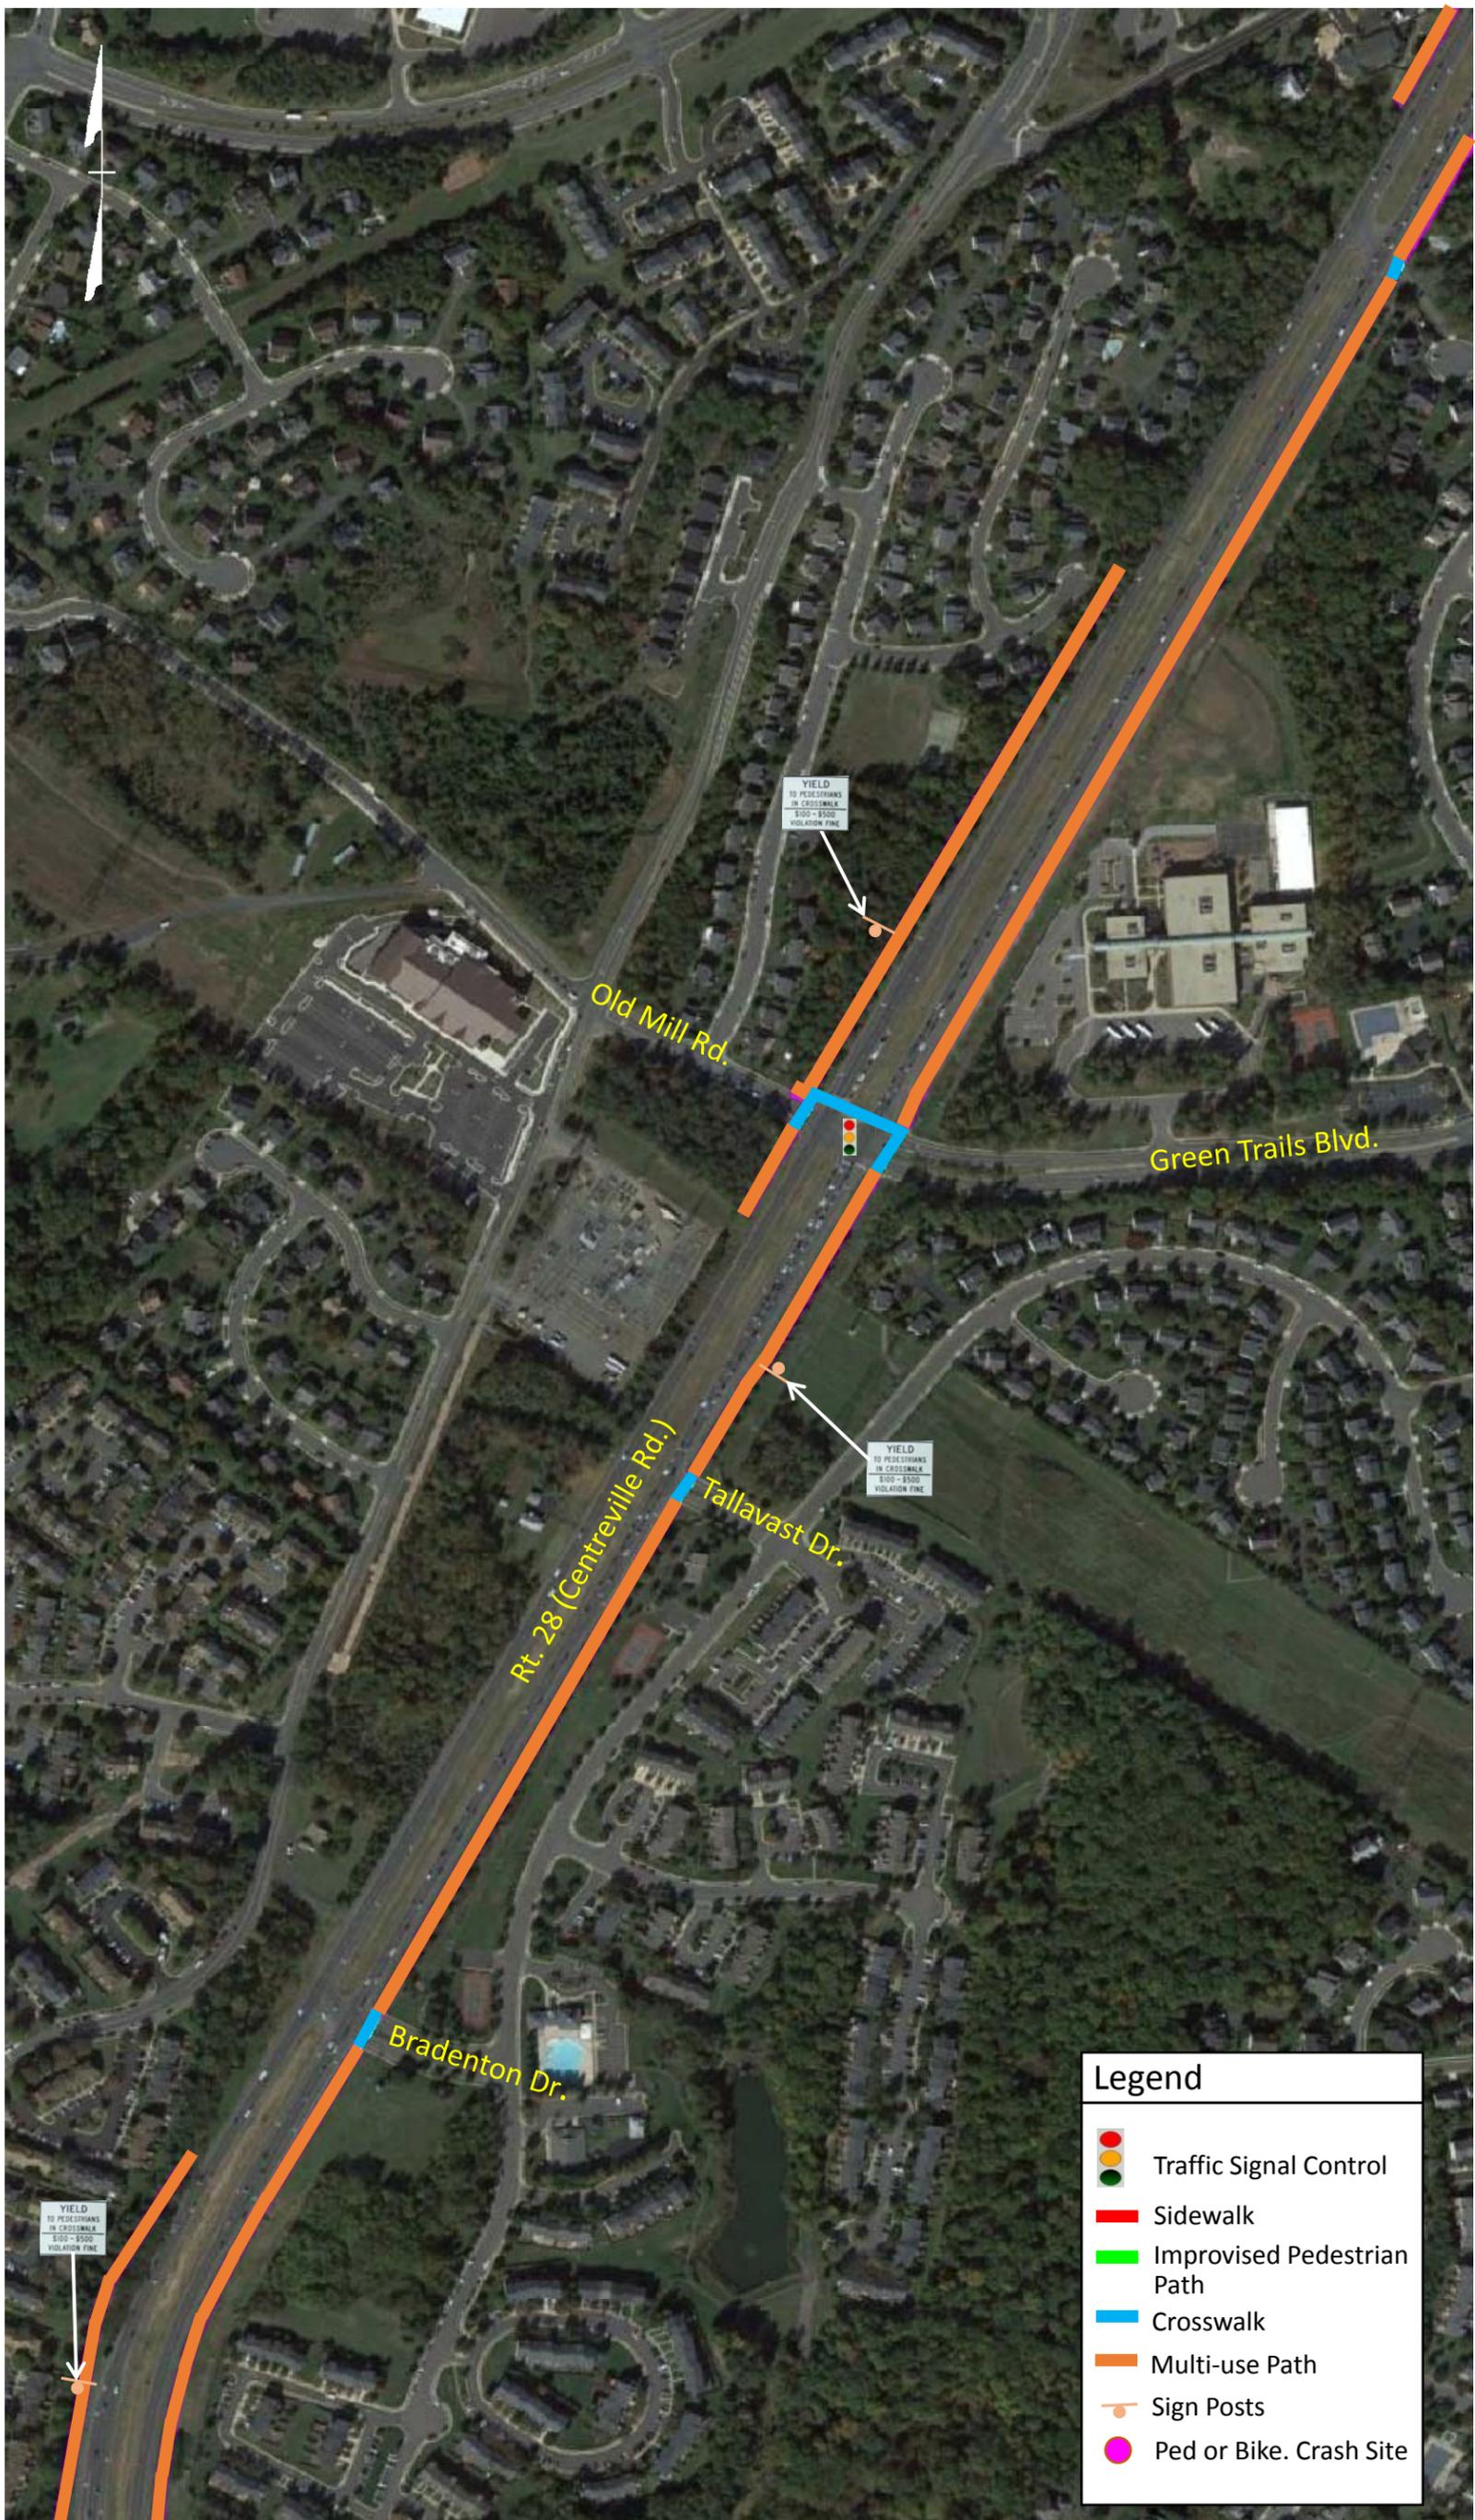
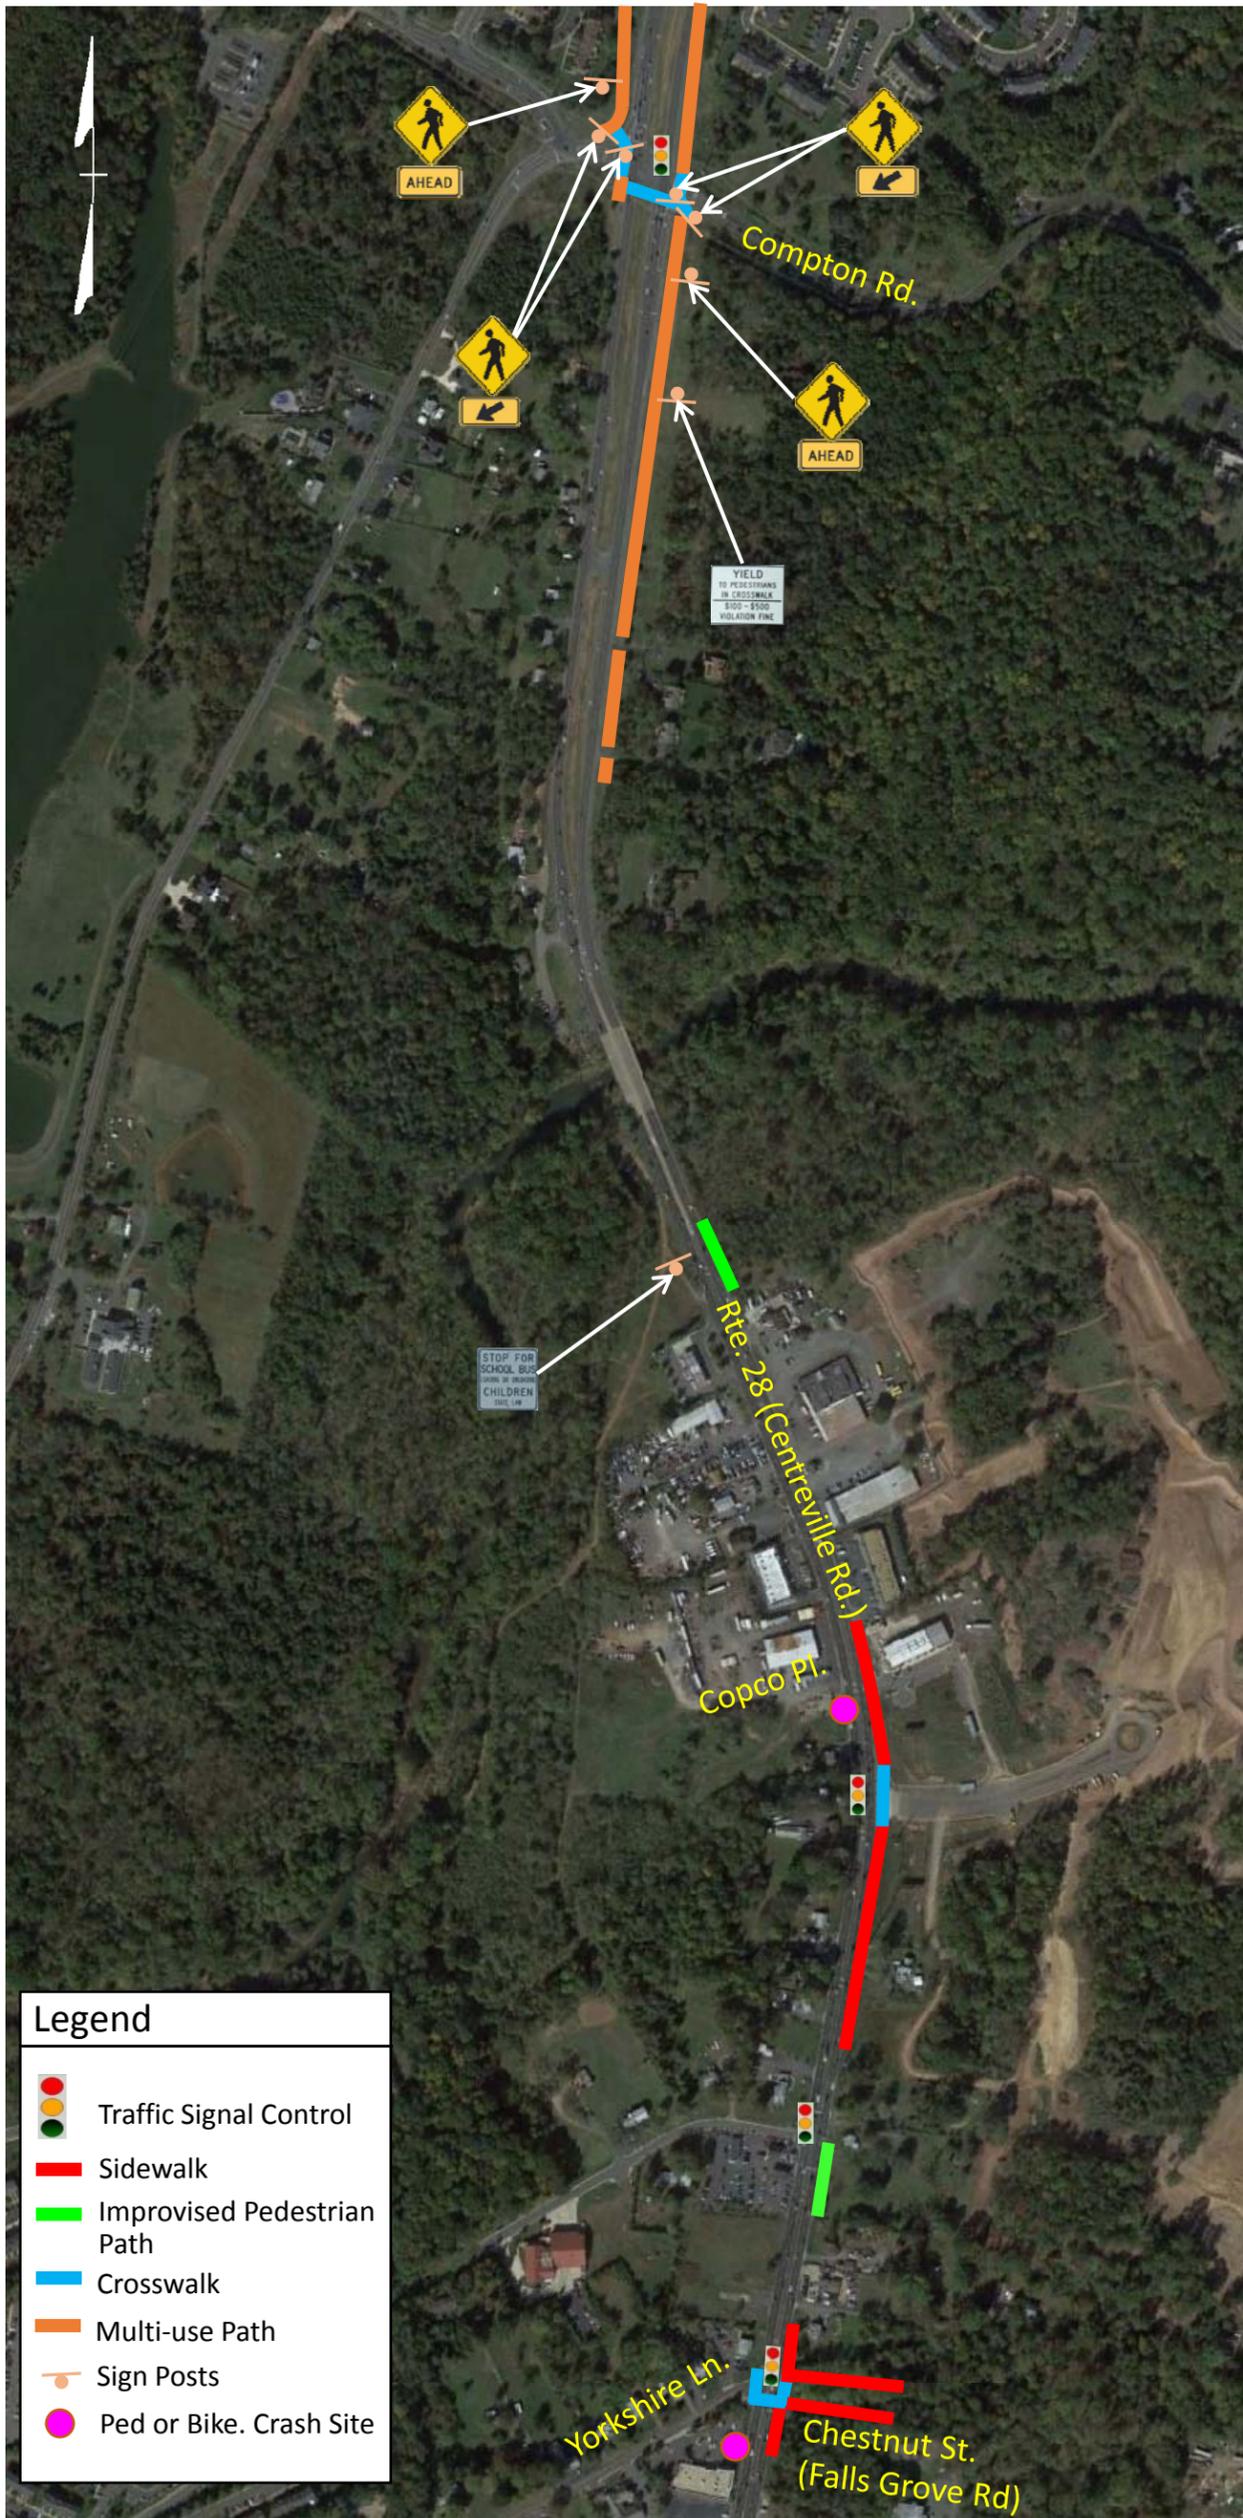
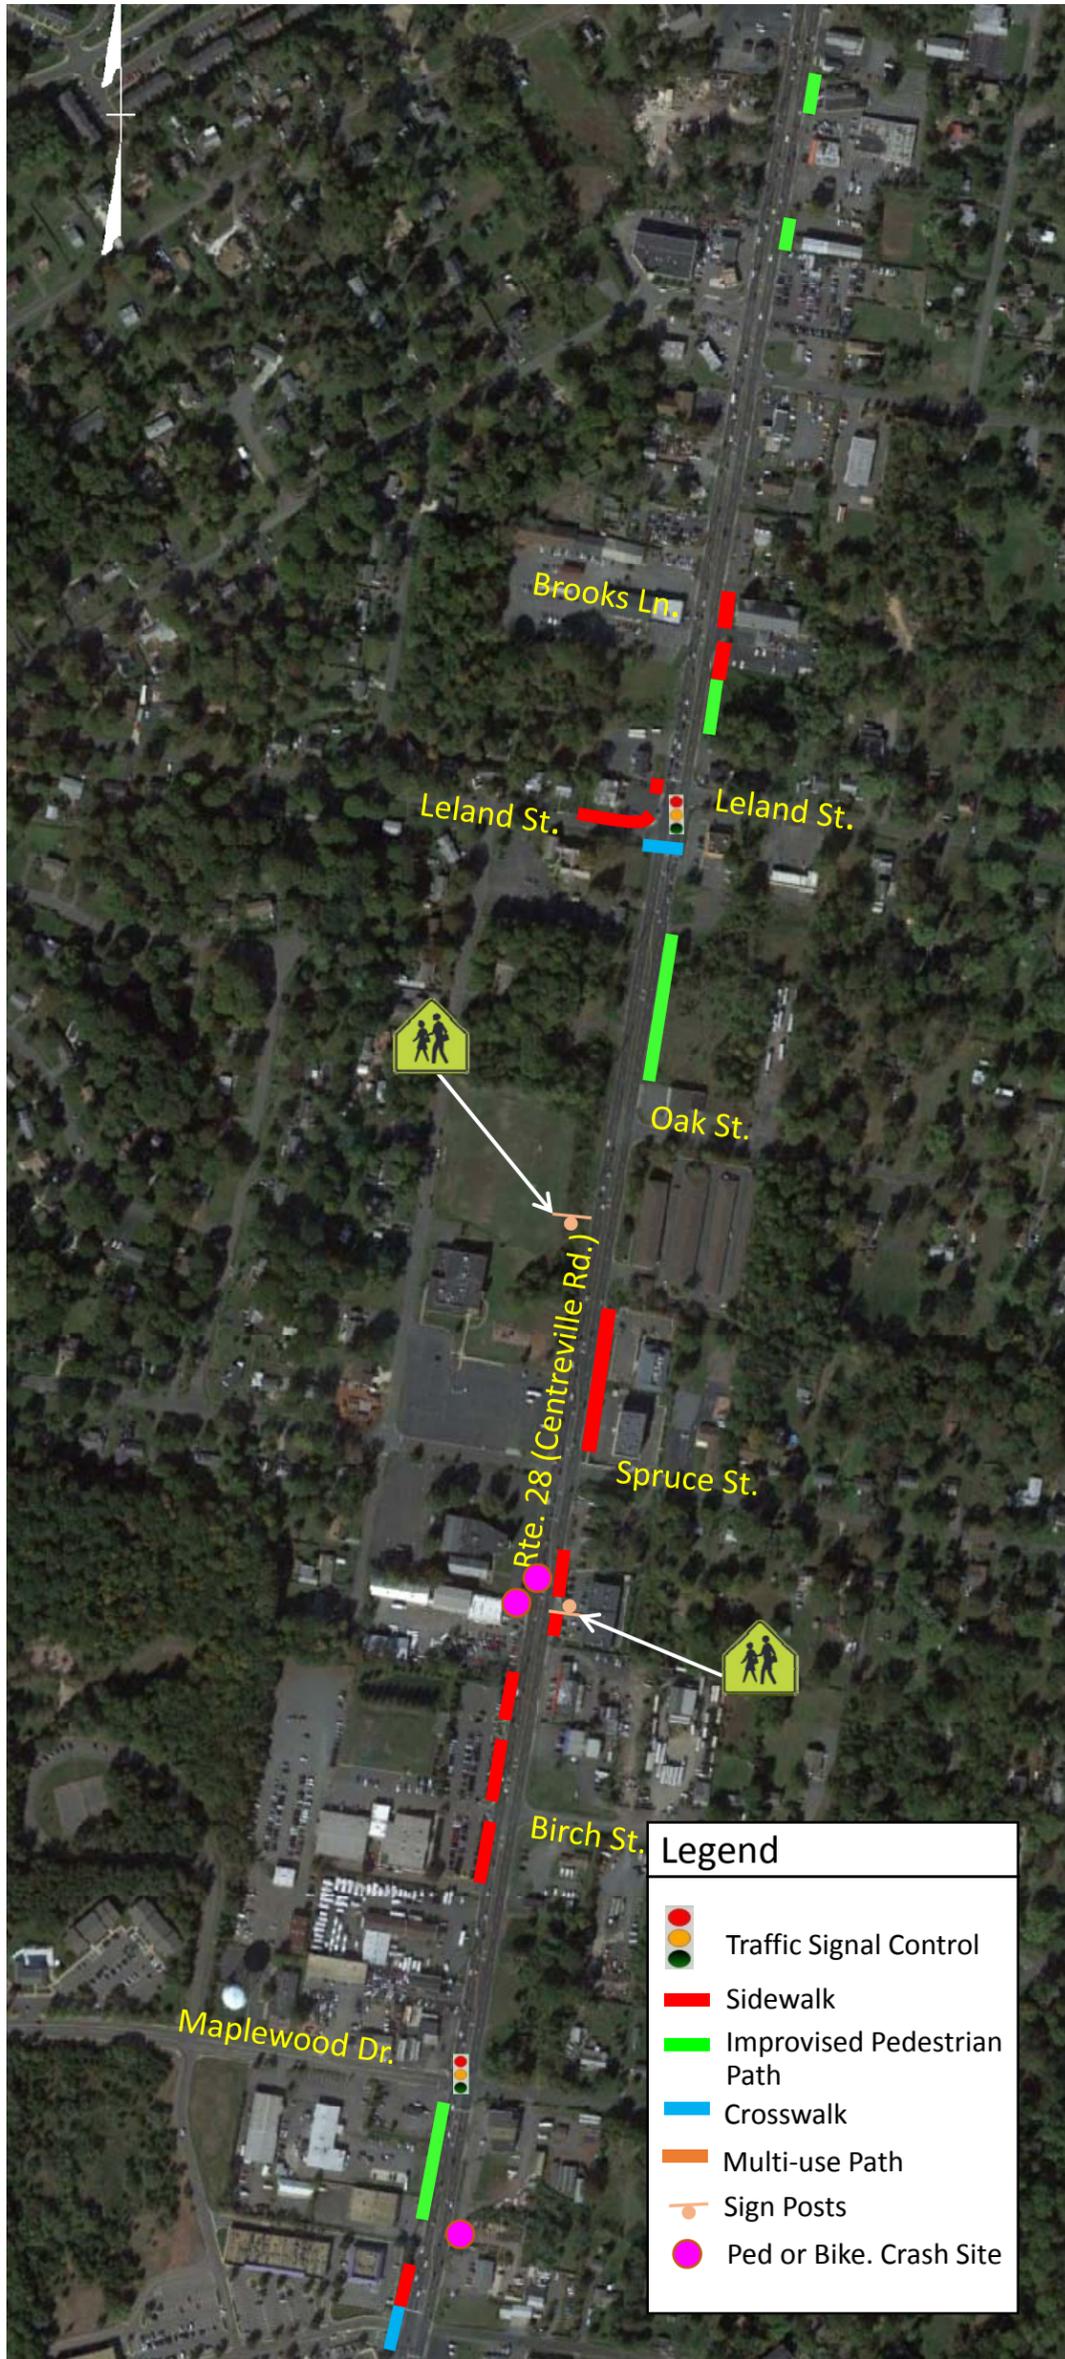
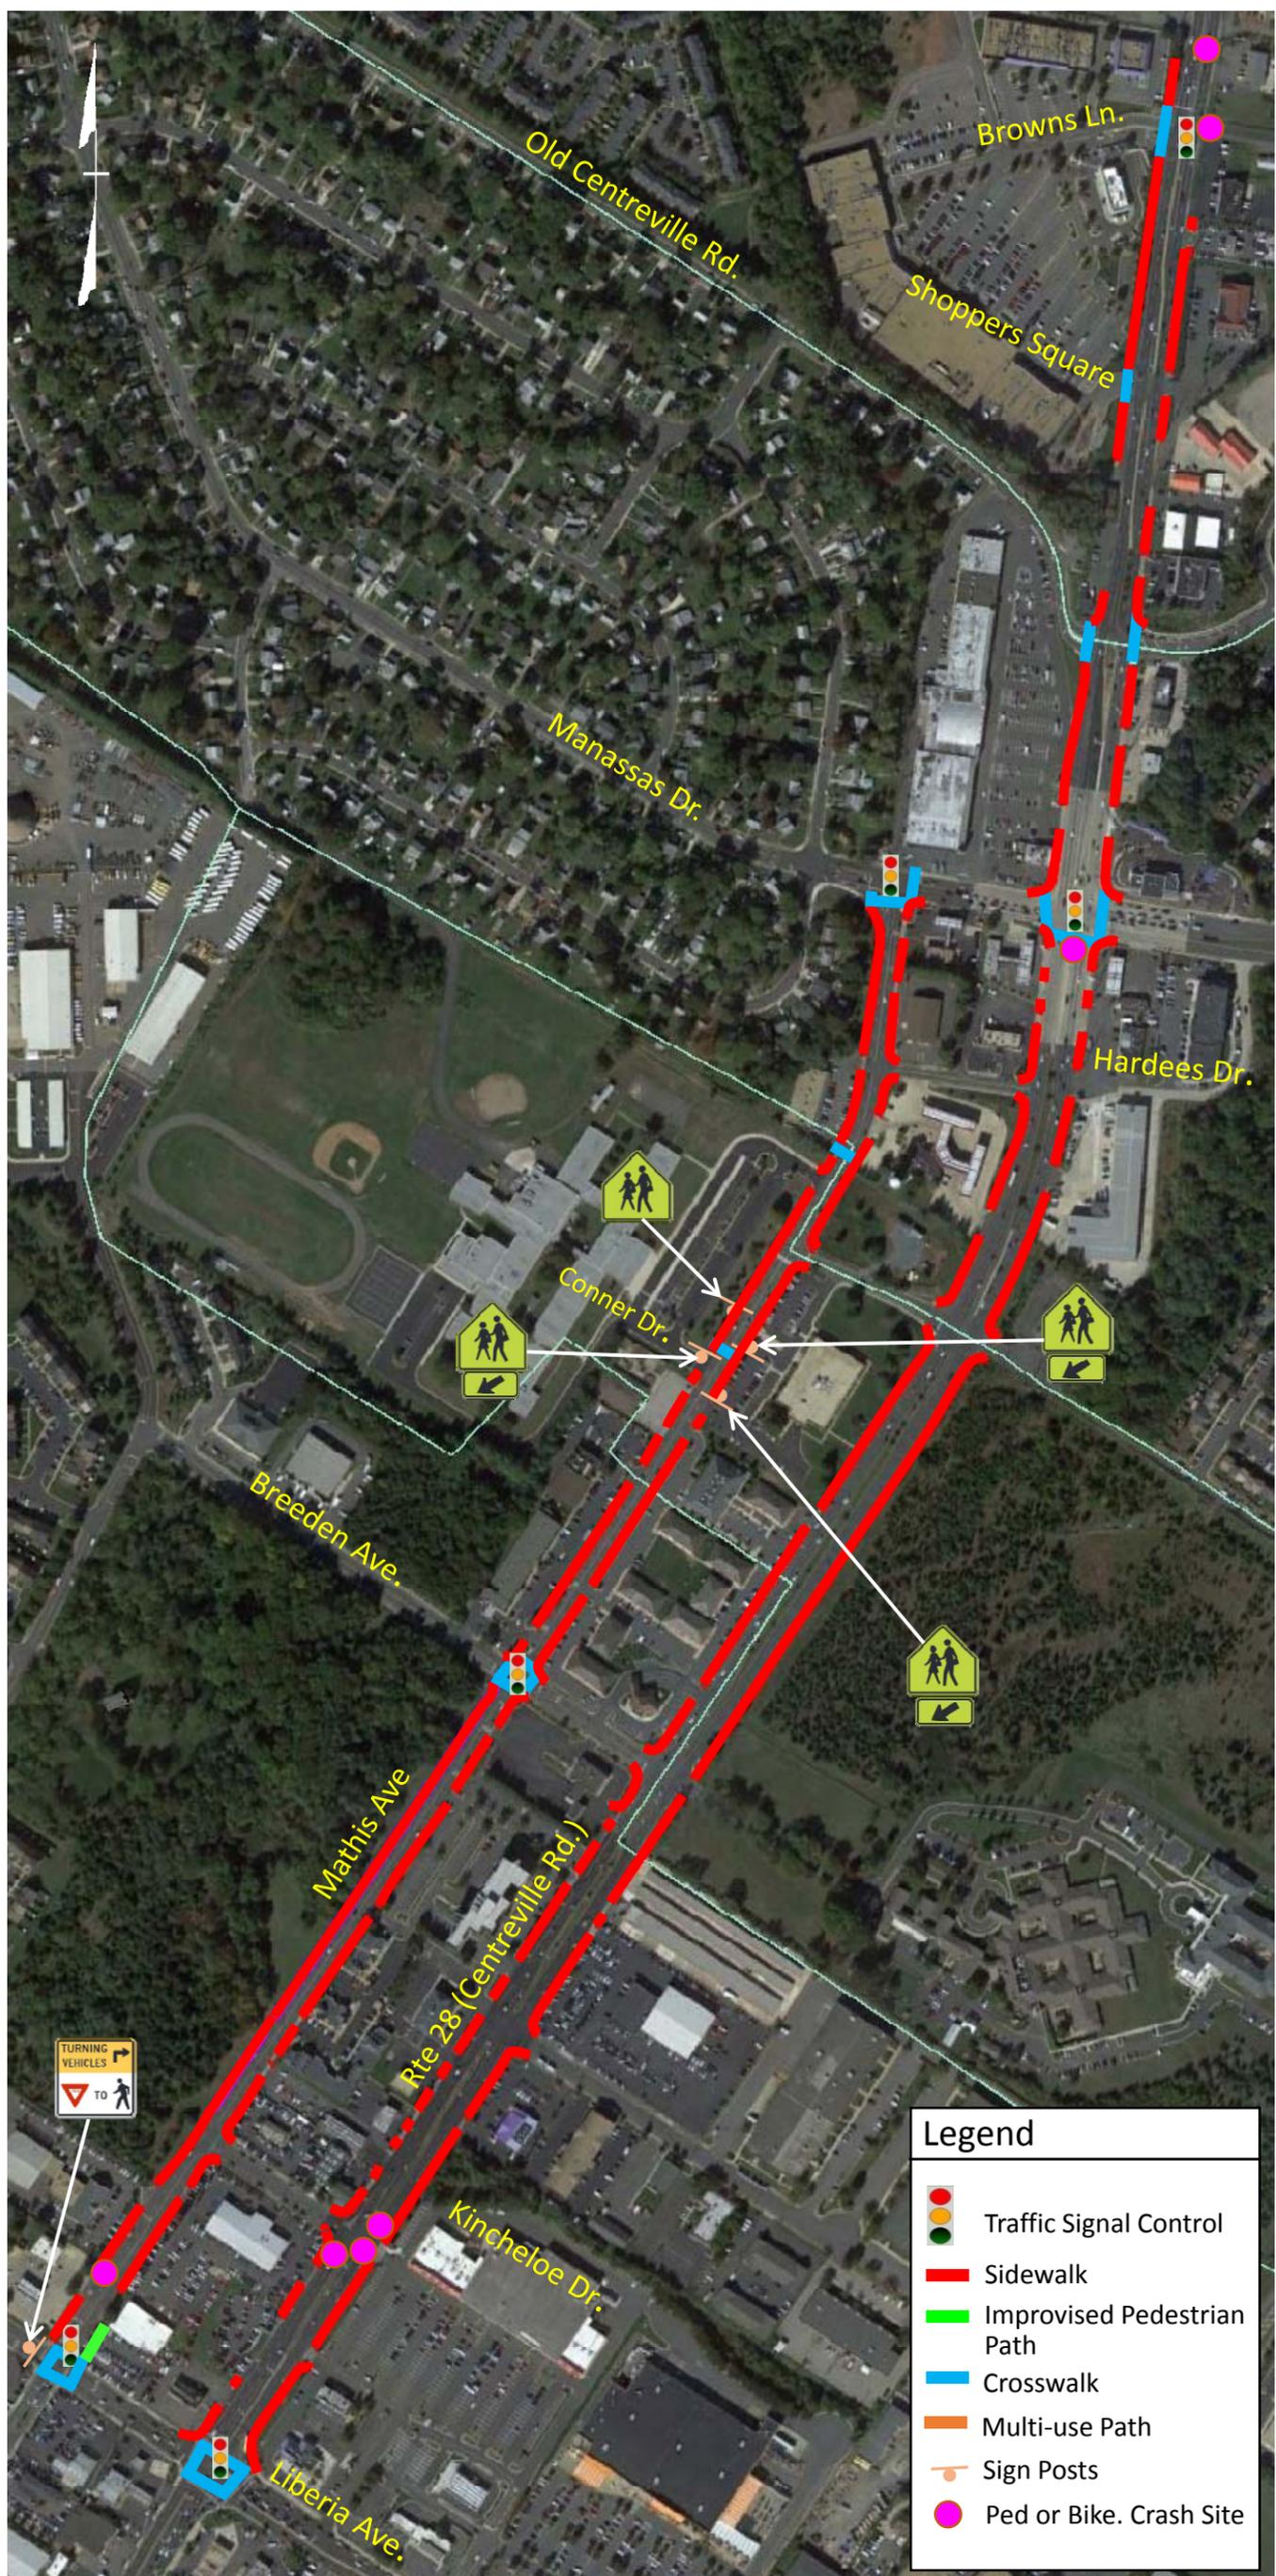
Figure 6: Route 28 Pedestrian and Bicycle Facilities Map
From Rt. 29 to New Braddock Rd. (Sheet 1 of 5)

Figure 6 in Appendix A displays the existing pedestrian and bicycle facilities throughout the corridor. A comprehensive analysis of pedestrian facilities is included in the Safety Study Technical Memorandum located in Appendix B. Lighting conditions will be evaluated along the corridor during the analysis portion of this study. General pedestrian facility observations are included as follows:

- Although pedestrian facilities are fairly continuous on the north end of the corridor, north of Bull Run, there are a few missing sections of the multi-use path on the north end of the corridor.
