Subject: Route 28 Corridor Safety and Operations Study (South of I-66 to Liberia Avenue)
Summary of Data Collection

Technical Memorandum

Subject: Route 28 Corridor Safety and Operations Study
From South of I-66 to Liberia Avenue
Summary of Data Collection

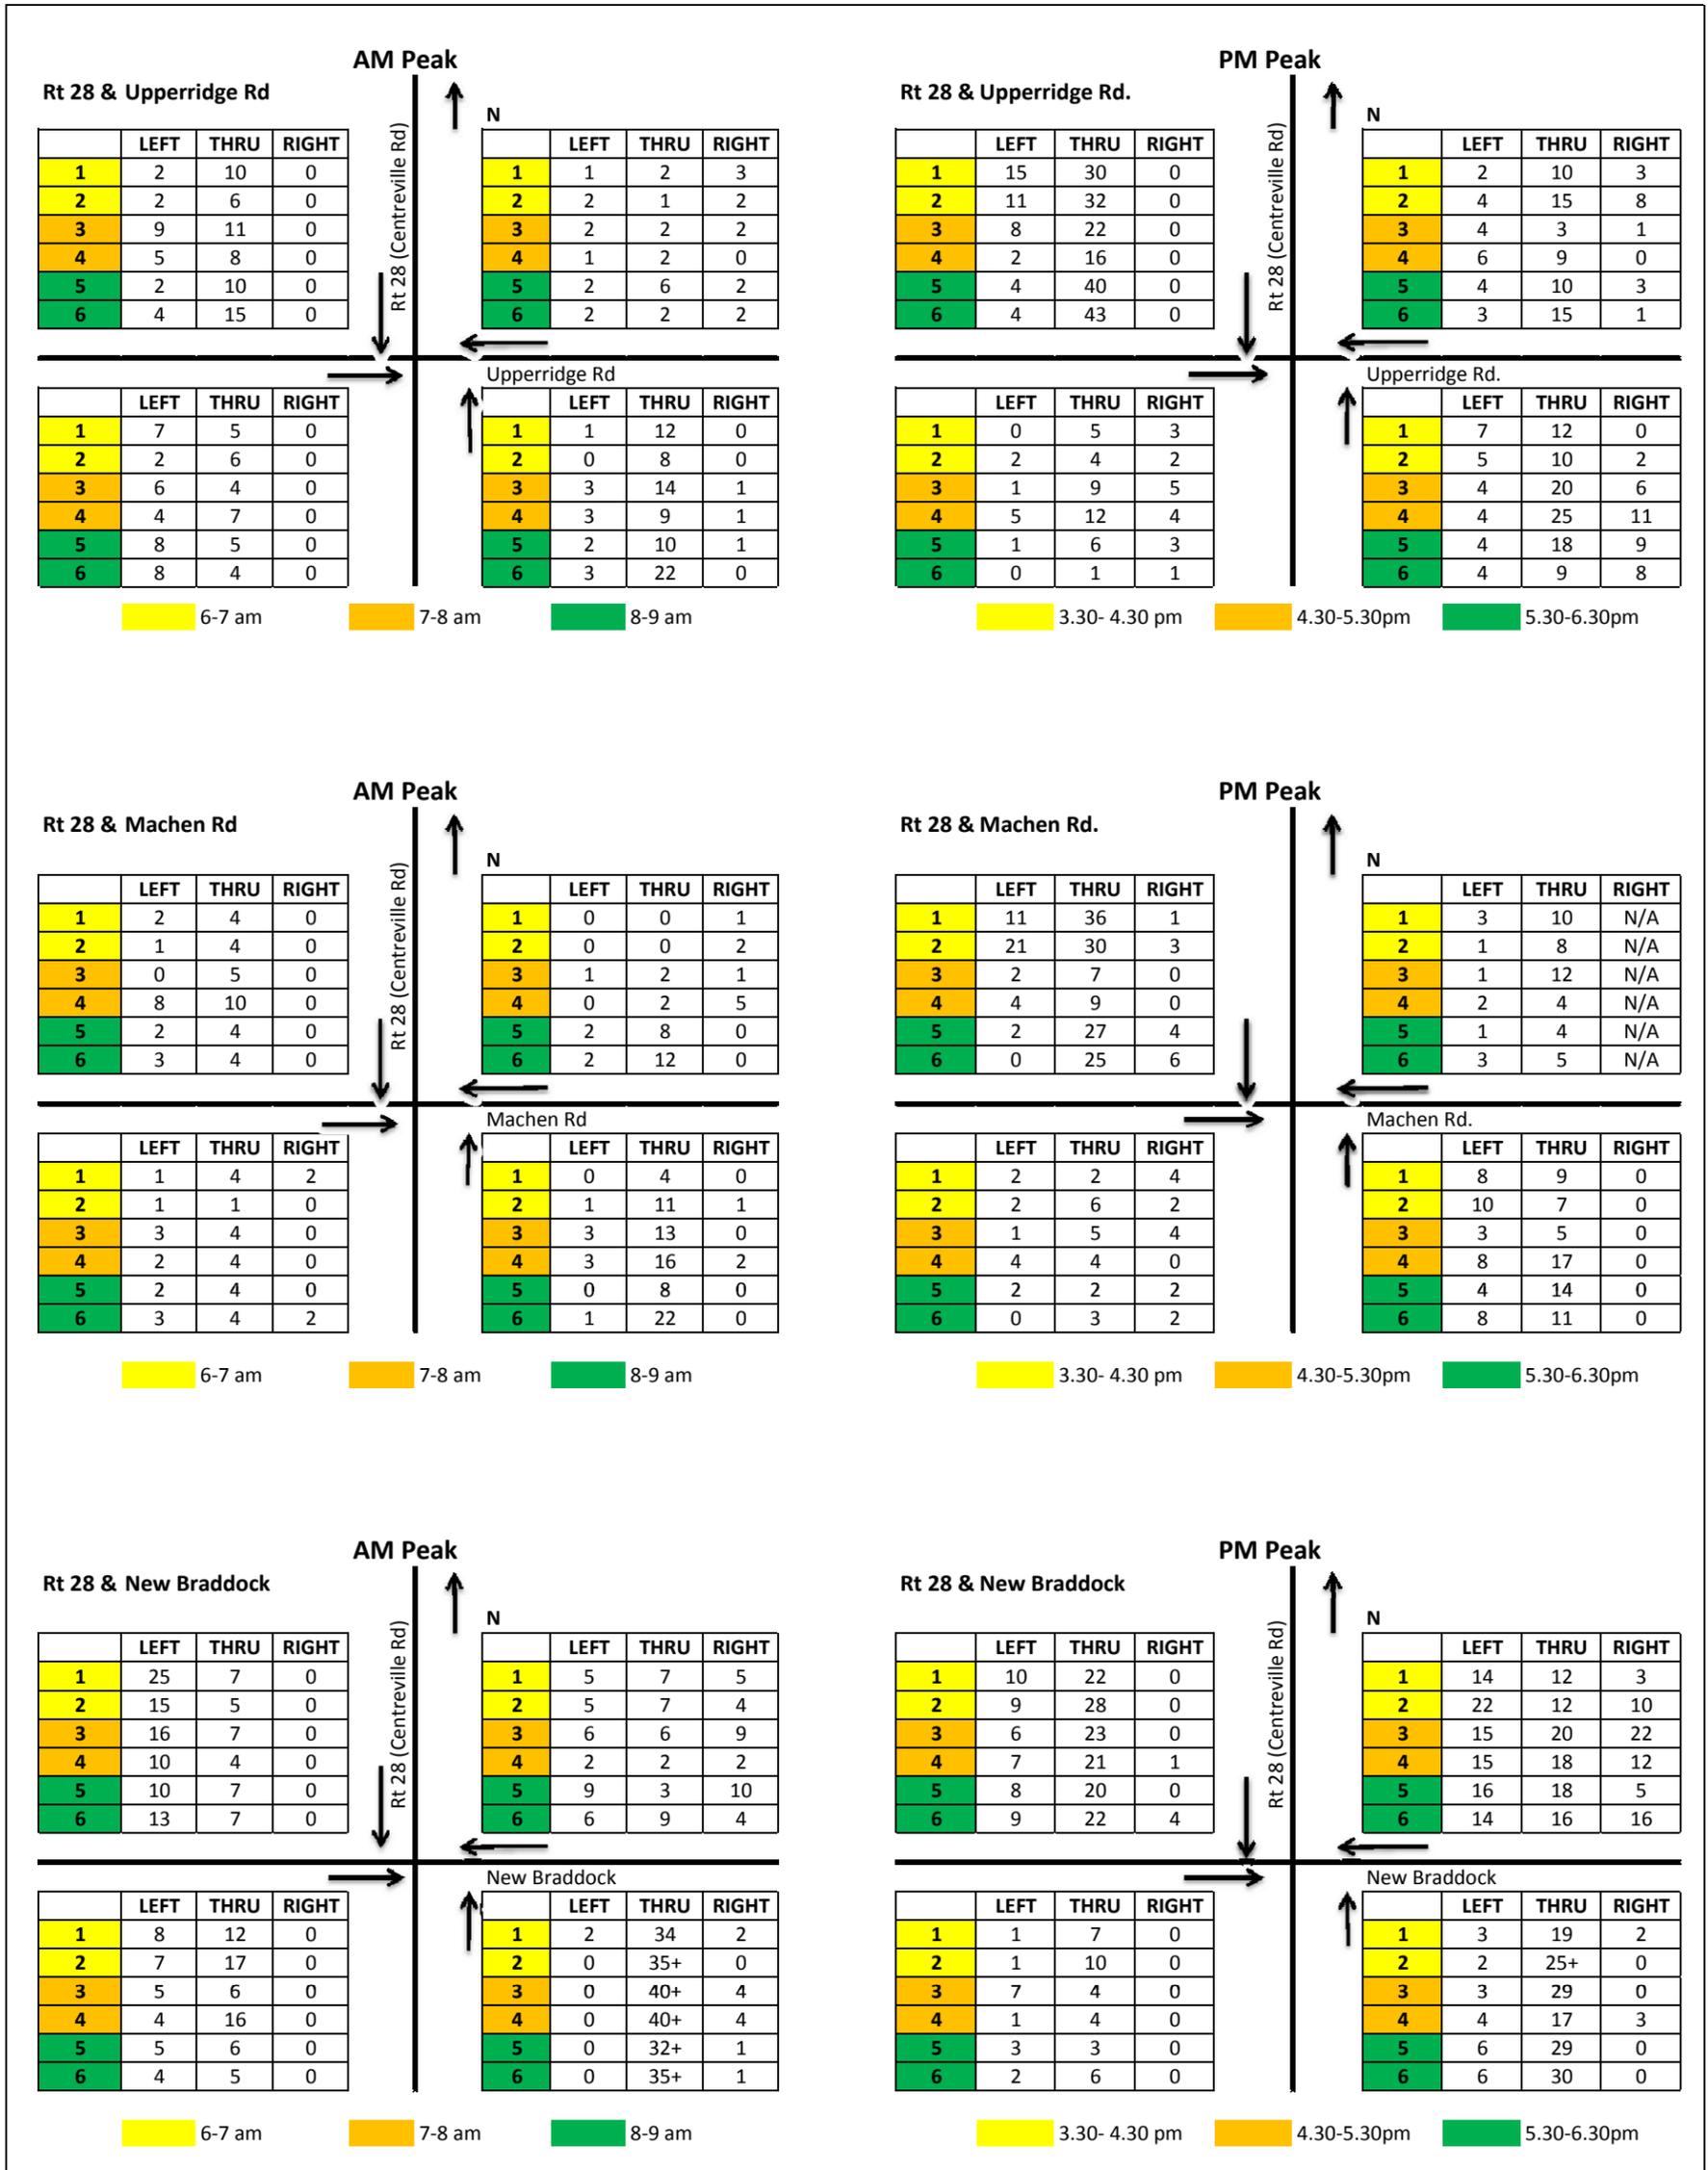
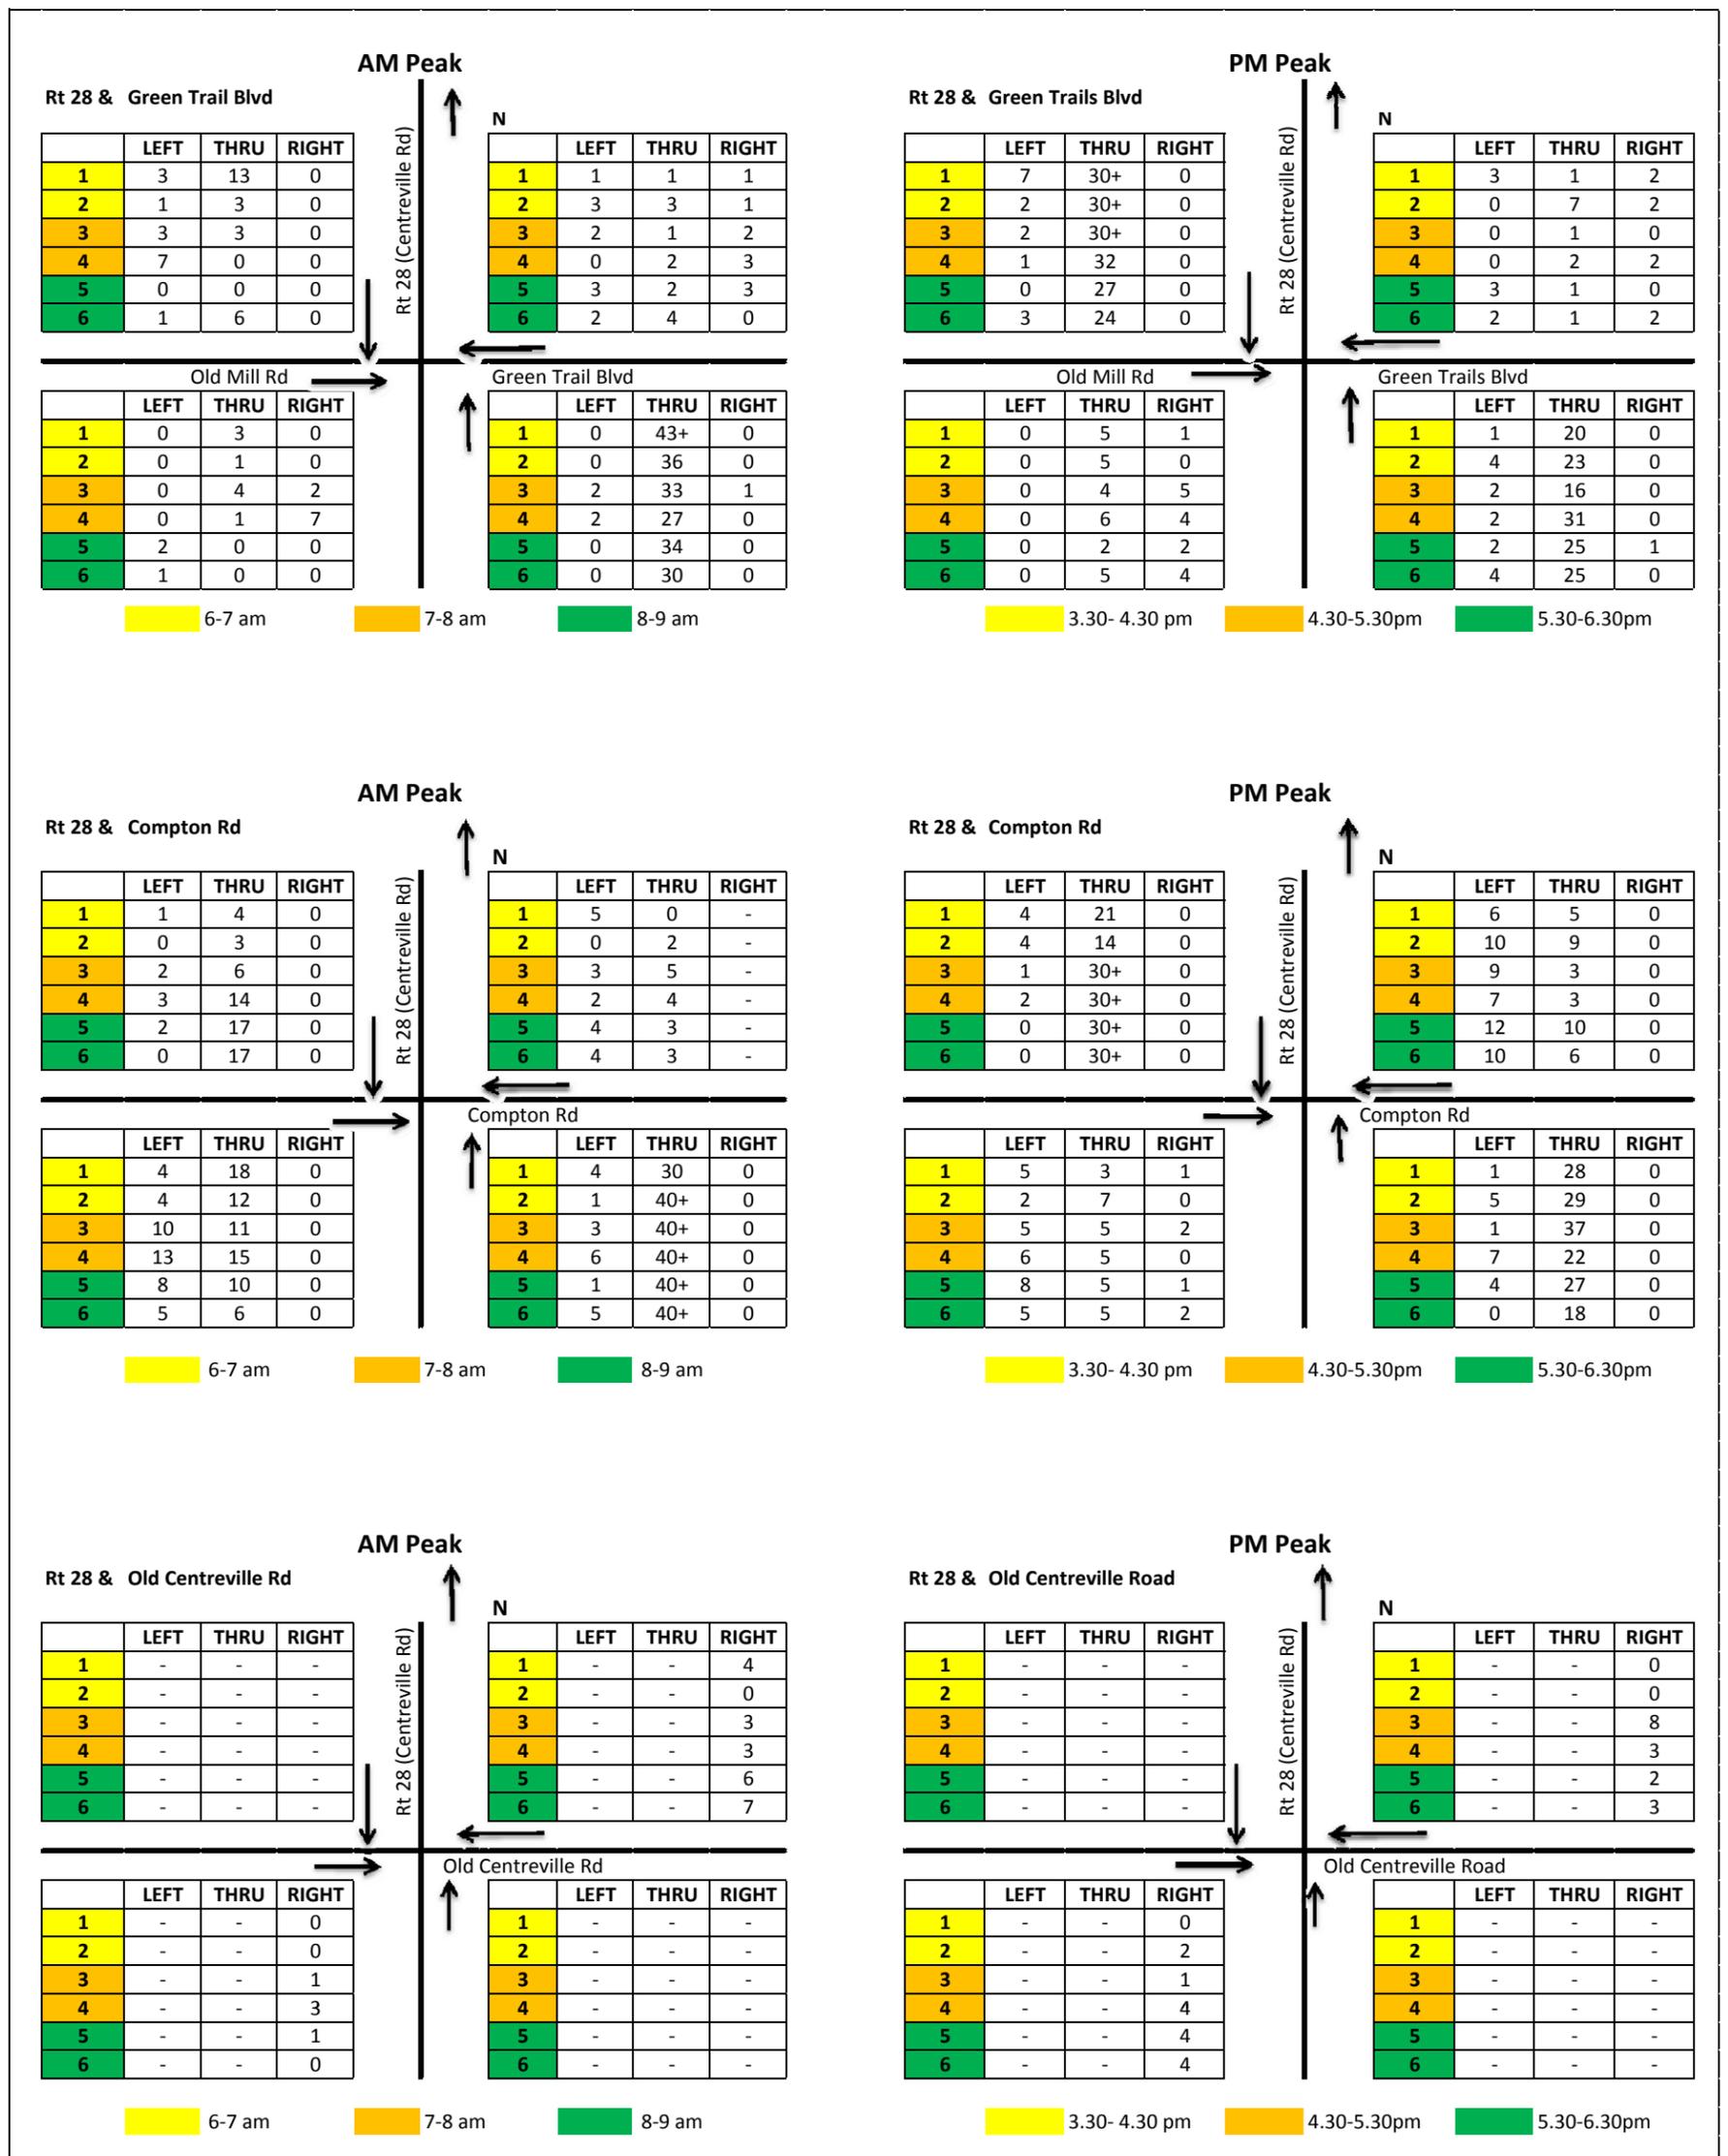
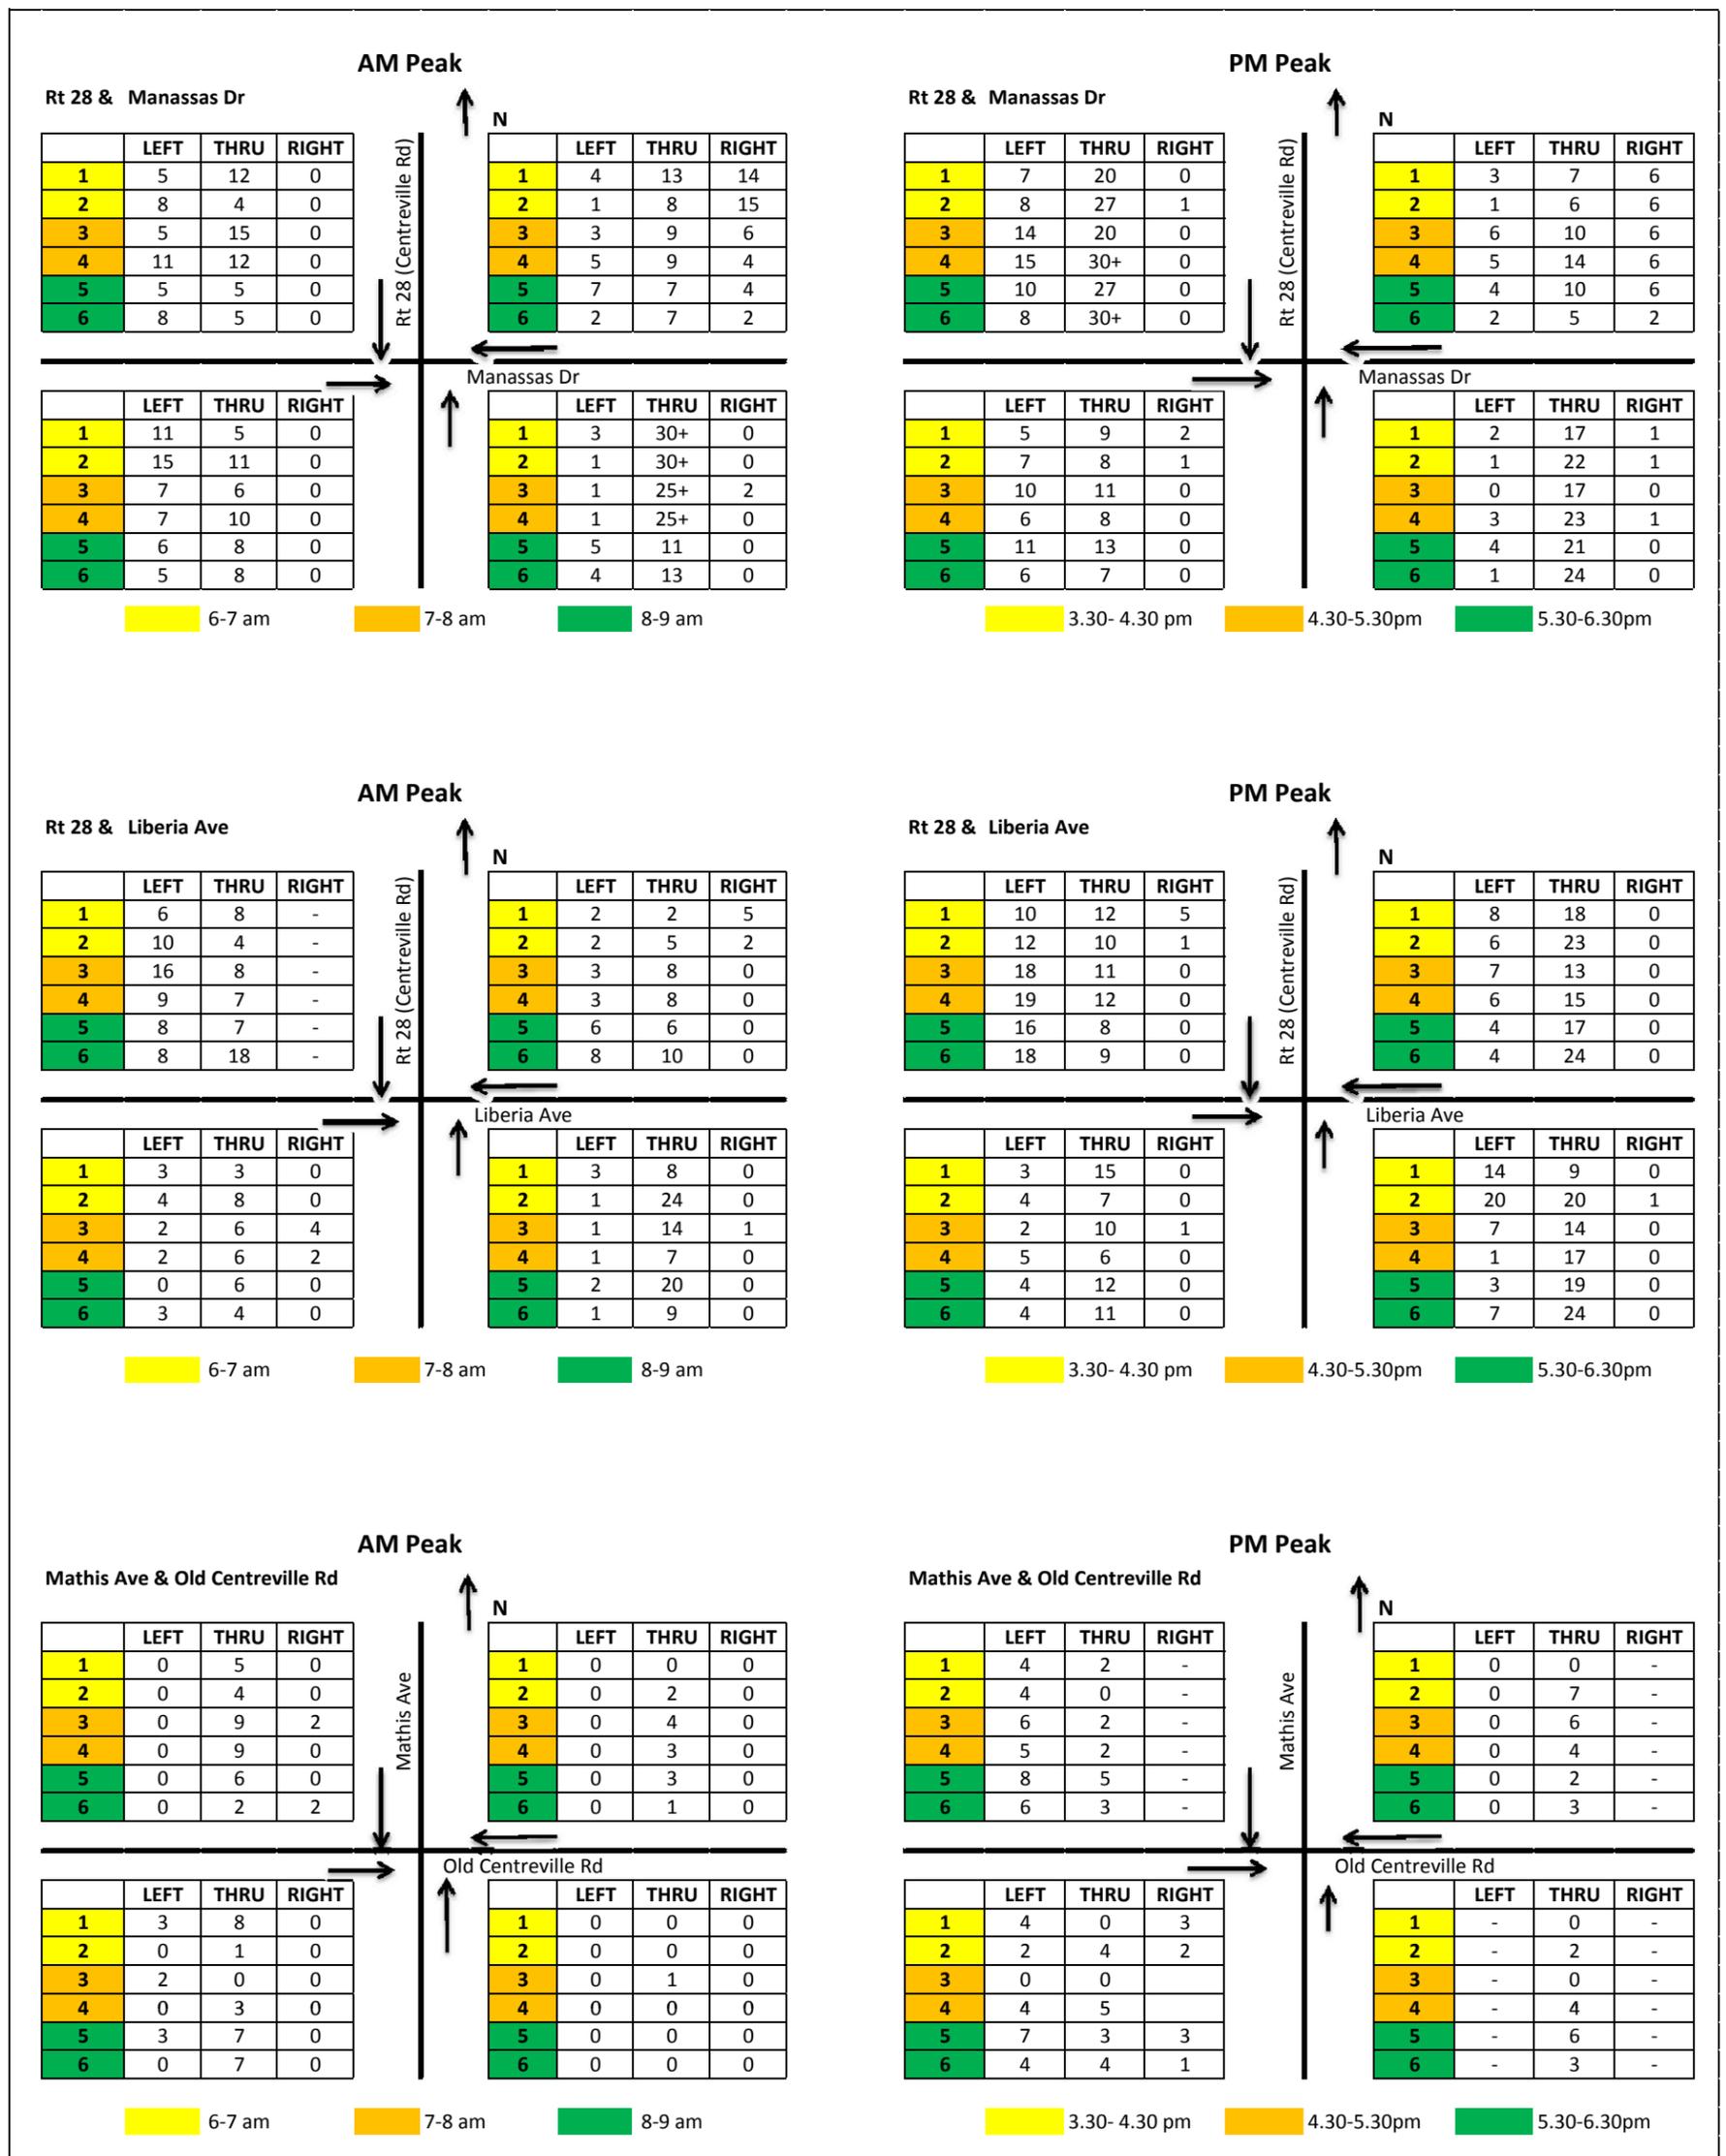
Figure 7: Sample Queues (vehicles) During One Signal Cycle
(Sheet 1 of 3)

- Northbound AM queues: extend from New Braddock Road to Manassas Drive
- Southbound PM queues: extend from Compton Road to Upperridge Drive.

The intersection queue lengths for 10 intersections within the study area were observed within the study area on a typical weekday (Tues-Thurs) in June 2014 when school was in session, between the hours of 6:00 AM to 9:00 AM and 3:30 PM to 6:30 PM. **Table 3** identifies the intersections in which queue lengths were observed. The queue length observation included a sampling and identification of six maximum queue lengths during each of the three-hour peak periods. **Figure 7** in Appendix A displays the results of the queue observations. This information will be utilized in the analysis component of this study to validate the existing traffic analysis models.

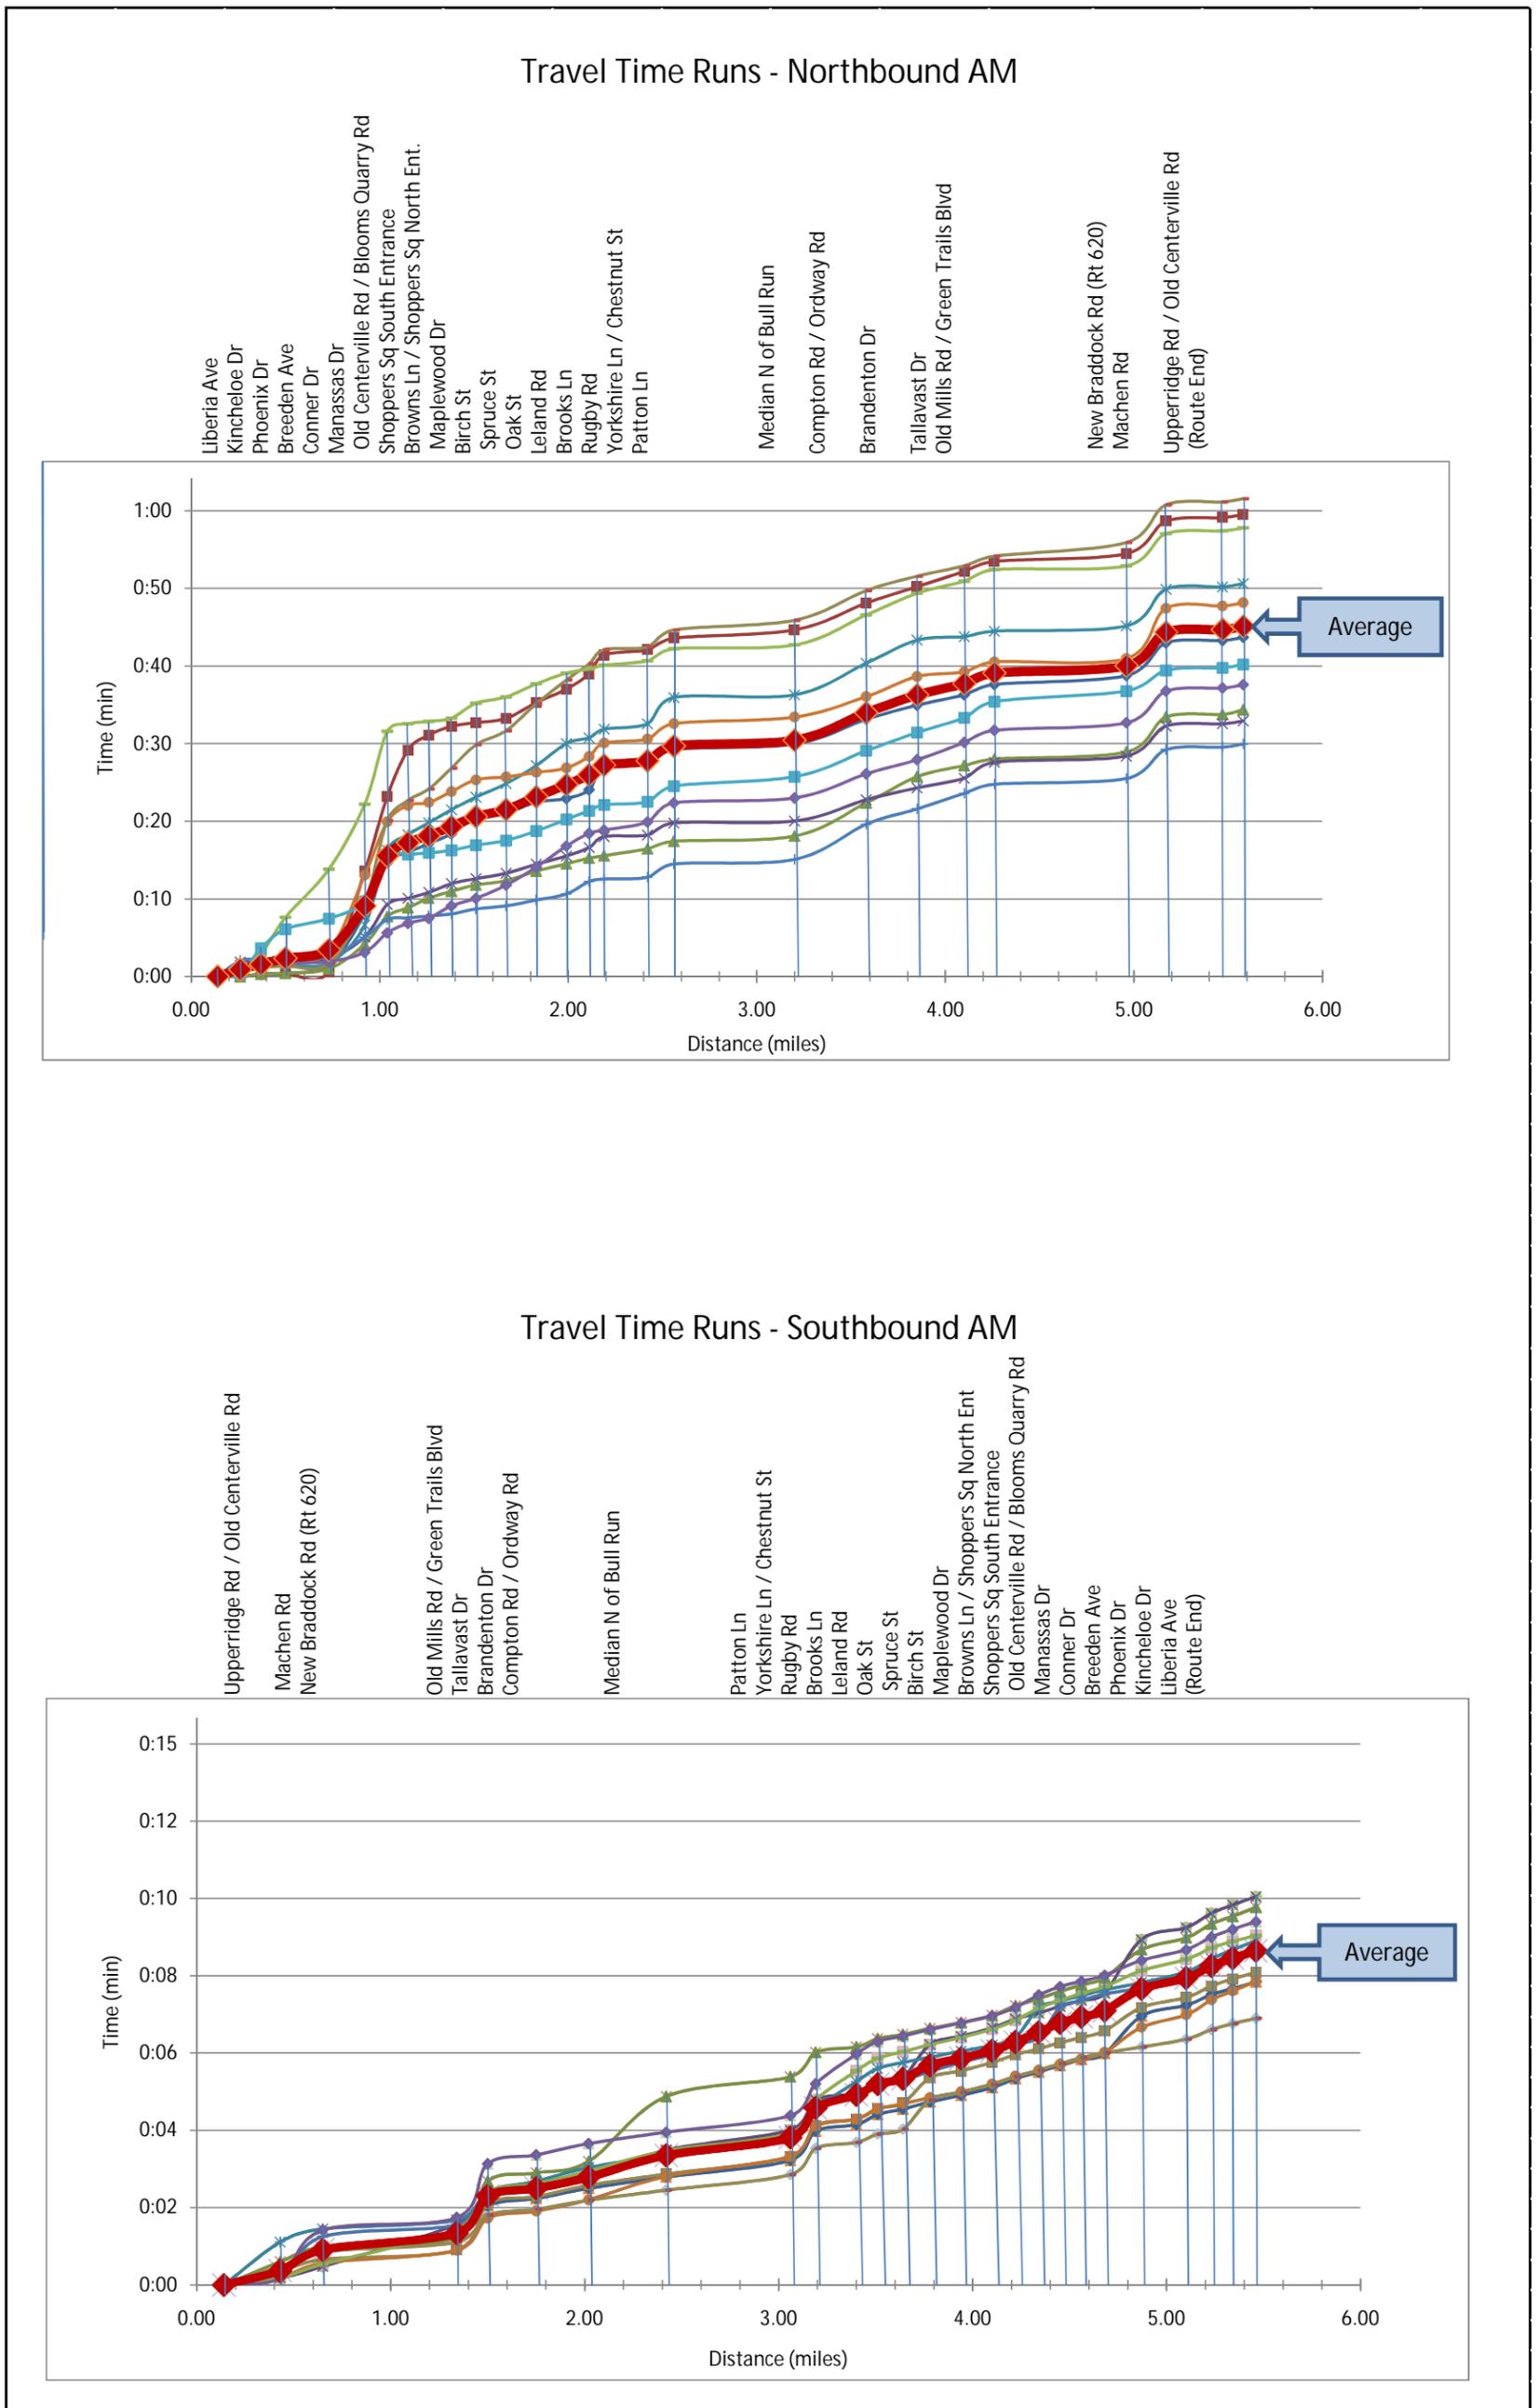
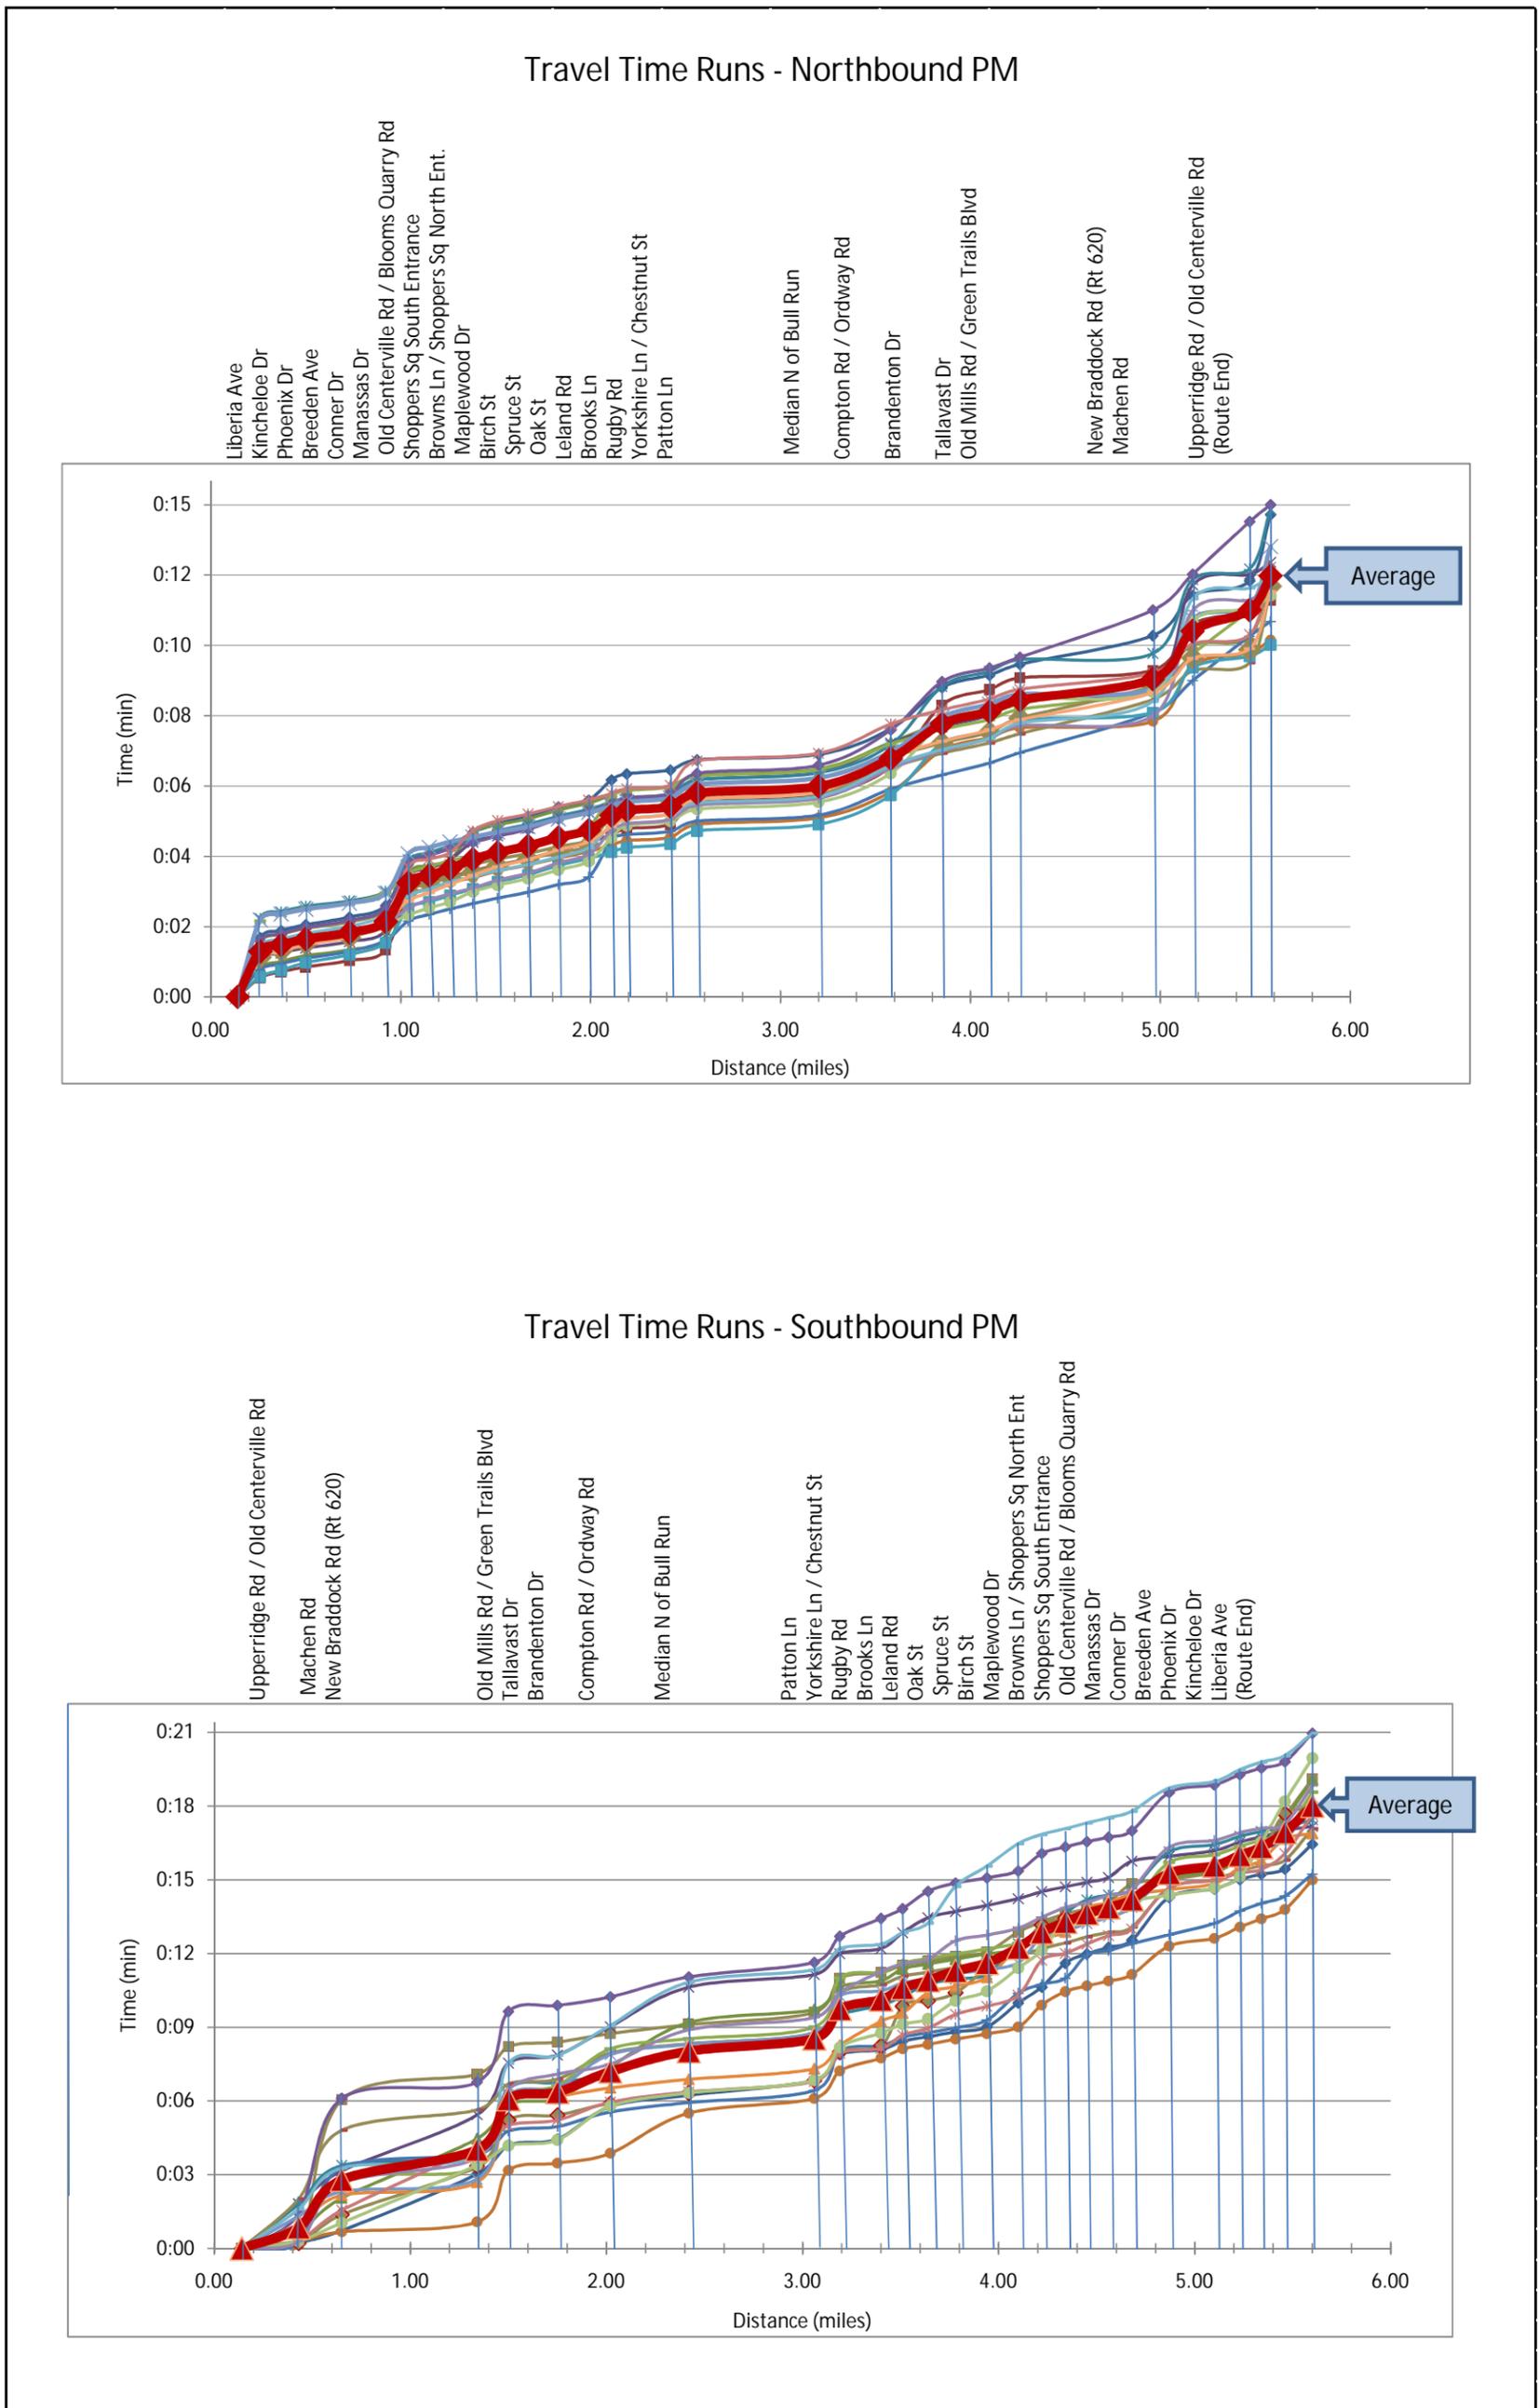
Figure 8: Travel Time Runs (Sheet 1 of 2)

Travel time data along Route 28 for the entire length of the study corridor was collected during AM and PM weekday peak periods in May 2014. Travel time information indicates that the most congested intersections were New Braddock Road and Manassas Drive in the AM peak and the south end of the corridor in the PM peak.

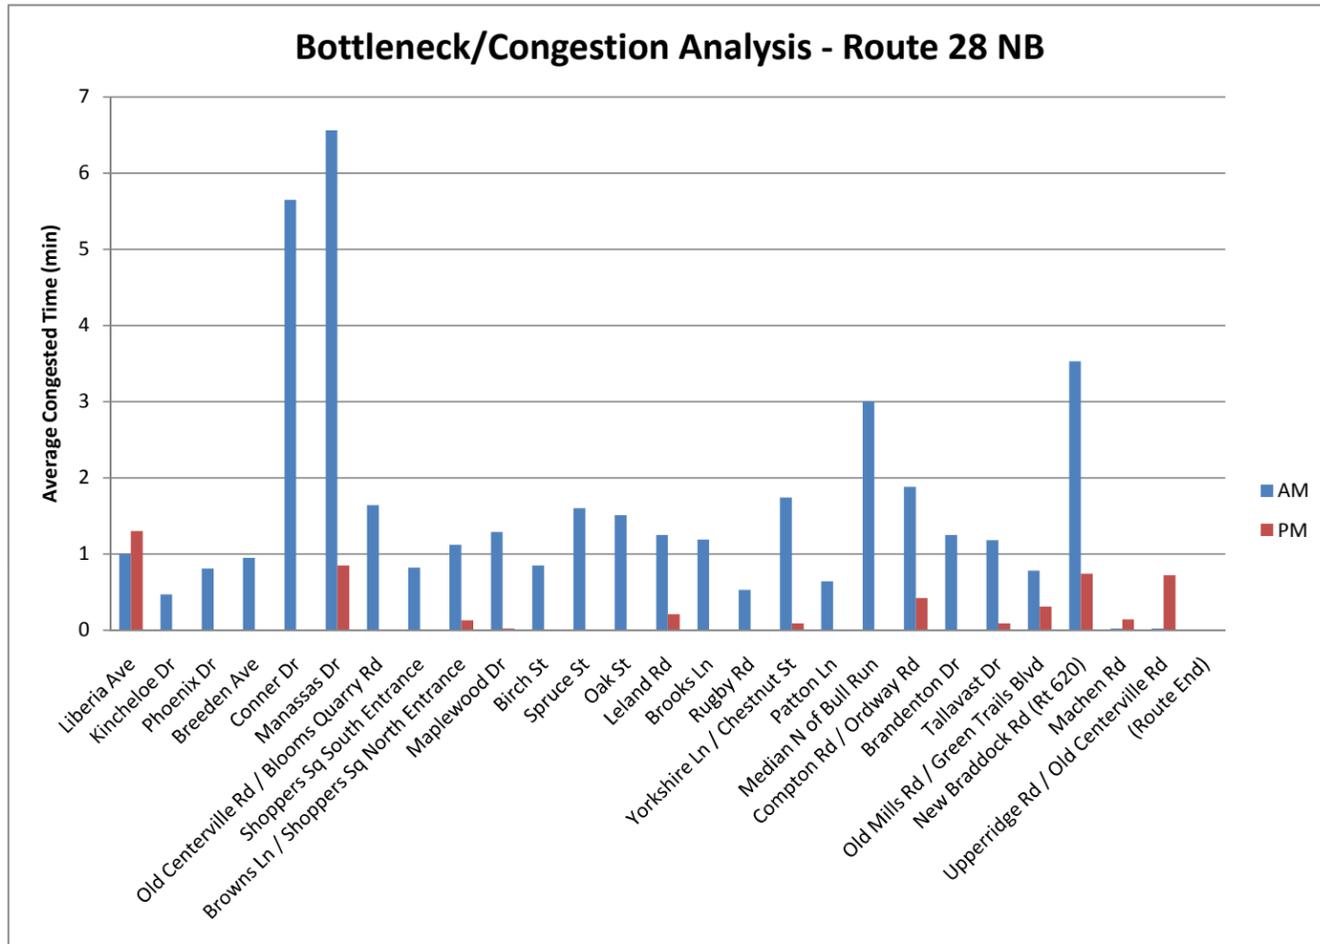
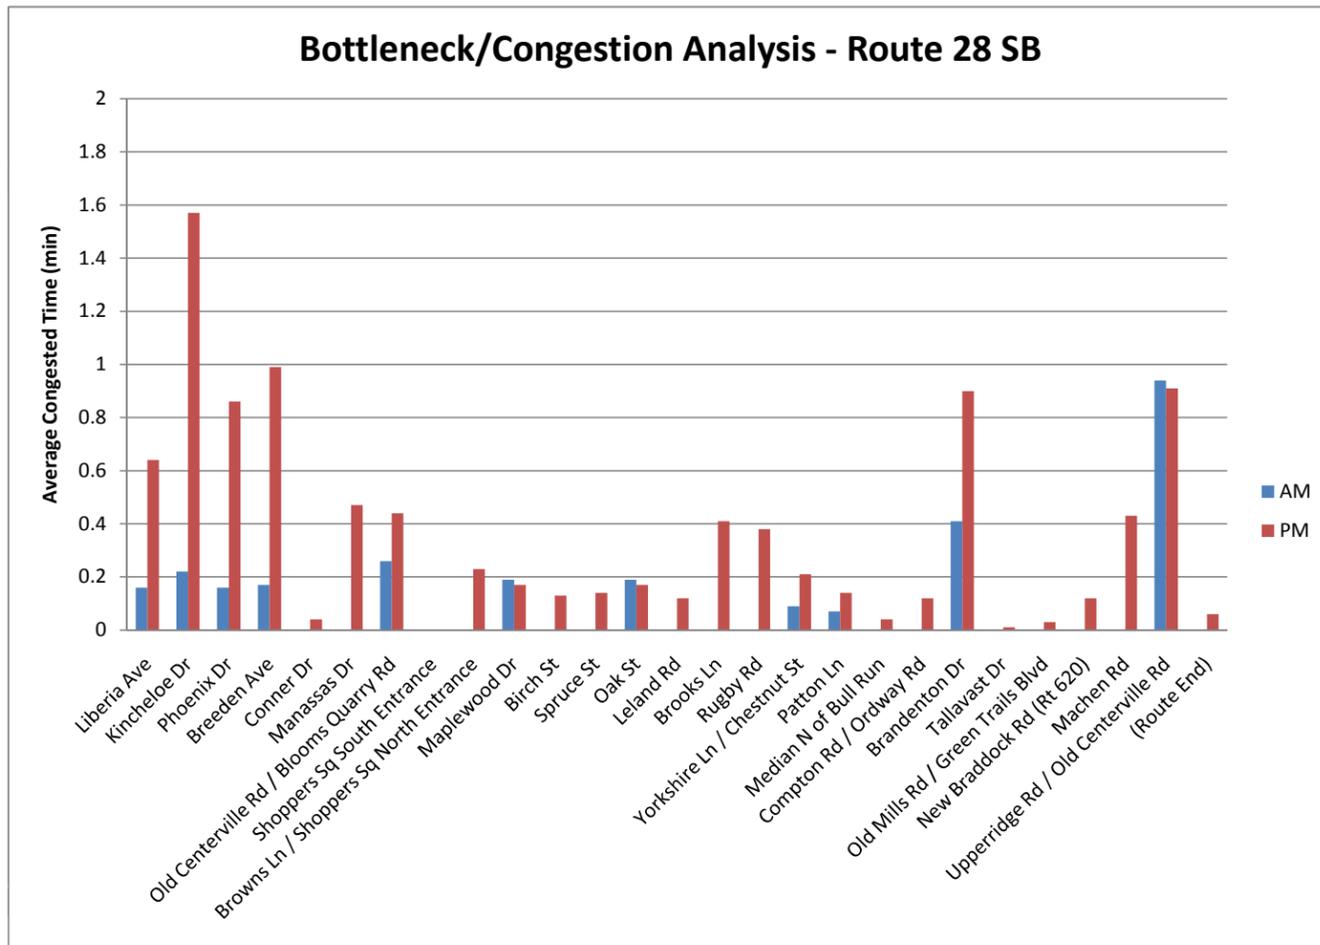
Figure 9: Bottleneck / Congestion Analysis

Congested Time = time in which speed is below 20 mph
