Subject: Route 28 Corridor Safety and Operations Study (South of I-66 to Liberia Avenue)
Summary of Data Collection

Technical Memorandum

Subject: Route 28 Corridor Safety and Operations Study
From South of I-66 to Liberia Avenue
Summary of Data Collection

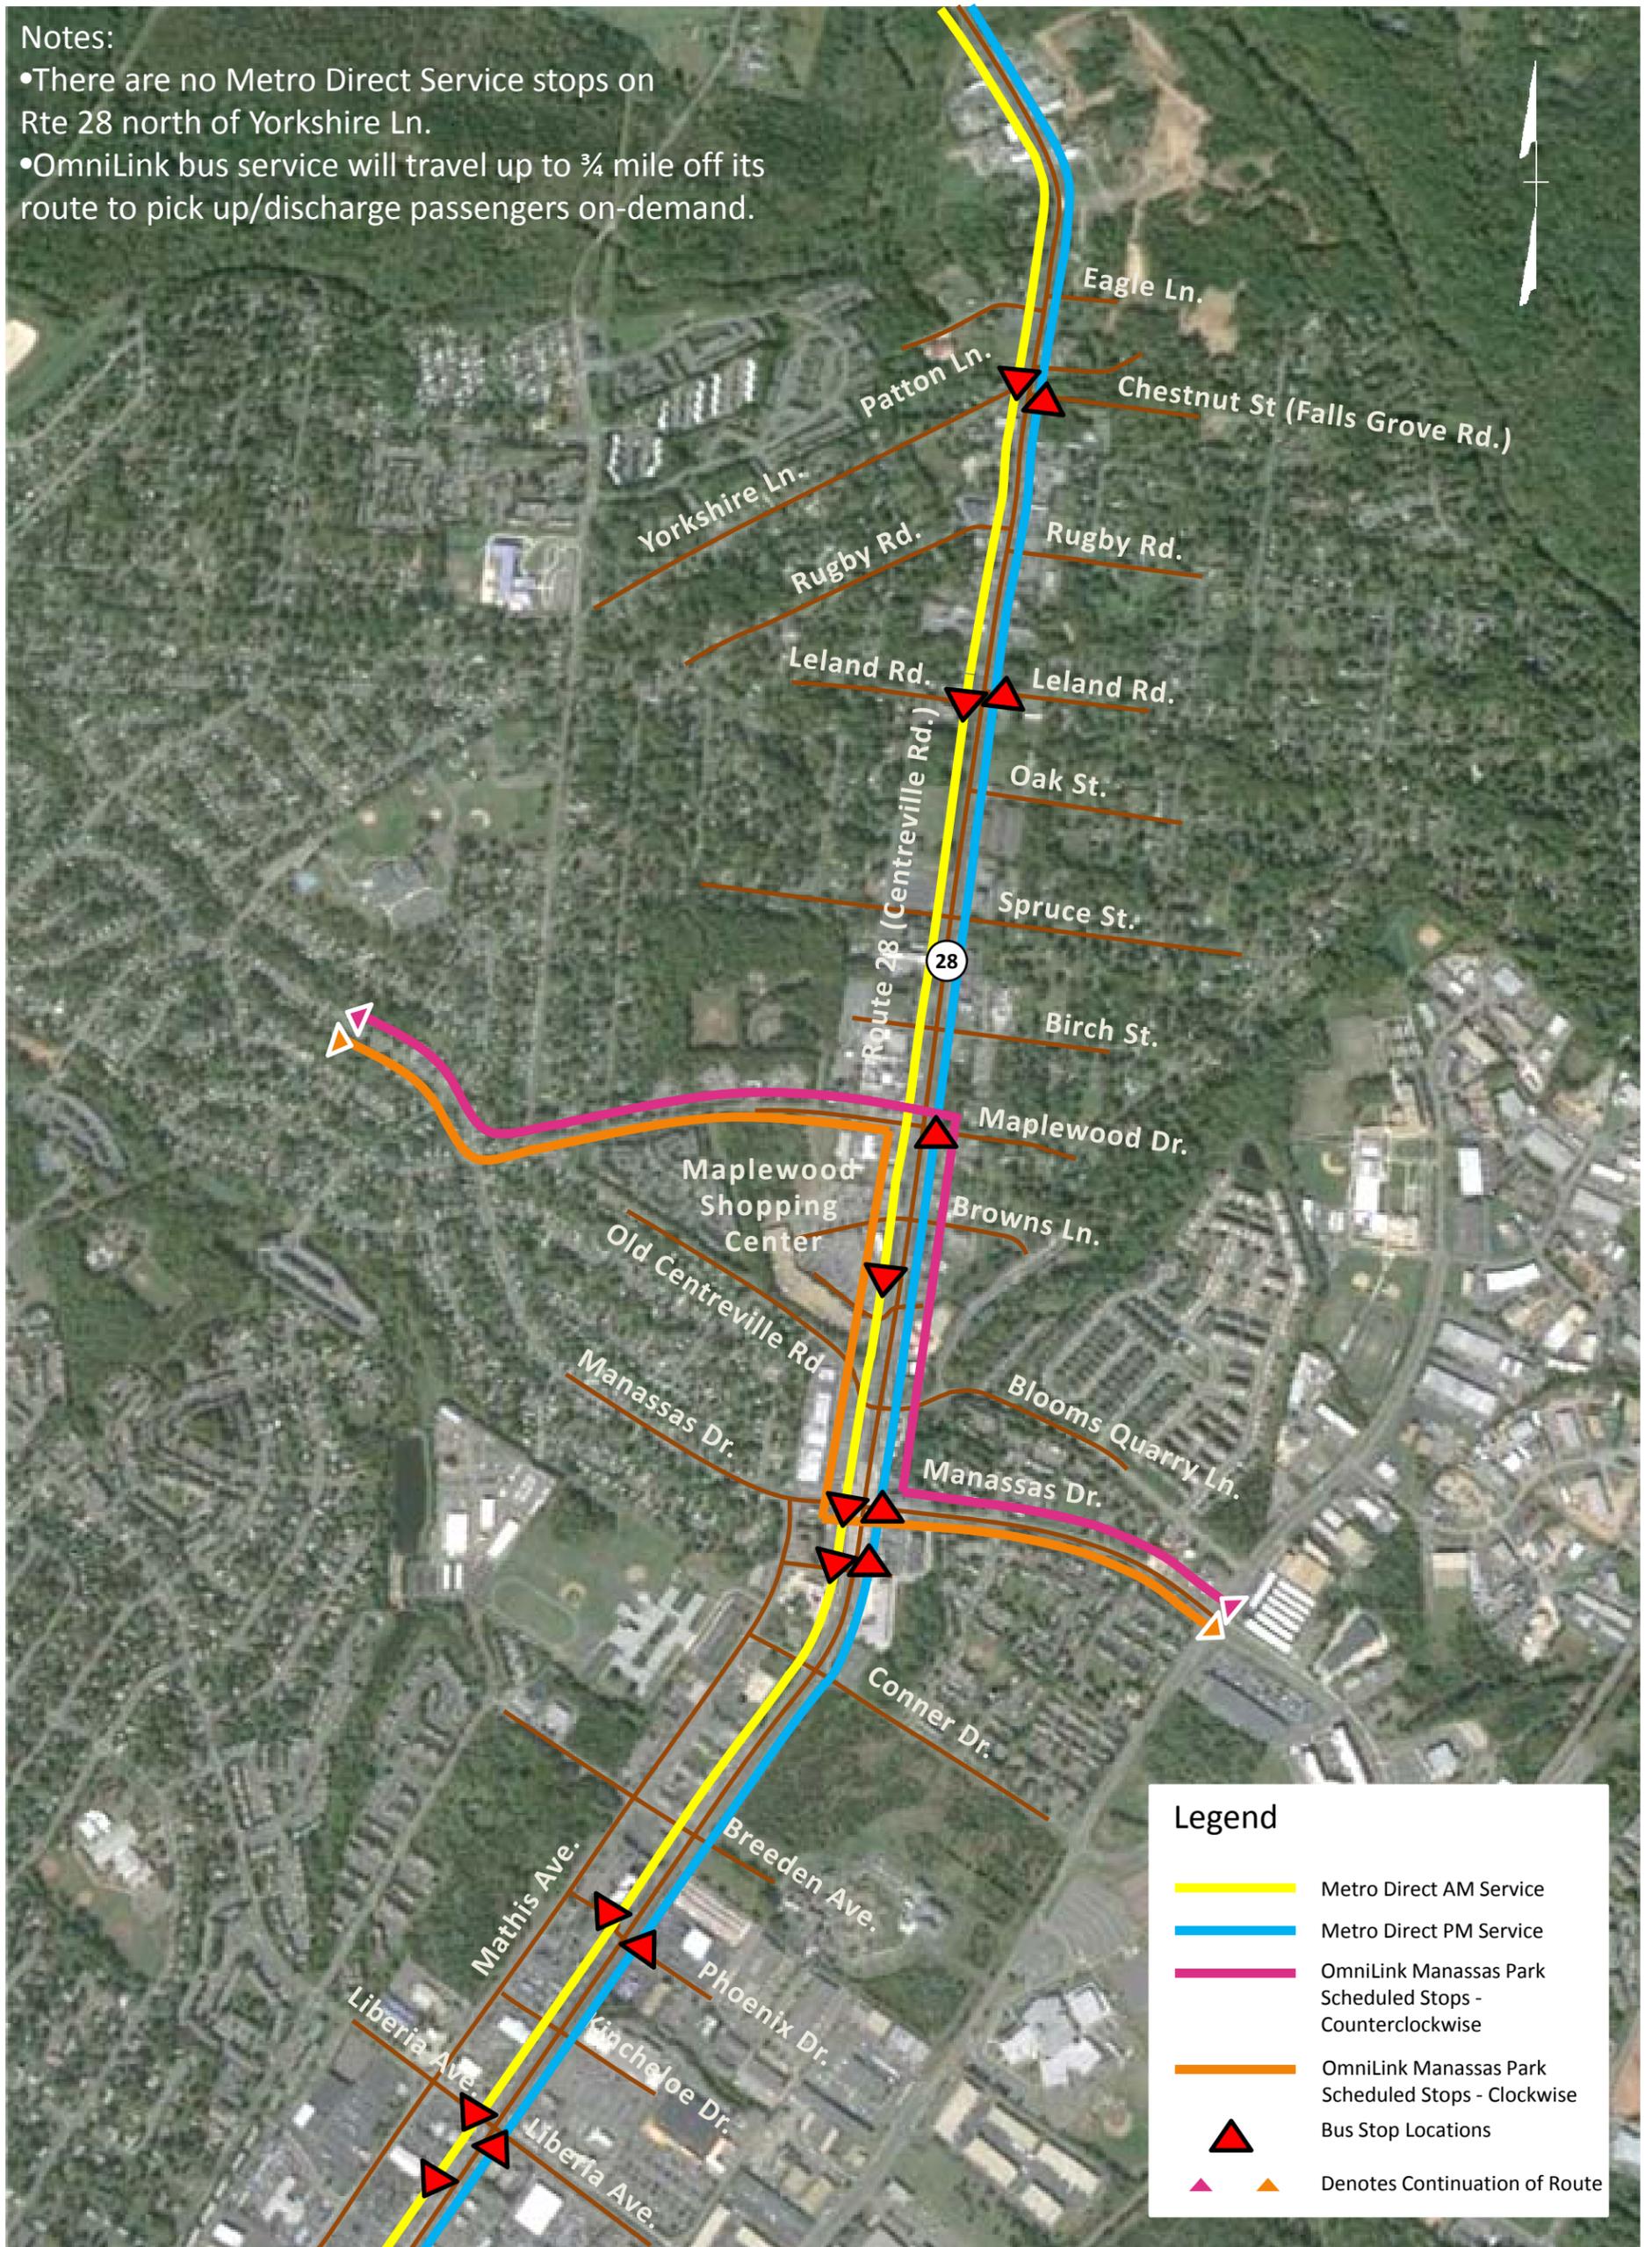
Figure 12: Route 28 Bus Routes & Bus Stop Information

Multi-modal function data has been inventoried. Although there are a decent amount of stops along Route 28, there are no Metro Direct Service stops north of Yorkshire Lane.

- There are no Metro Direct Service stops on Rte 28 north of Yorkshire Ln.
- OmniLink bus service will travel up to ¼ mile off its route to pick up/discharge passengers on-demand.

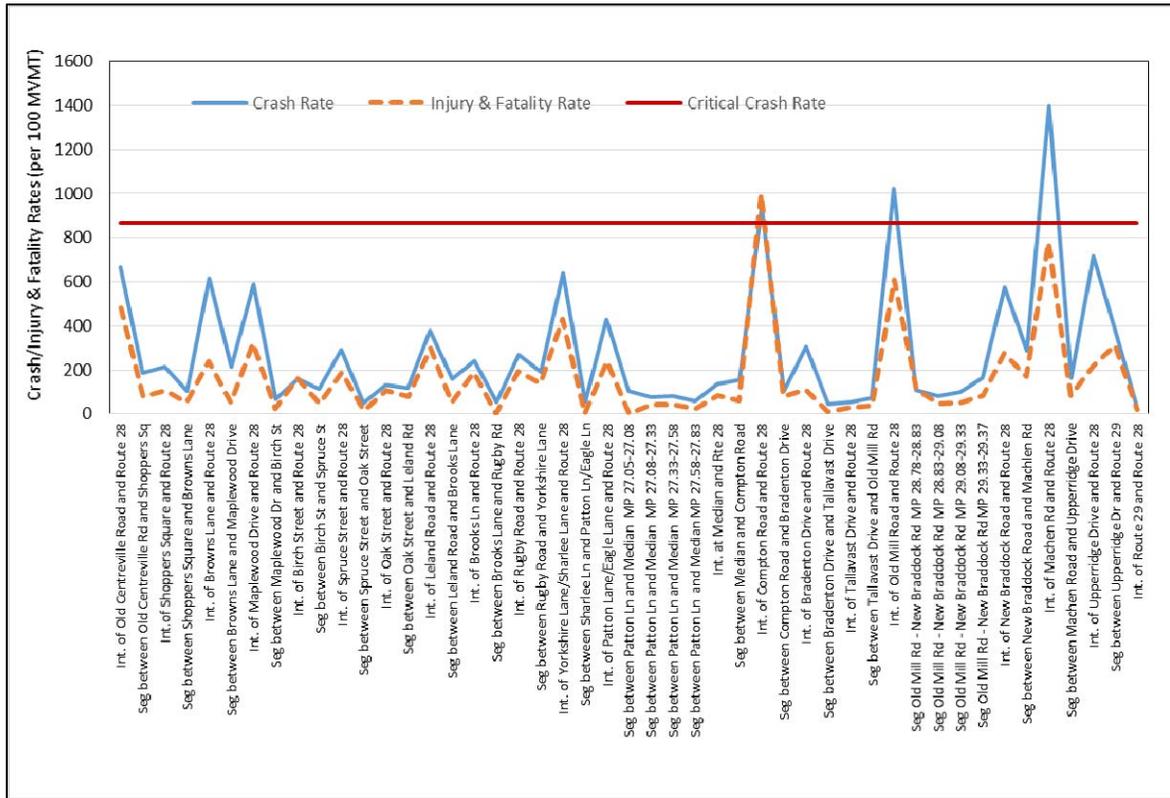
Figure 2: Route 28 Crash, Injury & Fatality Rates Vs. Critical Crash Rate

Based on the methodology stated previously, the critical crash rate was calculated to be 867 crashes per 100 Million Vehicles Miles Traveled (MVMT). Figure 2 presents a graph of the crash and injury and fatality rates for each location, along with a straight line for the critical crash rate.

There are three locations where the crash rate is higher than the line for the critical crash rate, so these three locations are identified as hot spots:

1. Intersection of Route 28 at Compton Road
2. Intersection of Route 28 at Old Mill Road
3. Intersection of Route 28 at Machen Road

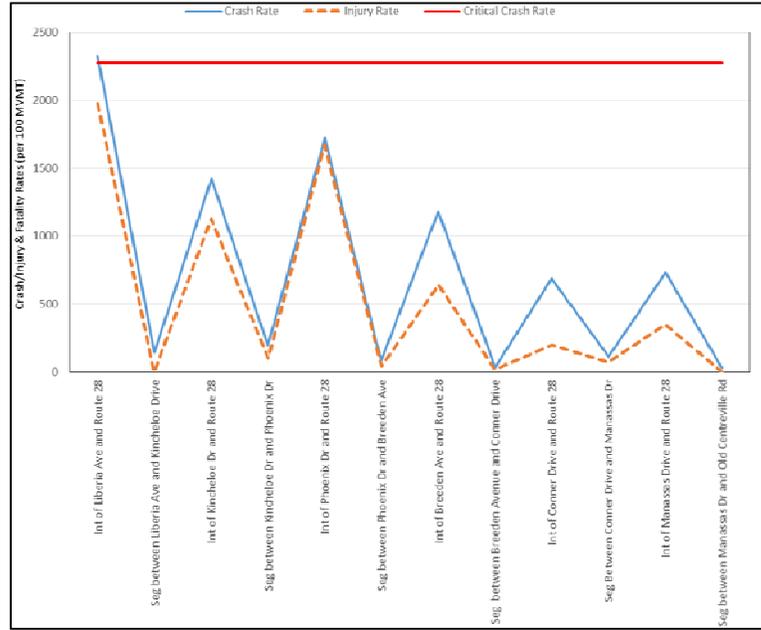
Figure 3: Route 28 Crash Rate Comparison (From Liberia Avenue to Old Centreville Road)

Based on the methodology stated previously, the critical crash rate was calculated to be 2,273 crashes per 100 Million Vehicles Miles Traveled (MVMT). Figure 3 presents a graph of the crash and injury and fatality rates for each location, along with a straight line for the critical crash rate.

The crash rate for the intersection of Route 28 and Liberia Avenue is above the critical crash rate and it is therefore identified as the only hot spot within this study segment. A detailed crash analysis of the intersection of Route 28 and Liberia Avenue is discussed below.

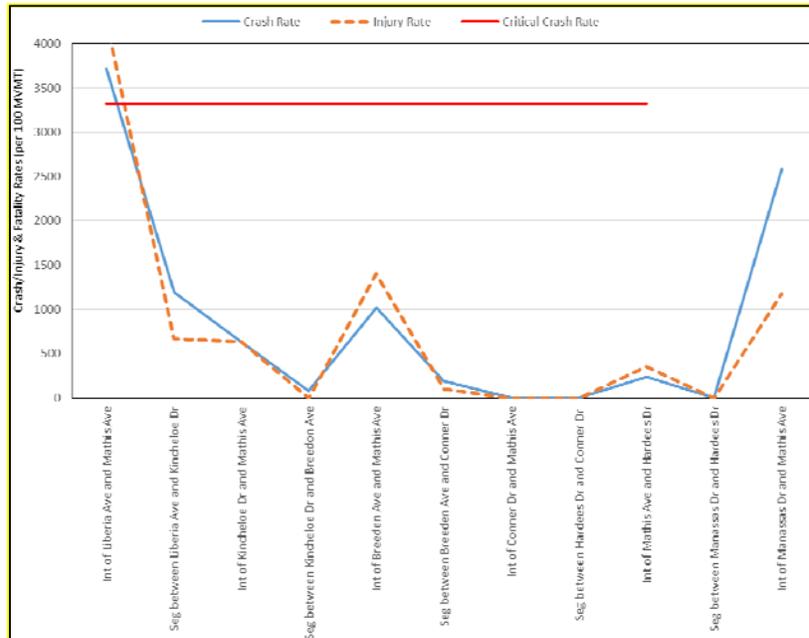
Figure 4: Mathis Avenue Crash Rate Comparison

Based on the methodology previously described, the critical crash rate was calculated as 3,329 crashes per 100 Million Vehicles Miles Traveled (MVMT). Figure 4 shows a graph of the crash, injury and fatality rates for each location, along with a straight line for the critical crash rate.

The crash rate for the intersection of Mathis Avenue and Liberia Avenue is above the critical crash rate and is therefore identified as the only hot spot. A detailed crash analysis of this hot spot is discussed below.
