Effective Strategies to Address
REFLECTIVE CRACKING
Virginia Case Studies

Trenton M. Clark, P.E.
Executive Vice President

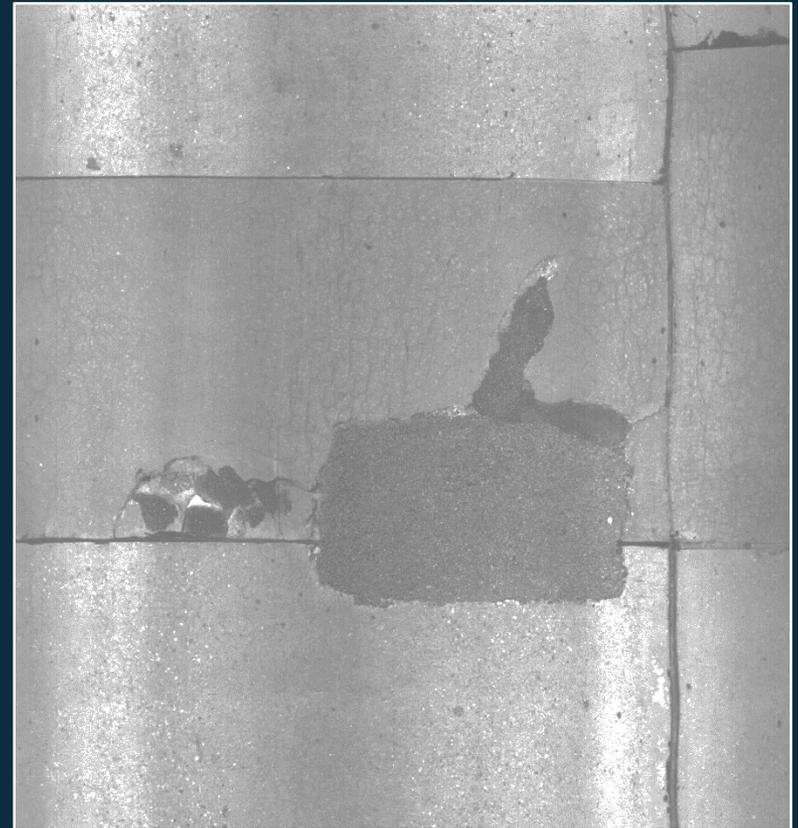
- Laburnum Ave. to Bottoms Bridge
- By mid-2000's, existing jointed concrete pavement very deteriorated
- Deteriorated joints with poor ride quality

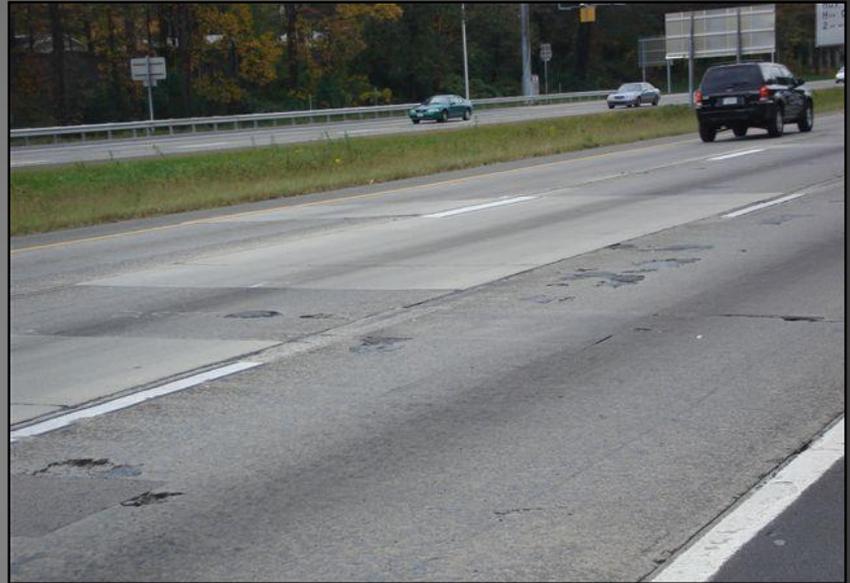
Old
Pavement
in Poor
Condition

Approx. 20%
of all
pavement in
poor shape

Distresses
generally at
transverse
joints

Isolated
slabs have
distress
(spalling)
throughout
