# Resilient Infrastructure

Trygve W. Hoff, PE  
Northeast Region Engineer  
American Concrete Pipe Association  
[thoff@concretepipe.org](mailto:thoff@concretepipe.org)

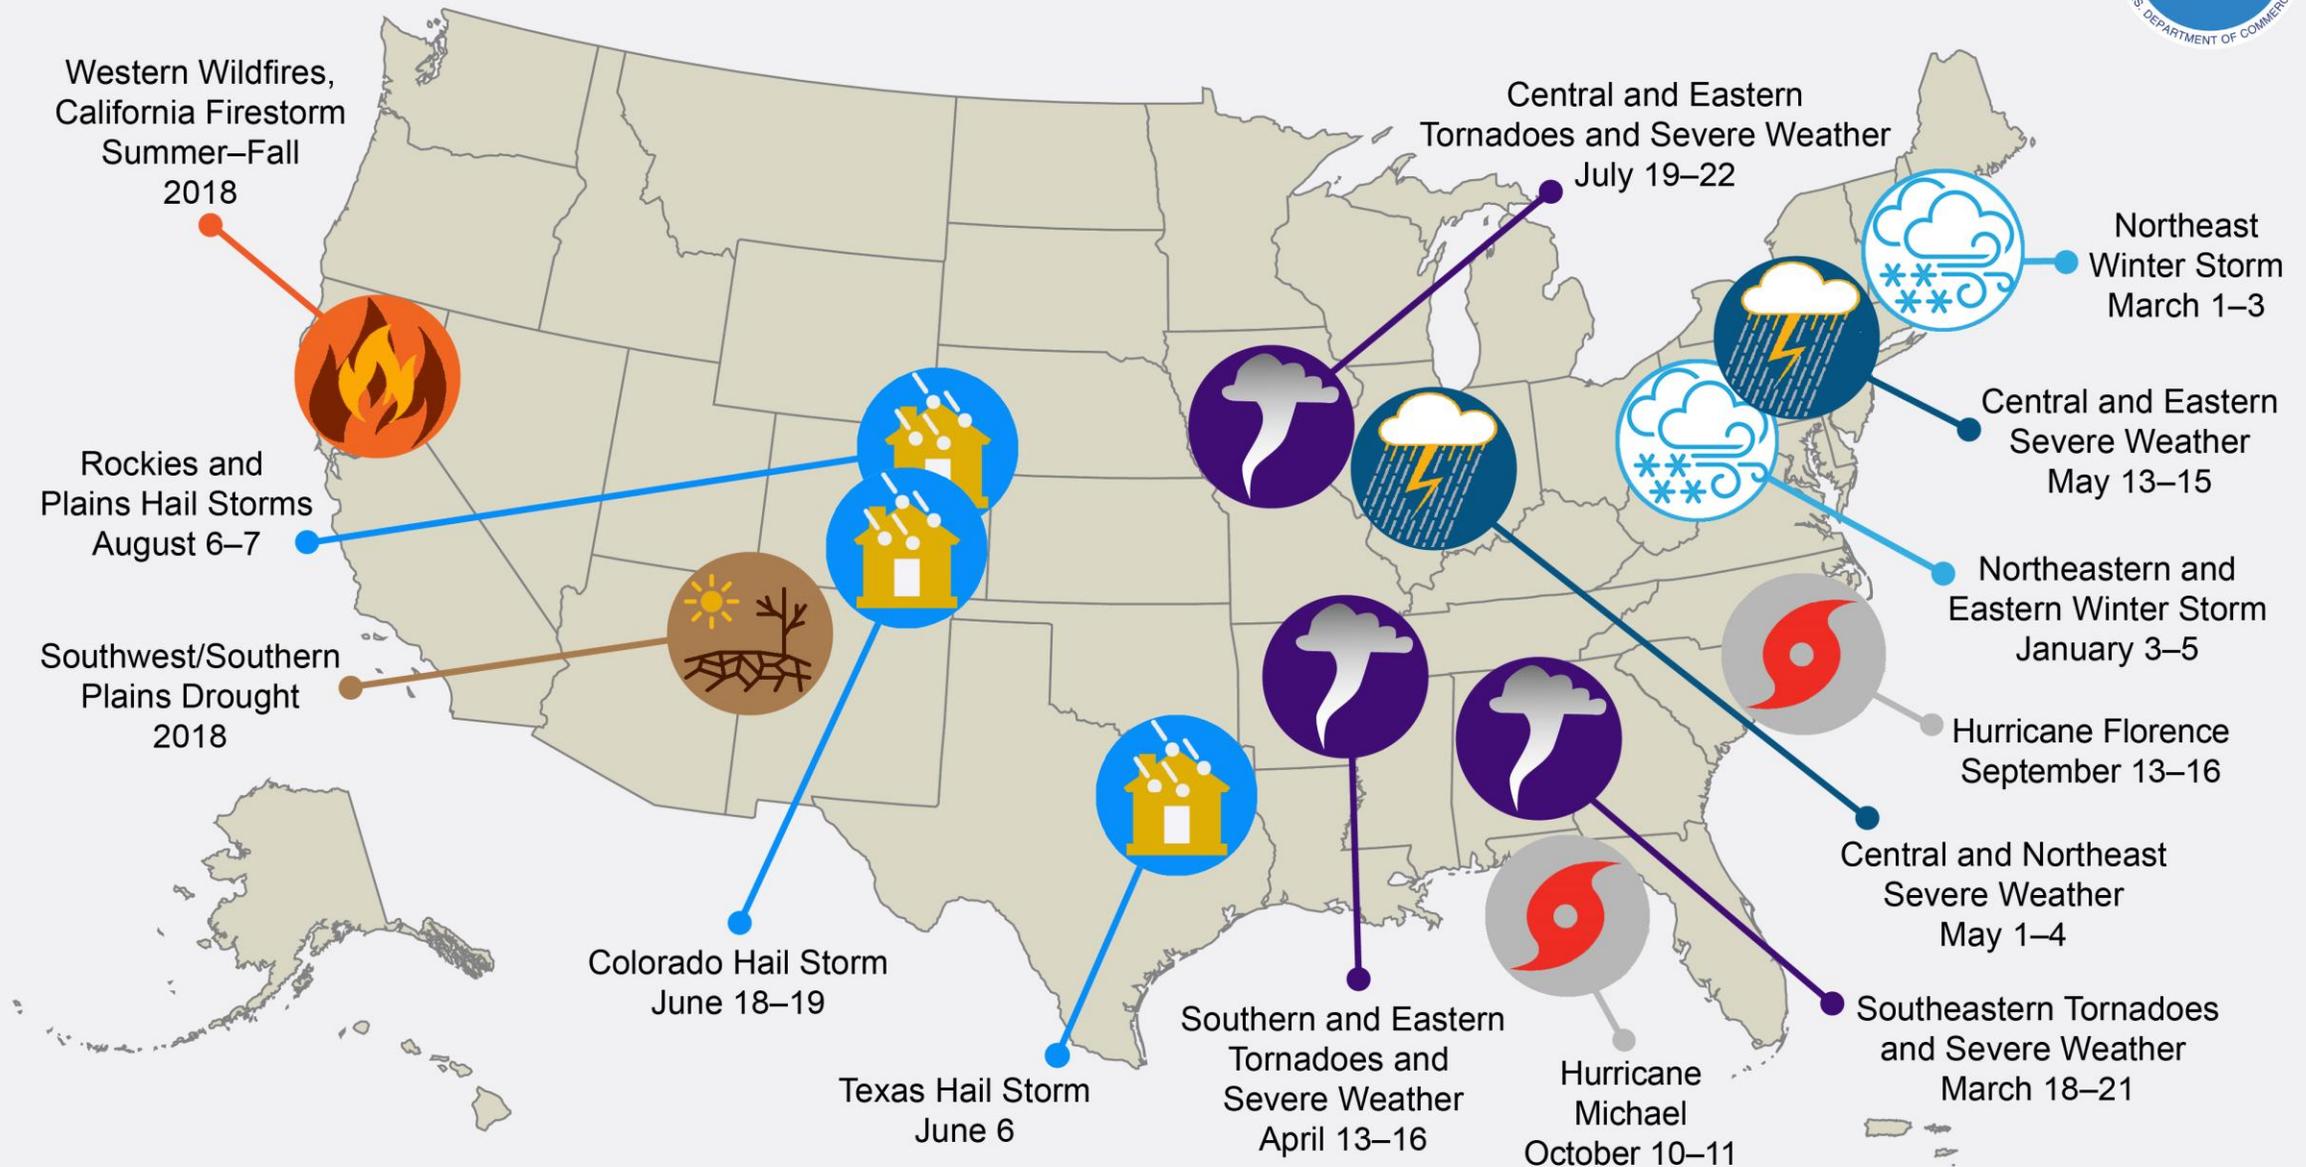
*This map denotes the approximate location for each of the 14 separate billion-dollar weather and climate disasters that impacted the United States during 2018.*

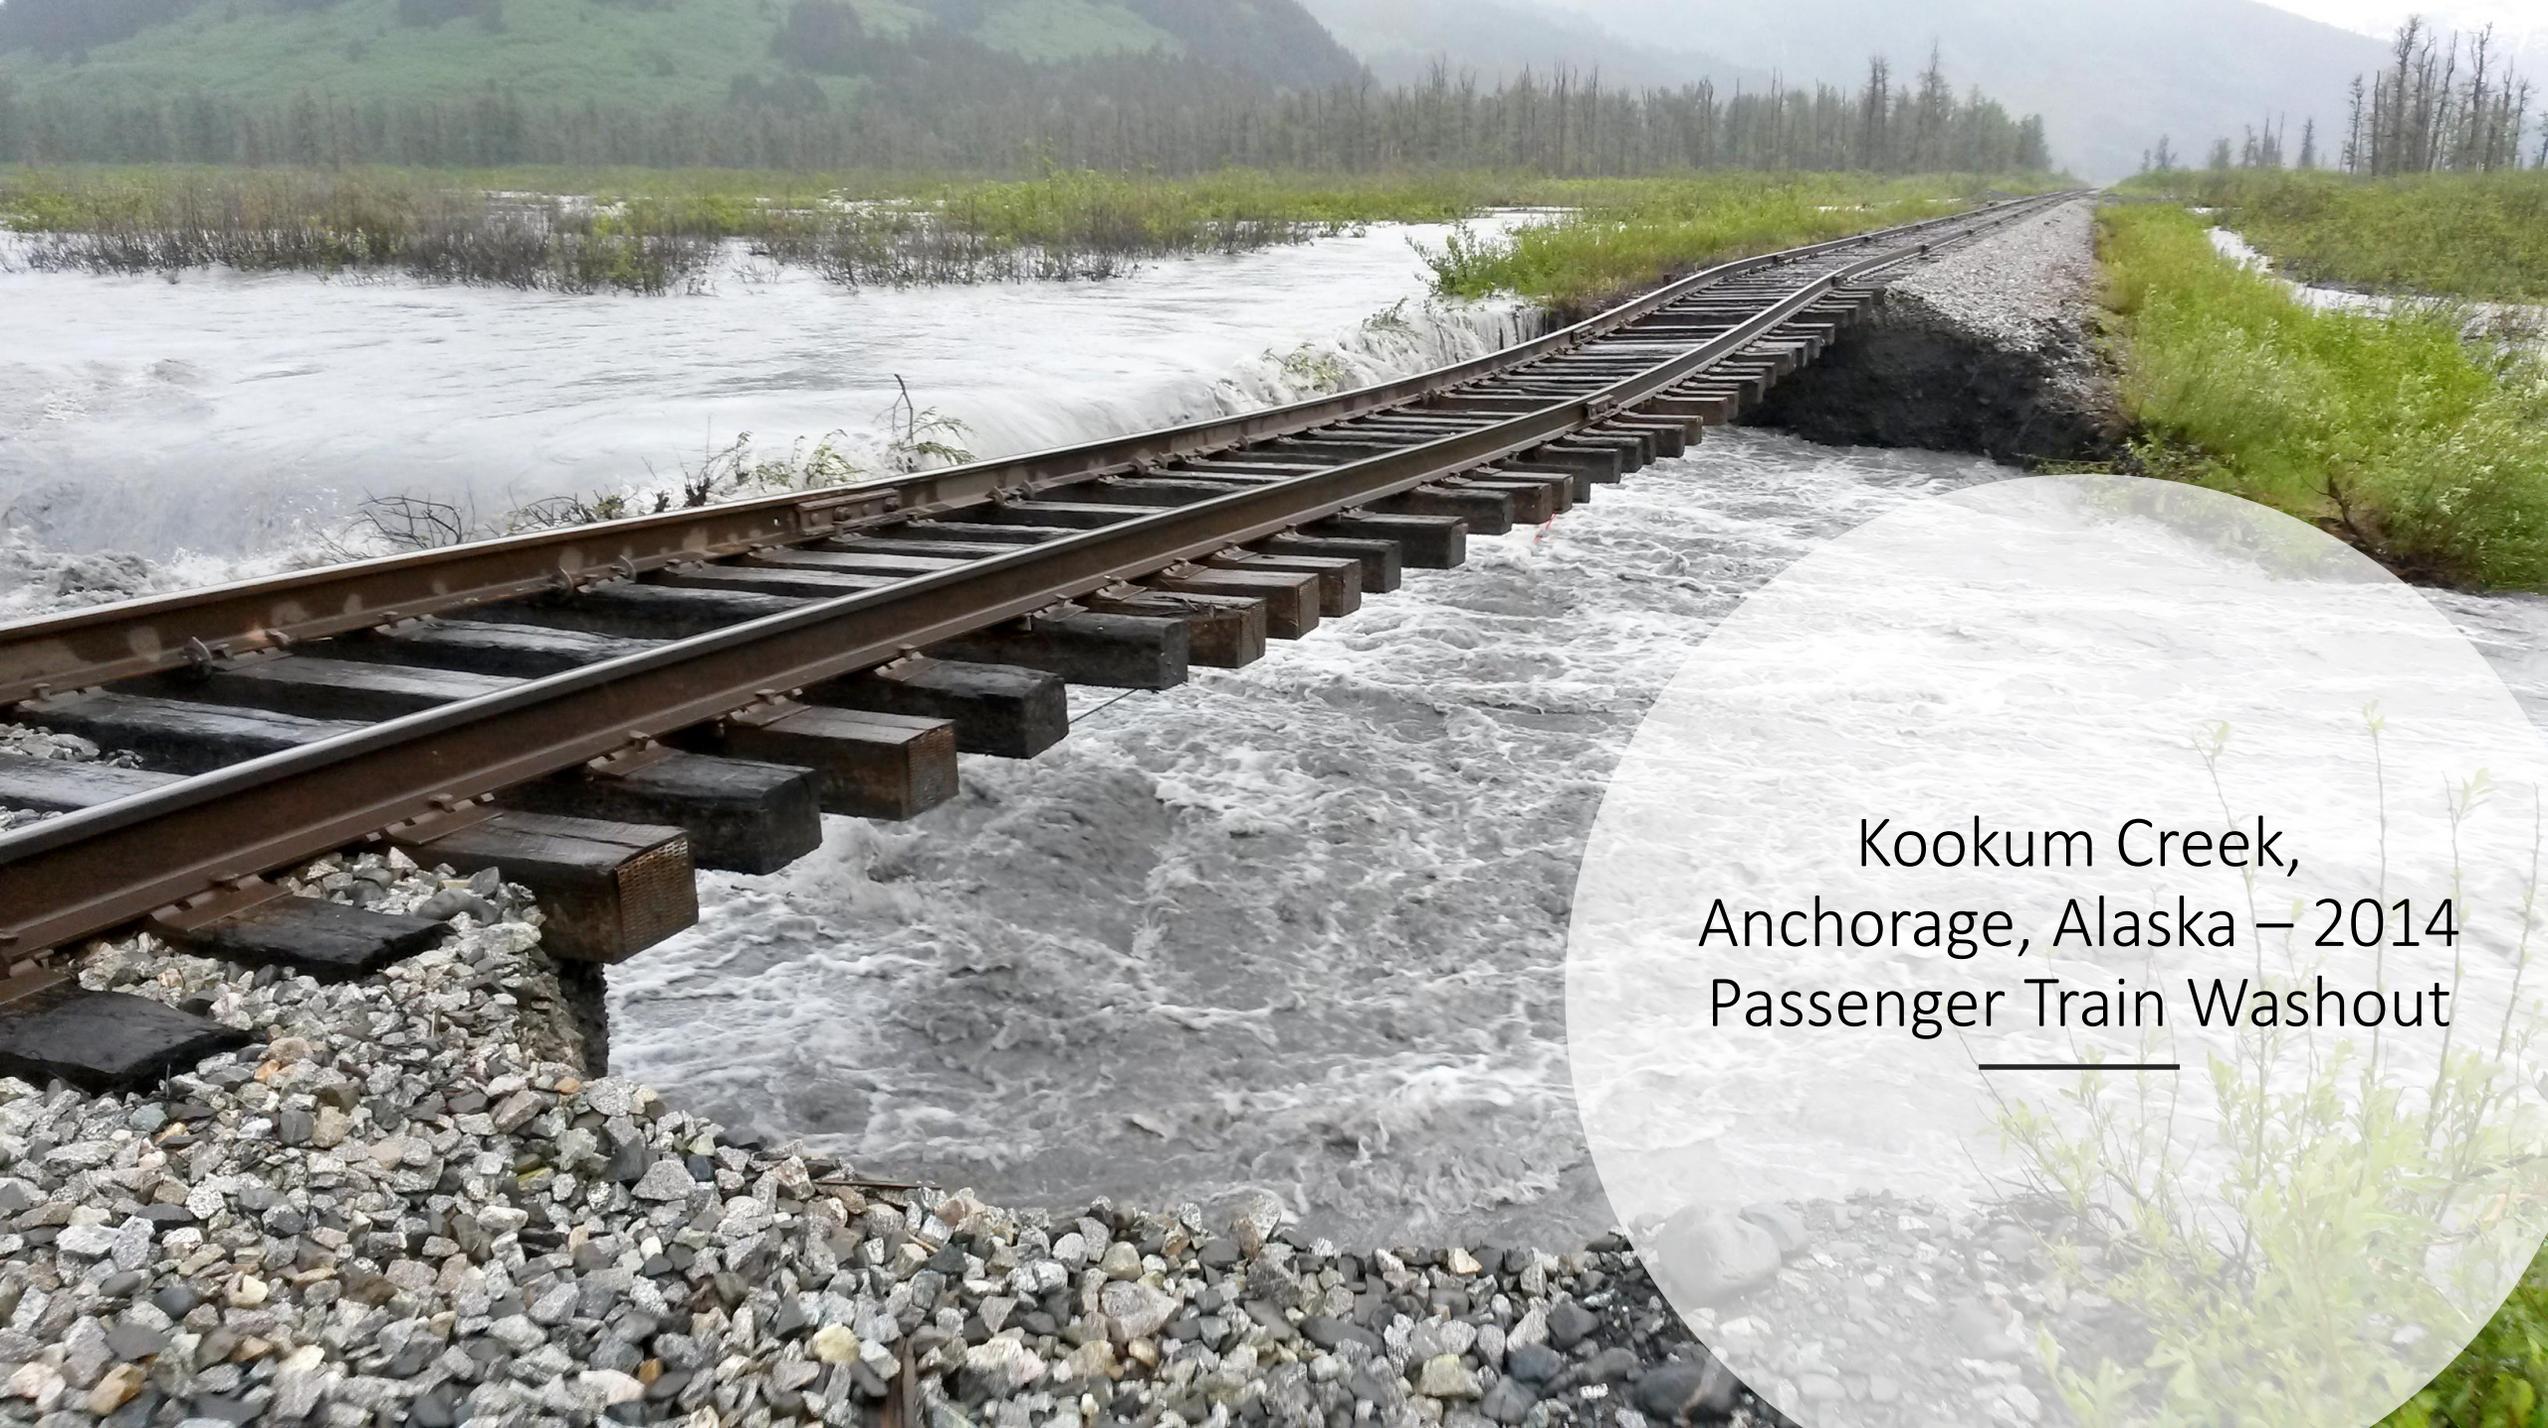
Kookum Creek,  
Anchorage, Alaska – 2014  
Passenger Train Washout

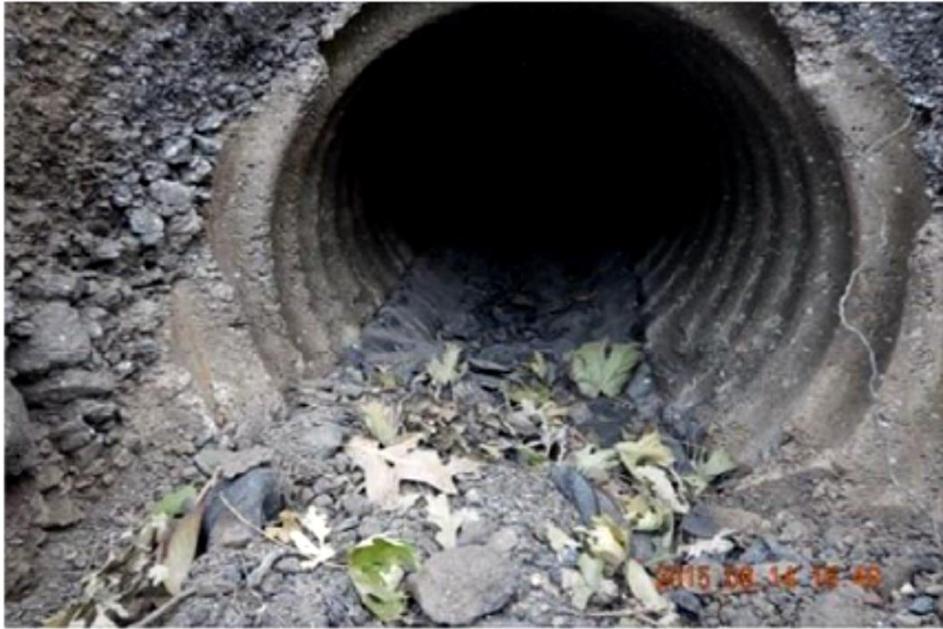
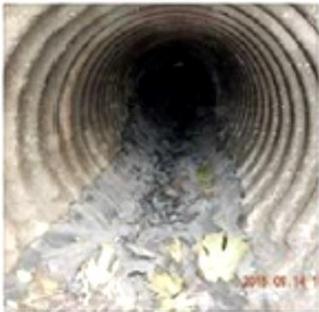
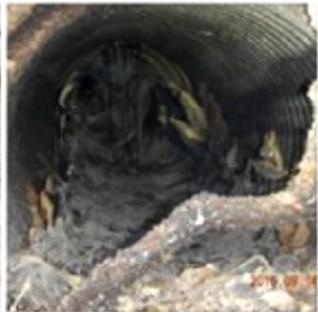
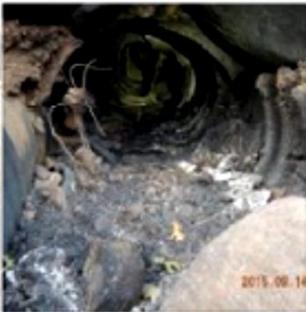
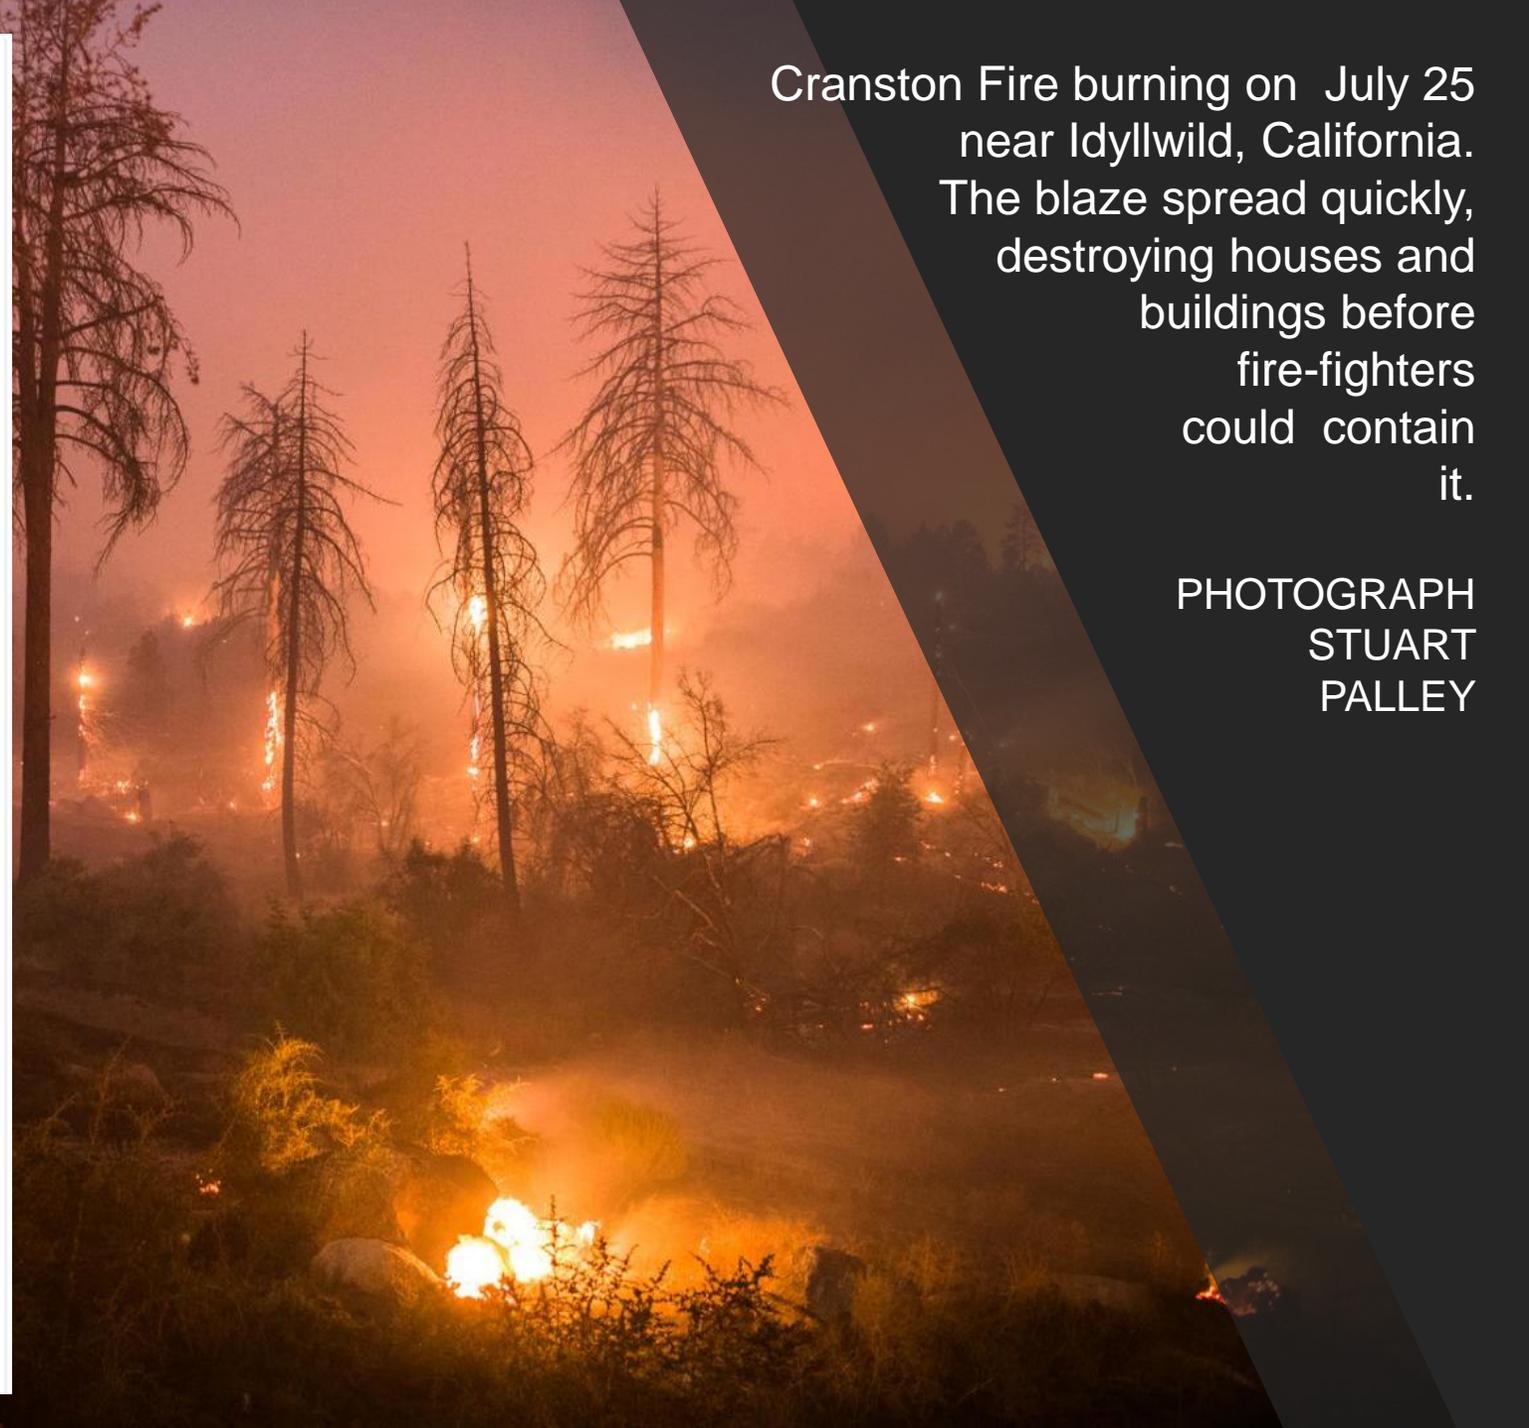
You ever wonder what happens to plastic culvert piping when a wildfire is burning everything around it? Wonder no more.

Some culverts along Route 29 and Route 175 liquefied from the heat of the fire; in the first two photos, the plastic piping sits in a puddle at the bottom of the culvert. The earth around the culvert retains its shape.

In other cases, the pipes partially melted, impacting drainage and the integrity of the culvert.

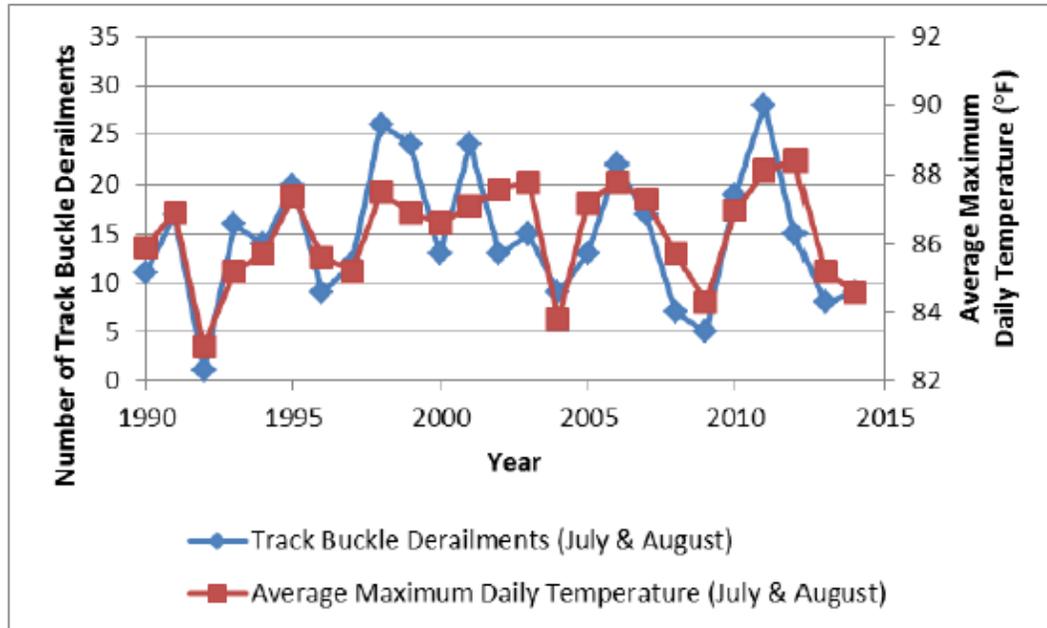
**Figure 2. Number of track buckle derailments and the average maximum daily temperature for the contiguous United States for July and August of each year from 1990 through 2014**

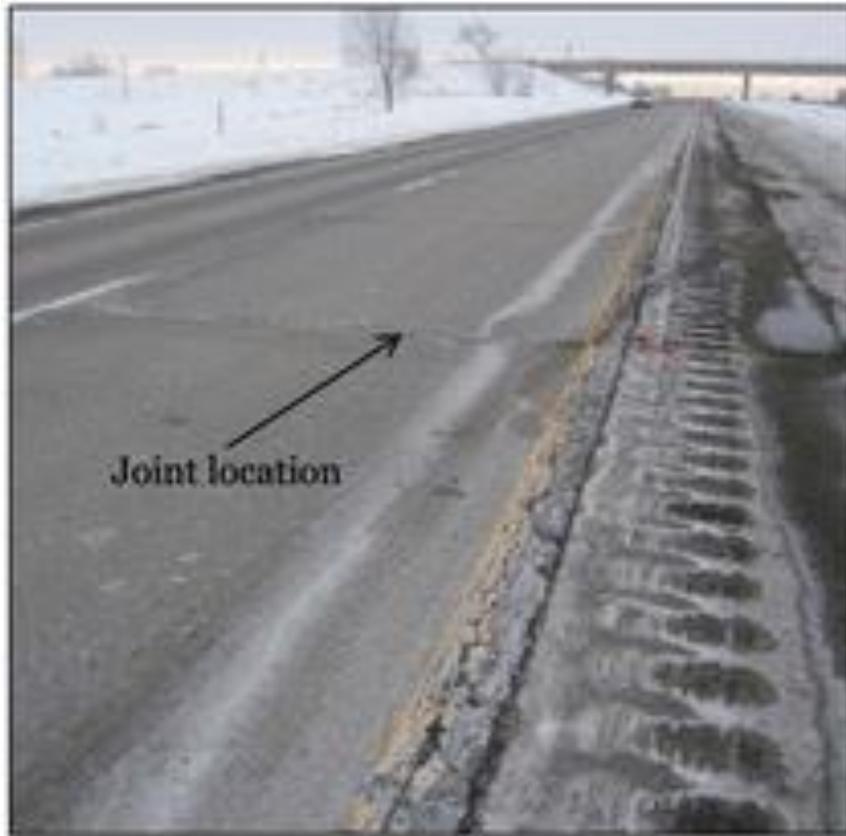
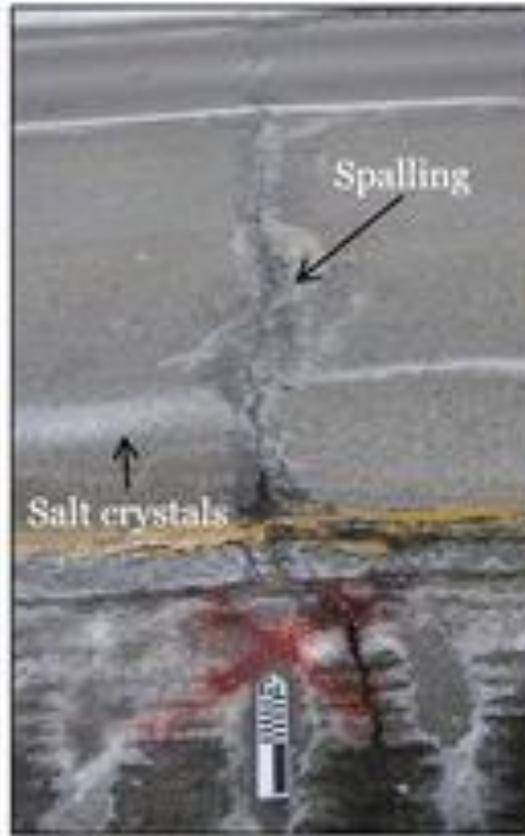
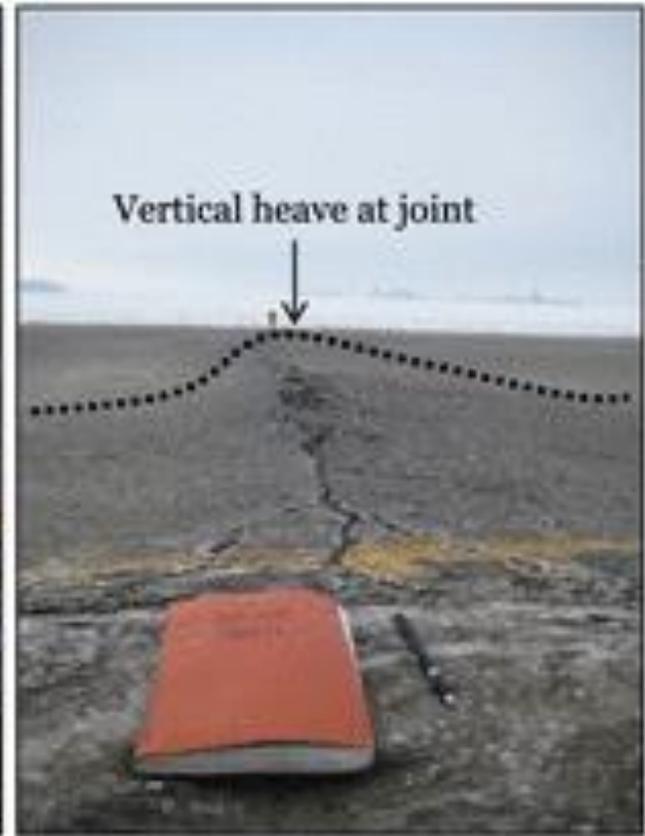
# “Investigating Frost Heave Deterioration at Pavement Joint Locations”

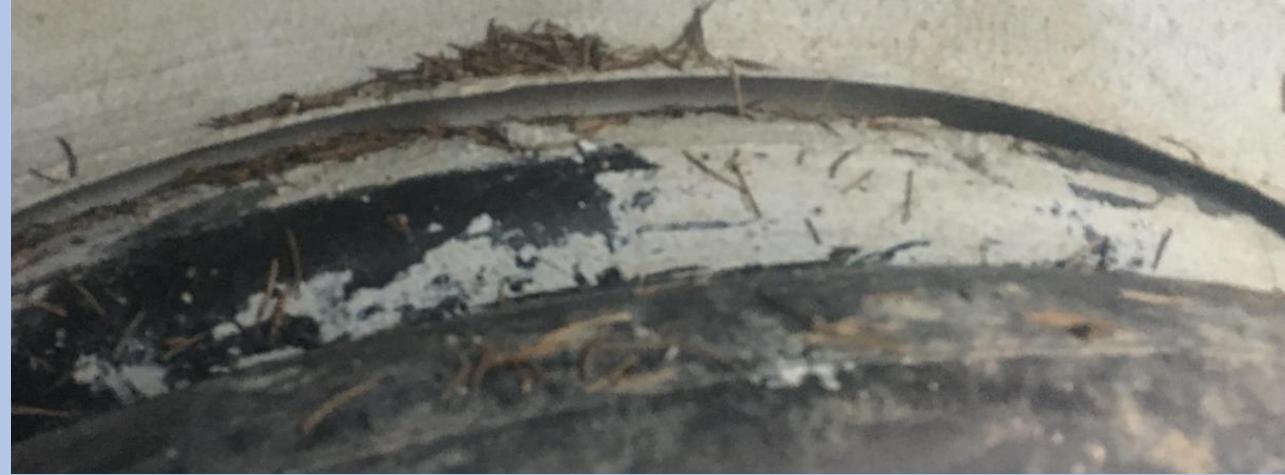
Thermal strain occurs when changes in temperature cause changes in the dimensions of an object

- These changes happen simultaneously in all directions
- Thermal strain in each direction is the same
- More you heat/cool an object, the larger the magnitude of strain

$$\epsilon_{\text{(Thermal)}} = \alpha (\Delta T)$$

Material	$\alpha$ ( $\times 10^{-6}$ in./°F)	$\Delta_{\text{Length}}$ (100°F per 20')	$\Delta_{\text{Circ}}$ (100°F per 60" Dia.)
Steel*	6.1-6.7	0.12 inches	0.09 inches
Concrete*	4.1-7.3	0.12 inches	0.09 inches
<b>HDPE**</b>	<b>80-100</b>	<b>1.92 inches</b>	<b>1.50 inches</b>

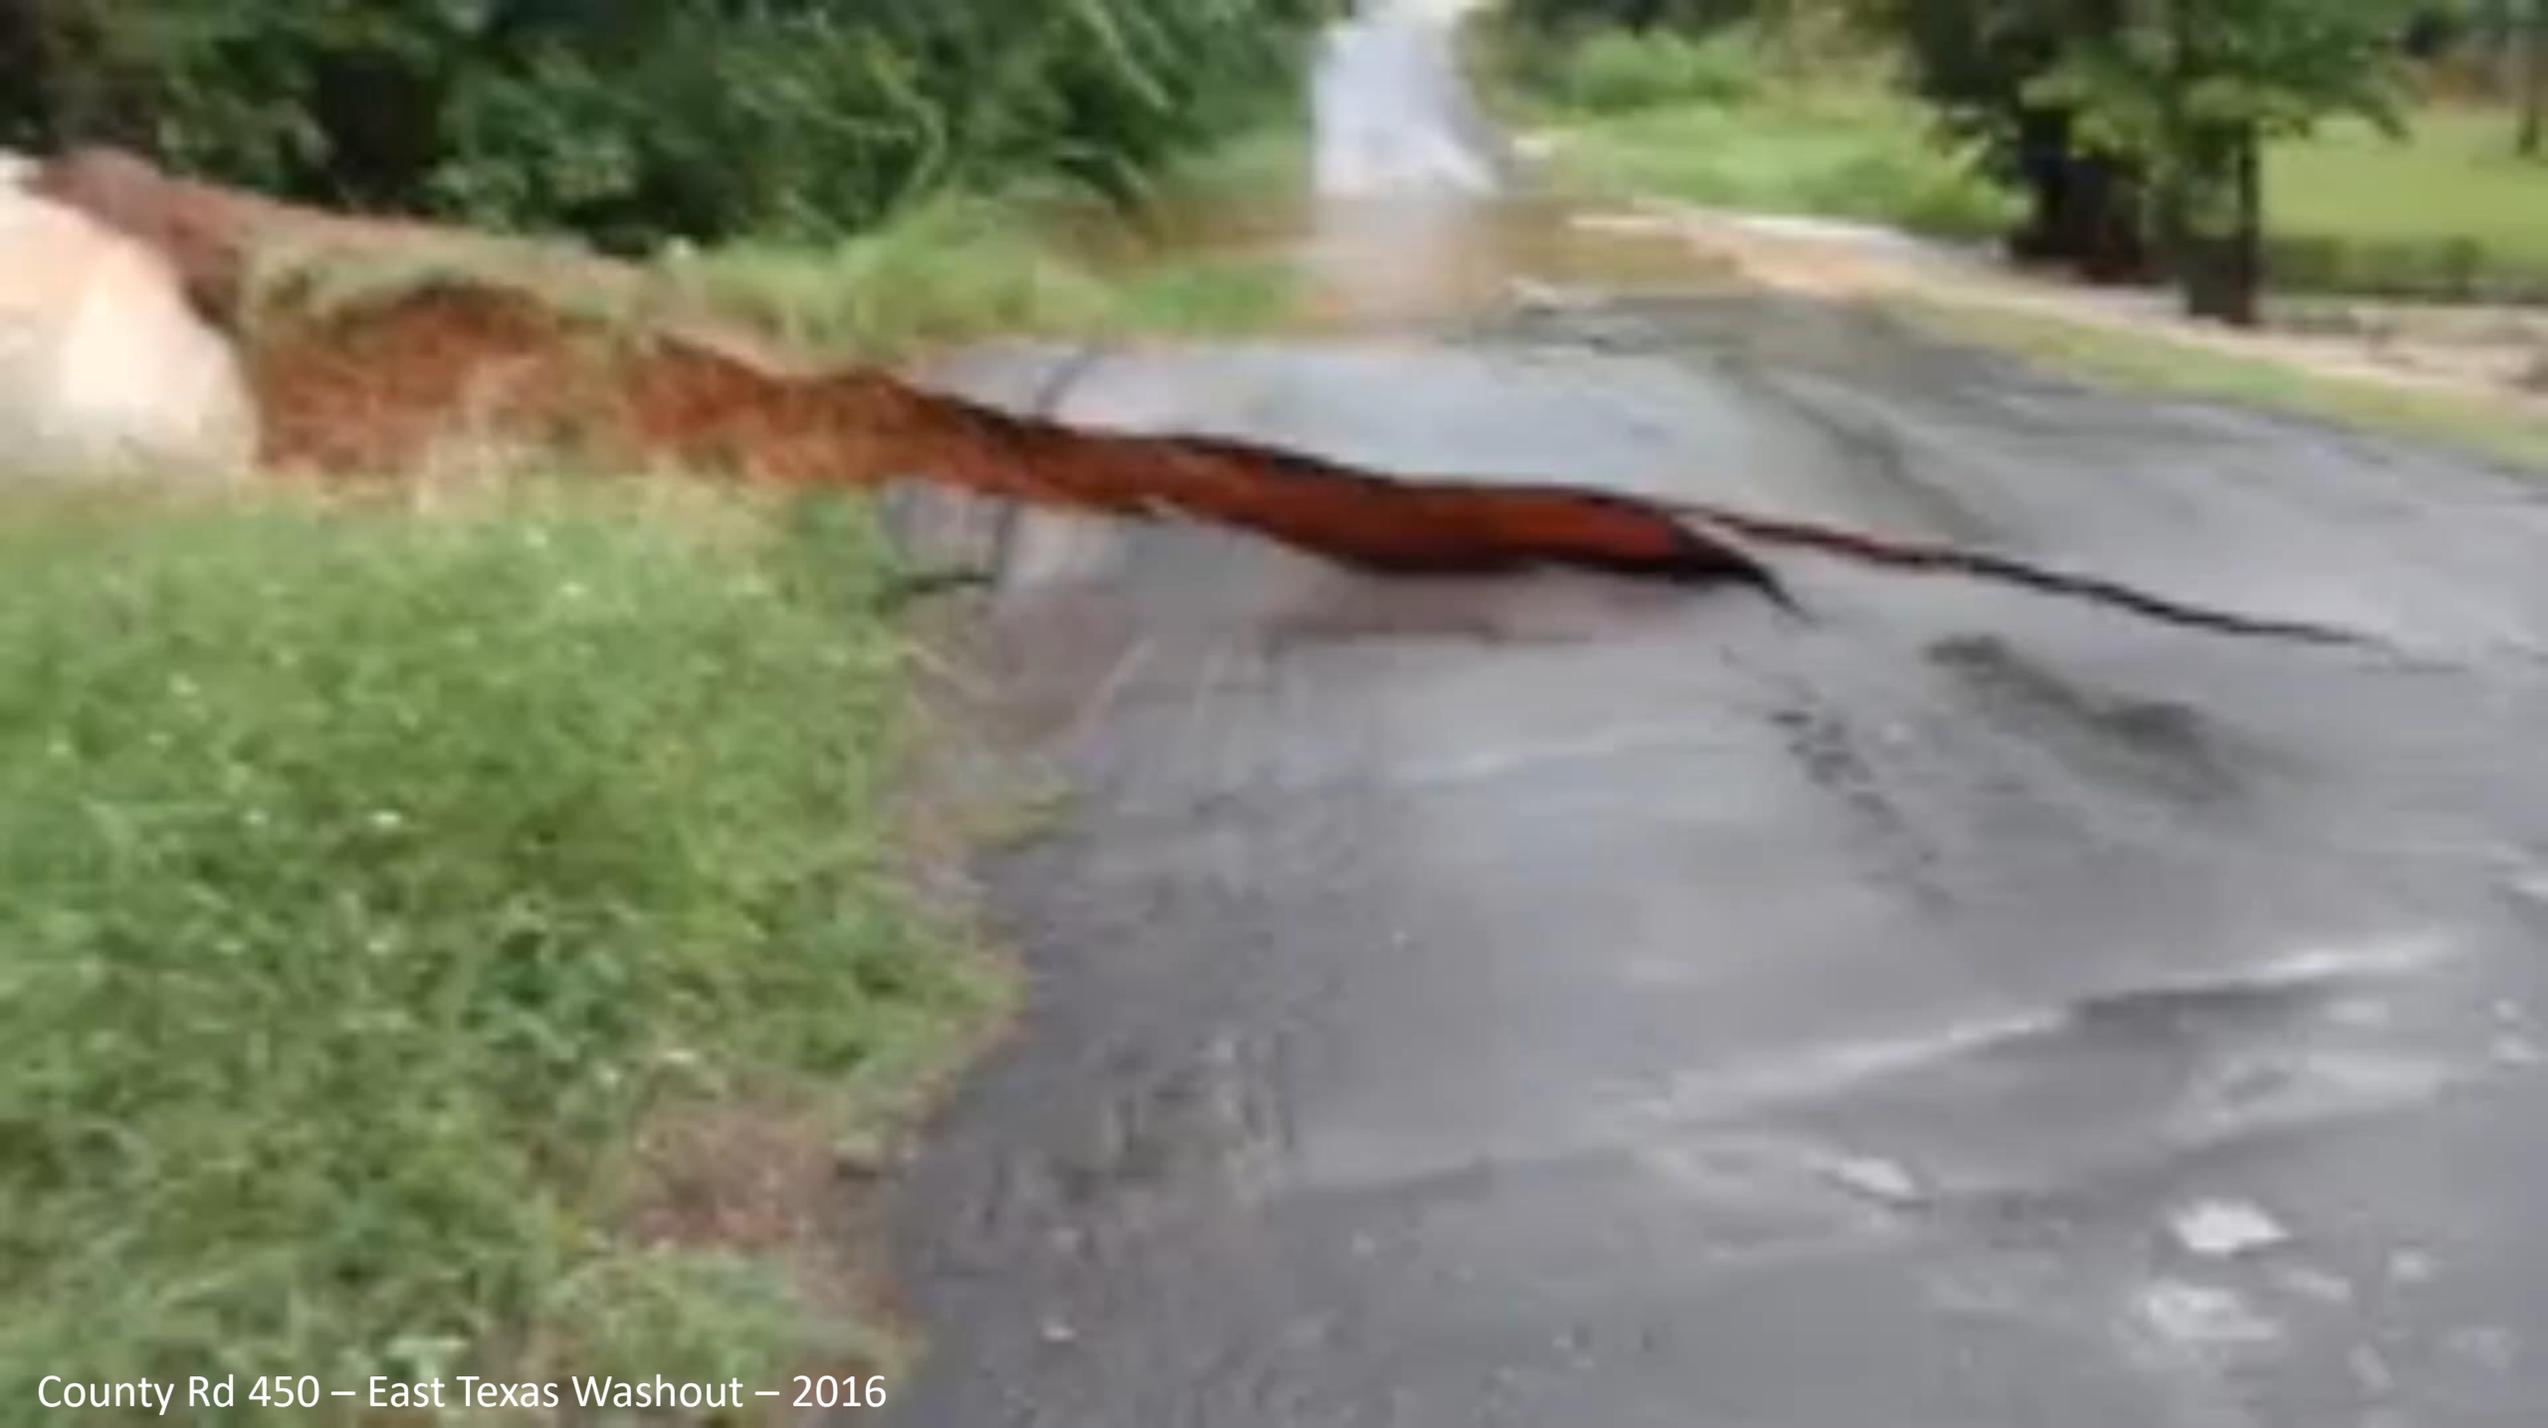
County Rd 450 – East Texas Washout – 2016

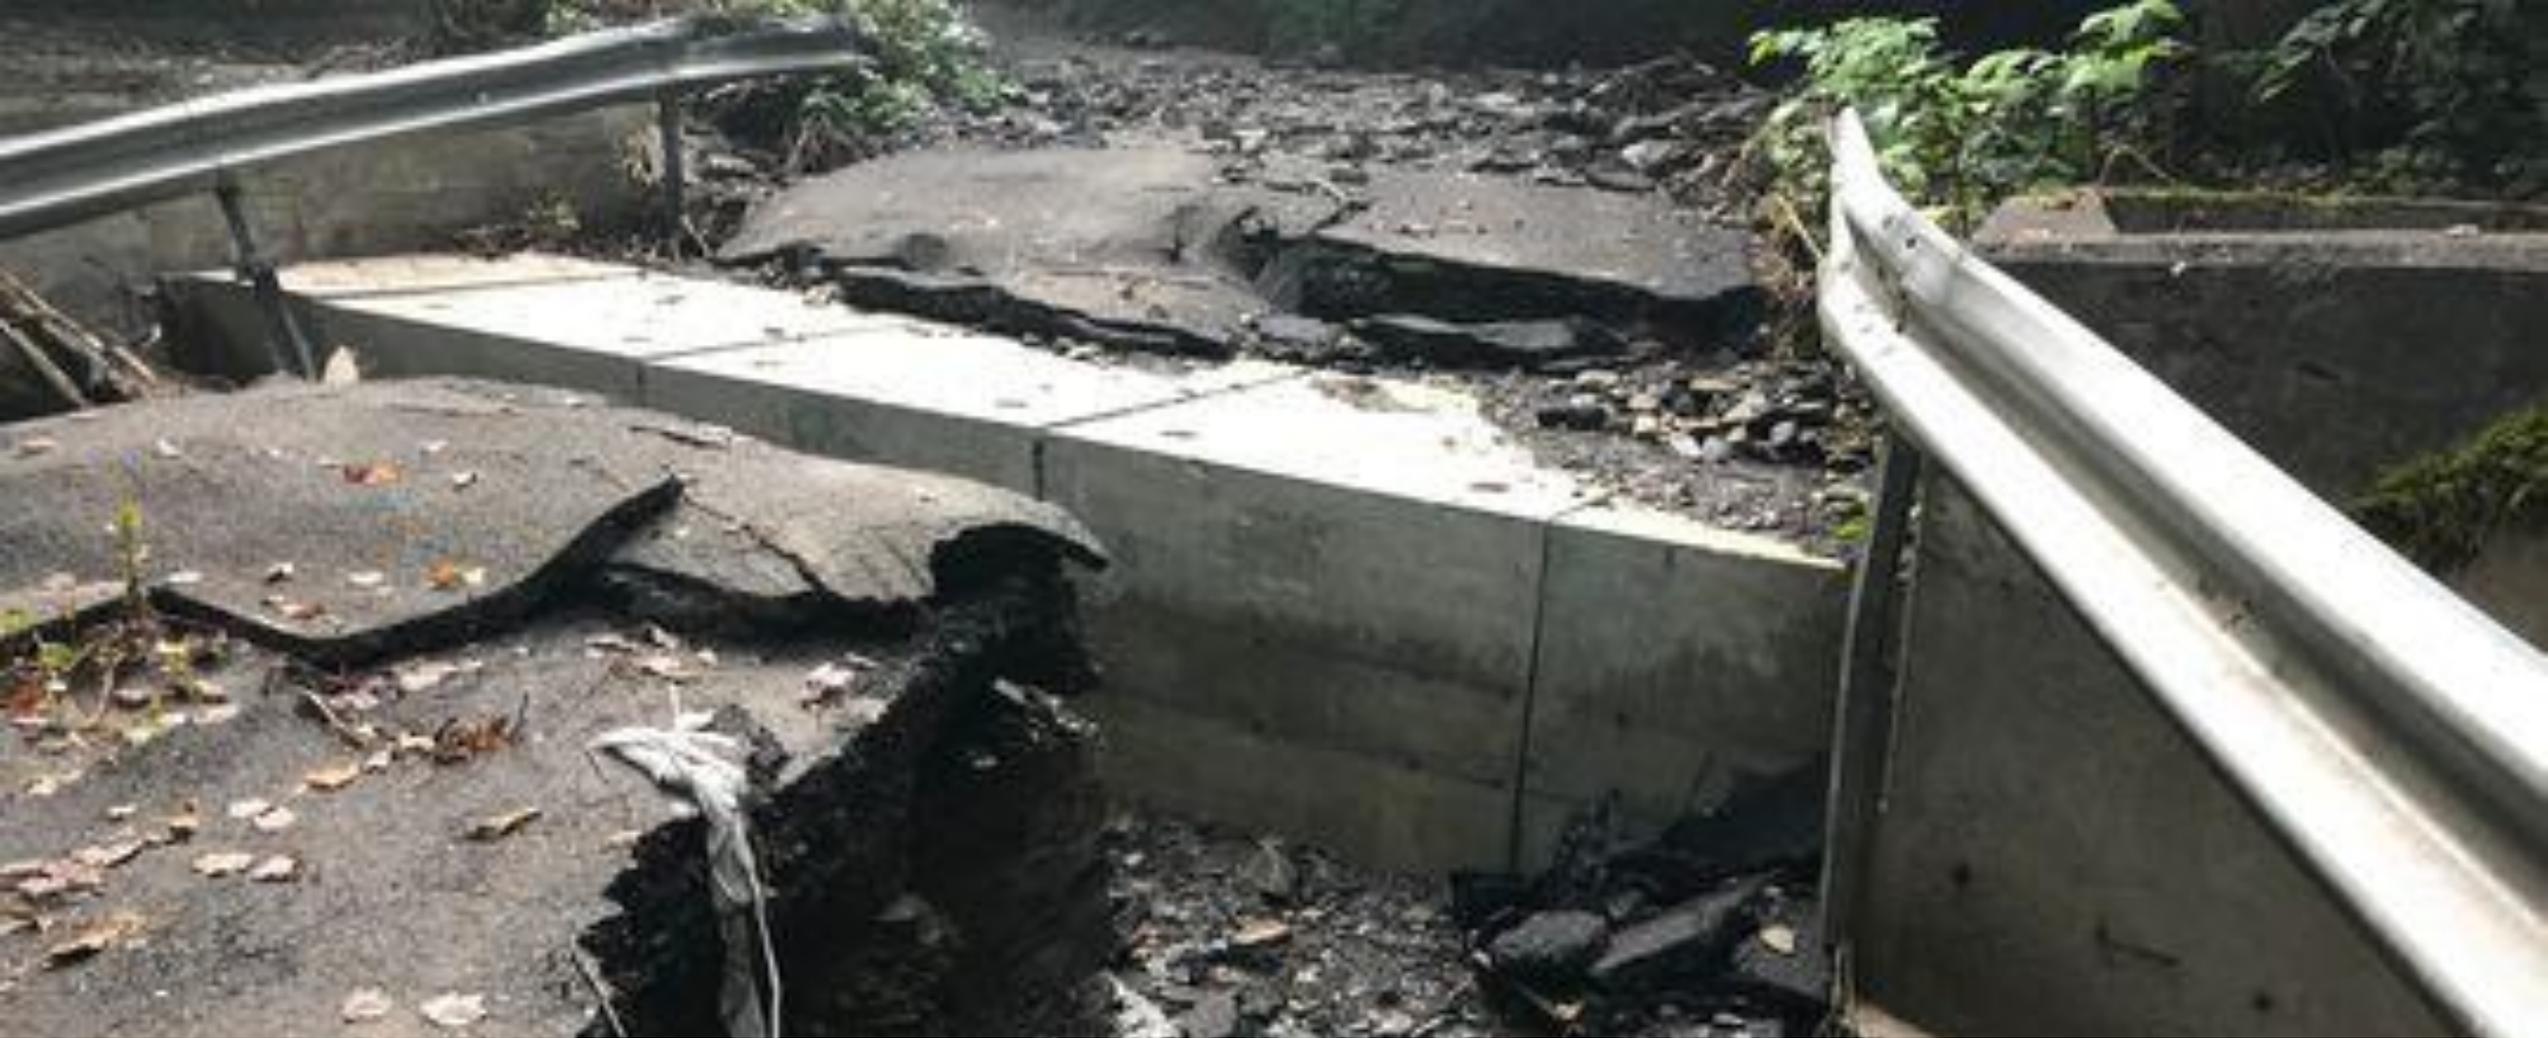
Binghamton, NY August 14, 2018:

- Heavy storms severely damaged Hiner Rd & Upper Fairview Ave
- Costs to repair estimated at \$3-\$5 million
- Precast box culvert on Hiner Rd remained completely intact
- Resilient box culvert allowed road to be reopened to emergency personnel in short period.

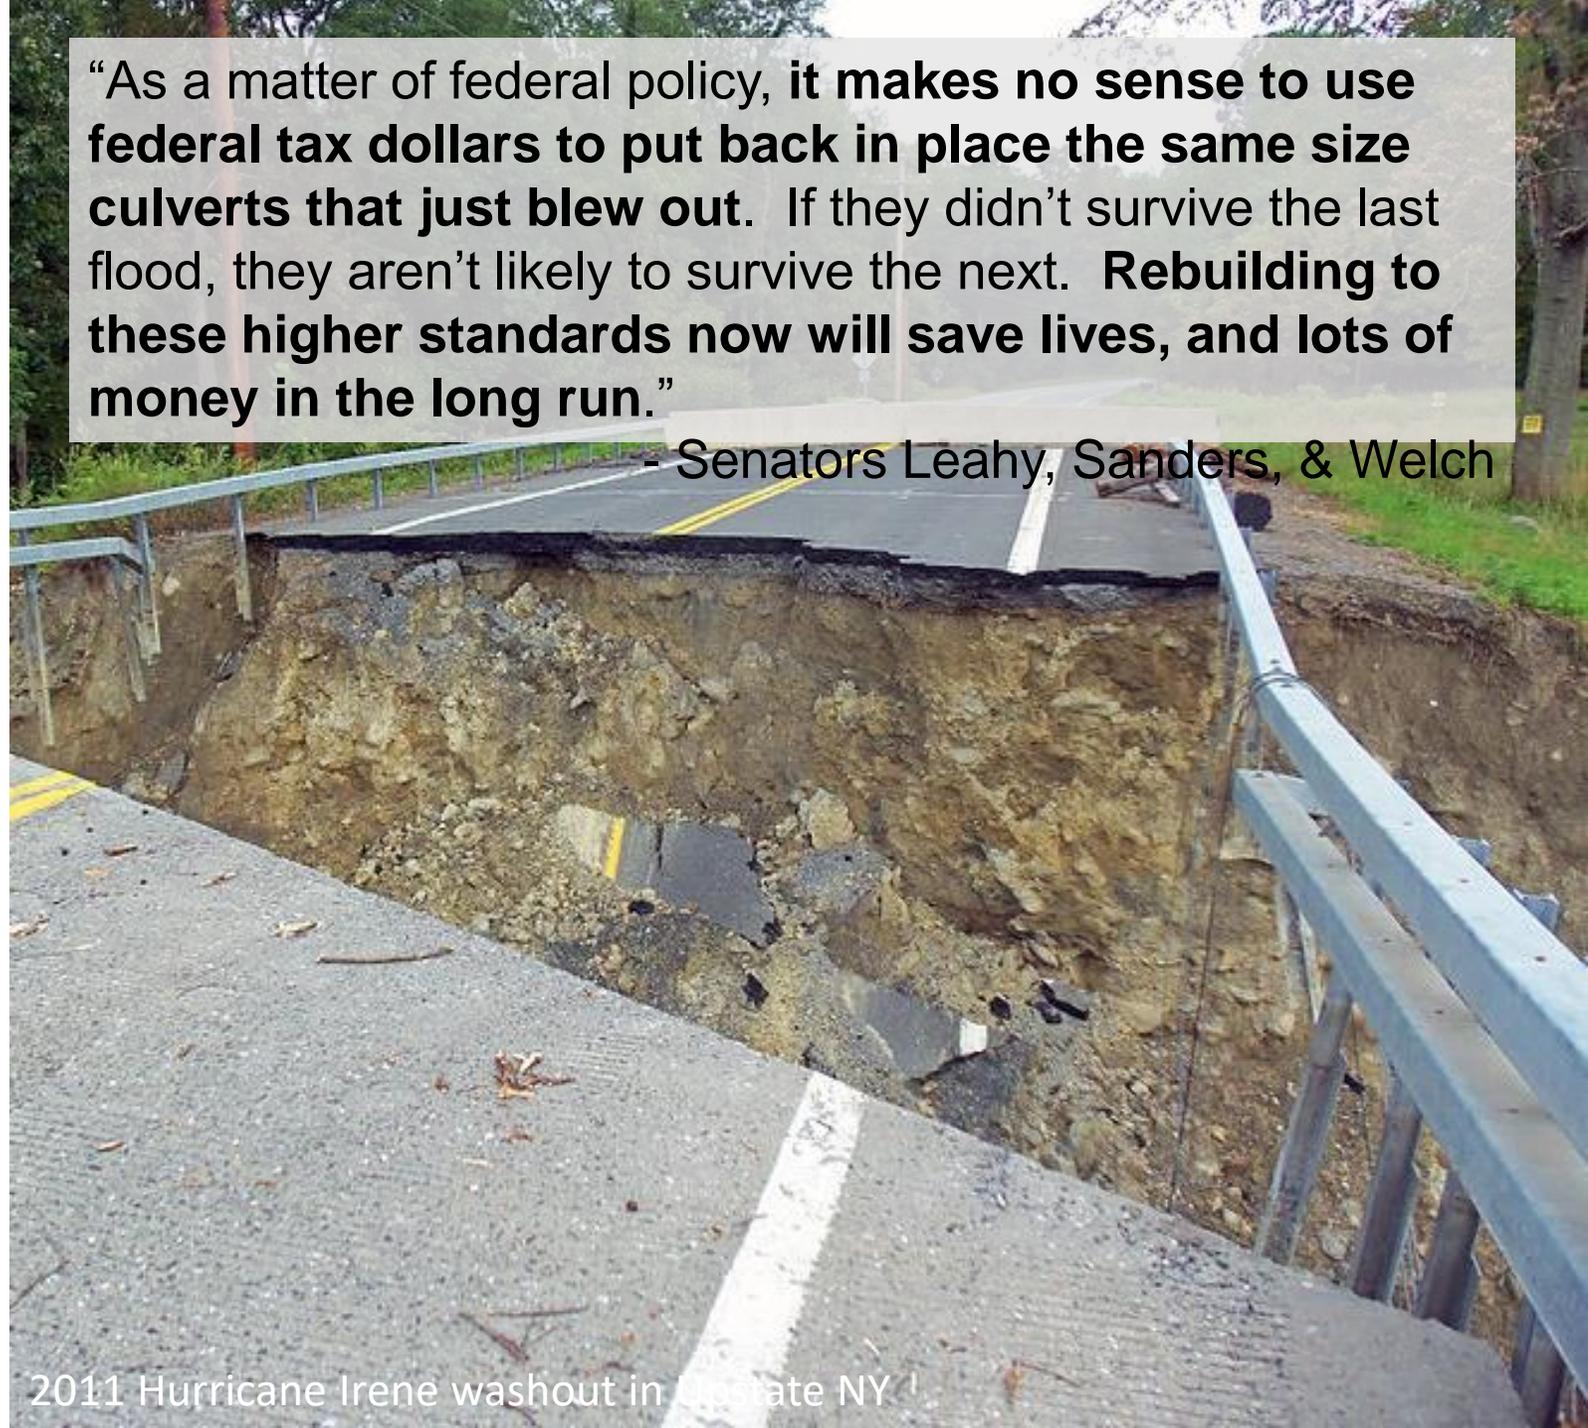
2011 Hurricane Irene washout in Upstate NY

- More than 2000 culverts damaged in Vermont alone
- One 14' CMP was washed out and VTrans chose to replace it with a precast 28x7 3-sided box culvert
- FEMA deemed that an “upgrade” and refused reimbursement.
- Town of Townshend & VTrans officials petitioned FEMA twice to accept the state’s new flood hazard mitigation policies.
- At 2<sup>nd</sup> review, FEMA found the increased capacity and resilient structure to meet the Federal 406 Hazard Mitigation designation.
