**Waters of the U.S. Boundary Delineation
for
Braddock Road at Pleasant Valley Road Intersection Improvements
Fairfax County, Virginia**

VDOT Project Number:
0620-029-017, C501, P101, R201

Prepared by:
Virginia Department of Transportation
4975 Alliance Drive
Fairfax, Virginia 22030

Project Summary Sheet for USACE Confirmation Site Visit

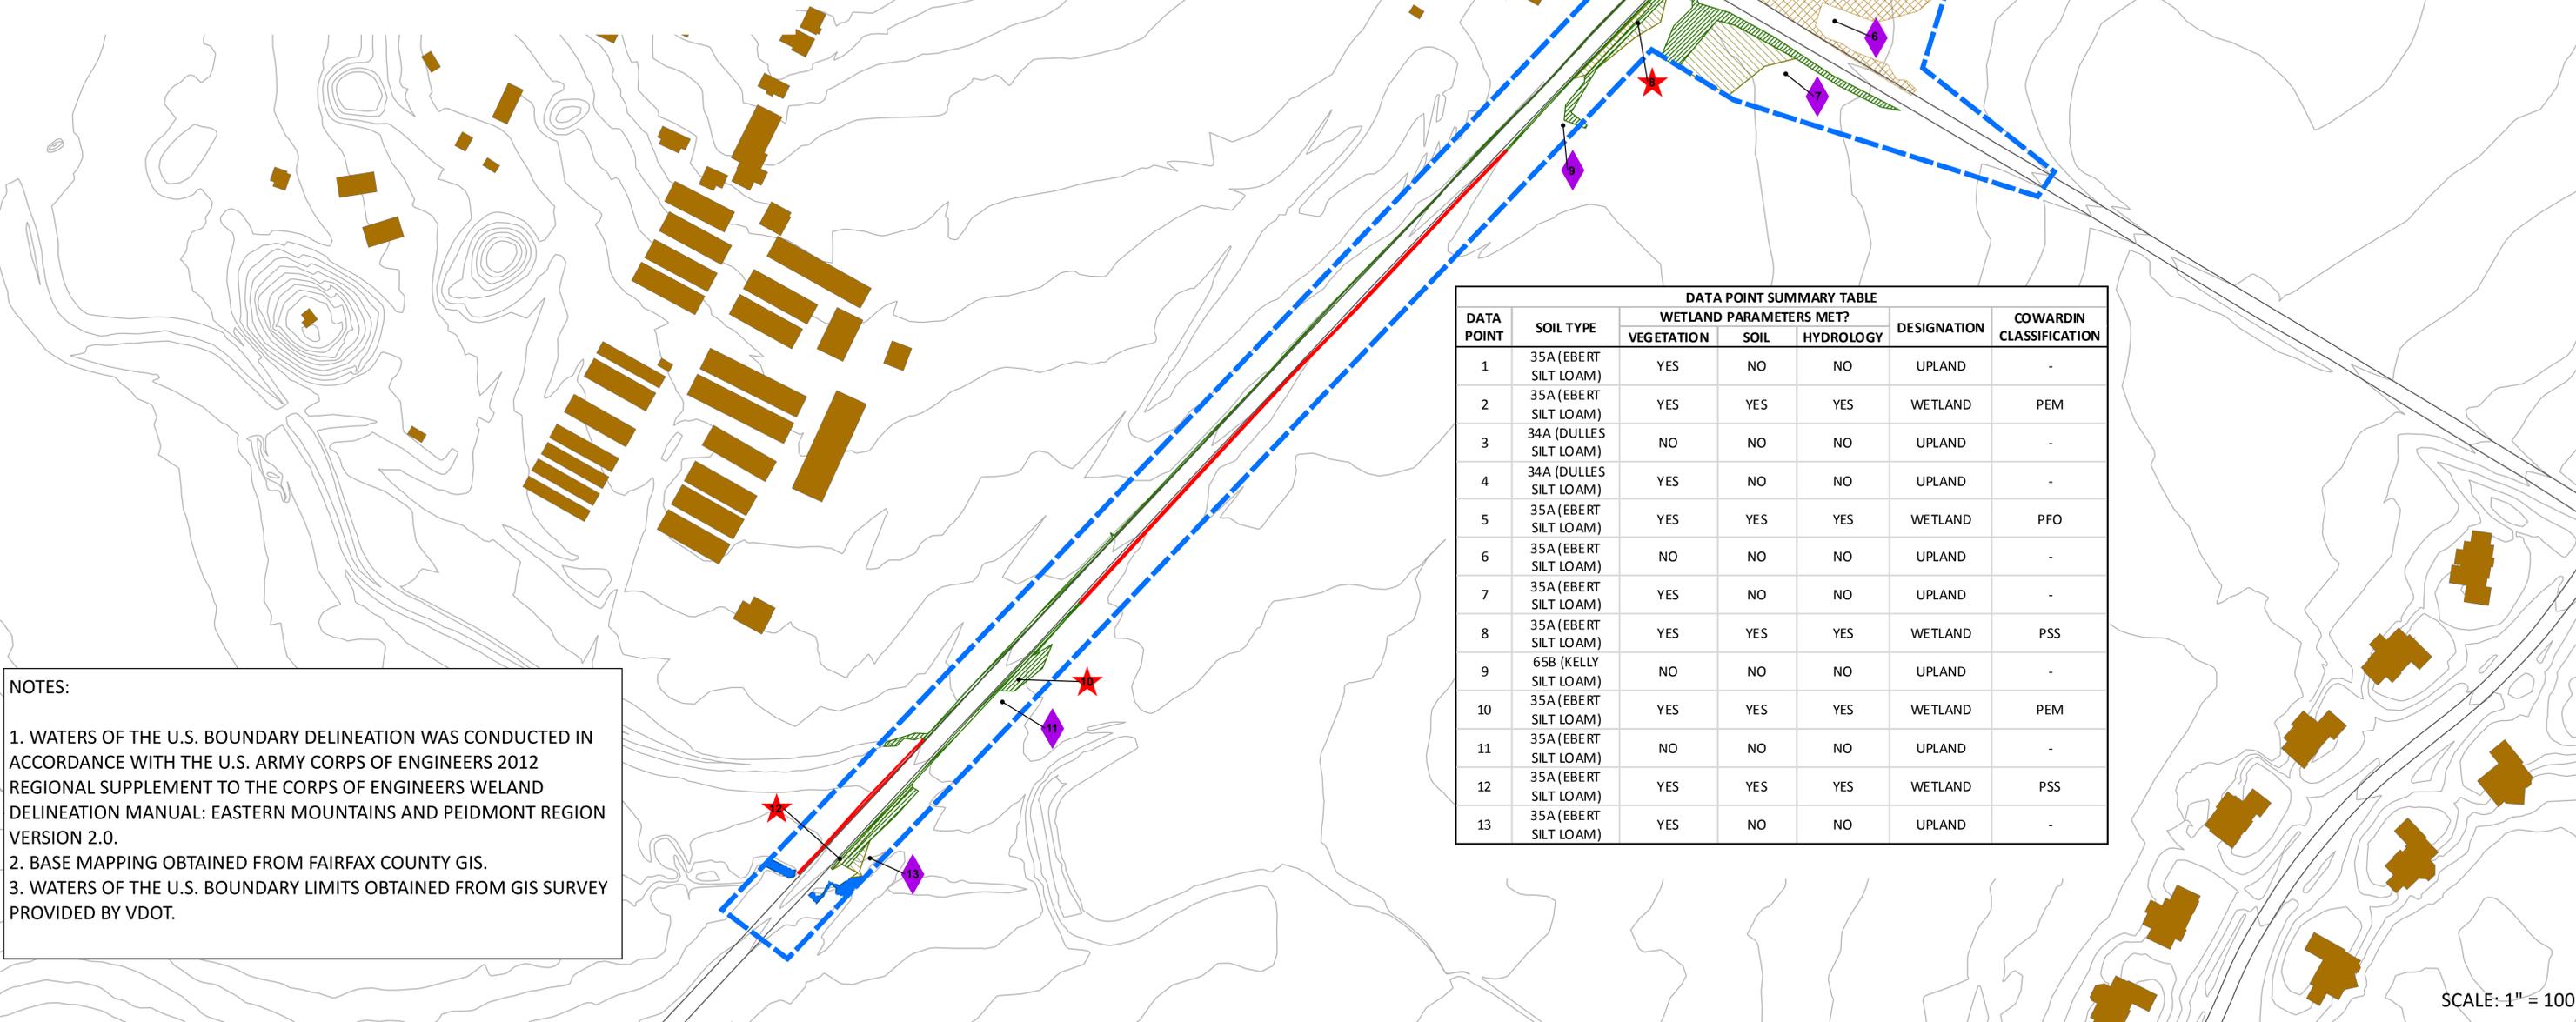
- EDGE OF ROAD
- PEM
- PFO
- PSS
- STREAM CHANNEL
- DITCH
- BUILDINGS
- 2 FT TOPO
- ★ WETLAND DATA POINT
- ◆ UPLAND DATA POINT
- LIMITS OF WATERS OF U.S. BOUNDARY INVESTIGATION

SF	AC	LF
PROJECT AREA	684,211.809	15.707	N/A
TOTAL WATERS OF THE U.S.	239,964.248	5.508	N/A
TOTAL PEM	141,448.163	3.247	N/A
TOTAL PFO	90,947.434	2.087	N/A
TOTAL PSS	6,267.049	0.143	N/A
TOTAL STREAMS (R3/R4)	1,301.602	N/A	115

1. WATERS OF THE U.S. BOUNDARY DELINEATION WAS CONDUCTED IN ACCORDANCE WITH THE U.S. ARMY CORPS OF ENGINEERS 2012 REGIONAL SUPPLEMENT TO THE CORPS OF ENGINEERS WELAND DELINEATION MANUAL: EASTERN MOUNTAINS AND PEIDMONT REGION VERSION 2.0.
2. BASE MAPPING OBTAINED FROM FAIRFAX COUNTY GIS.
3. WATERS OF THE U.S. BOUNDARY LIMITS OBTAINED FROM GIS SURVEY PROVIDED BY VDOT.

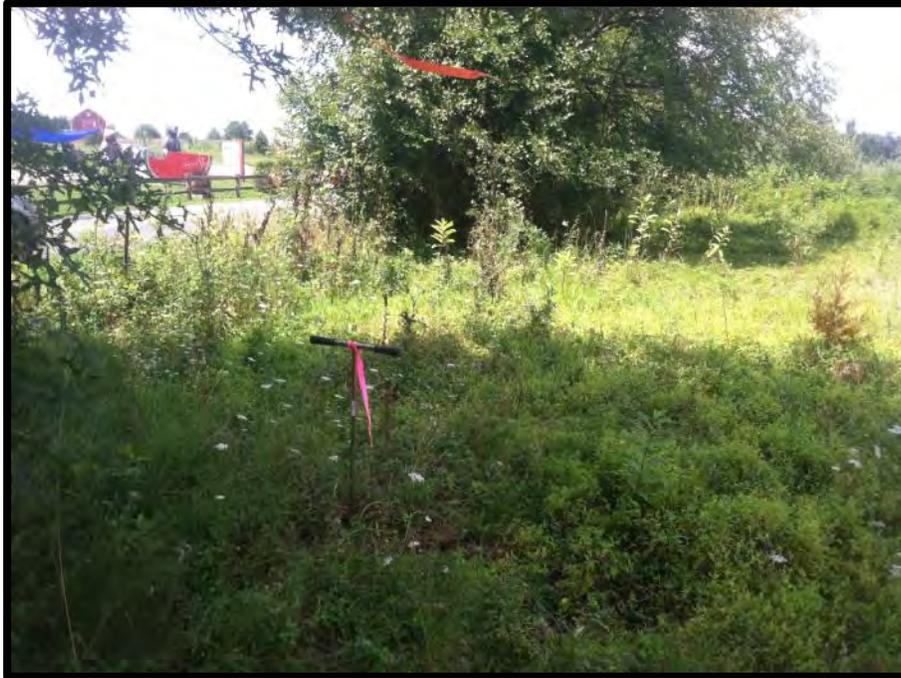
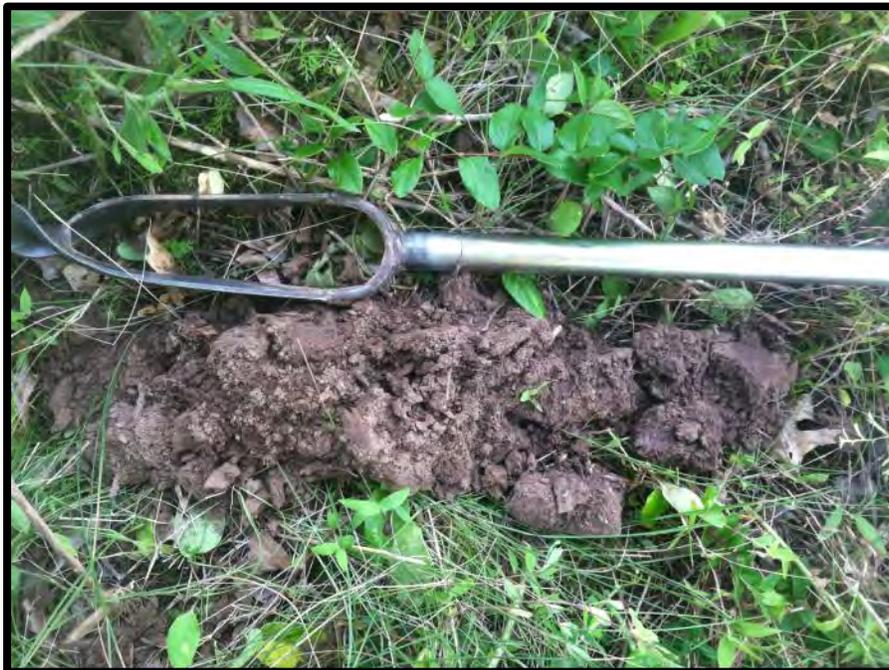
Hydrophytic Vegetation Present? Yes <input checked="" type="checkbox"/> No _____ Hydric Soil Present? Yes _____ No <input checked="" type="checkbox"/> Wetland Hydrology Present? Yes _____ No <input checked="" type="checkbox"/>	Is the Sampled Area within a Wetland? Yes _____ No <input checked="" type="checkbox"/>
Remarks: Data collected approximately 15' south of Flag C-5.

Depth (inches)	Matrix		Redox Features				Texture	Remarks
	Color (moist)	%	Color (moist)	%	Type ¹	Loc ²		
0-4	10YR 4/3	100					SiL	
4-18	10YR 5/3	95	10YR 5/6	5	C	M	SiL

Restrictive Layer (if observed): Type: _____ Depth (inches): _____	Hydric Soil Present? Yes _____ No <input checked="" type="checkbox"/>
---	---

Representative Photograph of Data Point 1

Representative Soil Profile for Data Point 1

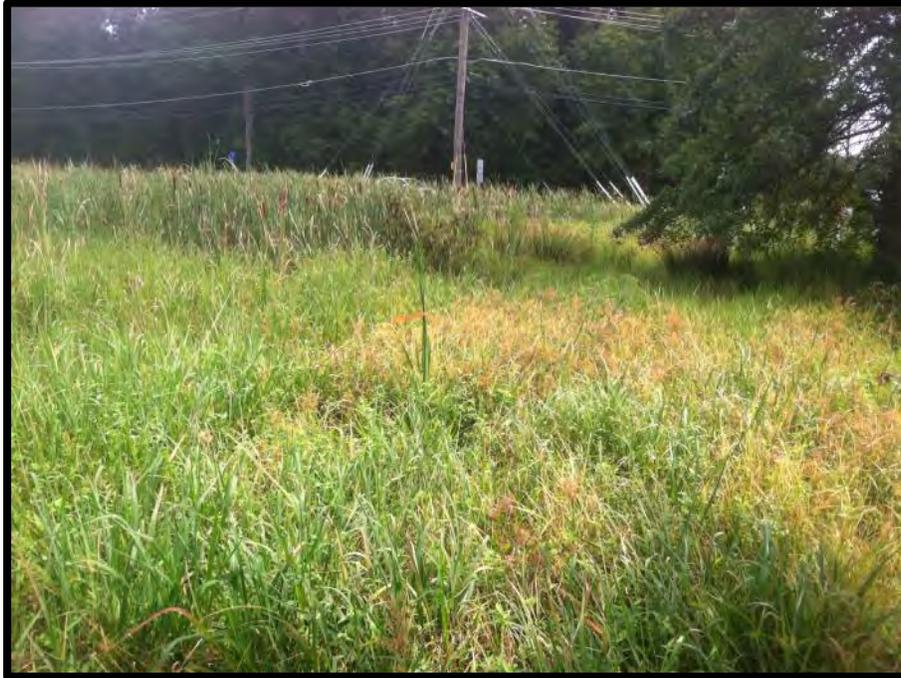
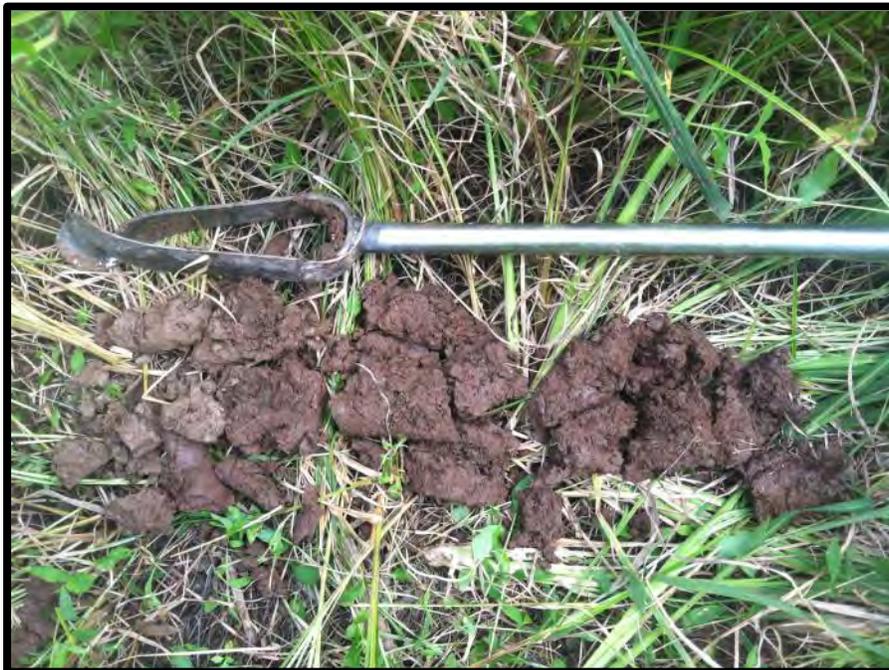
Depth (inches)	Matrix		Redox Features				Texture	Remarks
	Color (moist)	%	Color (moist)	%	Type ¹	Loc ²		
0-14	7.5YR 4/2	85	7.5YR 4/6	15	C	M	SiCL	
14-18	7.5YR 5/2	85	5YR 4/6	15	C	M	SiCL

Restrictive Layer (if observed): Type: _____ Depth (inches): _____	Hydric Soil Present? Yes <input checked="" type="checkbox"/> No <input type="checkbox"/>
---	---

Representative Photograph of Data Point 2

Representative Soil Profile for Data Point 2

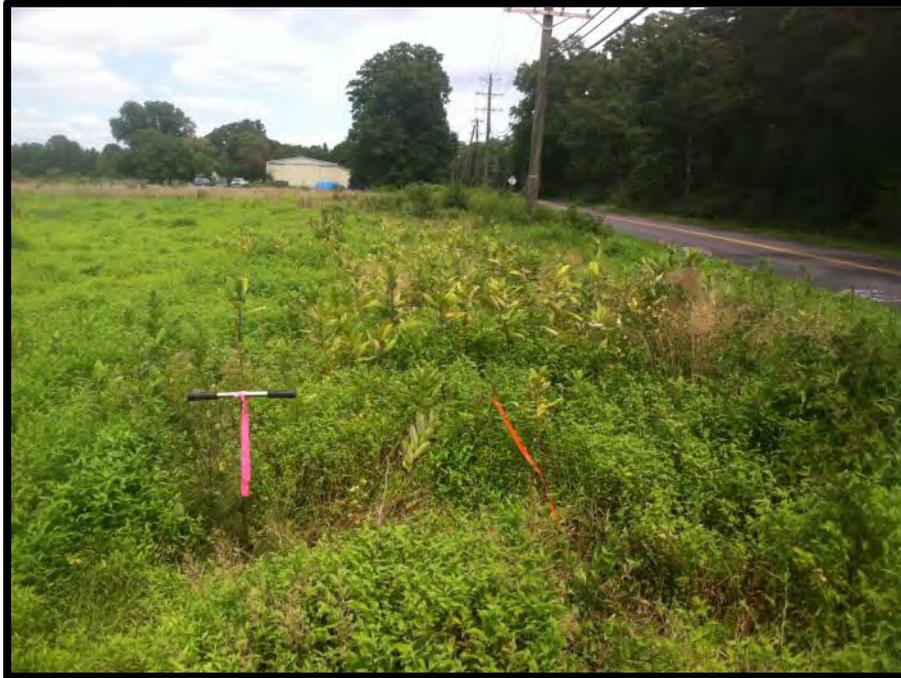
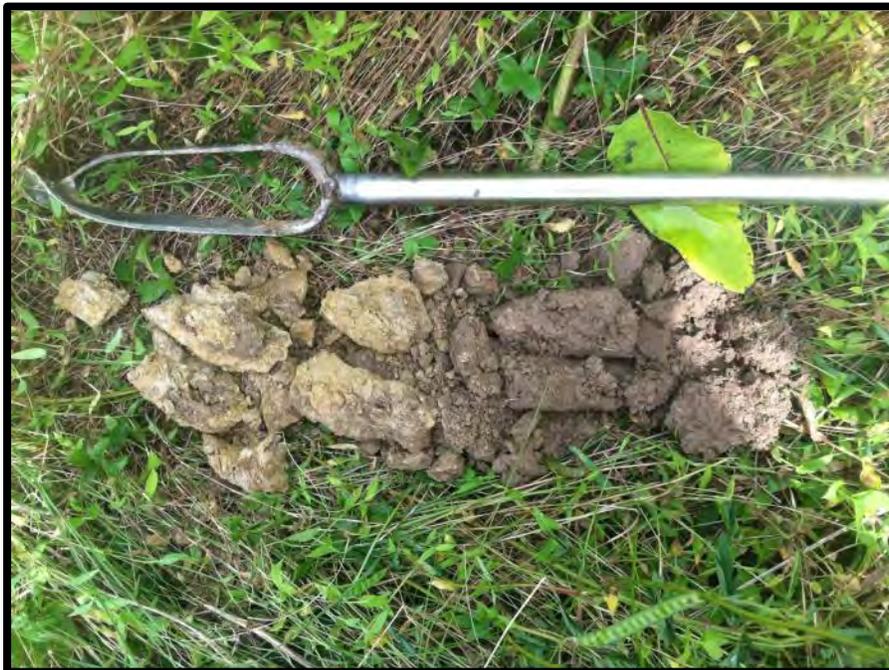
Depth (inches)	Matrix		Redox Features				Texture	Remarks
	Color (moist)	%	Color (moist)	%	Type ¹	Loc ²		
0-9	10YR 5/3	100					SiL	
9-18	2.5Y 6/3	85	2.5Y 6/8	10	C	M	SiL	
			2.5Y 6/2	5	D	M

Restrictive Layer (if observed): Type: _____ Depth (inches): _____	Hydric Soil Present? Yes _____ No <input checked="" type="checkbox"/>
---	---

Representative Photograph of Data Point 3

Representative Soil Profile for Data Point 3

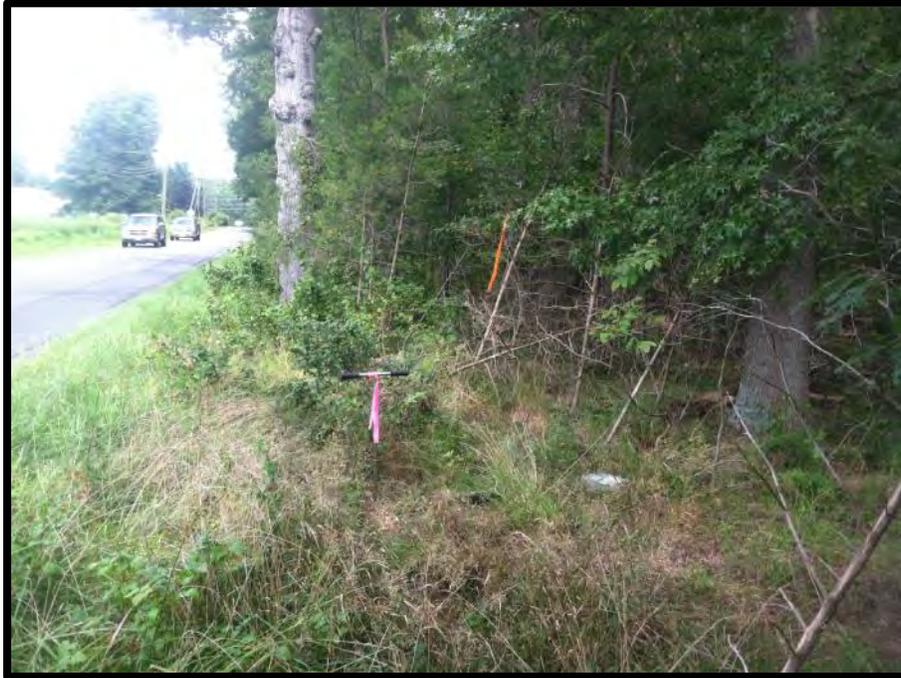
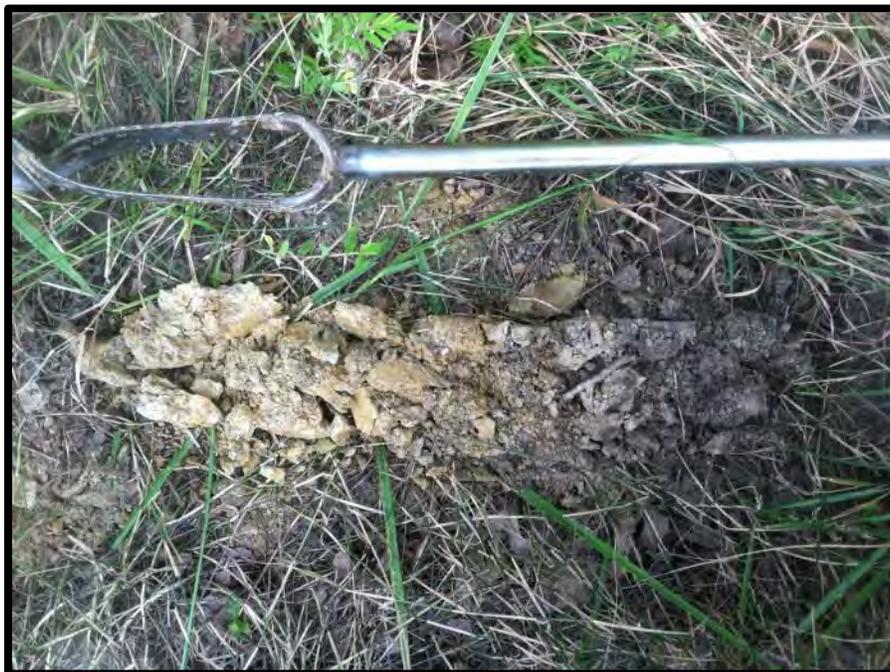
Depth (inches)	Matrix		Redox Features				Texture	Remarks
	Color (moist)	%	Color (moist)	%	Type ¹	Loc ²		
0-5	10YR 4/2	100					L	
5-18	2.5Y 6/4	75	10YR 6/8	5	C	M	SiC	
			2.5Y 6/1	20	D	M

Restrictive Layer (if observed): Type: _____ Depth (inches): _____	Hydric Soil Present? Yes _____ No <input checked="" type="checkbox"/>
---	---

Representative Photograph of Data Point 4

Representative Soil Profile for Data Point 4

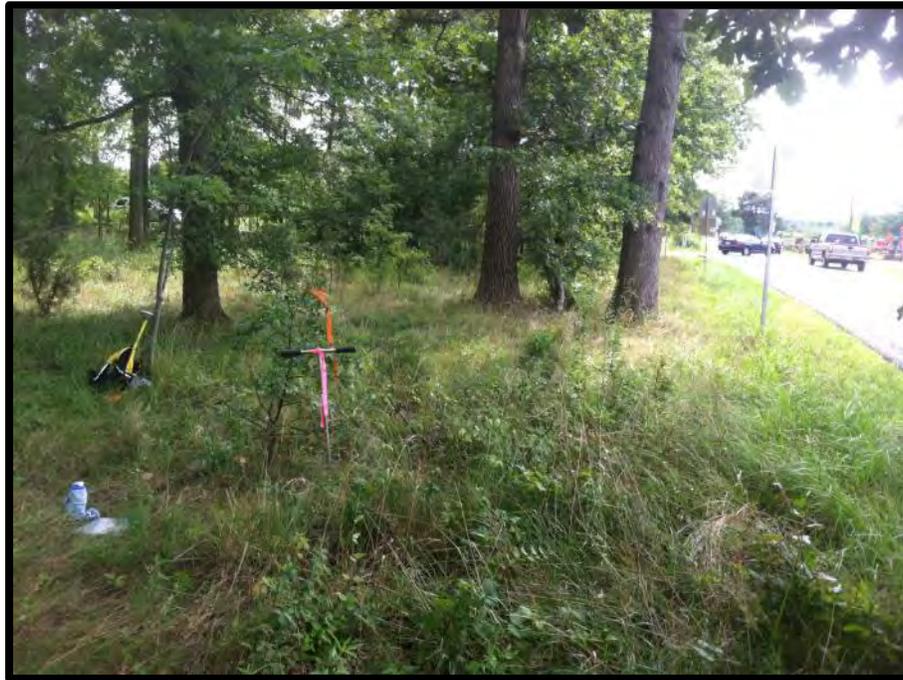
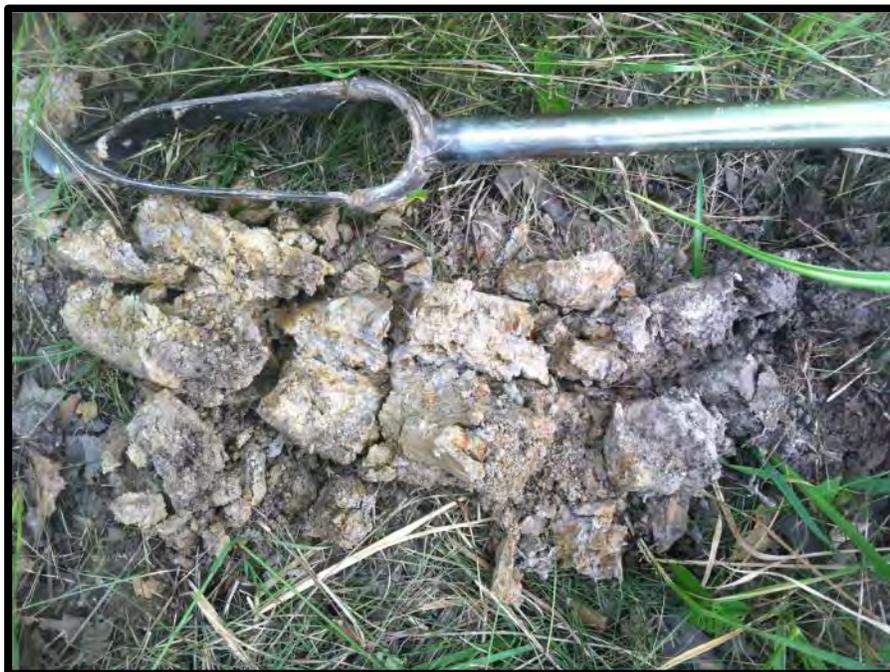
Depth (inches)	Matrix		Redox Features				Texture	Remarks
	Color (moist)	%	Color (moist)	%	Type ¹	Loc ²		
0-4	7.5YR 4/2	90	7.5YR 6/2	10	D	M	SiL	
4-18	7.5YR 6/1	60	7.5YR 5/8	20	C	M	C	
			7.5YR 6/3	20	C	M

Representative Photograph of Data Point 5

Representative Soil Profile for Data Point 5

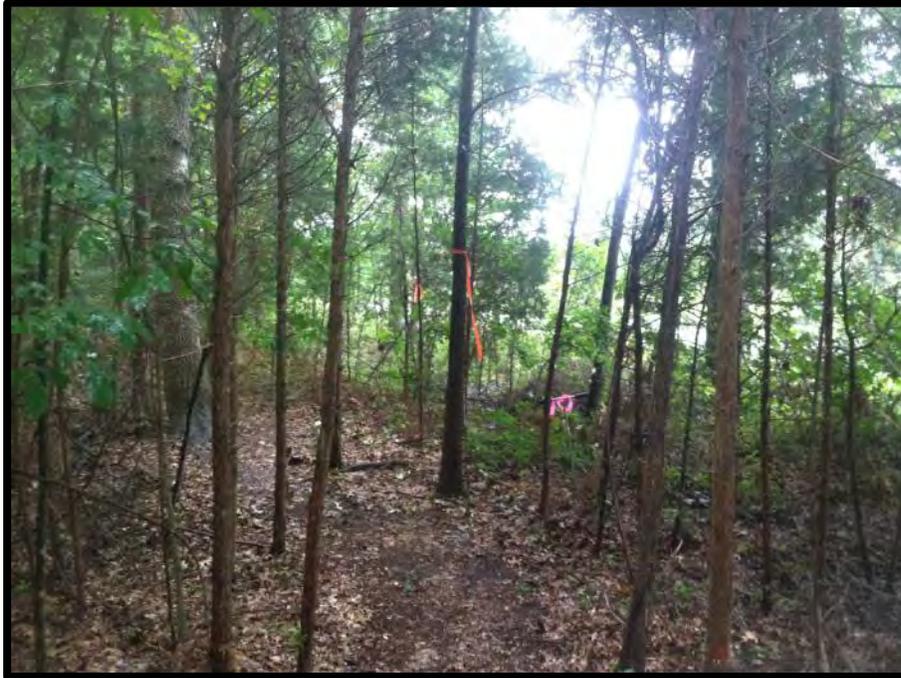
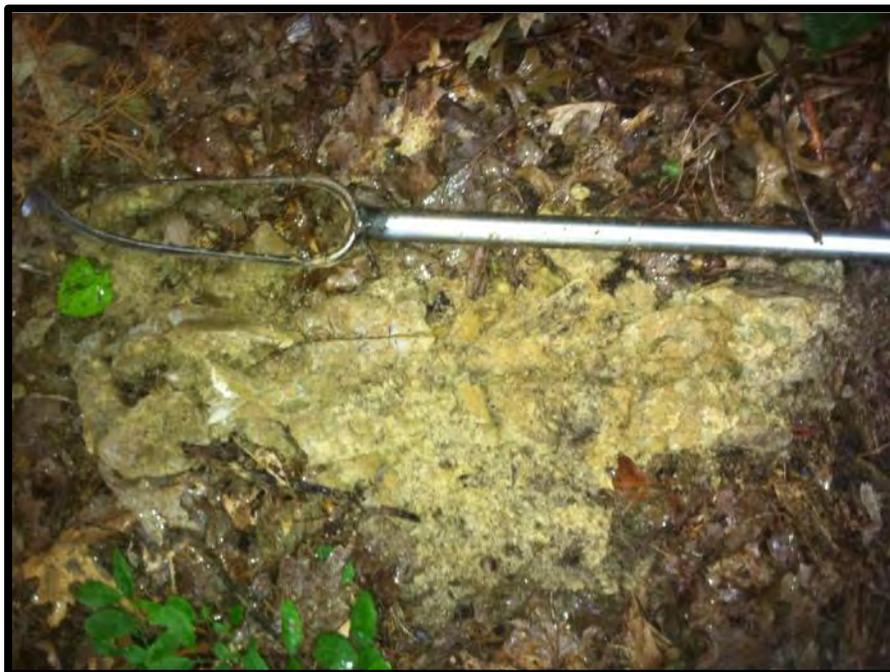
Depth (inches)	Matrix		Redox Features				Texture	Remarks
	Color (moist)	%	Color (moist)	%	Type ¹	Loc ²		
0-3	10YR 4/2	100					L	
3-12	2.5Y 6/3	80	10YR 6/6	10	C	M	SiCL	
			2.5Y 6/1	10	D	M		
12-18	2.5Y 5/4	80	10YR 5/6	15	C	M	C	
			2.5Y 6/1	5	D	M

Representative Photograph of Data Point 6

Representative Soil Profile for Data Point 6

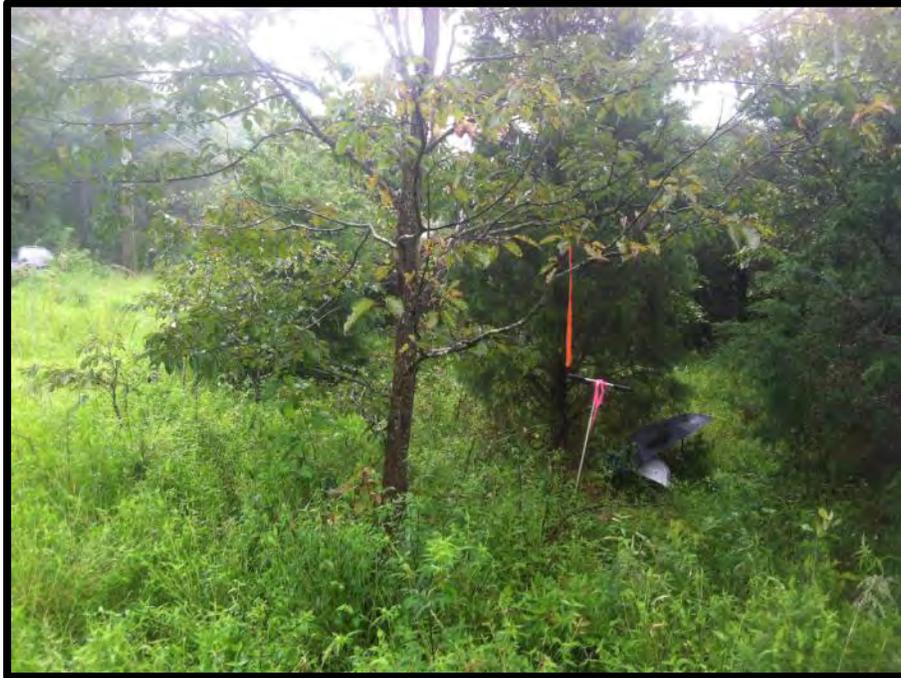
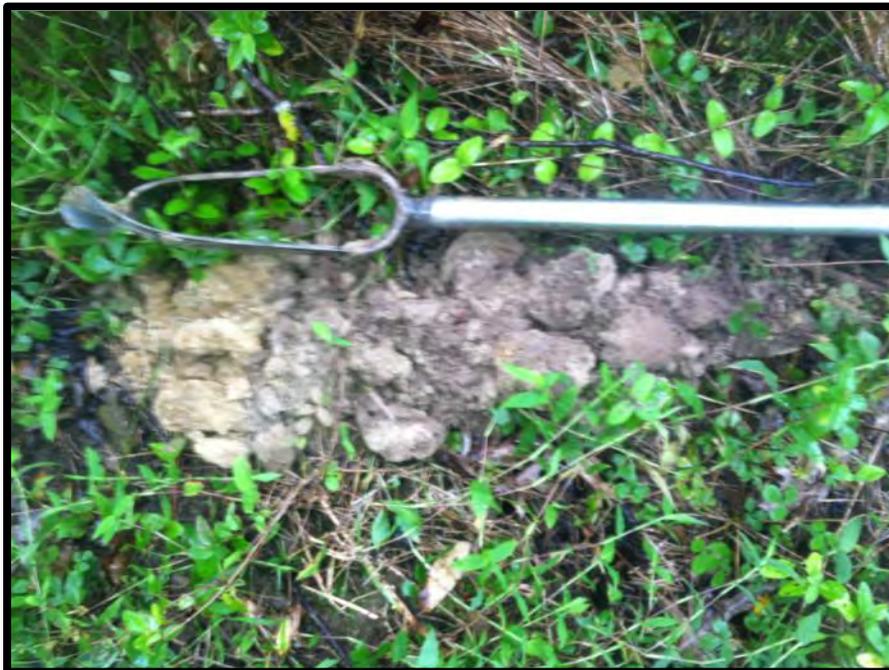
Depth (inches)	Matrix		Redox Features				Texture	Remarks
	Color (moist)	%	Color (moist)	%	Type ¹	Loc ²		
0-14	2.5 Y 5/3	90	10YR 6/6	3	C	M	SiL	
			2.5Y 6/2	7	D	M		
14-18	2.5Y 6/6	80	10YR 6/8	5	C	M	SiC	
			2.5Y 7/3	15	D	M

Representative Photograph of Data Point 7

Representative Soil Profile for Data Point 7

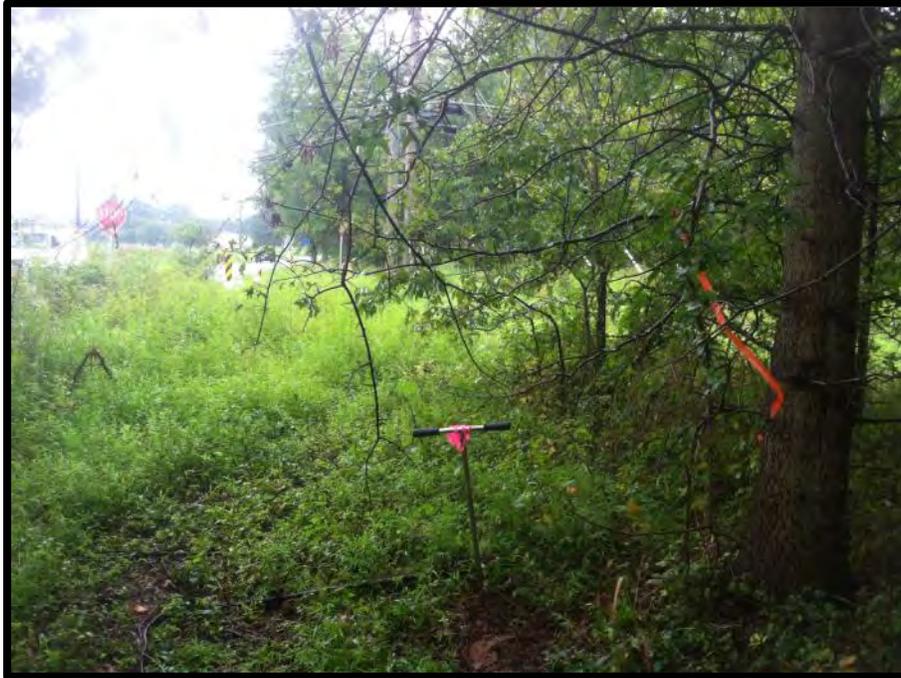
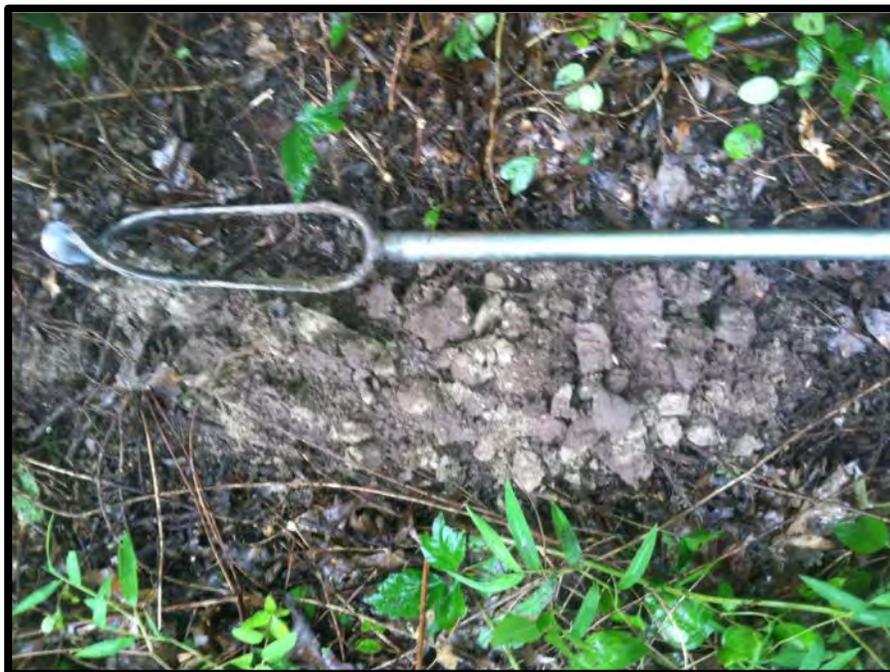
Depth (inches)	Matrix		Redox Features				Texture	Remarks
	Color (moist)	%	Color (moist)	%	Type ¹	Loc ²		
0-15	7.5YR 4/2	92	10YR 4/6	3	C	M	SiCL	
			7.5YR 4/1	5	D	M		
15-18	7.5YR 4/2	85	10YR 4/6	10	C	M	C	
			7.5YR 4/1	5	D	M

Restrictive Layer (if observed): Type: _____ Depth (inches): _____	Hydric Soil Present? Yes <input checked="" type="checkbox"/> No <input type="checkbox"/>
---	---

Representative Photograph of Data Point 8

Representative Soil Profile for Data Point 8

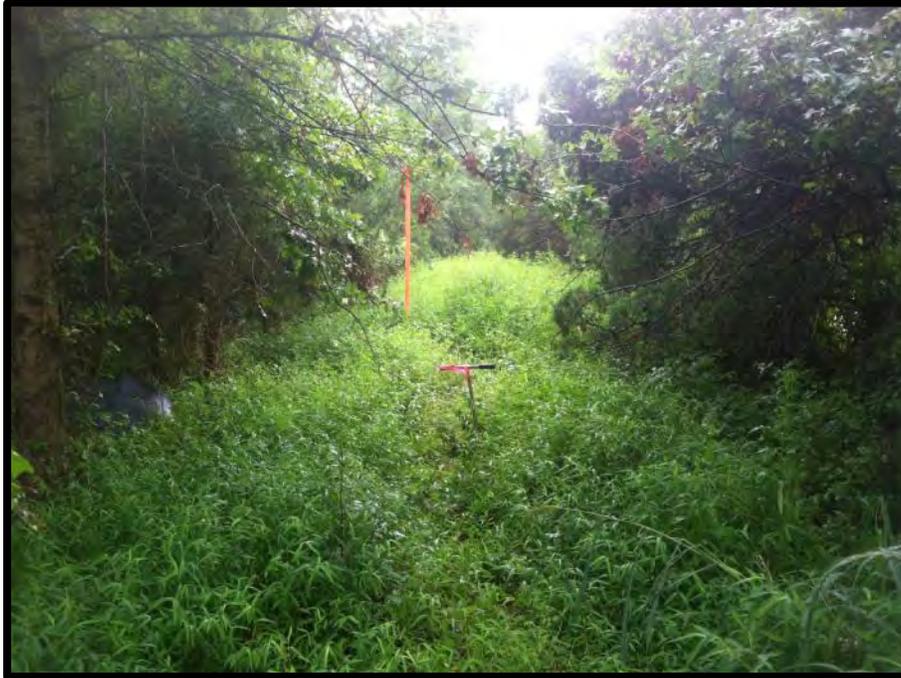
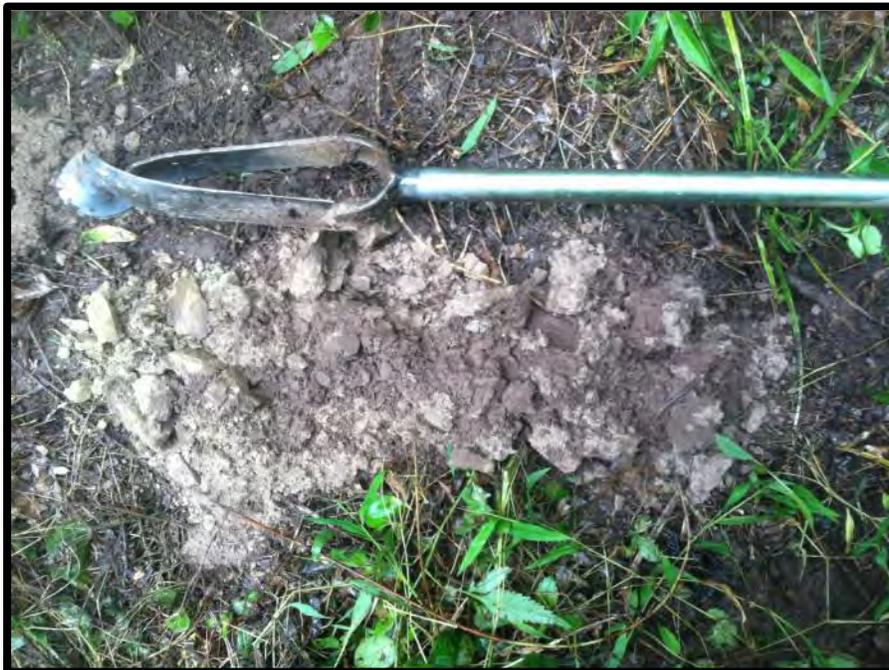
Depth (inches)	Matrix		Redox Features				Texture	Remarks
	Color (moist)	%	Color (moist)	%	Type ¹	Loc ²		
0-12	7.5YR 4/2	100					SiCL	
12-15	7.5YR 4/2	95	10YR 5/6	2	C	M	SiC	
			7.5YR 5/2	3	D	M		
15-18	2.5Y 5/4	80	7.5YR 5/8	10	C	M	C	
			2.5Y 6/1	10	D	M

Representative Photograph of Data Point 9

Representative Soil Profile for Data Point 9

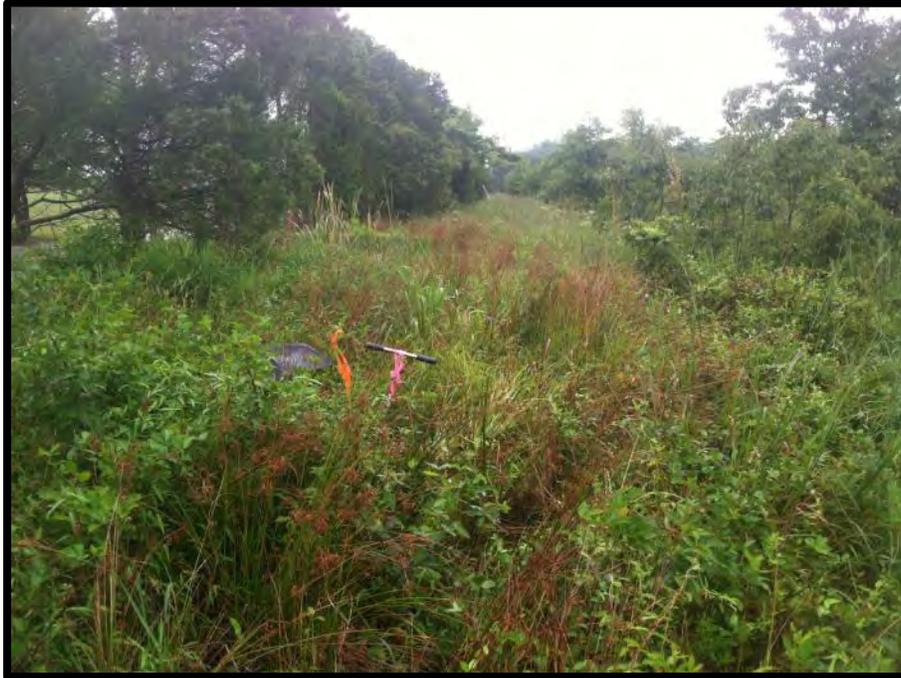
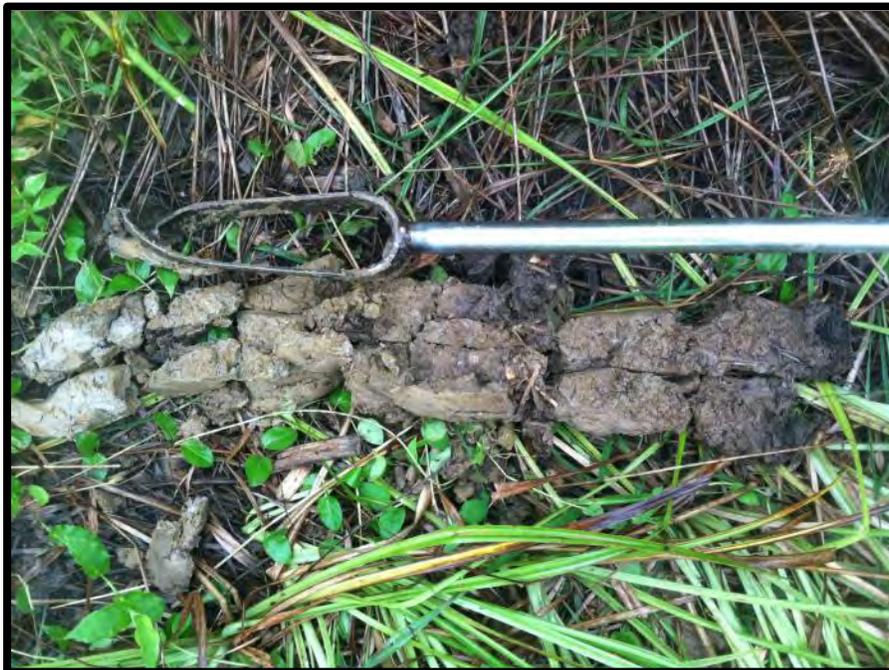
Depth (inches)	Matrix		Redox Features				Texture	Remarks
	Color (moist)	%	Color (moist)	%	Type ¹	Loc ²		
0-9	7.5YR 5/2	90	10YR 6/6	10	C	M	SiCL	
9-15	10YR 5/3	70	10YR 6/6	5	C	M	C	
			10YR 6/2	25	D	M		
15-18	10YR 6/2	85	10YR 6/8	15	C	M	C

Restrictive Layer (if observed): Type: _____ Depth (inches): _____	Hydric Soil Present? Yes <input checked="" type="checkbox"/> No <input type="checkbox"/>
---	--

Representative Photograph of Data Point 10

Representative Soil Profile for Data Point 10

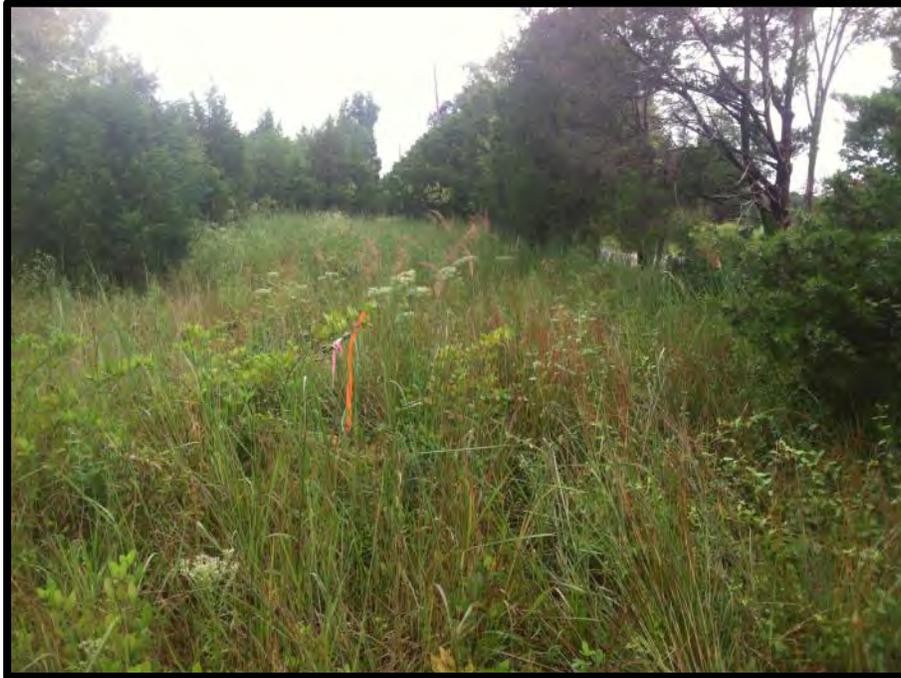
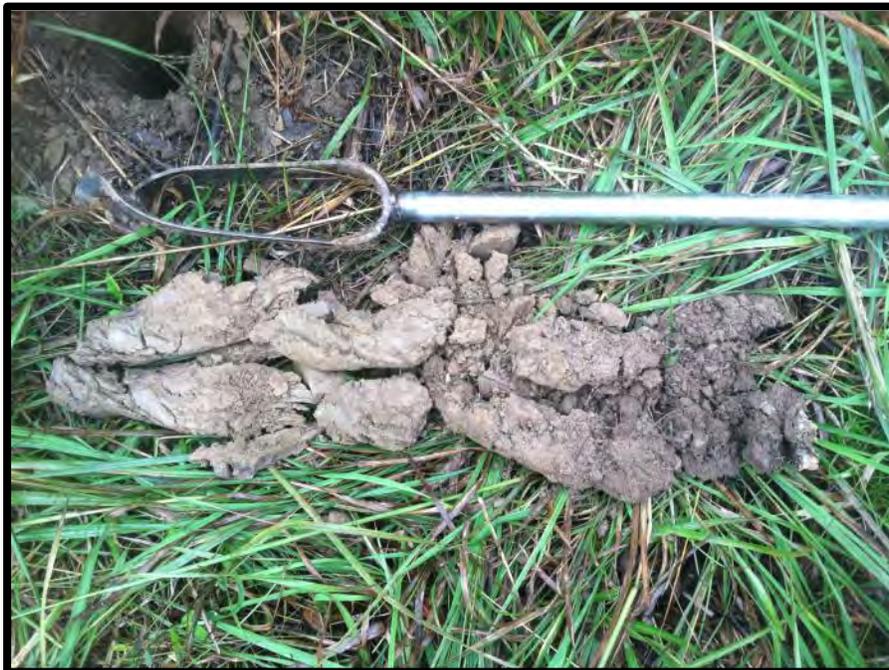
Depth (inches)	Matrix		Redox Features				Texture	Remarks
	Color (moist)	%	Color (moist)	%	Type ¹	Loc ²		
0-3	10YR 4/2	100					SiL	
3-9	10YR 5/3	80	10YR 5/6	5	C	M	SiCL	
			10YR 5/2	15	D	M		
9-18	10YR 5/3	75	10YR 5/8	5	C	M	C	
			10YR 5/1	20	D	M

Restrictive Layer (if observed): Type: _____ Depth (inches): _____	Hydric Soil Present? Yes _____ No <input checked="" type="checkbox"/>
---	---

Representative Photograph of Data Point 11

Representative Soil Profile for Data Point 11

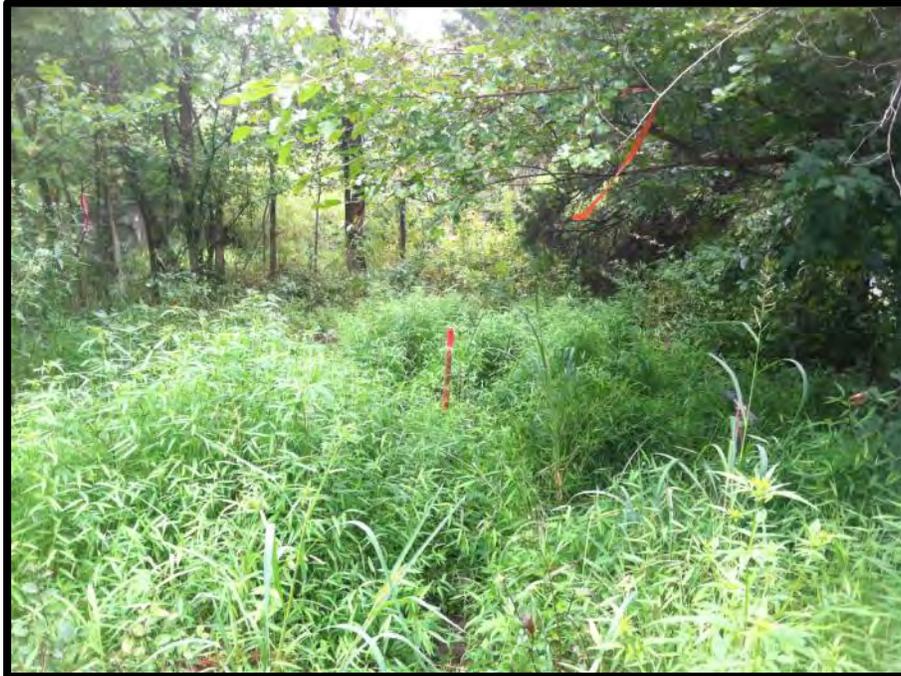
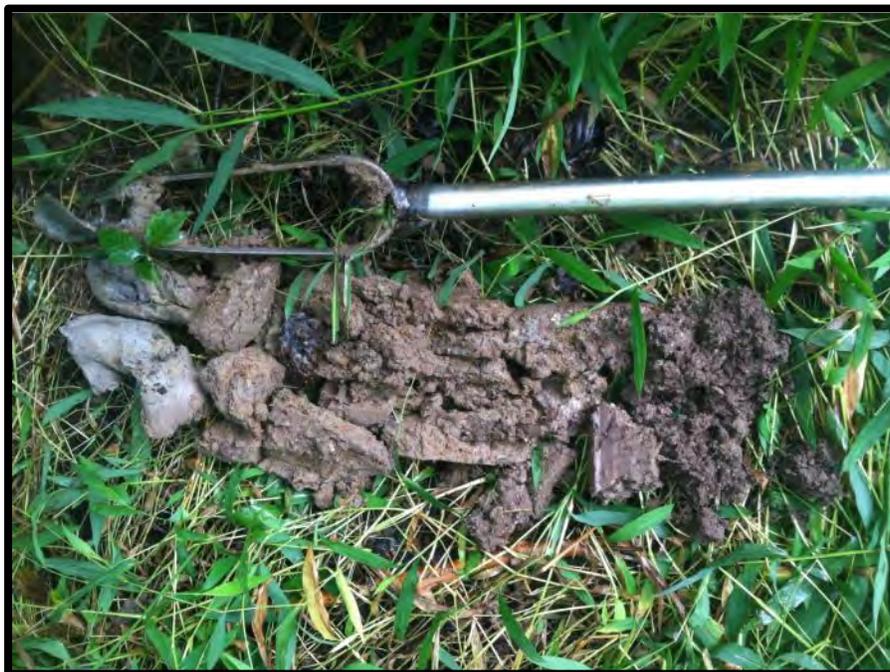
Depth (inches)	Matrix		Redox Features				Texture	Remarks
	Color (moist)	%	Color (moist)	%	Type ¹	Loc ²		
0-3	7.5YR 4/2	100					SiL	
3-6	7.5YR 4/1	80	10YR 5/8	20	C	M	SiCL	
6-16	7.5YR 5/2	85	10YR 5/8	10	C	M	C	
			7.5YR 5/1	5	D	M		
16-18	7.5YR 6/1	90	10YR 5/8	10	C	M	C

Restrictive Layer (if observed): Type: _____ Depth (inches): _____	Hydric Soil Present? Yes <input checked="" type="checkbox"/> No <input type="checkbox"/>
---	---

Representative Photograph of Data Point 12

Representative Soil Profile for Data Point 12

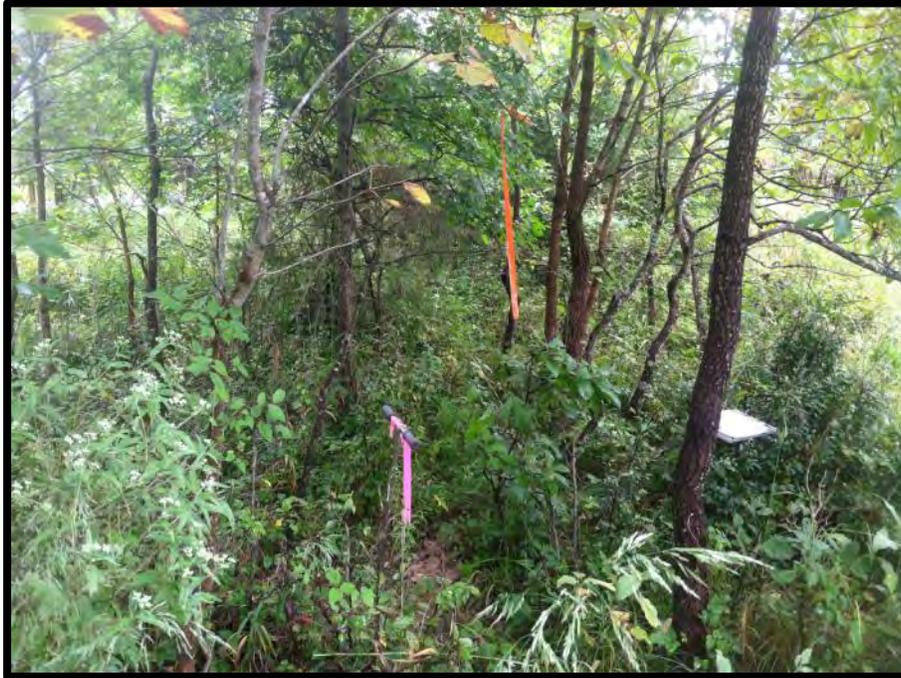
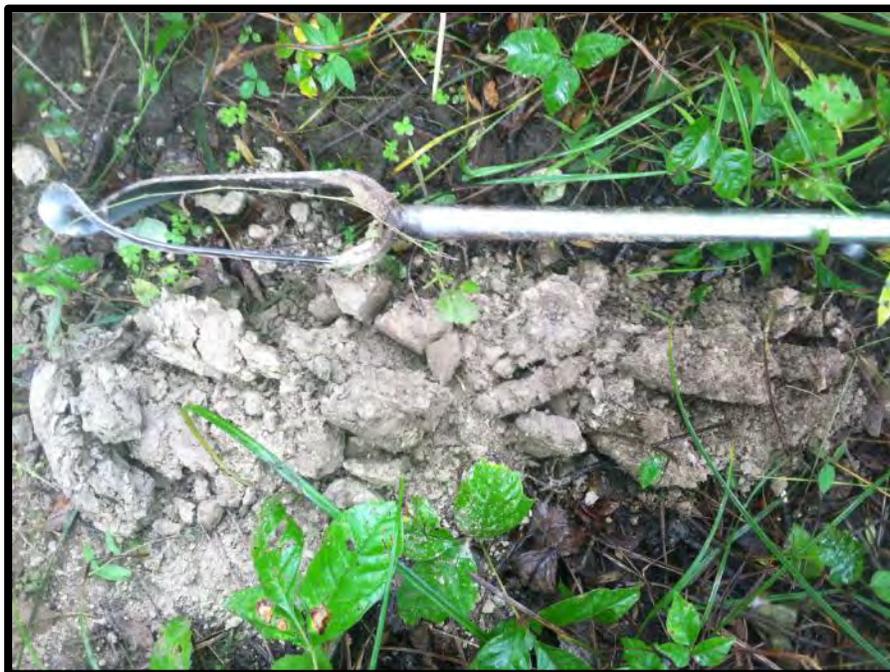
Field Observations: Surface Water Present? Yes _____ No <input checked="" type="checkbox"/> Depth (inches): _____ Water Table Present? Yes _____ No <input checked="" type="checkbox"/> Depth (inches): _____ Saturation Present? Yes _____ No <input checked="" type="checkbox"/> Depth (inches): _____ (includes capillary fringe)	Wetland Hydrology Present? Yes _____ No <input checked="" type="checkbox"/>
Describe Recorded Data (stream gauge, monitoring well, aerial photos, previous inspections), if available:	
Remarks: Upland scour patterns were observed throughout data point area.

Depth (inches)	Matrix		Redox Features				Texture	Remarks
	Color (moist)	%	Color (moist)	%	Type ¹	Loc ²		
0-6	10YR 5/3	95	10YR 5/8	5	C	M	SiCL	
6-12	2.5Y 5/3	75	10YR 5/8	5	C	M	SiCL	
			2.5Y 5/2	20	D	M		
12-18	2.5Y 5/3	90	10YR 6/6	5	C	M	C	
			2.5Y 5/2	5	D	M

Restrictive Layer (if observed): Type: _____ Depth (inches): _____	Hydric Soil Present? Yes _____ No <input checked="" type="checkbox"/>
---	---

Representative Photograph of Data Point 13

Representative Soil Profile for Data Point 13
