## **Route 151 Corridor Study**

Public Information Meeting

May 16, 2013

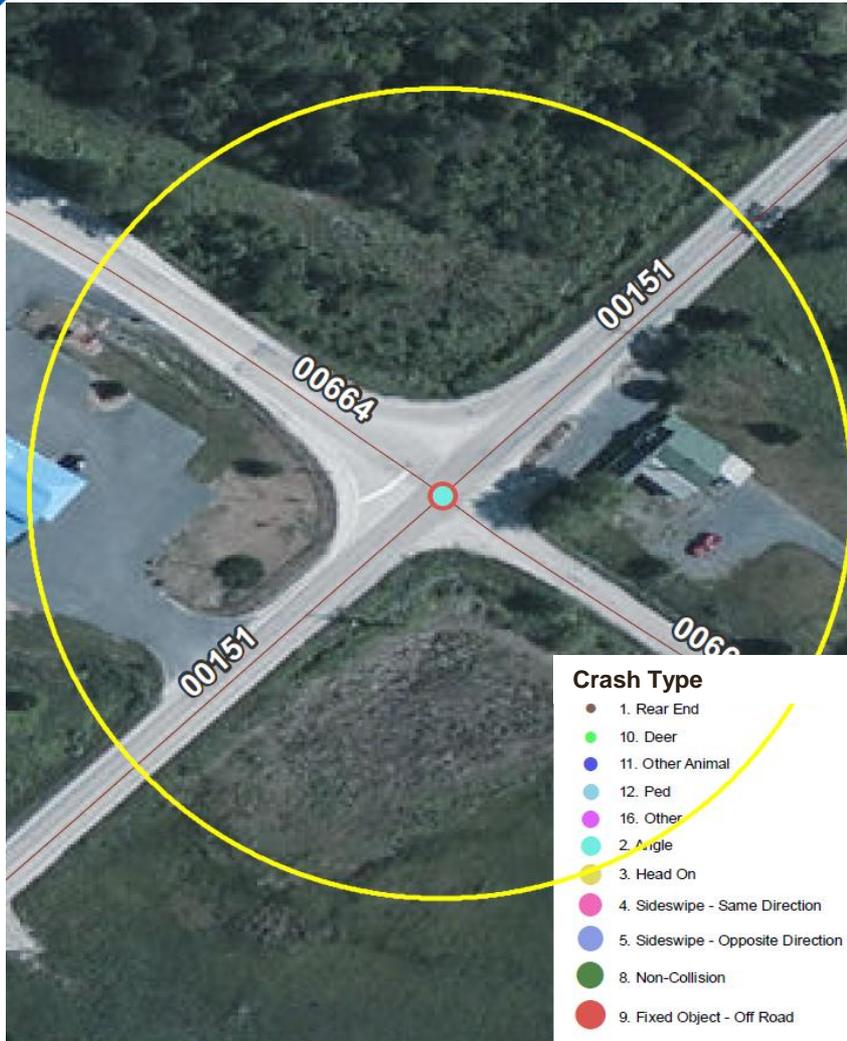
# 1) Rte. 151 at Rte. 664 (Beech Grove Road)

## Two crashes

- Angle
- Off-road

- Heavy southbound right turn traffic
- Overgrown vegetation
- Confusing signage

- Add southbound offset right turn bay
- Trim vegetation in northwest quadrant
- Adjust signage along northbound Rte. 151

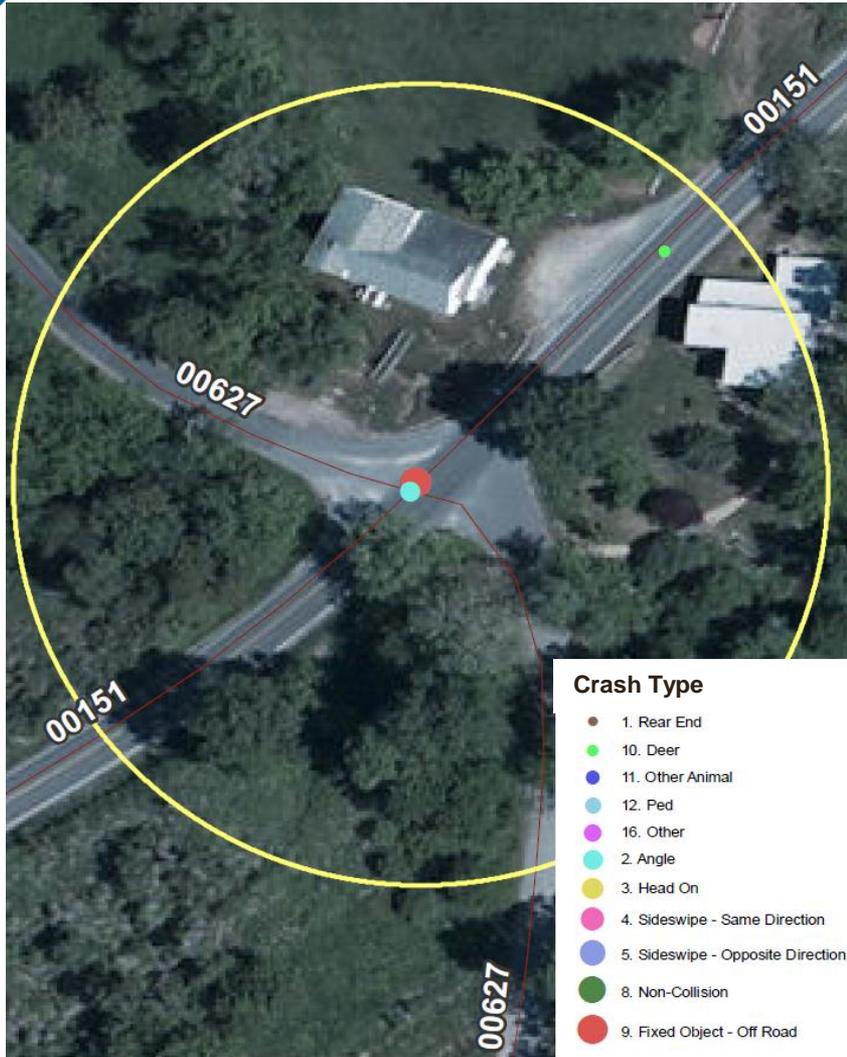
## 2) Rte. 151 at Rte. 627 (Spruce Creek Lane)

### Three crashes

- Angle
- Off-road
- Wildlife

- Poor sight distance
- Odd alignment of Rte. 627 affects turning traffic
- Location of driveways within intersection area
- Potential historic structure (mill foundation)

- Reconstruct intersection to realign Rte. 627 and modify embankment in southwest quadrant
- Add intersection-ahead signage with flashers on the northbound approach
- Monitor traffic volumes and crashes after improvements implemented to determine whether a signal is needed

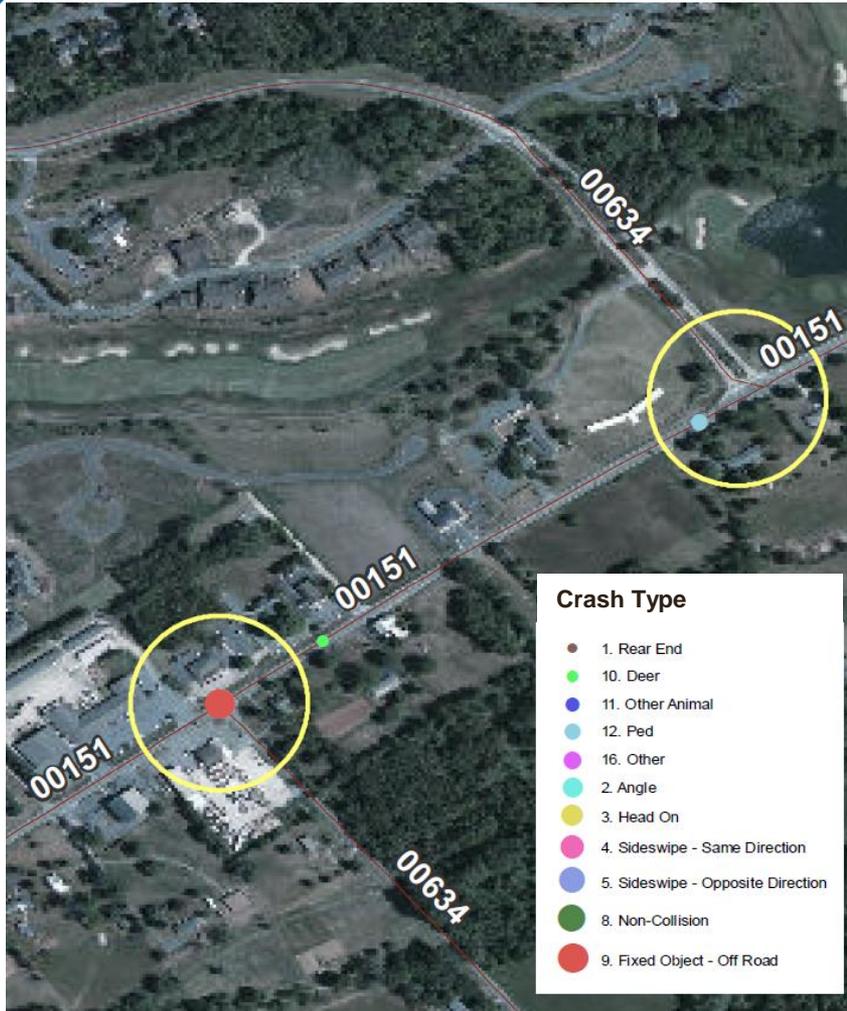
# 3) Rte. 151 at Rte. 634 (Nellysford area)

## Three crashes

- Pedestrian
- Off-road
- Wildlife

- Lack of pedestrian facilities
- Access Management/Poor inter-parcel connectivity
- Vegetation on Rte. 634 (Adial Road) limits sight distance approaching Rte. 151

- Add sidewalks for pedestrians
- As new development or re-development occurs, improve access management and inter-parcel connectivity
- On Adial Road, trim vegetation and relocate stop sign
- Perform detailed speed study to determine feasibility of reducing speed limit to 35 mph through Nellysford commercial area

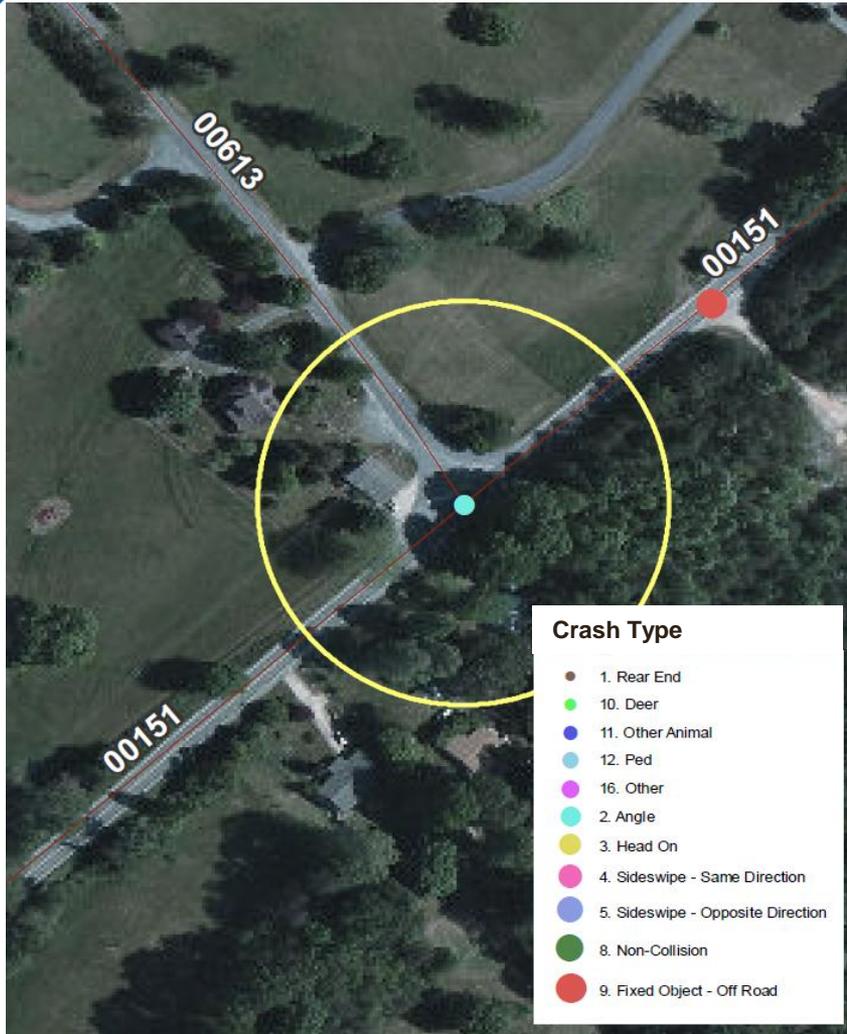
# 4) Rte. 151 at Rte. 613 (Rodes Farm and Lodebar Estates)

## Two crashes

- Angle
- Off-road

- Crest in road between Rodes Farm Road and Lodebar Estates limits sight distance
- Embankment along east side of Rte. 151 also contributes to sight distance issues
- Drivers have to be aggressive turning onto Rte. 151
- Commercial signage may be within VDOT right-of-way

- Review commercial signage to ensure not in VDOT right-of-way
- Regrade roadway in area to improve sight distance
  - Reduce crest of hill
  - Regrade embankment

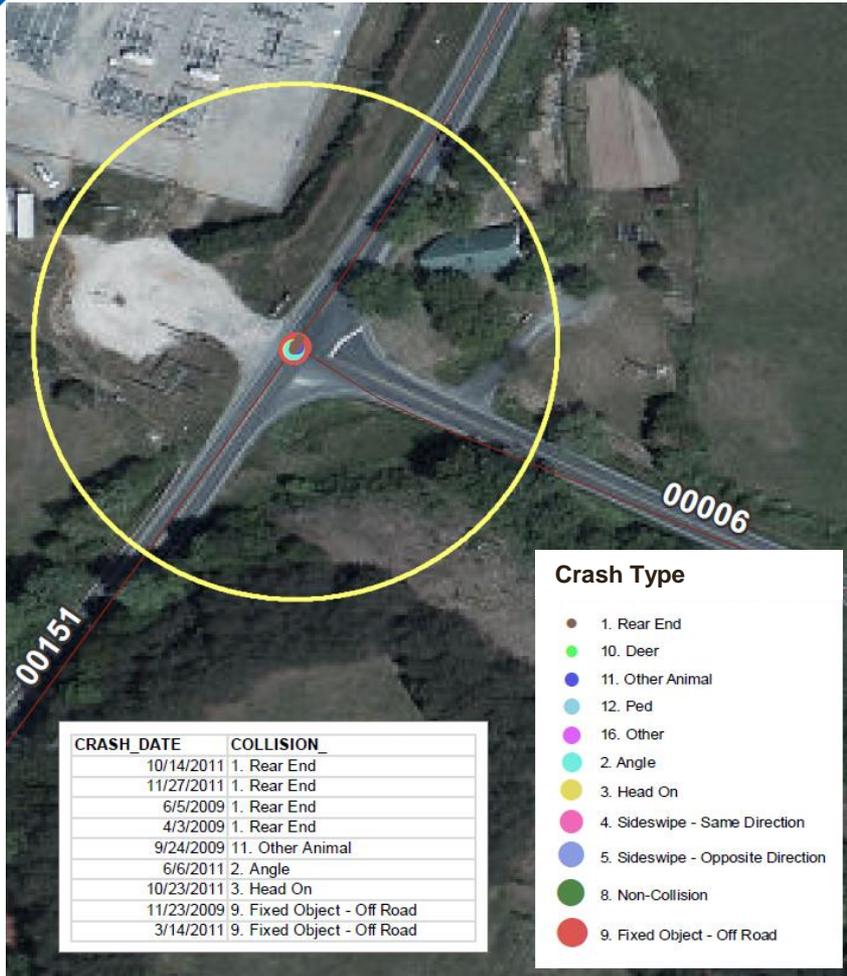
# 5) Rte. 151 at Rte. 6 (River Road)

## Multiple crashes

- 4 Rear-end
- 1 Angle
- 2 Off-road

- Heavy turning truck traffic
- Lack of turn lane
- Narrow receiving area, vehicles are crossing yellow lines (traveling into opposite lane)

- Widen east leg of intersection for wider receiving area to accommodate turning vehicles
- Consider roundabout or a southbound left turn lane

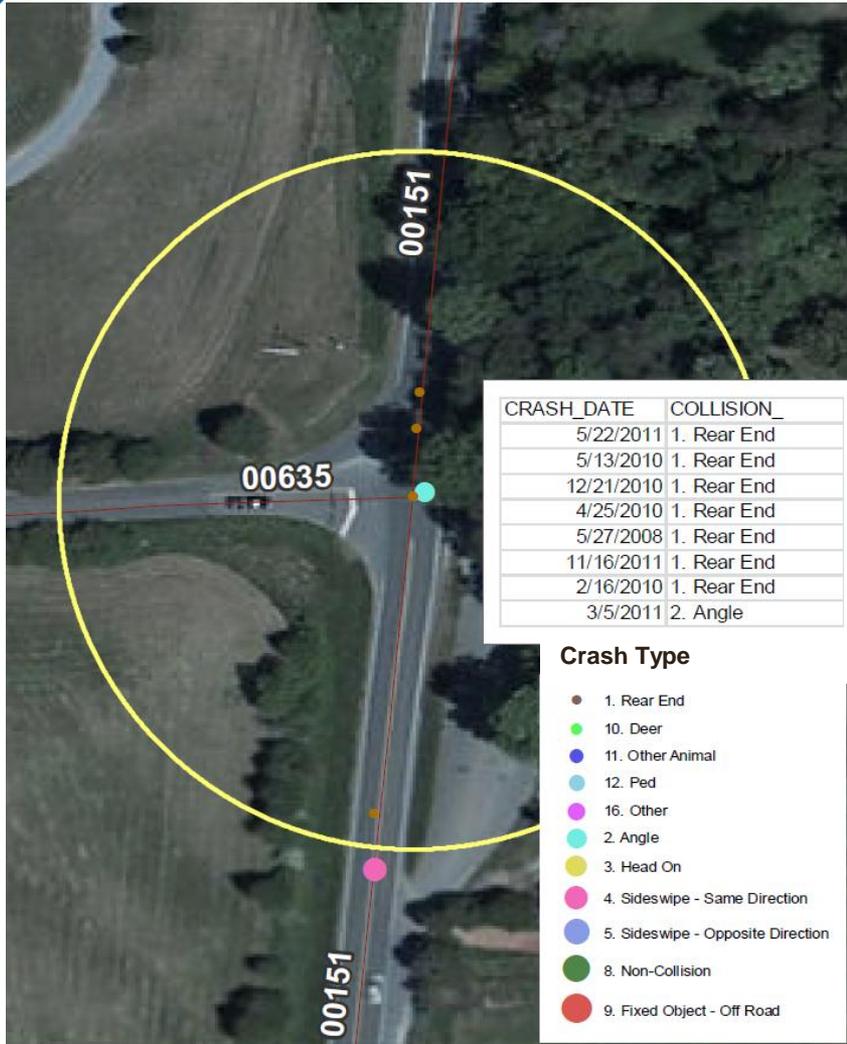
# 6) Rte. 151 at Rte. 635 (Rockfish School Lane)

## Multiple crashes

- 7 Rear-end
- 1 Angle

- **Increased in crashes last two years (2010/2011)**
  - Due to addition of Recycling Drop-off at Community Center
  - Park activities generate high traffic: soccer fields, horse and dog shows
- **Lack of turn lanes**

- **VDOT has approved a Highway Safety Improvement Program (HSIP) grant for construction of the northbound left turn lane on Route 151, preliminary start date of construction is October 2016**

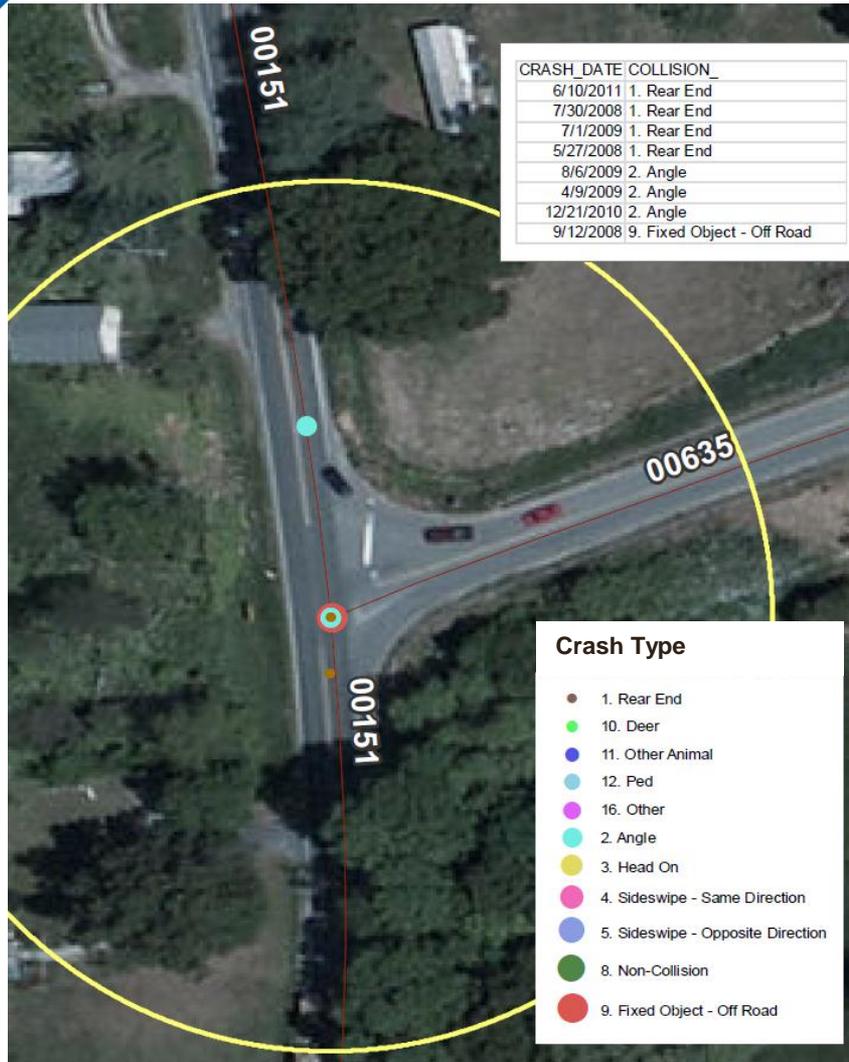
# 7) Rte. 151 at Rte. 635 (Greenfield Road)

## Multiple crashes

- 4 Rear-end
- 3 Angle
- 1 Fixed object/off-road
- Most in 2008 & 2009

- Location recently improved
- Short northbound right turn bay

- Extend northbound right turn bay

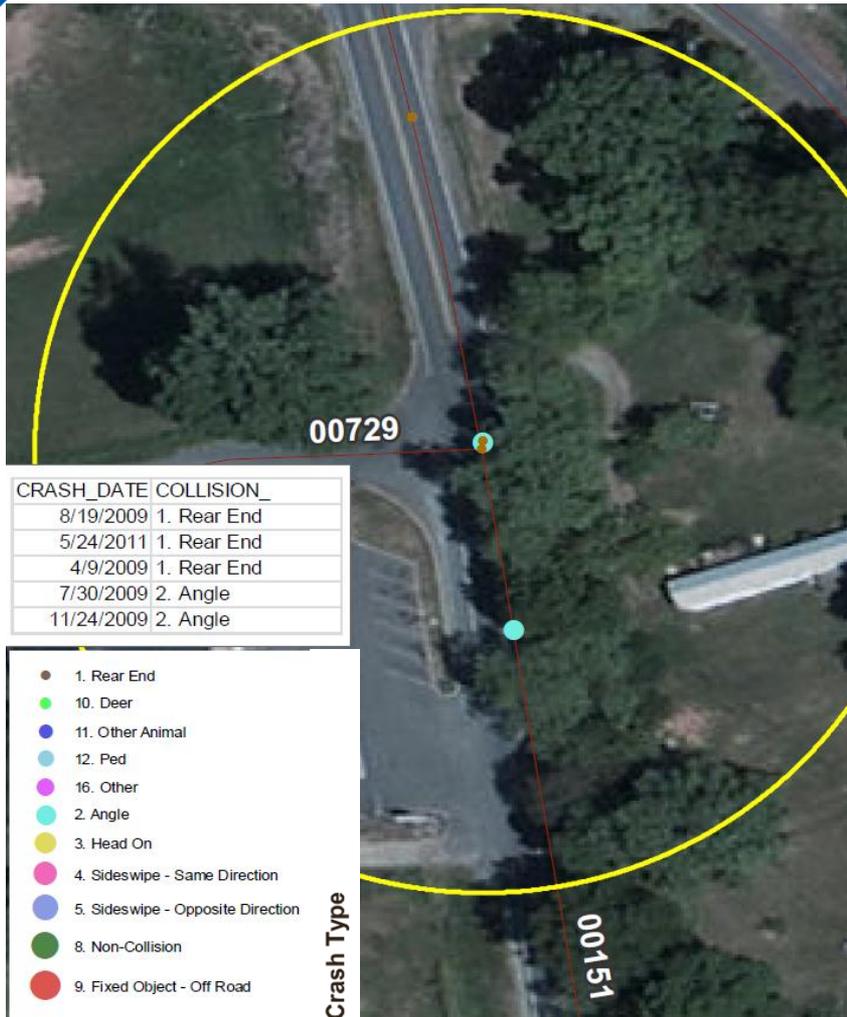
# 8) Rte. 151 at Rte. 729 (Creek Road)

## Multiple crashes

- 3 Rear-end
- 2 Angle

- Turning traffic and lack of turn bays
- Heavy traffic generator (store)

- Restripe roadway to provide northbound left turn bay into the store's southern access
- Add a southbound right turn bay onto Creek Road

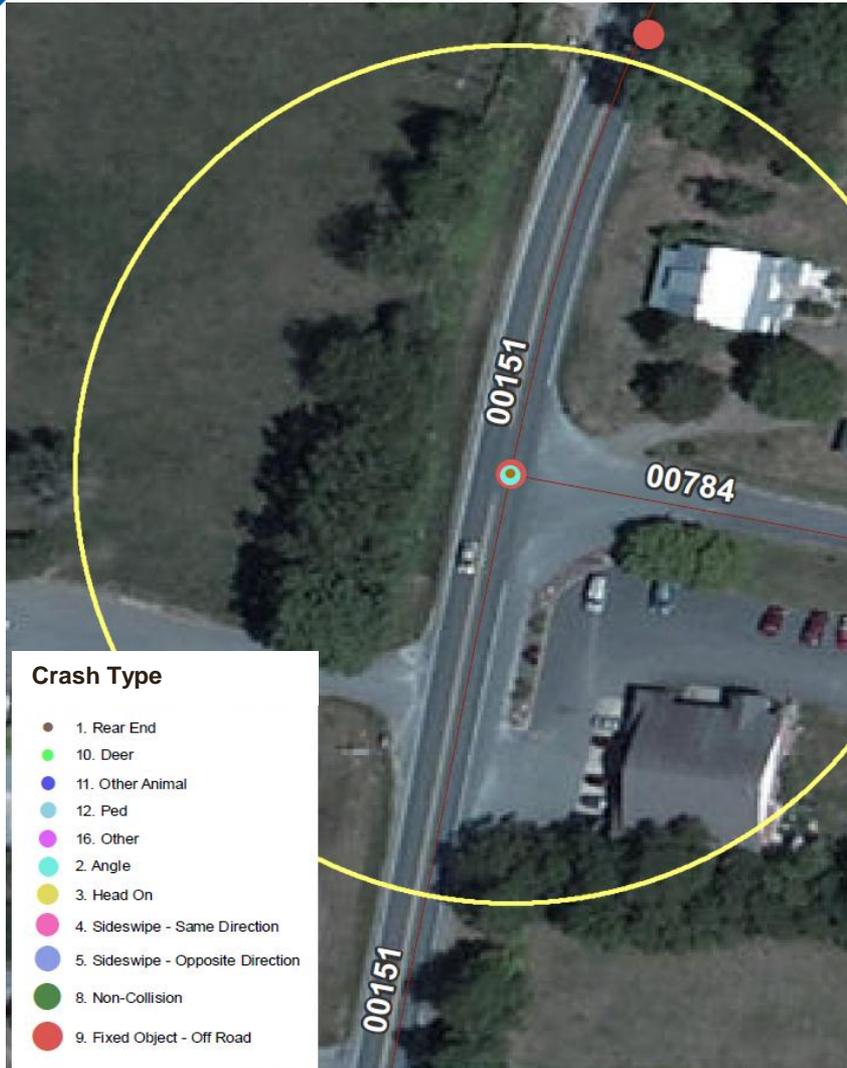
# 9) Rte. 151 at Rte. 784 (Bland Wade Lane)

## Multiple crashes

- 1 Rear-end
- 1 Angle
- 2 Off-road

- Limited sight distance due to hill in northeast quadrant affects Bland Wade and southbound left turn traffic
- Limited sight distance due to dip in road to the south
- Traffic cuts through Fitness Center parking lot

- Regrade hill to improve sight distance, eliminate dip in road, and add a northbound right turn bay; or
- Relocate Bland Wade Lane south of the Fitness Center

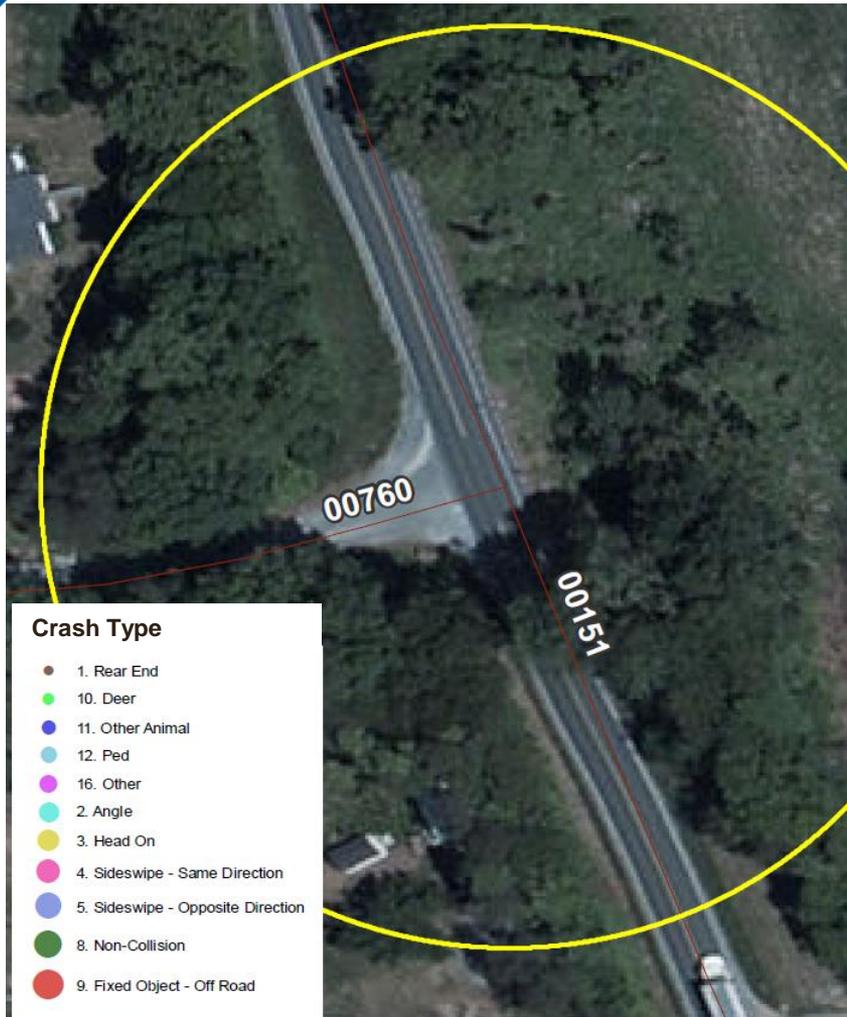
# 10) Rte. 151 at Rte. 760 (Sunrise Drive)

**No reported crashes for analysis years**

- **Crash debris present south of intersection during site visit**
- **Guardrail condition indicates two accidents**

- Limited sight distance due to crest in roadway to the south
- Portion of guardrail in poor condition

- Rehabilitate guardrail and improve drainage
- Regrade roadway to reduce crest
- Modify embankment in southwest quadrant

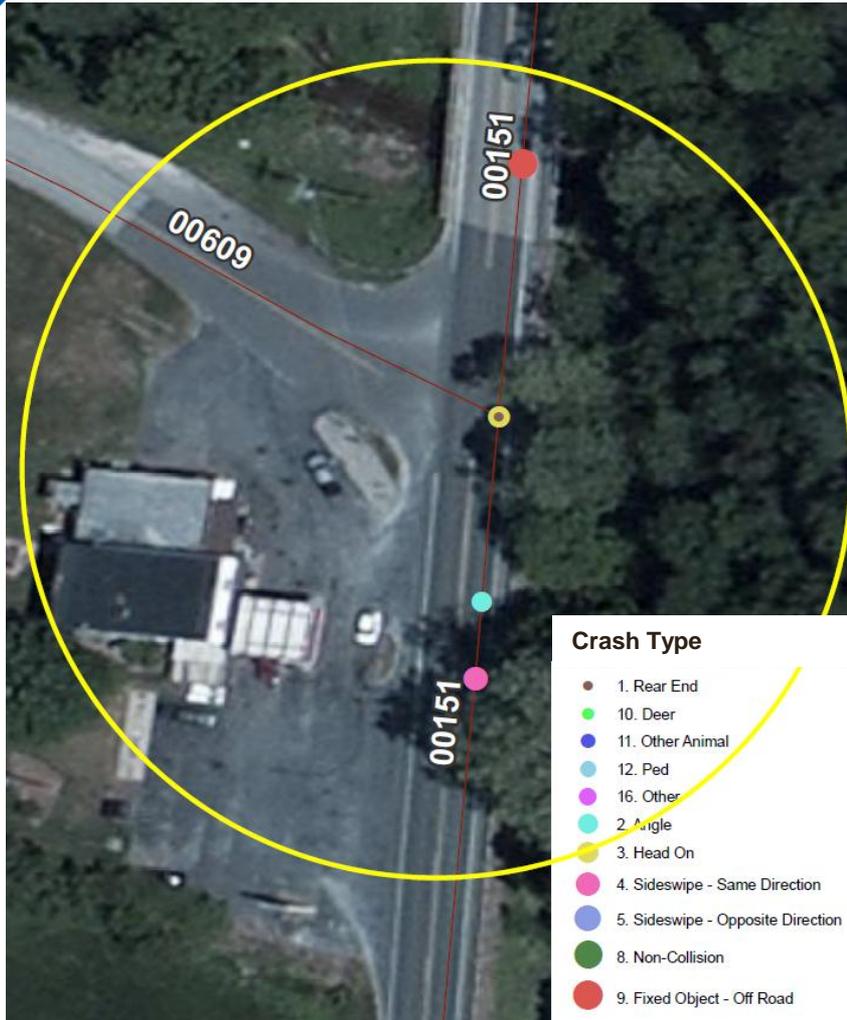
# 11) Rte. 151 at Rte. 609 (Mill Lane)

## Multiple crashes

- 1 Rear-end
- 1 Angle
- 1 Fixed Object/Off-road
- 1 Sideswipe

- **Poor sight distance**
  - Goodwins Creek bridge
  - Overgrown vegetation
- **Driveways of gas station in close proximity of intersection**

- **Trim vegetation**
- **Improve access management**
- **Improve signage on Rte. 151 for Rte. 609**
- **Add stop bar**
- **Widen bridge structure**

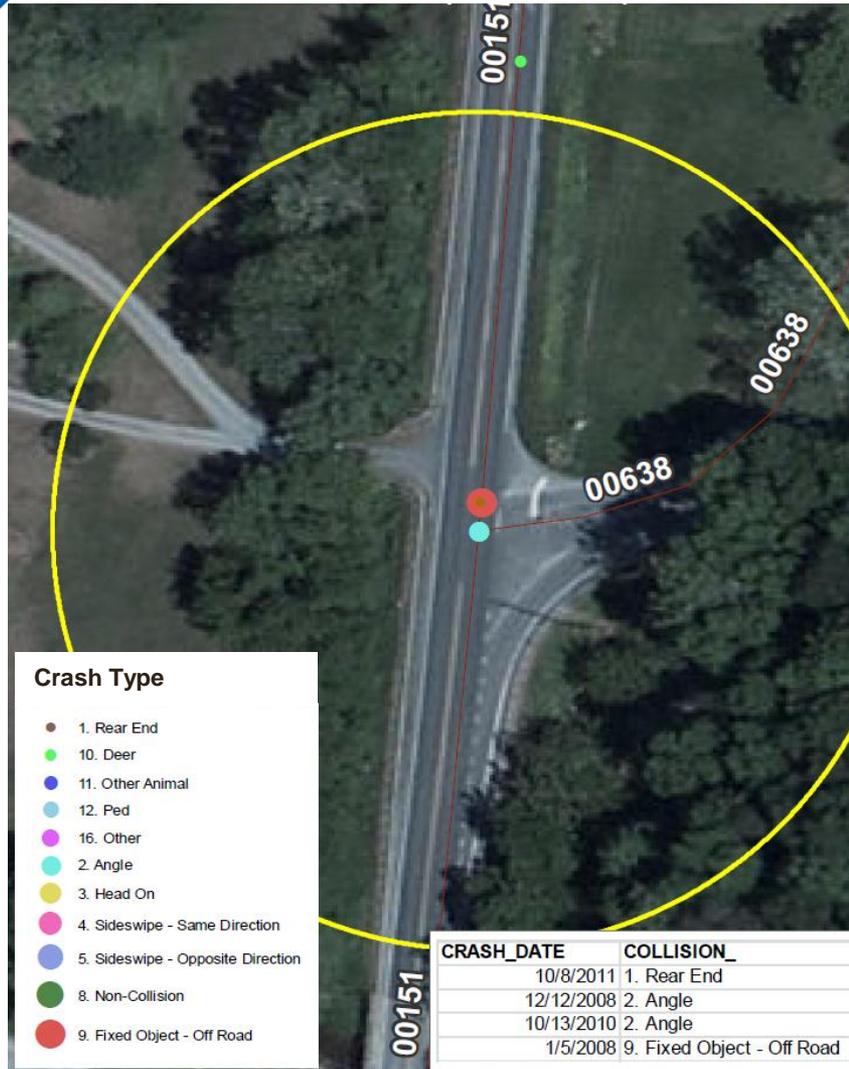
# 12) Rte. 151 at Rte. 638 (Avon Road - south)

## Multiple crashes

- 1 Rear-end
- 1 Angle
- 1 Fixed Object/Off-road

- Driver inattention
- Overgrown vegetation in southeast quadrant limits sight distance
- Stop bar too far back

- Move stop bar closer to the northbound travel lane to improve sight distance
- Trim vegetation

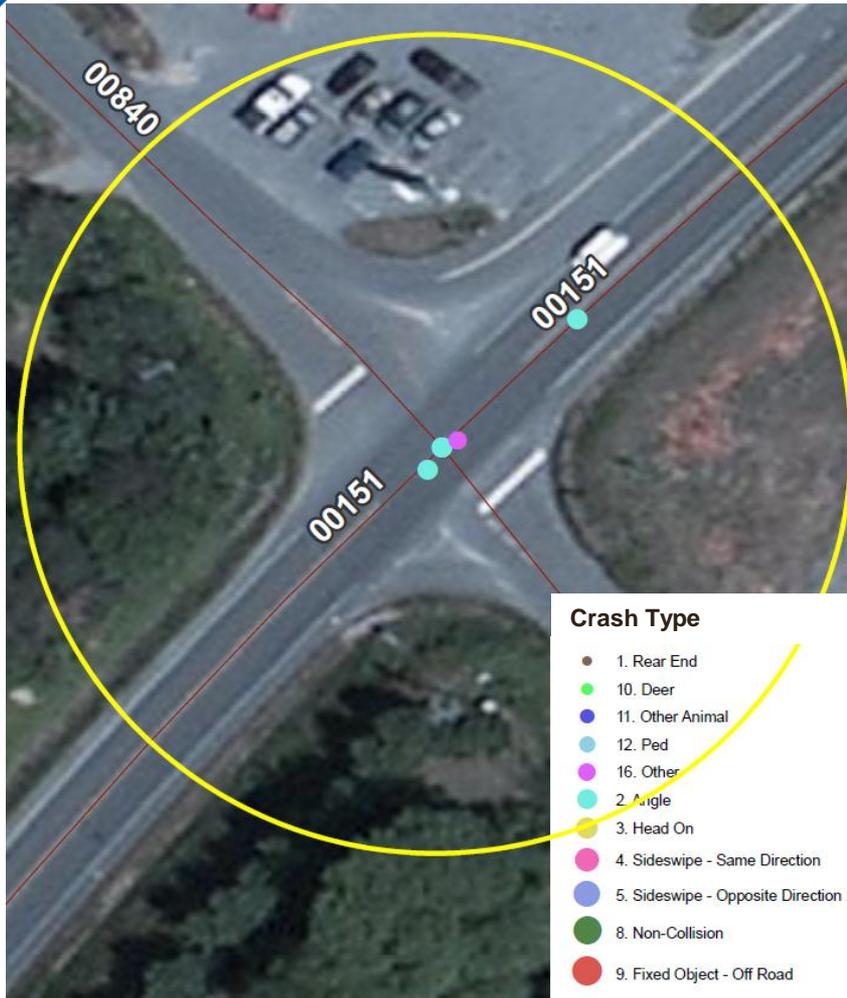
# 13) Rte. 151 at Rte. 840 (Tanbark Road)

## Multiple crashes

- 3 Angle
- 1 other

- Site of two fatalities in a 2012 crash
- Center lines and stop bars faded on Tanbark Road
- Crest on Tanbark Road limits approach sight distance
- Embankments limits sight distance

- Refresh center lines and stop bars and relocate stop sign
- Add intersection ahead signs on Rte. 840
- Add 45mph advisory sign to the existing Intersection Warning Sign
- Regrade Tanbark Road to improve visibility to Rte. 151
- Improve Tanbark Road at Greenberry Road
- Modify embankment in southwest and southeast quadrant

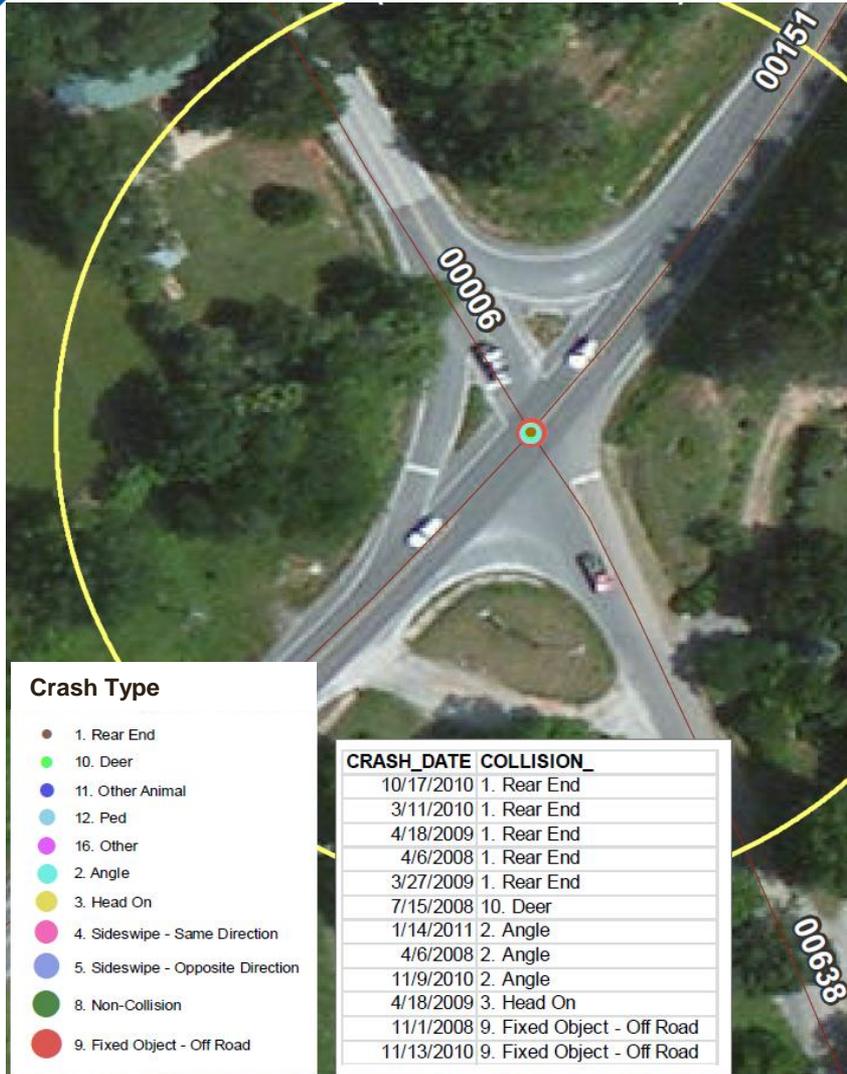
# 14) Rte. 151 at Rte. 6 (Afton Mountain Road)

## Multiple crashes

- 5 Rear-end
- 3 Angle
- 4 other types

- Minor road dips on approach to Rte. 151, hiding view until vehicles near intersection
- Vegetation in southwest quadrant limits sight distance
- Stop signs are not consistent in size
- Eastbound right turn approach is at an awkward angle, drivers looking over shoulder to see southbound vehicles
- Dip on Rte. 151 to the south limits sight distance
- Heavy turning volume during tourist season

- VDOT has approved an HSIP grant for construction of Route 151 left turn lanes, preliminary start date of construction is March 2016
- Regrade Rte. 6 to improve sight distance and reconfigure eastbound right turn lane
- Regrade Rte. 638 approach to improve sight distance
- Improve signage

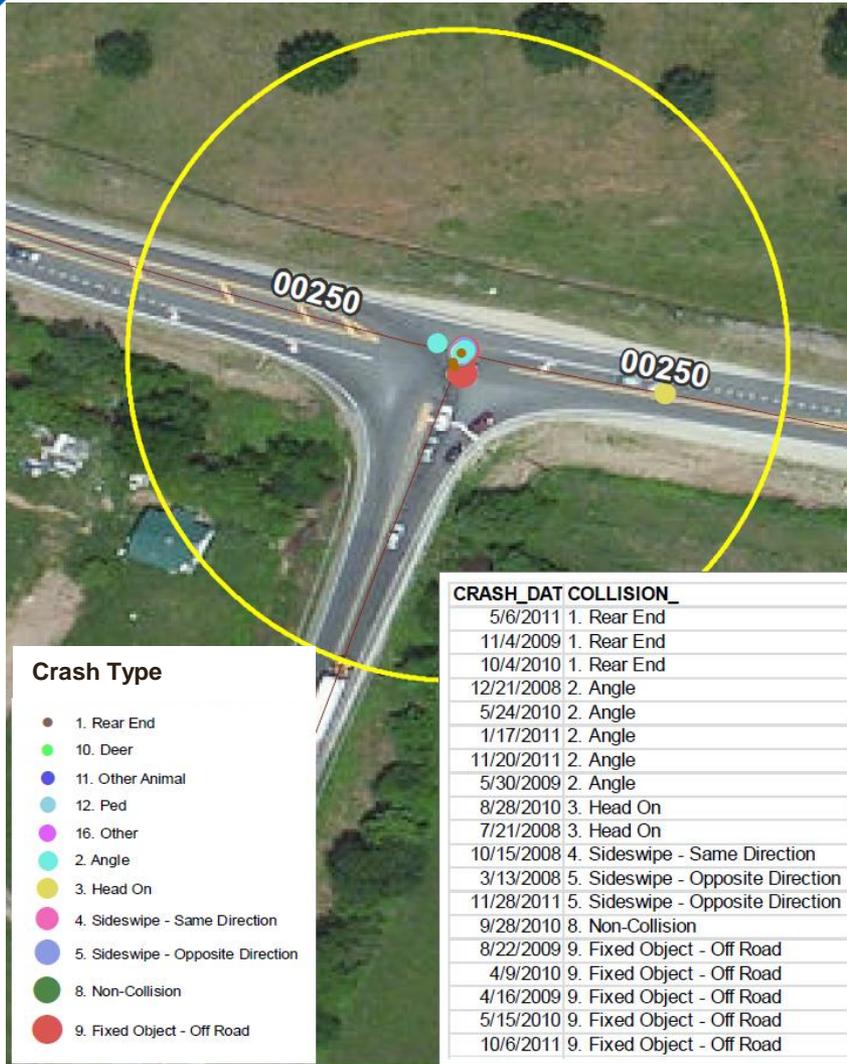
# 15) Rte. 151 at US 250 (Rockfish Gap Turnpike)

## Multiple crashes

- 3 Rear-end
- 5 Angle
- 2 Head-on
- 5 Fixed Object/Off-road
- 4 other types

- **Heavy turn movements with short turn bays**
  - Eastbound US 250 right turning vehicles block Rte. 151 traffic's view of the through movement
  - Westbound US 250 left turning traffic queue extends into through lane, through vehicles driving around on grass area

- **Offset the eastbound right turn bay by 12 feet to improve visibility of eastbound through vehicles**
- **Extend the westbound left turn lane**
- **Add a northbound right turn lane with an acceleration lane on US 250 (if signal not installed)**
- **Consider a roundabout or a traffic signal**
