# CULTURAL RESOURCES SURVEY FOR THE FAIRFAX COUNTY PARKWAY (ROUTE 286) WIDENING PROJECT FAIRFAX COUNTY, VIRGINIA

VDOT PROJECT: 0286-029-259, B619, B620, B621,  
B622, B623, B624, B625, B627, B628, B629,  
B630, B631, B632, D604, D605, P101  
IPM/UPC/CSC No: 107937  
VDHR FILE No: 2018-0073

**FINAL REPORT  
AUGUST 2018**

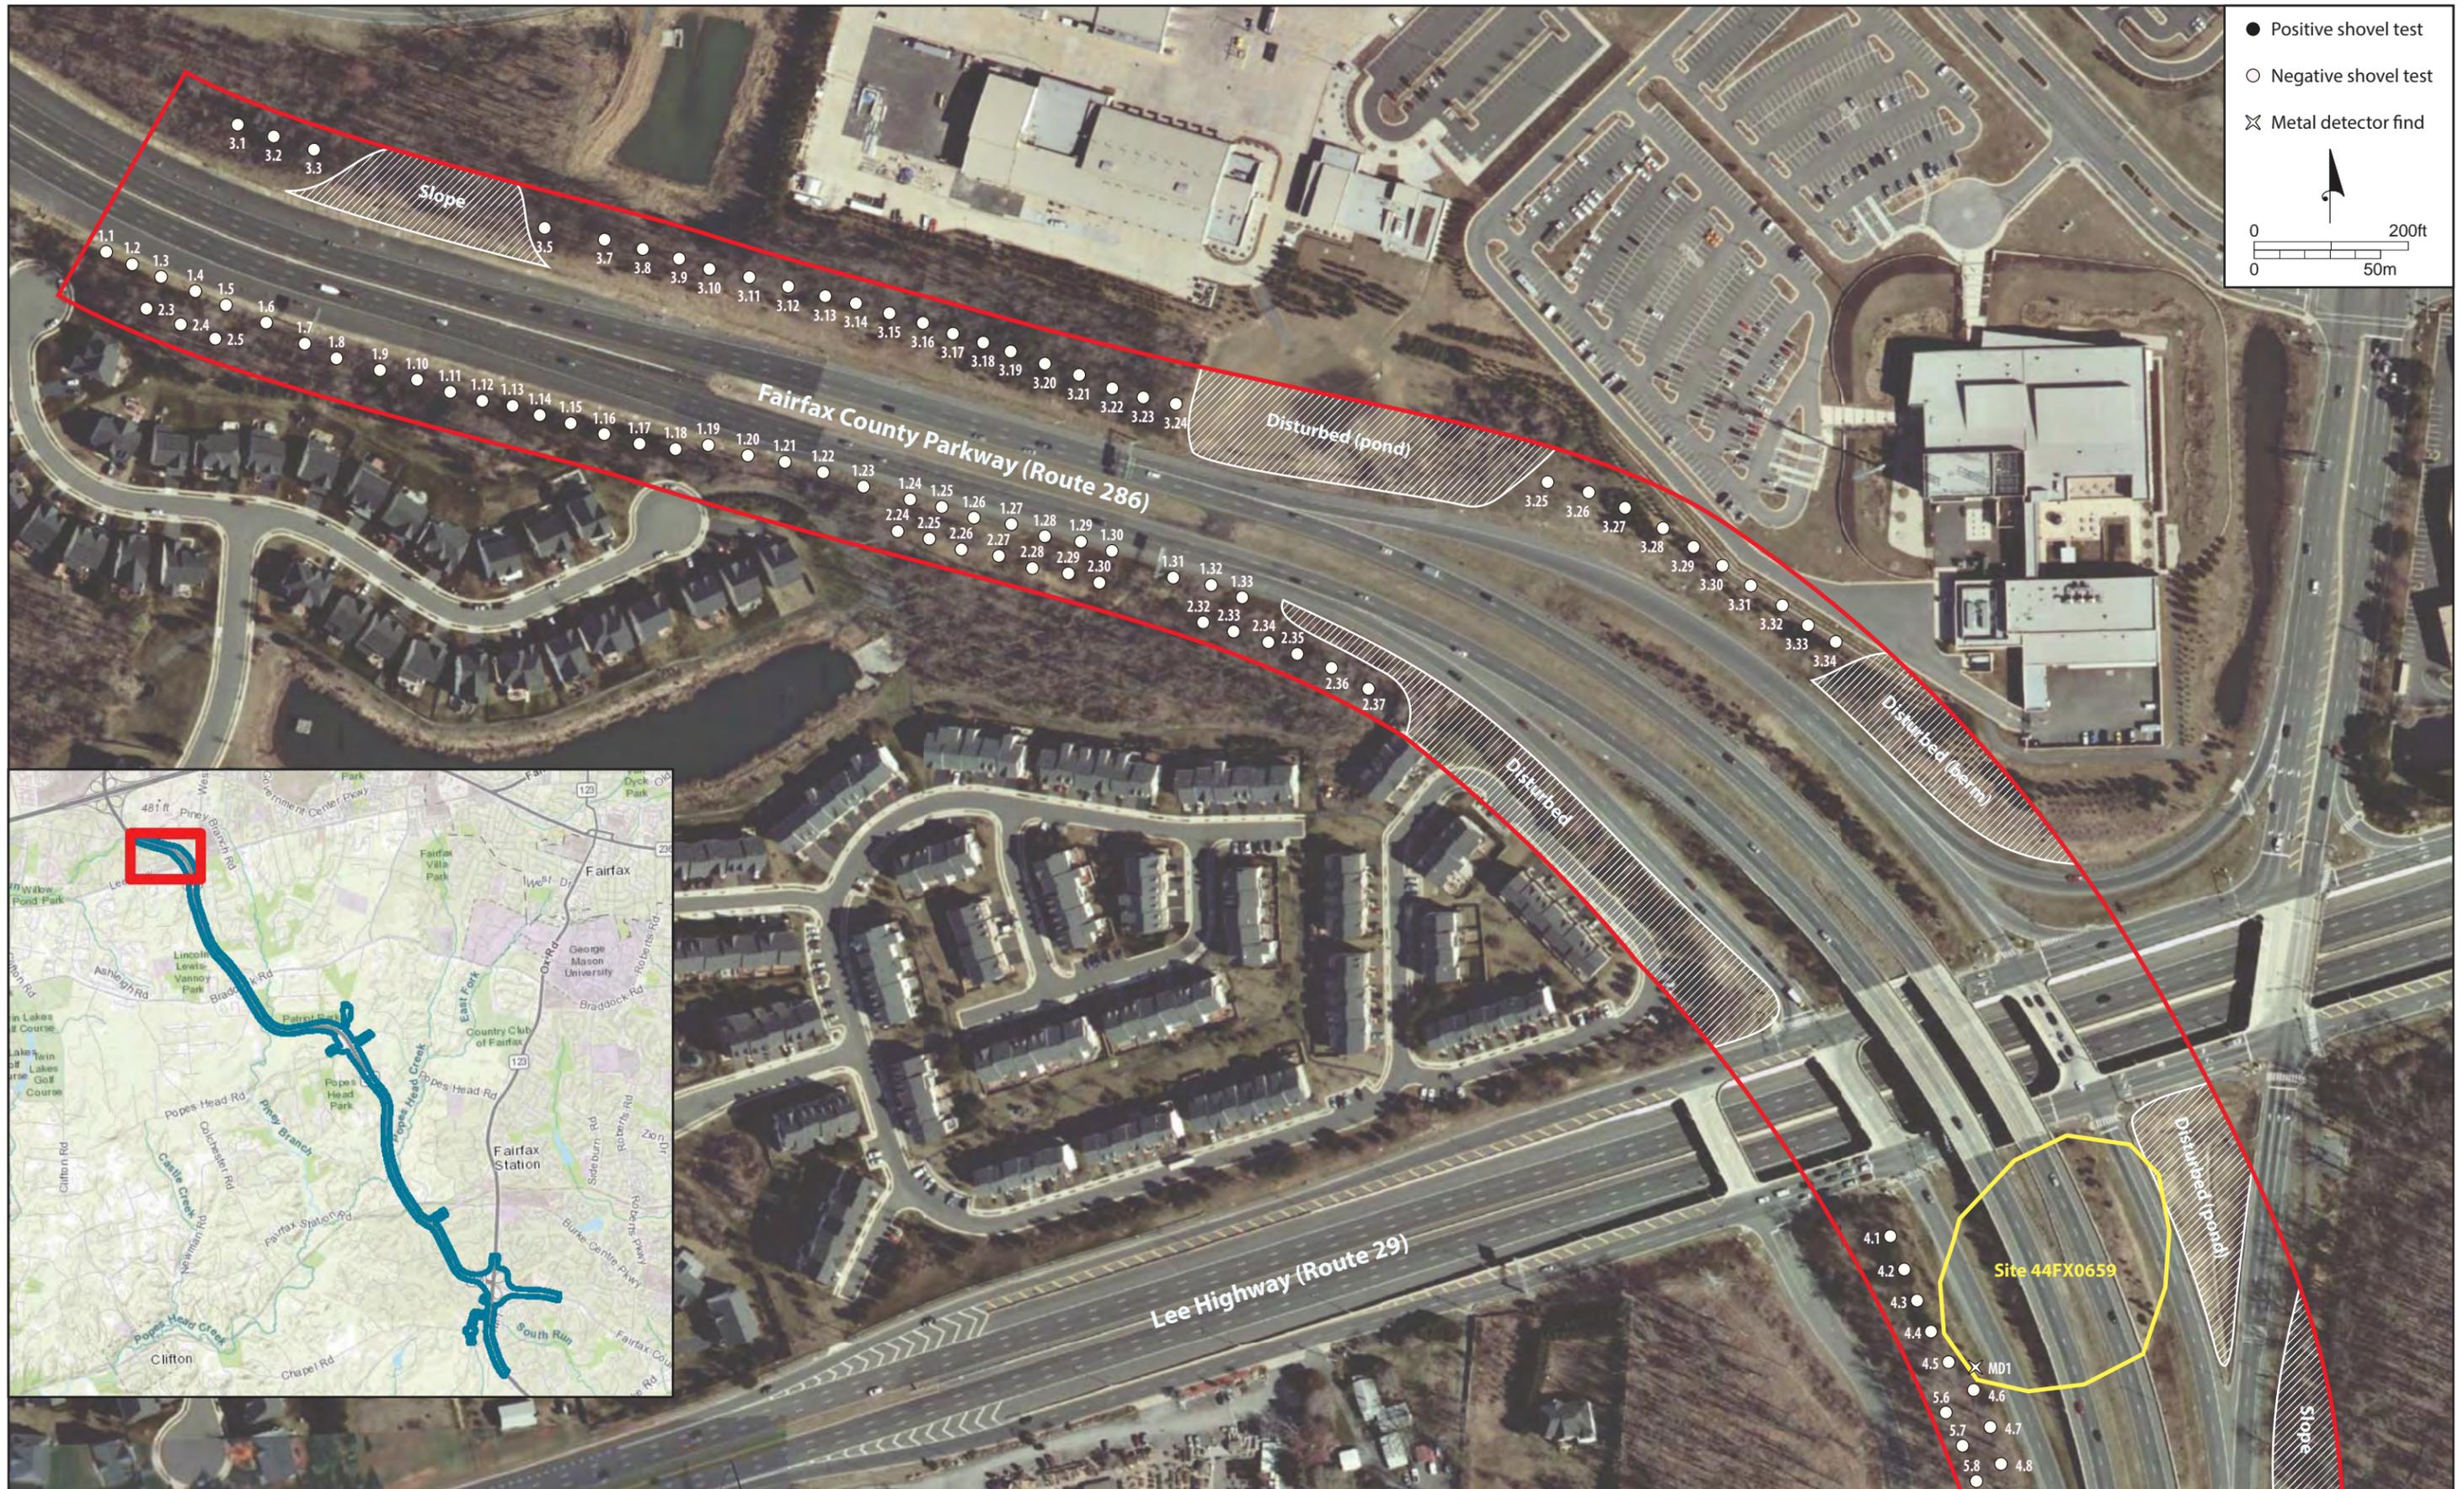
Figure 8. Aerial photograph showing the Archaeology APE, previously identified Site 44FX0659, existing conditions, and the location of shovel tests and metal detector hits.

Figure 8 shows the northernmost portion of the Archaeology APE. Eighty-one STs were excavated on both sides of Fairfax County Parkway (Route 286) between Lee Highway (Route 29) and the northern end of the Archaeology APE. These included 49 STs excavated on the southwest side and 32 STs excavated on the northeast side of Fairfax County Parkway. Soils in this area consisted of Glenelg silt loam, Wheaton loam, Sumerduck loam, Meadowville loam, Codorus and Hatboro floodplain soils, and urban land. Steep slopes and disturbed areas were noted within the Archaeology APE including areas with built up roadside berms, retention ponds and drainage channels, and developed areas with landscaping and impervious surfaces. A typical ST profile showed an Ap horizon of 10YR 4/4 dark yellowish brown silt loam of approximately 0.35 ft over a B horizon of 7.5YR 4/6 strong brown silty clay loam with degrading siltstone (Figure 22, ST 1.3). No artifacts were recovered from this portion of the Archaeology APE.

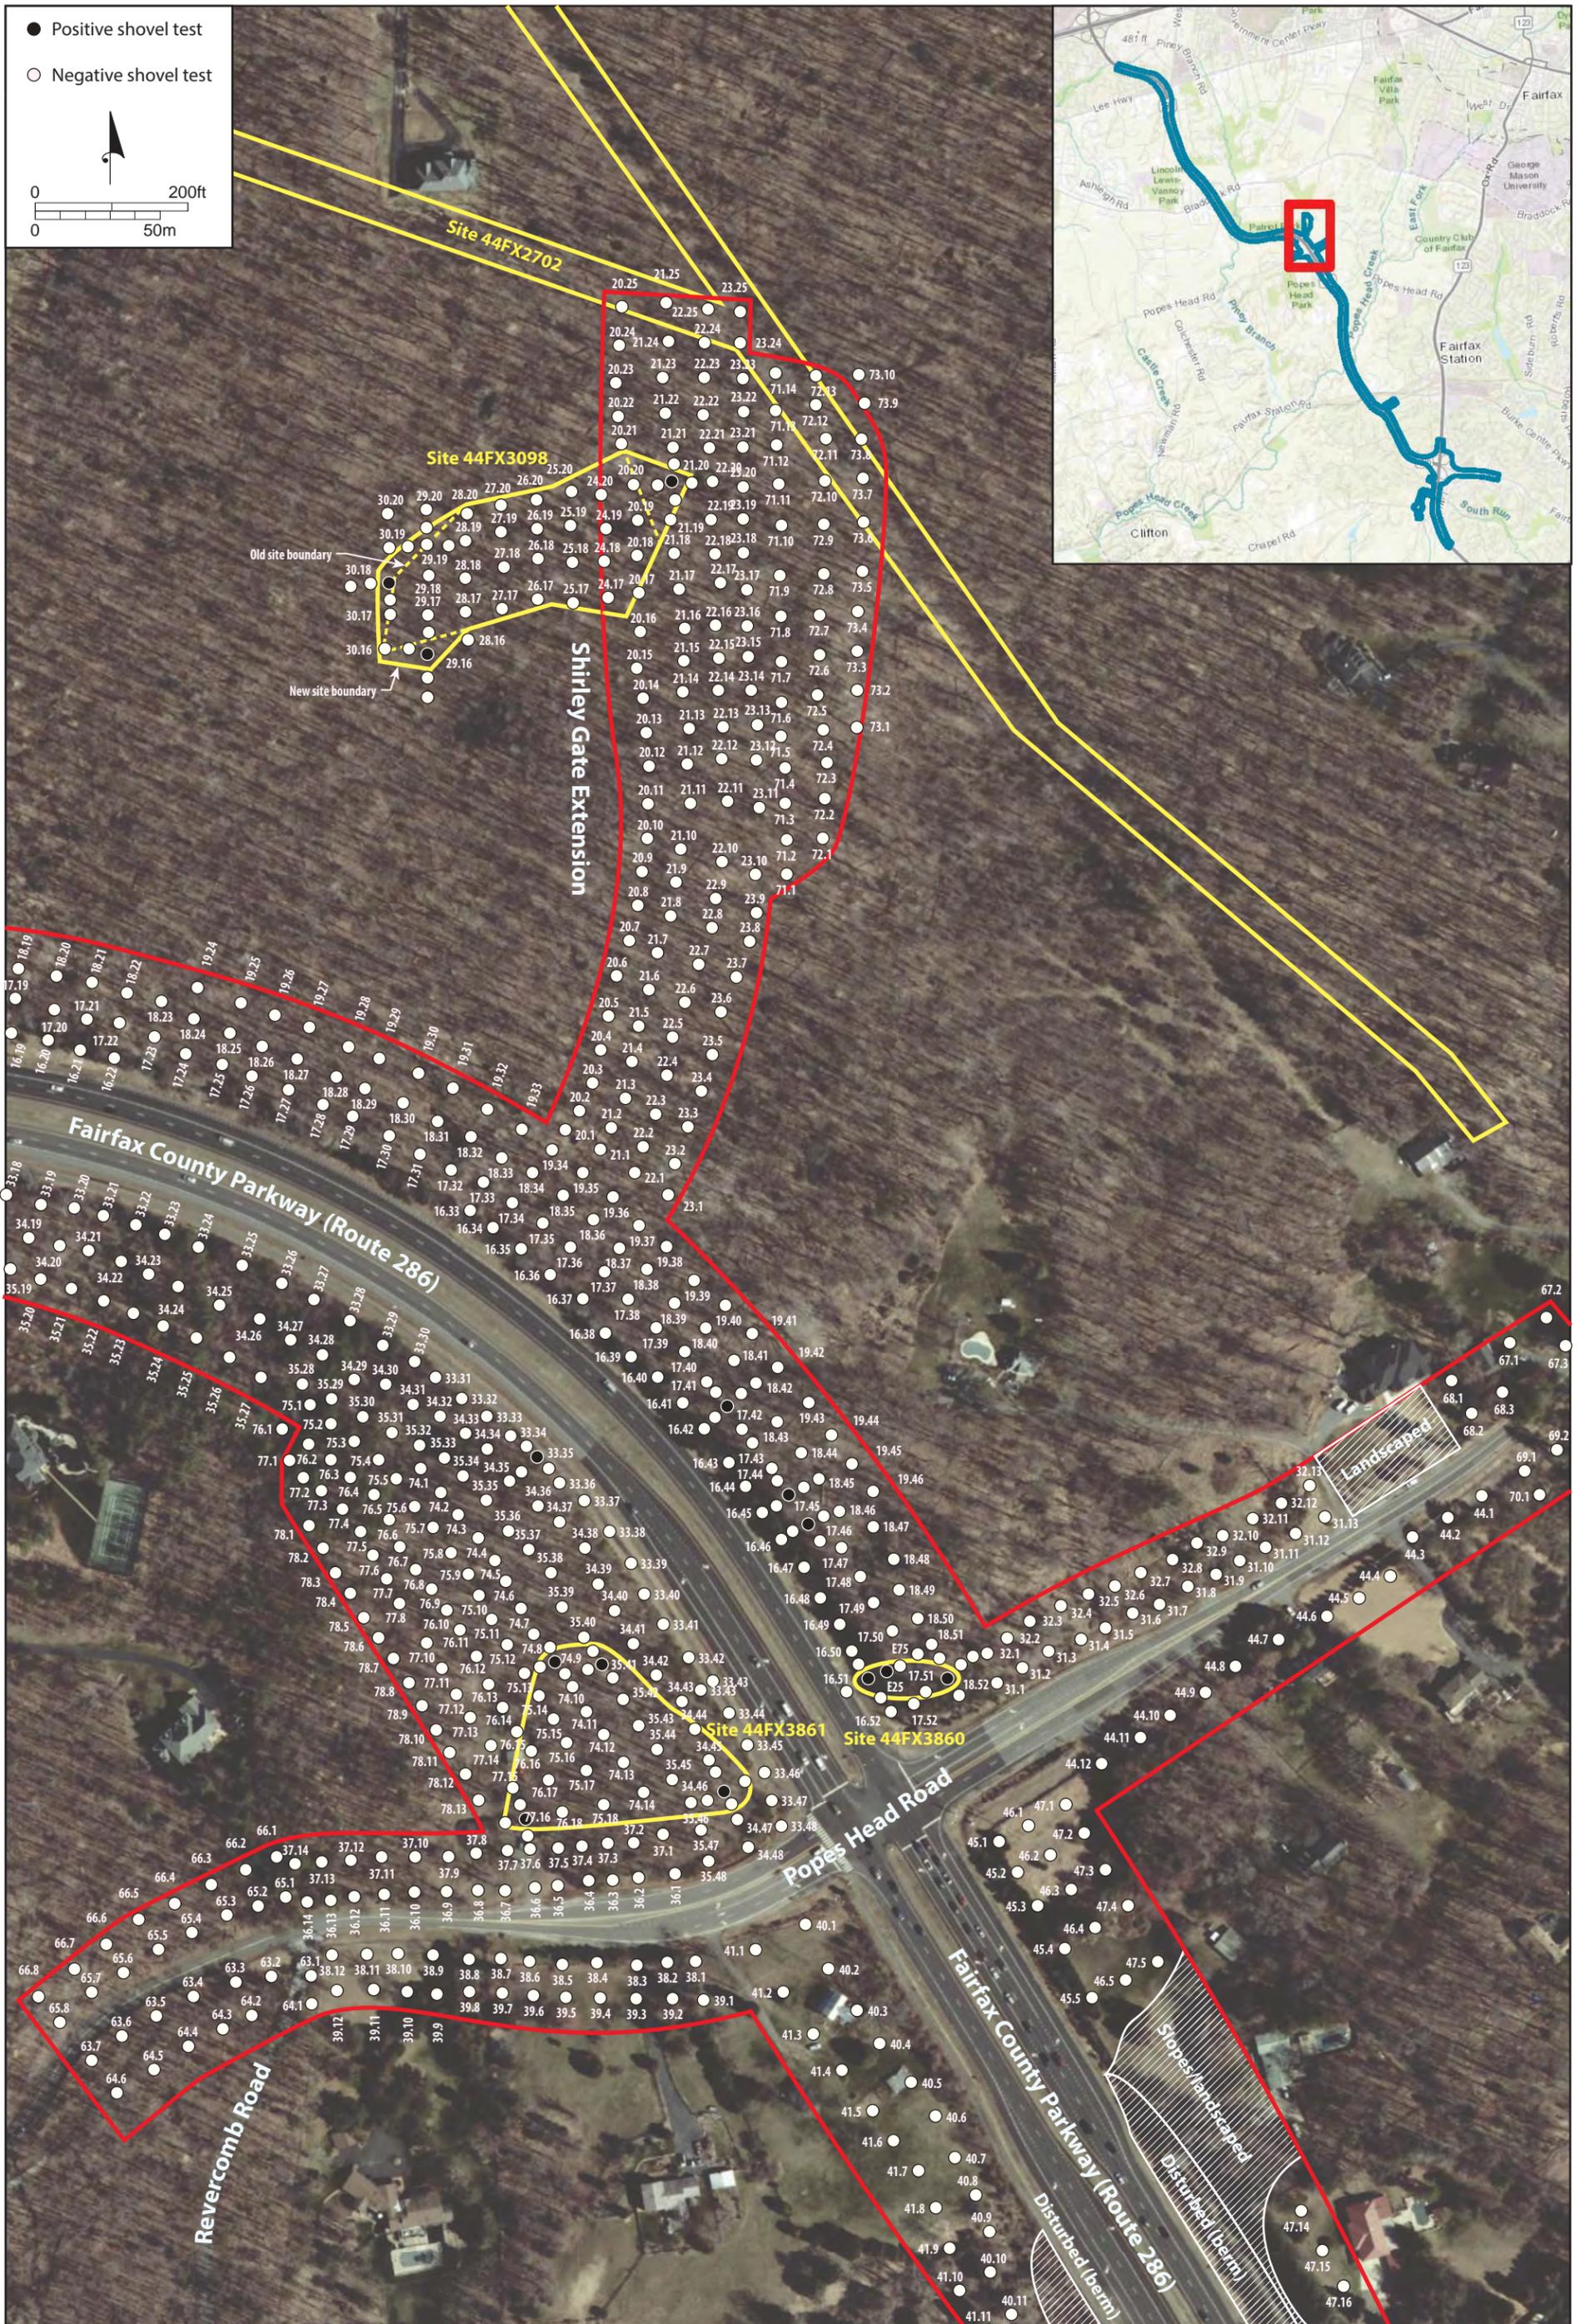
Figure 13. Aerial photograph showing the Archaeology APE, previously identified Sites 44FX2702 and 44FX3098, newly identified Sites 44FX3860 and 44FX3861, existing conditions, and the location of shovel tests.

Figure 13 shows the portion of the Archaeology APE extending along Popes Head Road. One hundred and thirty-three STs were excavated on both sides of Popes Head Road. These included 81 regular STs excavated on the west side and 52 regular STs excavated on the east side of Fairfax County Parkway. Soils in this area consisted of Glenelg silt loam, Orange silt loam, Meadowville loam, Hattontown-Orange complex, Wheaton-Meadowville complex, and Wheaton-Glenelg complex soils, and urban land. Disturbances were noted within the

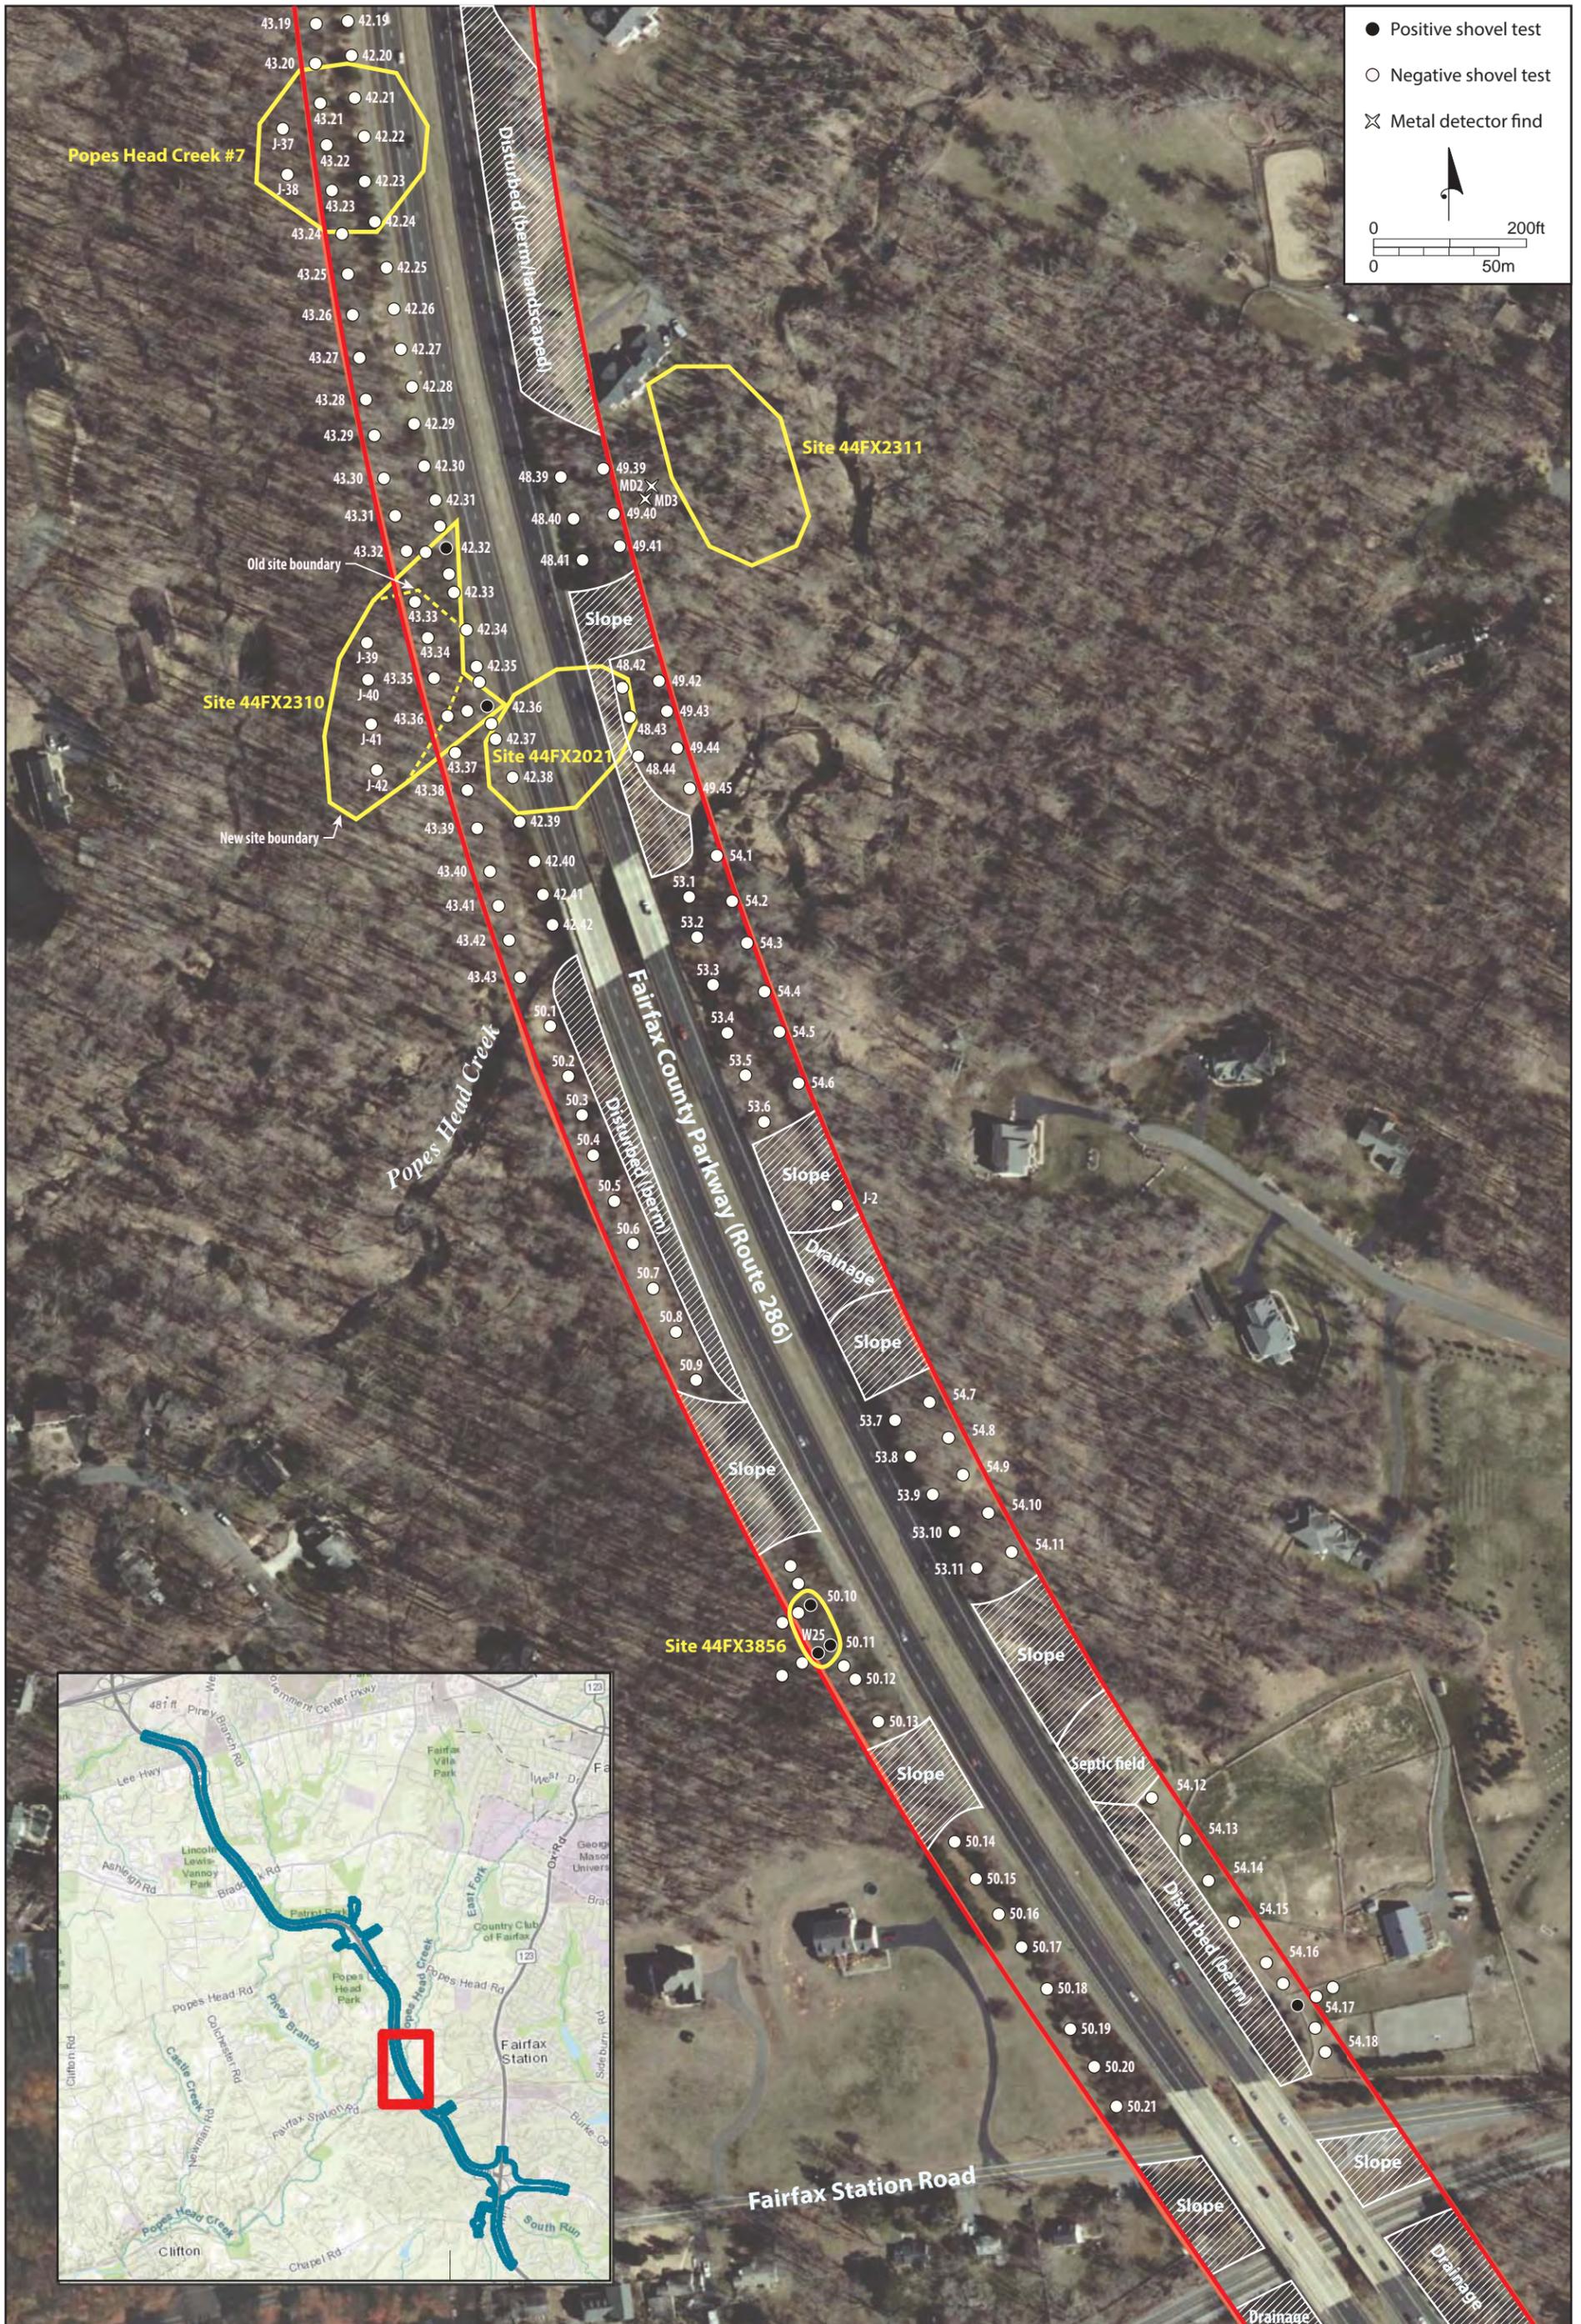
Figure 16. Aerial photograph showing the Archaeology APE, previously identified Sites 44FX2021, 44FX2310, and Popes Head Creek #7, newly identified Site 44FX3856, existing conditions, and the location of shovel tests and metal detector hits.

Site 44FX3856 is located on the west side of Fairfax County Parkway approximately 800 ft south of where it crosses Popes Head Creek (Figure 16). This site was identified during the current survey with two positive STs and one positive radial ST (Figure 34). The site is located on top of a ridge surrounded by steep slopes on all sides. Soils in this area consisted of Glenelg

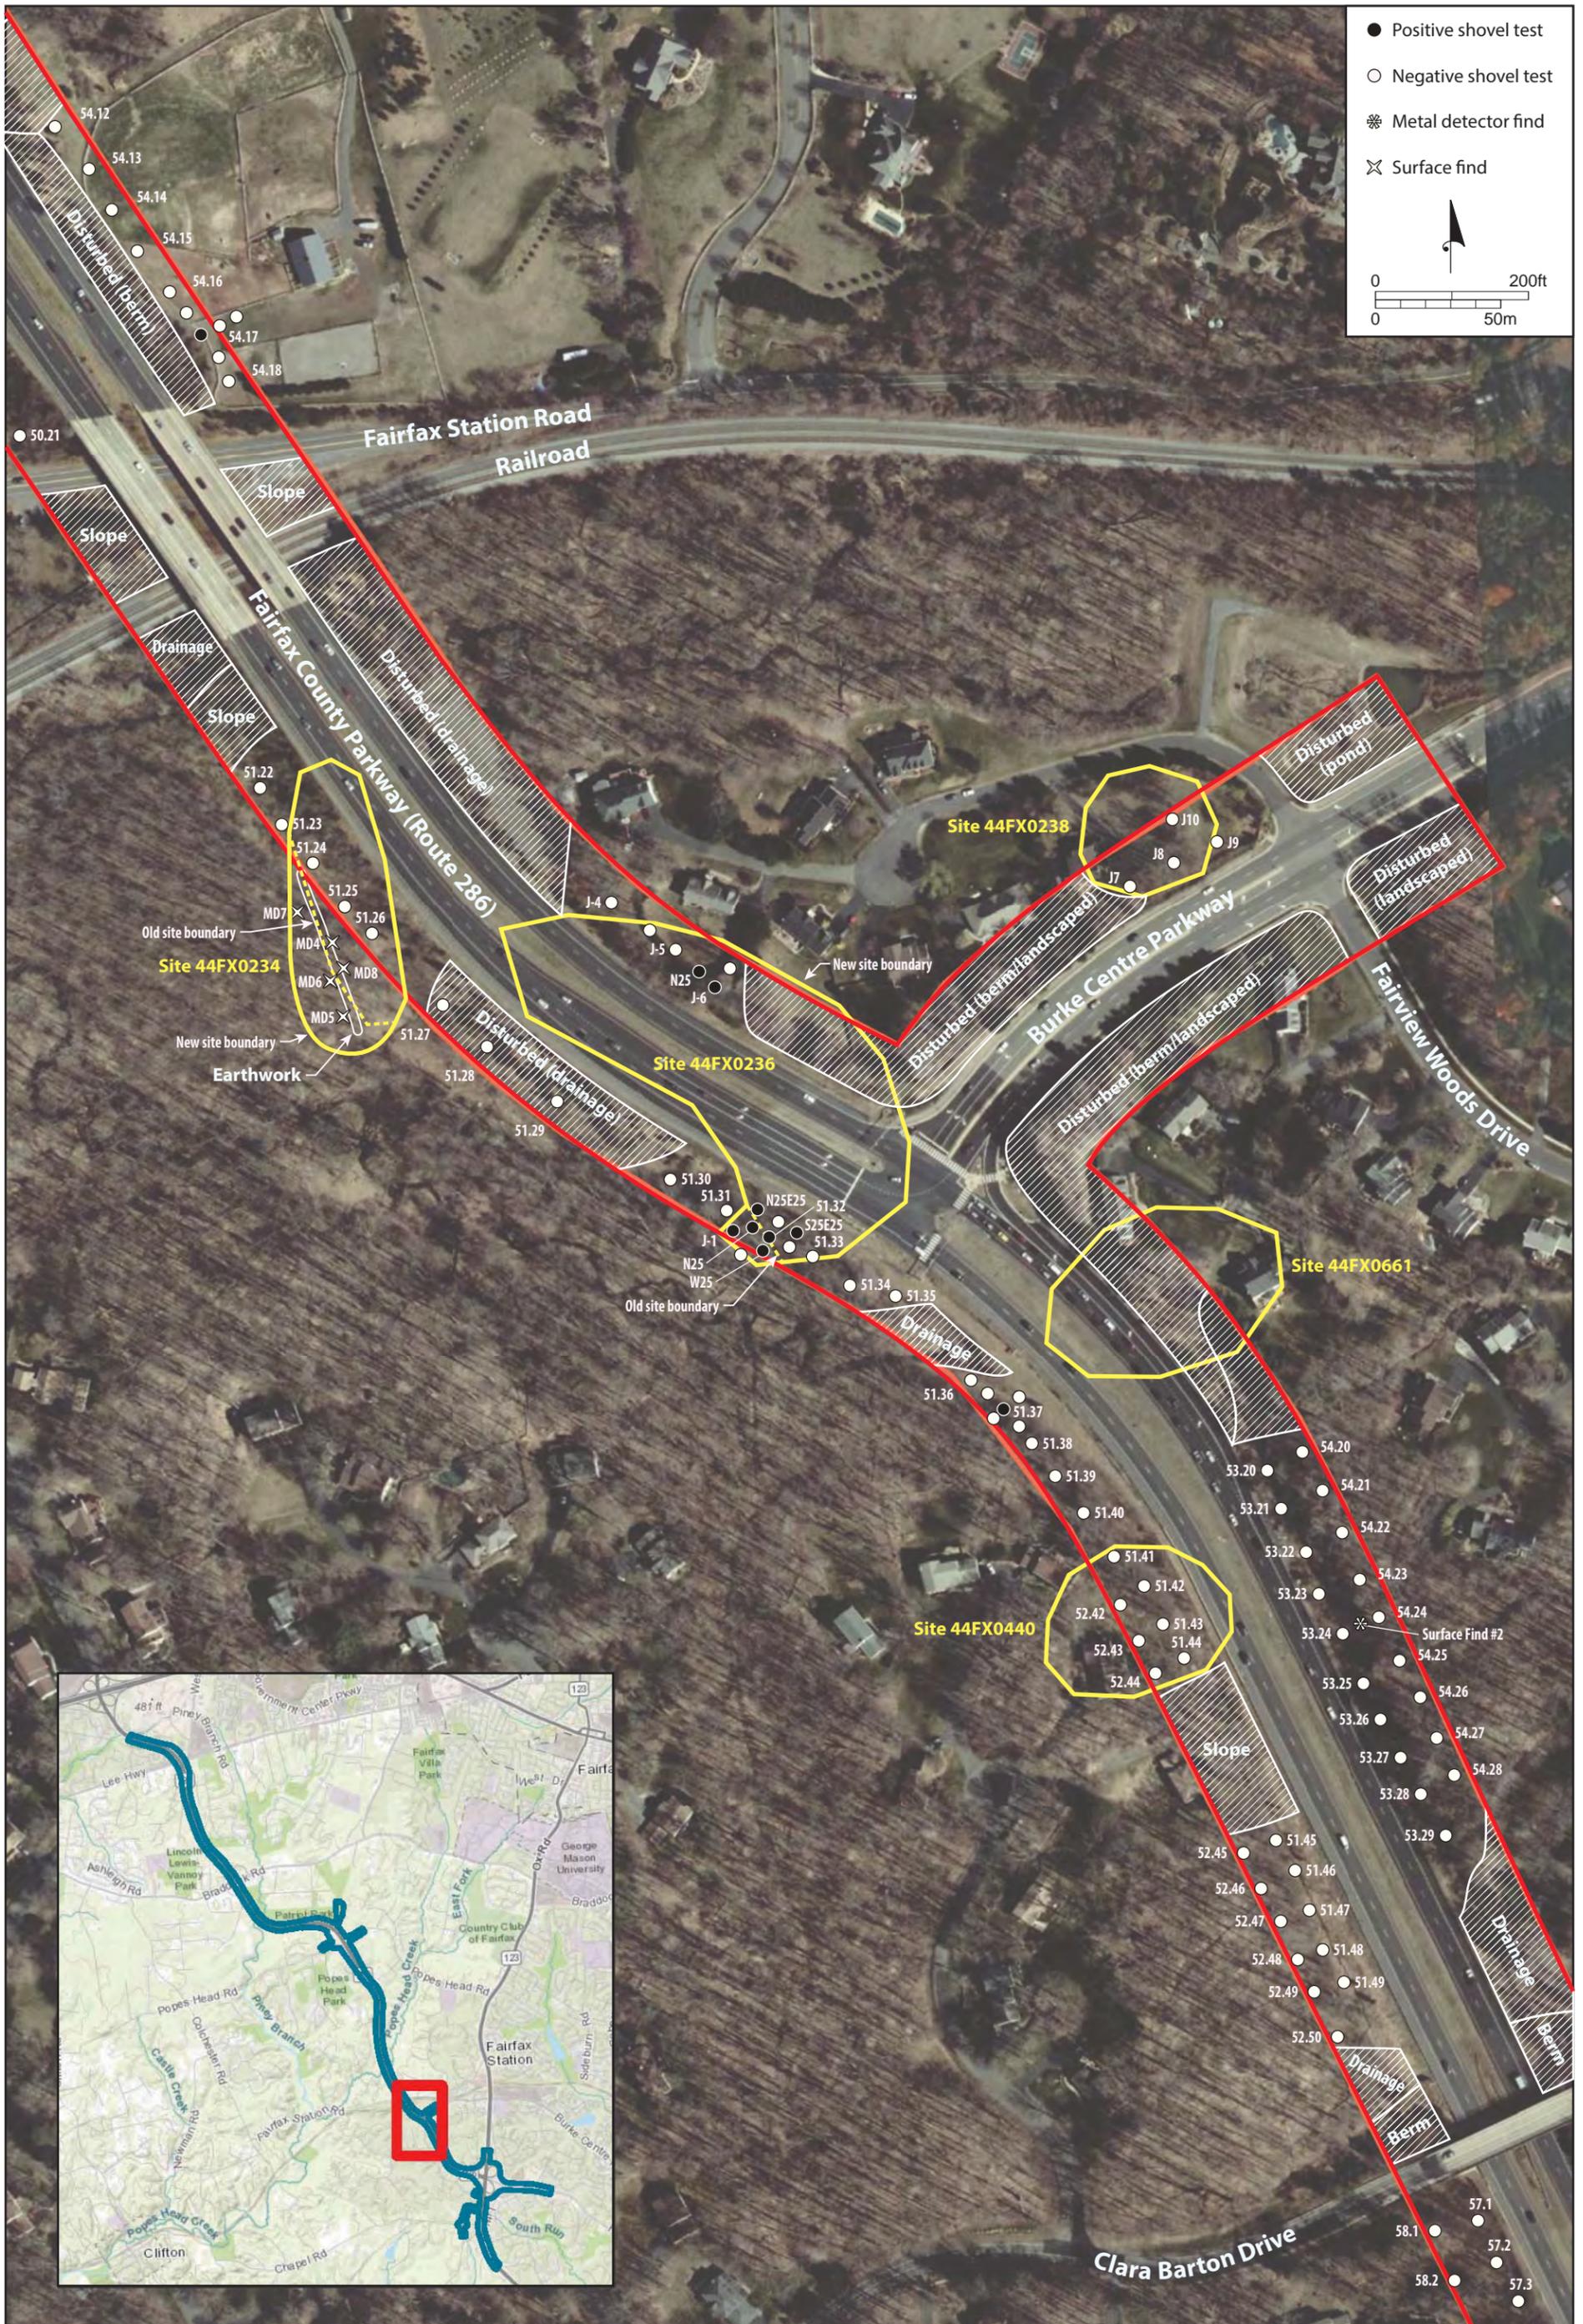
Figure 17. Aerial photograph showing the Archaeology APE, previously identified Sites 44FX0234, 44FX0236, 44FX0238, 44FX0440, and 44FX0661, existing conditions, and the location of shovel tests and metal detector hits.

Centre Parkway (Route 643) approximately 300 ft east of its intersection with Fairfax County Parkway (Figure 17). The site is approximately 200 ft long by 150 ft wide. This site was tested with four STs, which were all negative for artifacts (Figure 26). Soils at Site 44FX0238 primarily consisted of urban land with some small amounts of Wheaton complex. A typical ST showed an Ap horizon of 10YR 3/2 very dark grayish brown silt loam over a B horizon of 10YR 6/8 brownish yellow silty clay loam. Disturbances were noted within the Archaeology APE including areas with built up roadside berms, landscaped backyards, and utility corridors. Most of the site has already been destroyed by the construction of a housing development. No artifacts were recovered and no subsurface features were located. Due to disturbances, the site no longer possesses integrity or is capable of yielding information relevant to the significance of the site. Because of the lack of artifacts or other subsurface features, and the extensive previous disturbances to the site, it has little research potential and is recommended not eligible for listing to the NRHP. No further work is recommended.

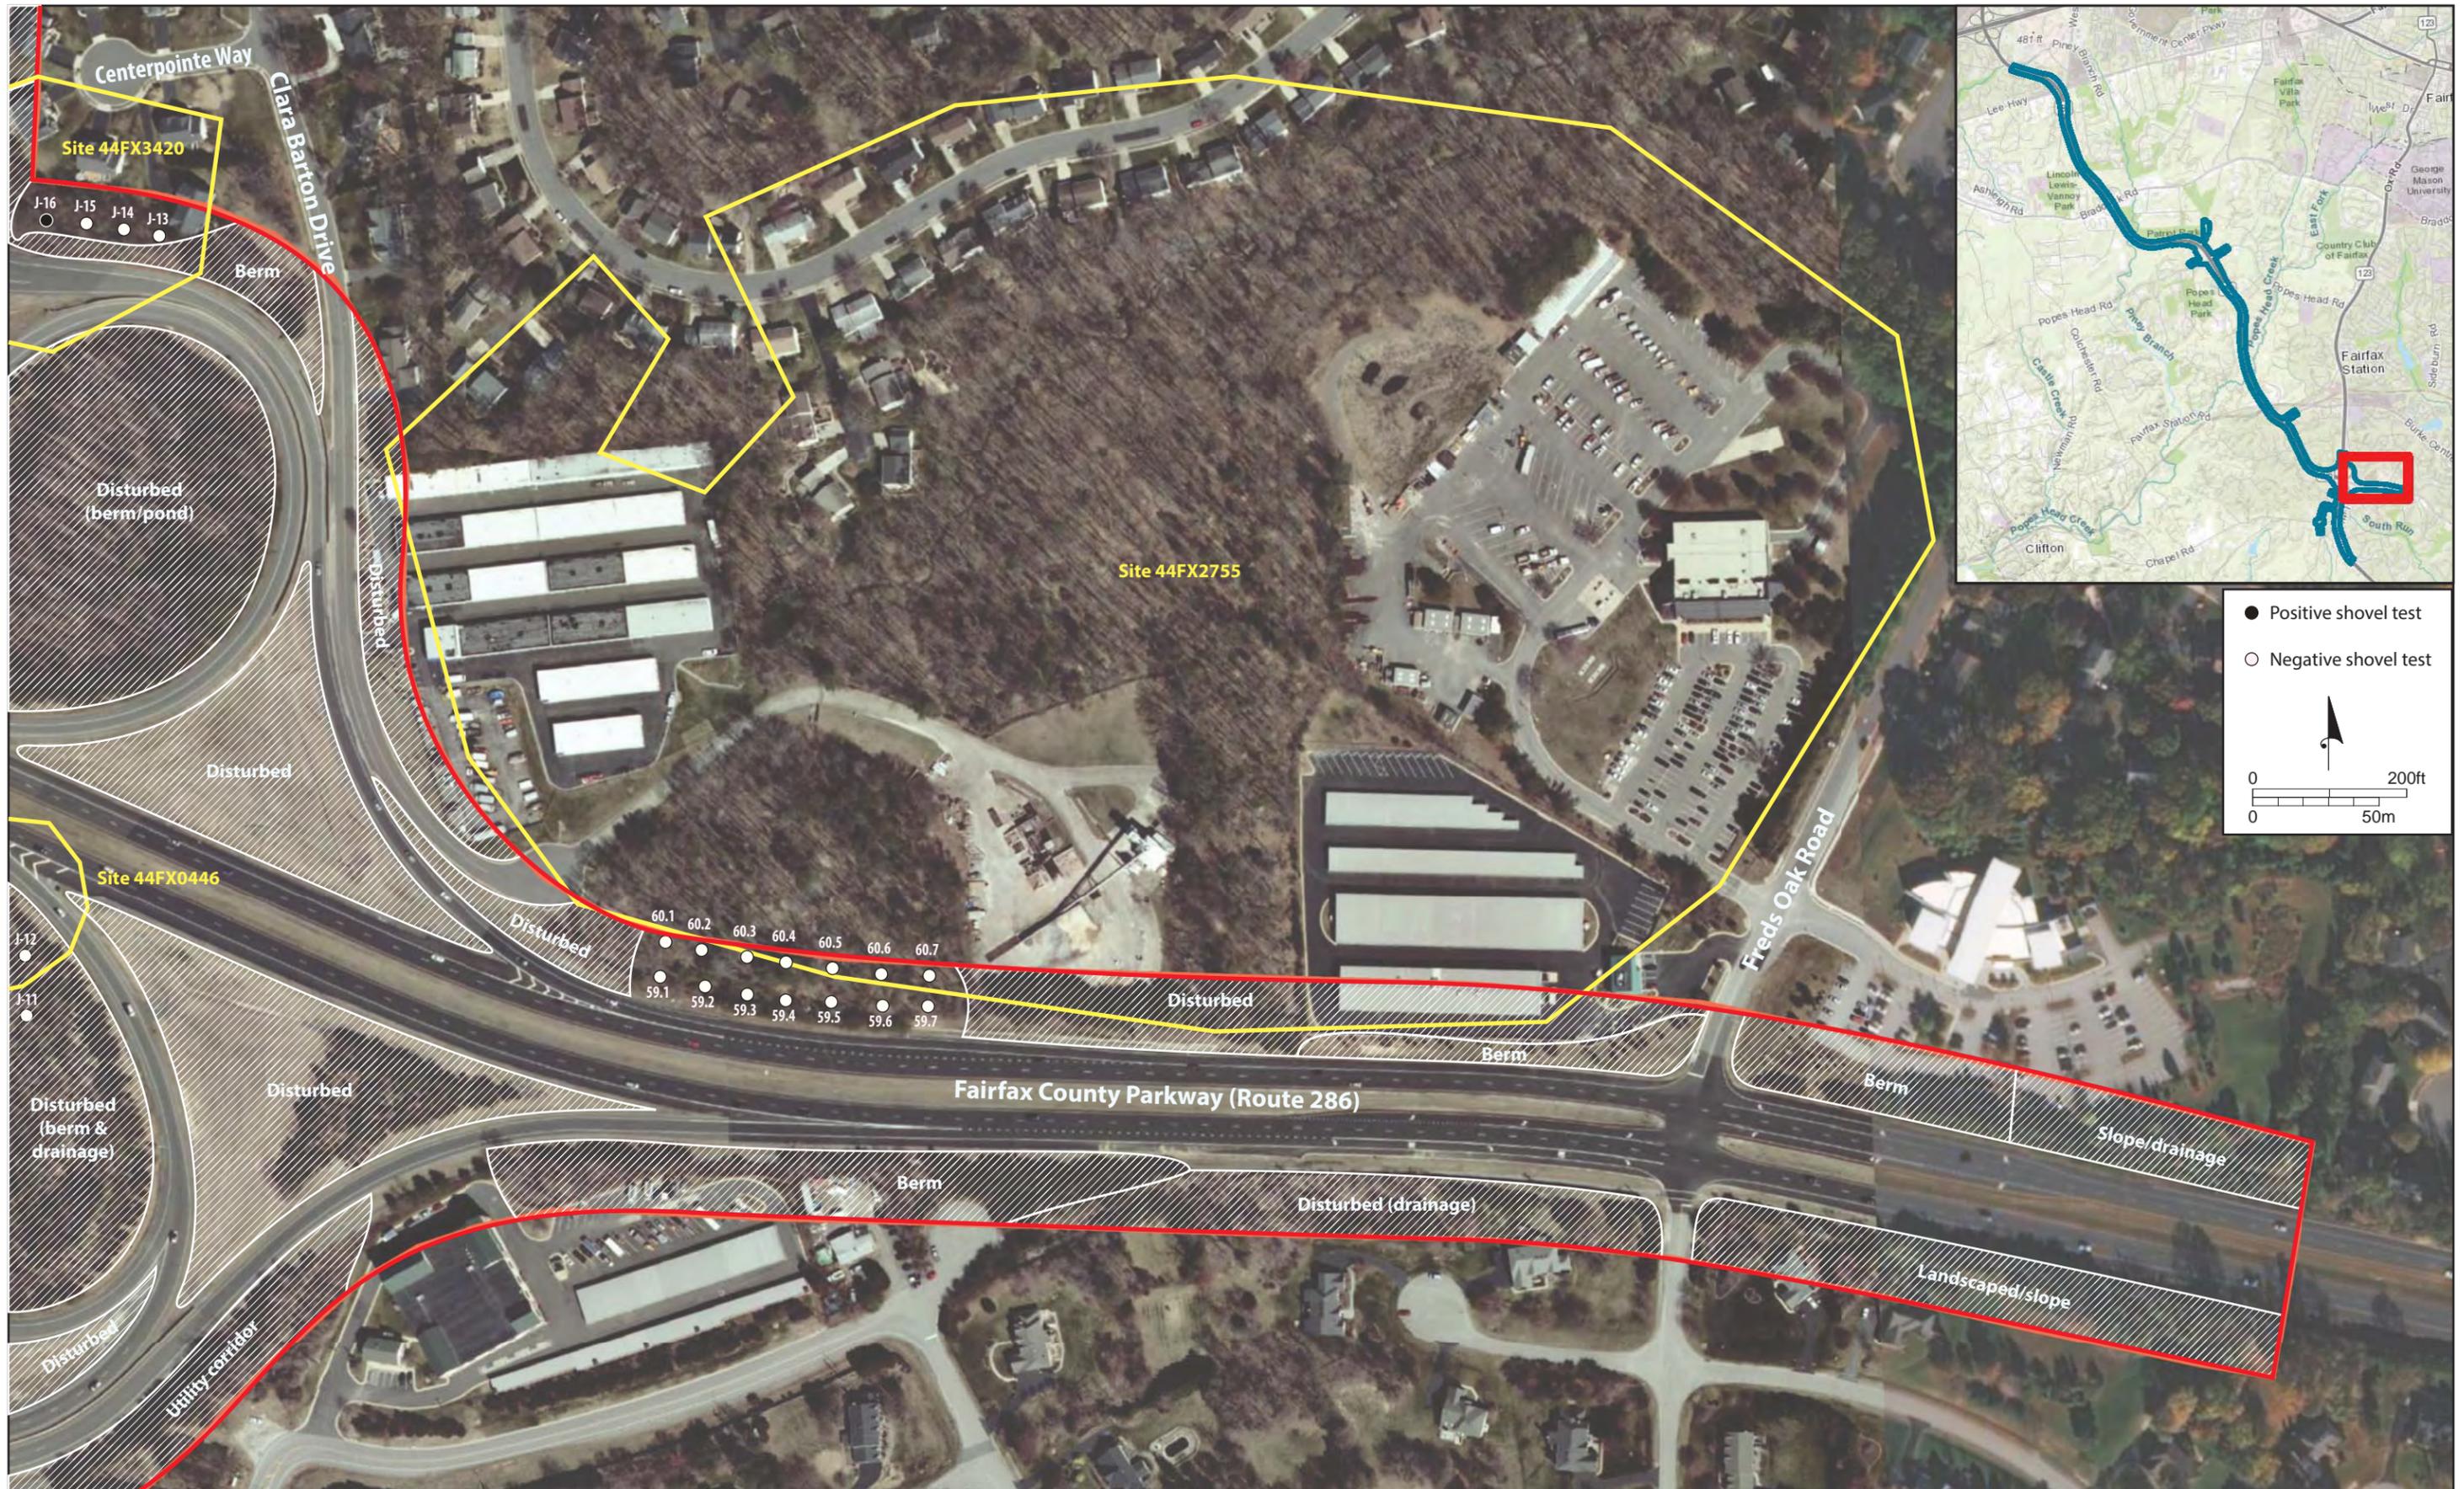
Figure 19. Aerial photograph showing the Archaeology APE, previously identified Sites 44FX0446, 44FX2755, and 44FX3420, existing conditions, and the location of shovel tests.

Site 44FX2755 is located on the north side of Fairfax County Parkway approximately 700 ft east of its intersection with Ox Road (Figure 19). The site is approximately 2,000 ft long by 1,200 ft wide and is located on a ridge. It has been partially destroyed on the north end by the construction of a housing development, on the west end by the construction of a storage facility and parking lots, in the center by the installation of a power grid station, and on the east end by the construction of another storage facility and a wastewater management facility. Only a small portion of this very large site intersects with the Archaeology APE along its southern edge, in between the storage facility and the power grid station (Figure 32). This portion of the site was tested with 7 STs, all of which were negative for artifacts. Soils at Site 44FX2755 consisted of Glenelg silt loam and urban land with slopes ranging from 7 to 15 percent. A typical ST showed an Ap horizon of 7.5YR 4/2 brown silt loam over a B horizon of 7.5YR 6/4 light brown silty clay loam. The portion of the site within the Archaeology APE had been impacted by the construction
