# CULTURAL RESOURCES SURVEY FOR THE FAIRFAX COUNTY PARKWAY (ROUTE 286) WIDENING PROJECT FAIRFAX COUNTY, VIRGINIA

VDOT PROJECT: 0286-029-259, B619, B620, B621,  
B622, B623, B624, B625, B627, B628, B629,  
B630, B631, B632, D604, D605, P101  
IPM/UPC/CSC No: 107937  
VDHR FILE No: 2018-0073

**FINAL REPORT  
AUGUST 2018**

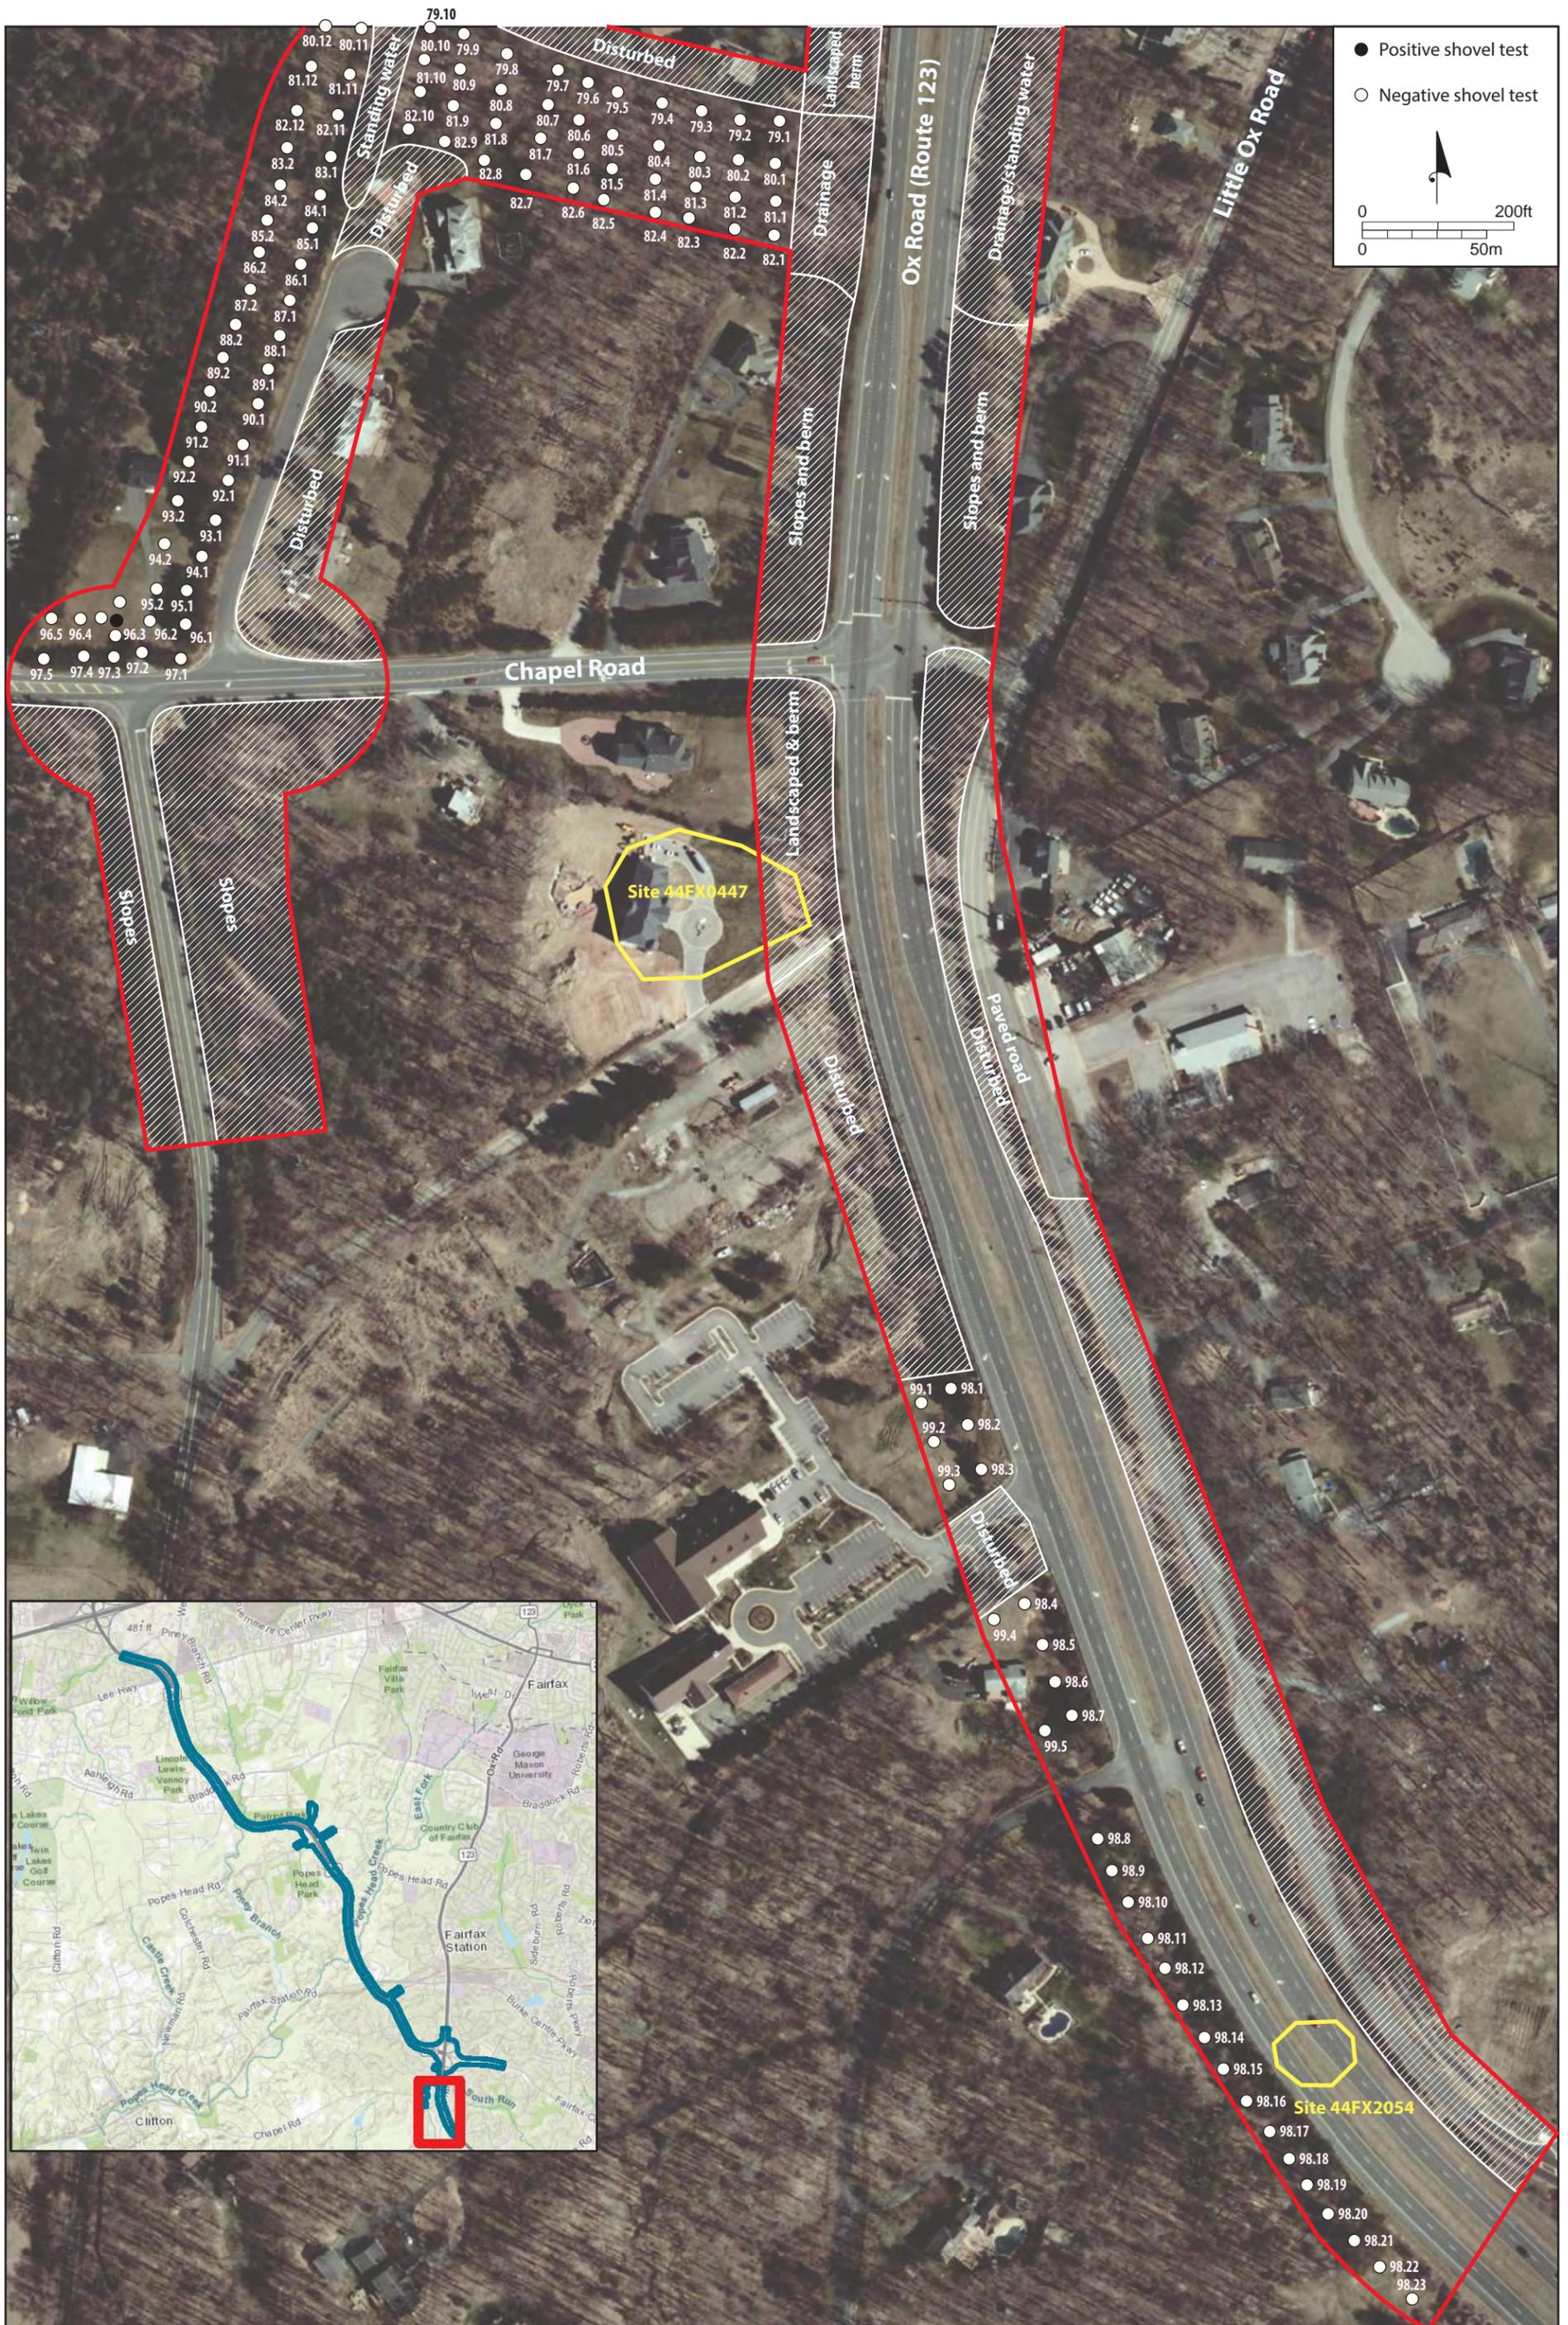
Figure 21. Aerial photograph showing the Archaeology APE, previously identified Sites 44FX0447, and 44FX2054, existing conditions, and the location of shovel tests.

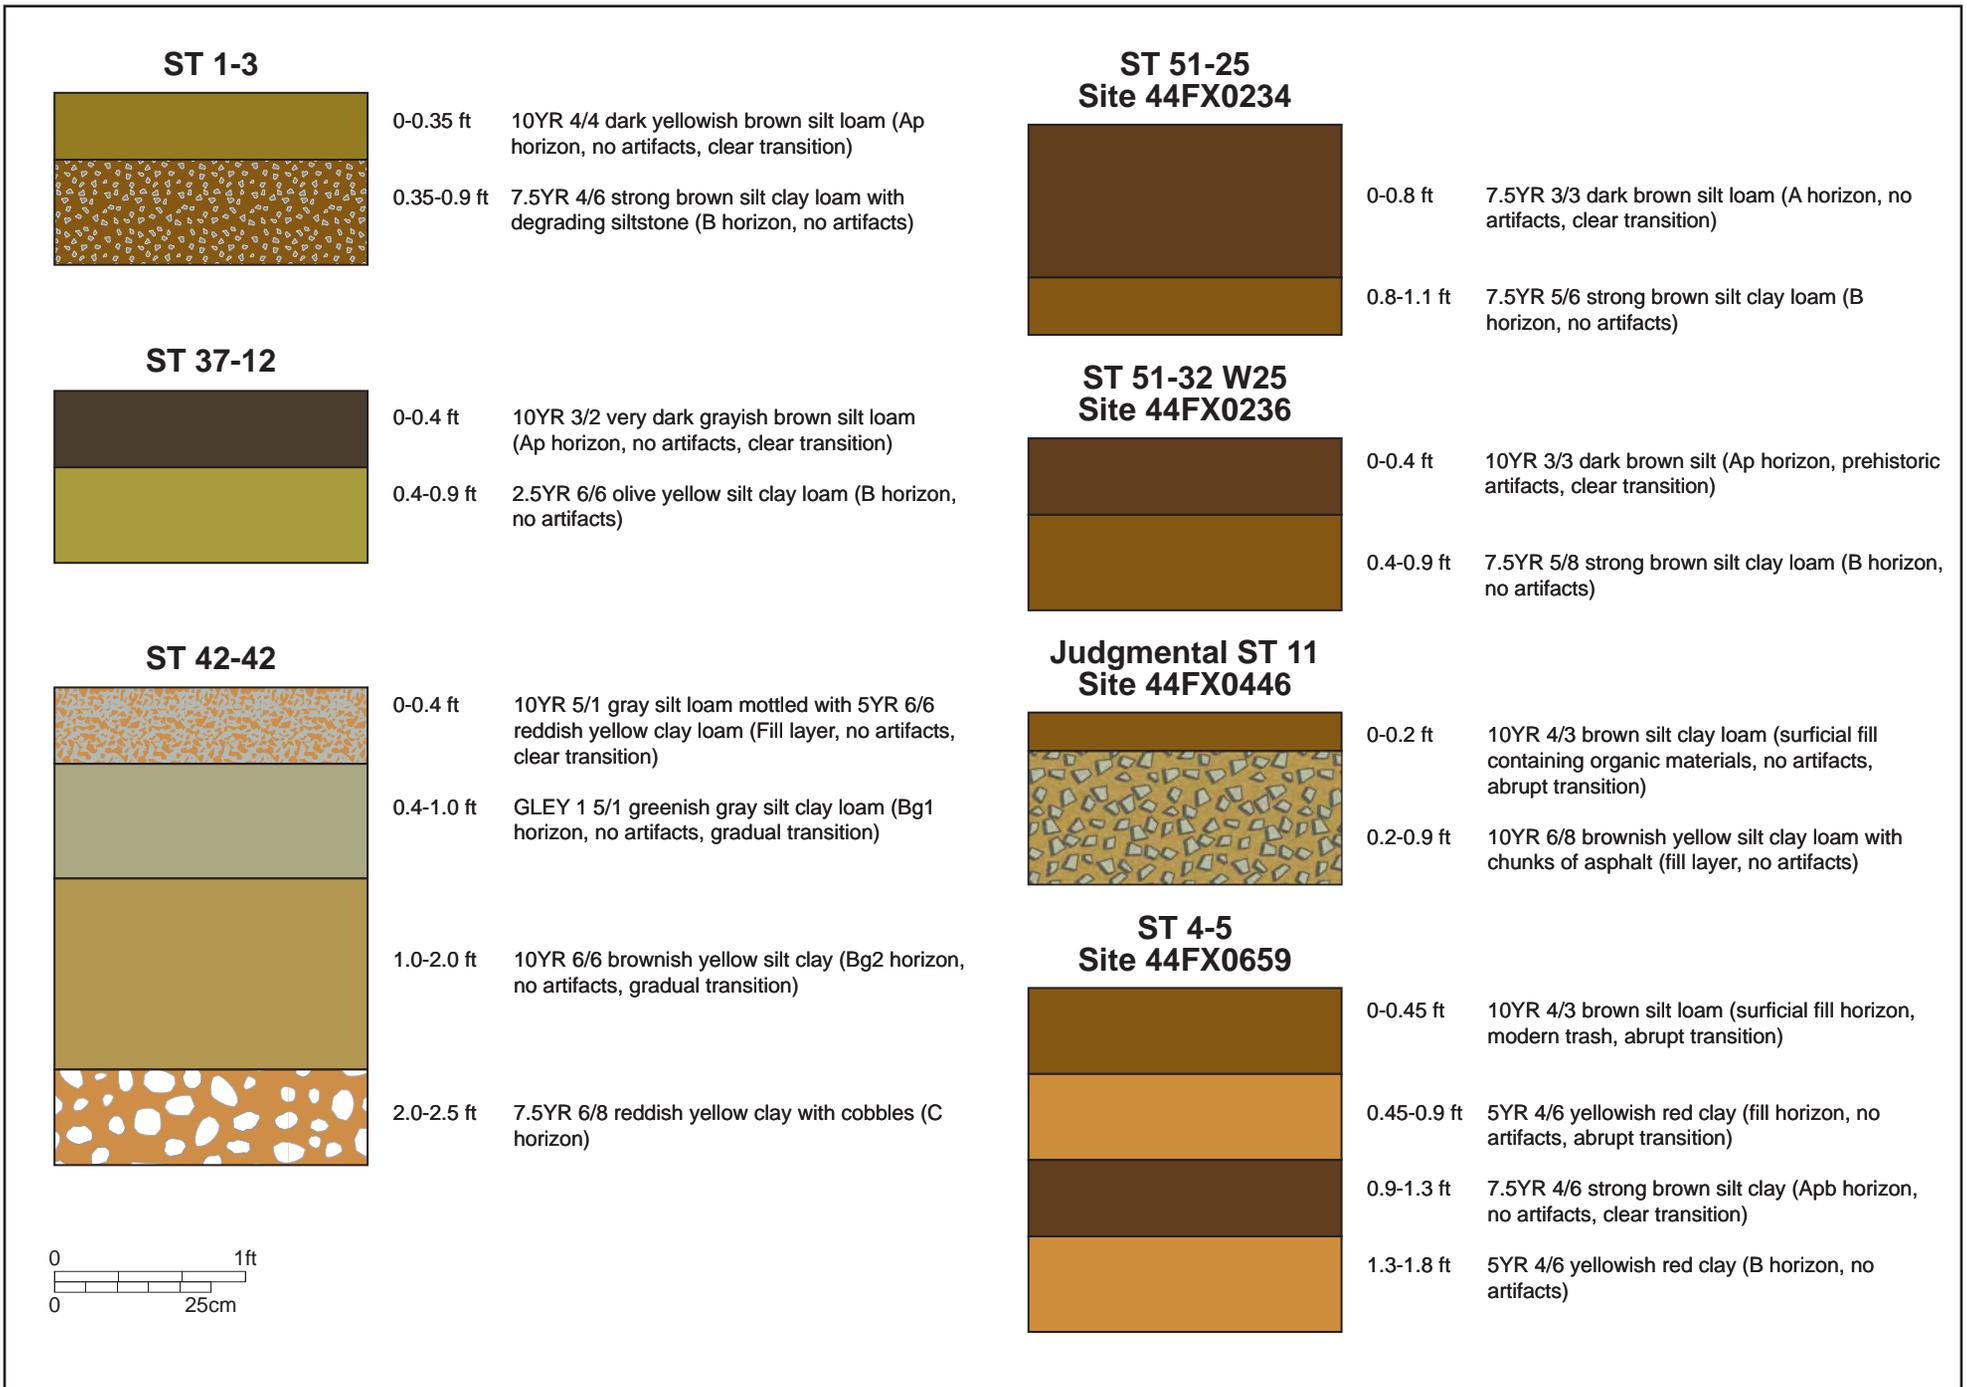
Figure 22. Representative shovel test profiles from portions of the Archaeology APE and Sites 44FX0234, 44FX0236, 44FX0446, and 44FX0659.

brown silty clay loam (Figure 22, ST 51-25). Disturbances were noted within the Archaeology APE, including a steeply sloping roadside berm and roadside drainages.

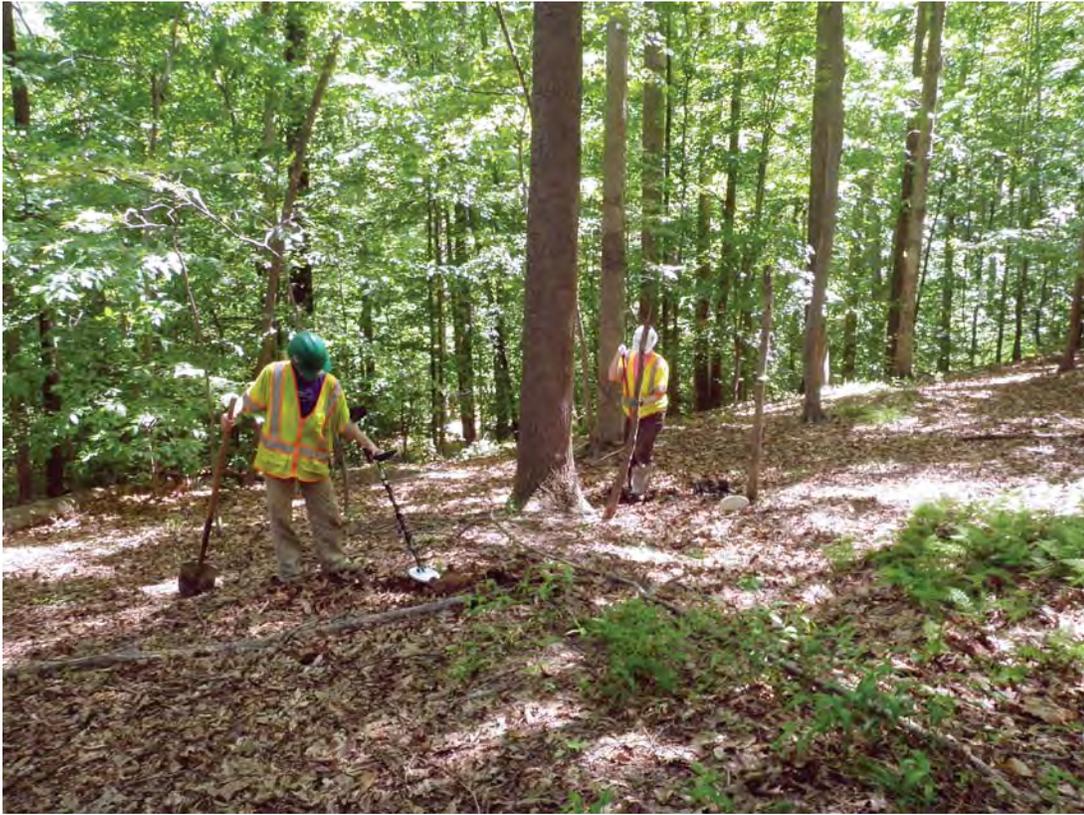
Figure 23. Photograph of metal detection in progress at Site 44FX0234, facing south.

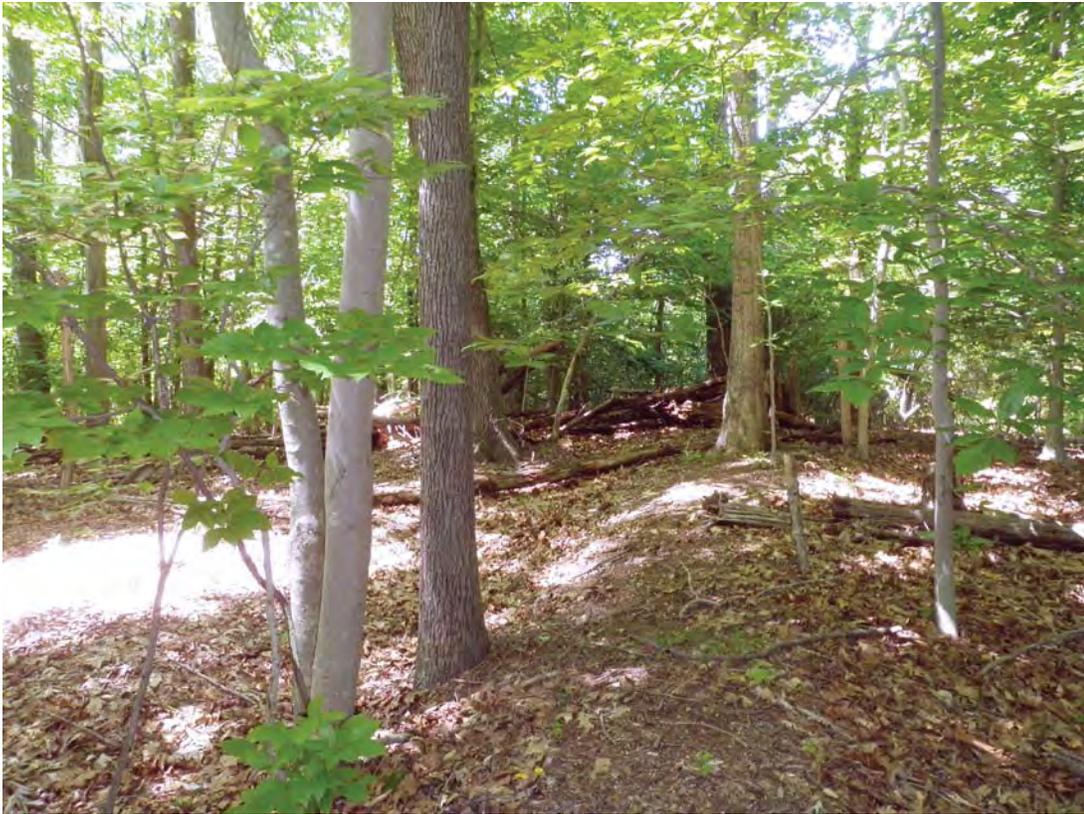
Figure 24. Photograph of possible Civil War trench, facing north.

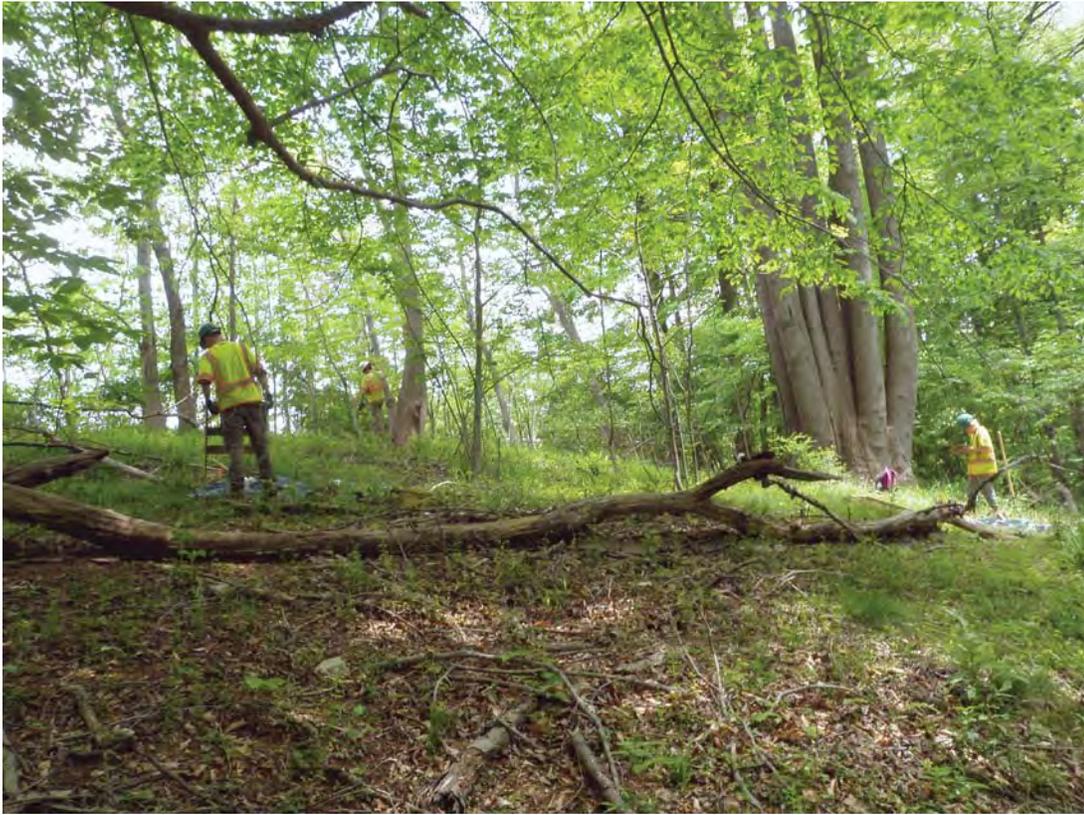
Figure 25. Overview of work in progress at the portion of Site 44FX0236 to the west of Fairfax County Parkway, facing northeast.

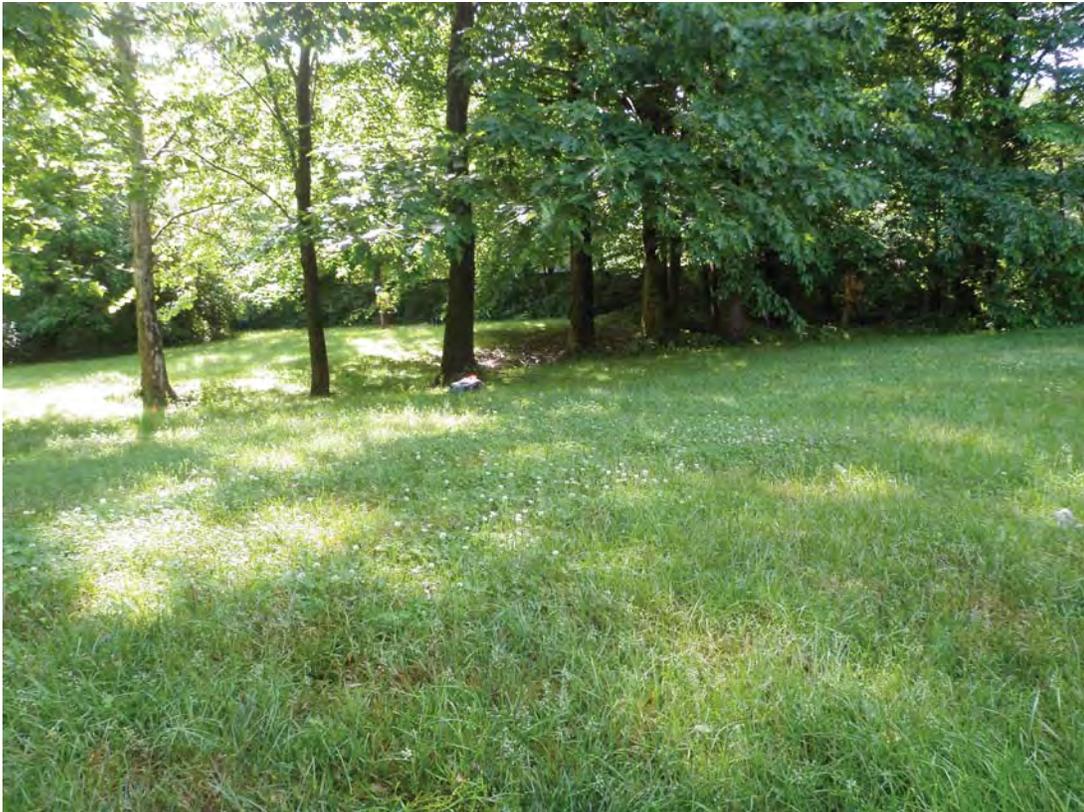
Figure 26. Overview of work in progress at Site 44FX0238, showing roadside berm and edge of landscaped housing development, facing north.

Centre Parkway (Route 643) approximately 300 ft east of its intersection with Fairfax County Parkway (Figure 17). The site is approximately 200 ft long by 150 ft wide. This site was tested with four STs, which were all negative for artifacts (Figure 26). Soils at Site 44FX0238 primarily consisted of urban land with some small amounts of Wheaton complex. A typical ST showed an Ap horizon of 10YR 3/2 very dark grayish brown silt loam over a B horizon of 10YR 6/8 brownish yellow silty clay loam. Disturbances were noted within the Archaeology APE including areas with built up roadside berms, landscaped backyards, and utility corridors. Most of the site has already been destroyed by the construction of a housing development. No artifacts were recovered and no subsurface features were located. Due to disturbances, the site no longer possesses integrity or is capable of yielding information relevant to the significance of the site. Because of the lack of artifacts or other subsurface features, and the extensive previous disturbances to the site, it has little research potential and is recommended not eligible for listing to the NRHP. No further work is recommended.

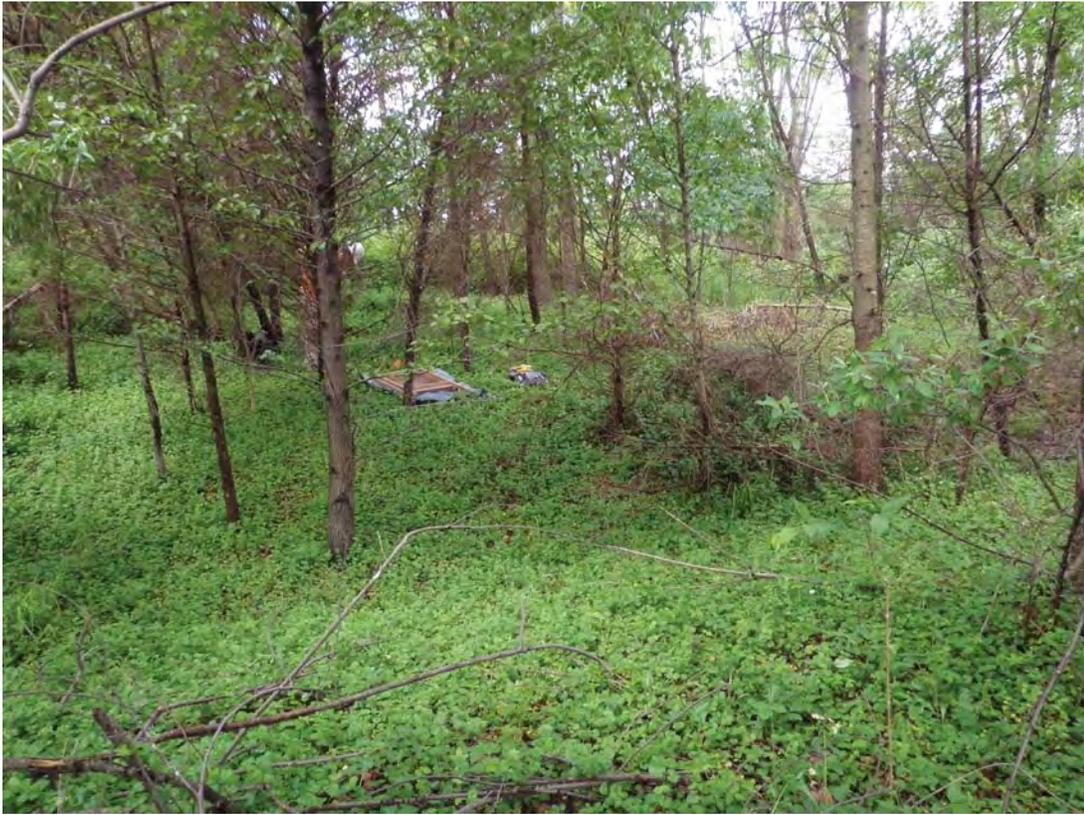
Figure 27. Overview of work in progress at Site 44FX0446, showing disturbed area within cloverleaf, facing north.

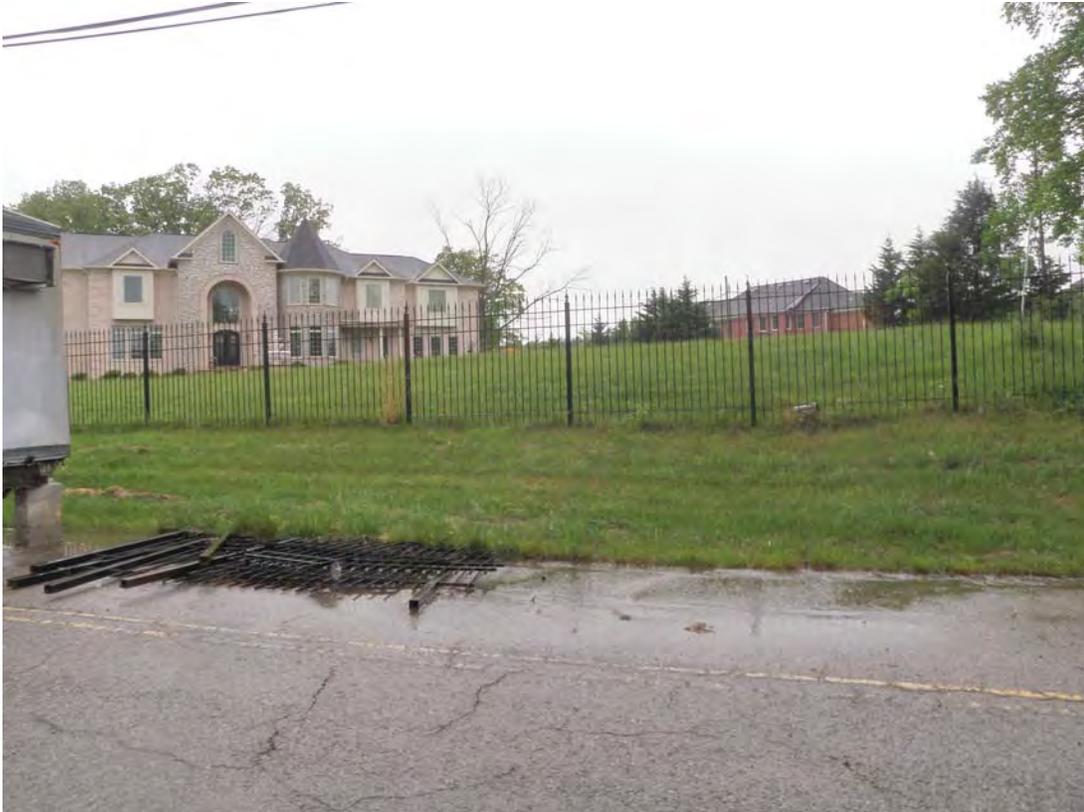
Figure 28. Overview of location of Site 44FX0447, showing area disturbed by house construction, facing north.

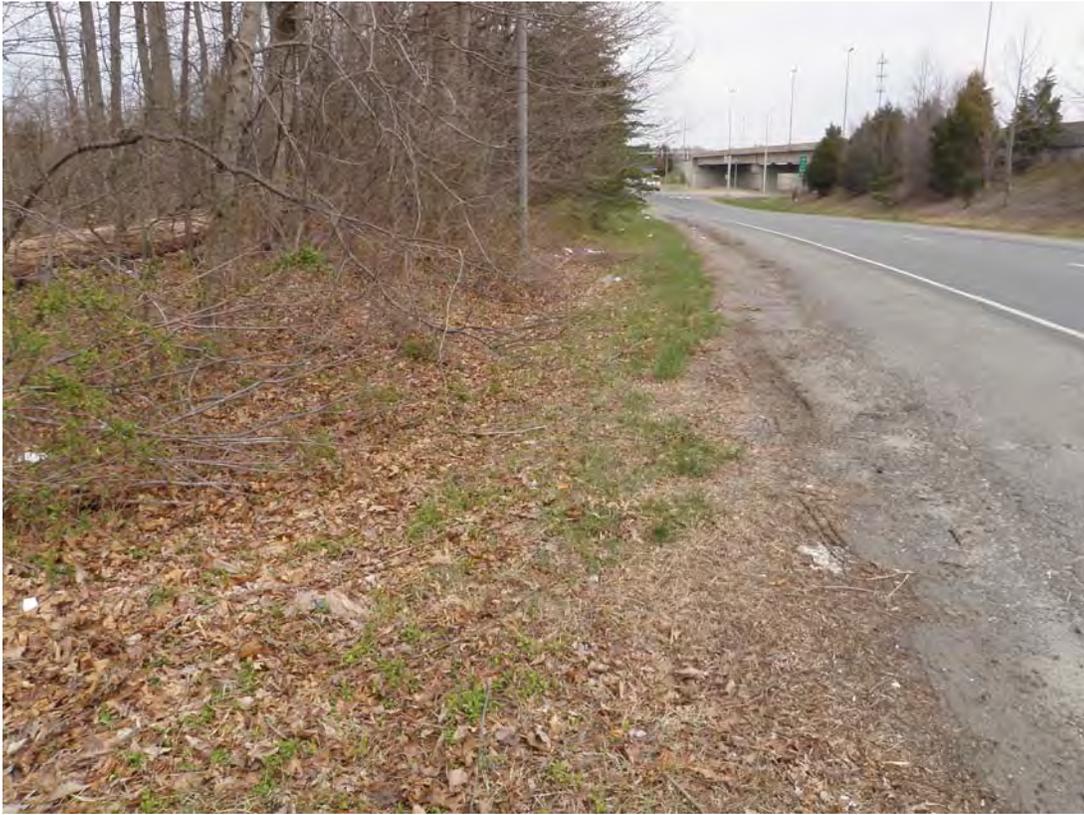
Figure 29. Overview of location of Site 44FX0659, showing area disturbed by the construction of Fairfax County Parkway, facing north.

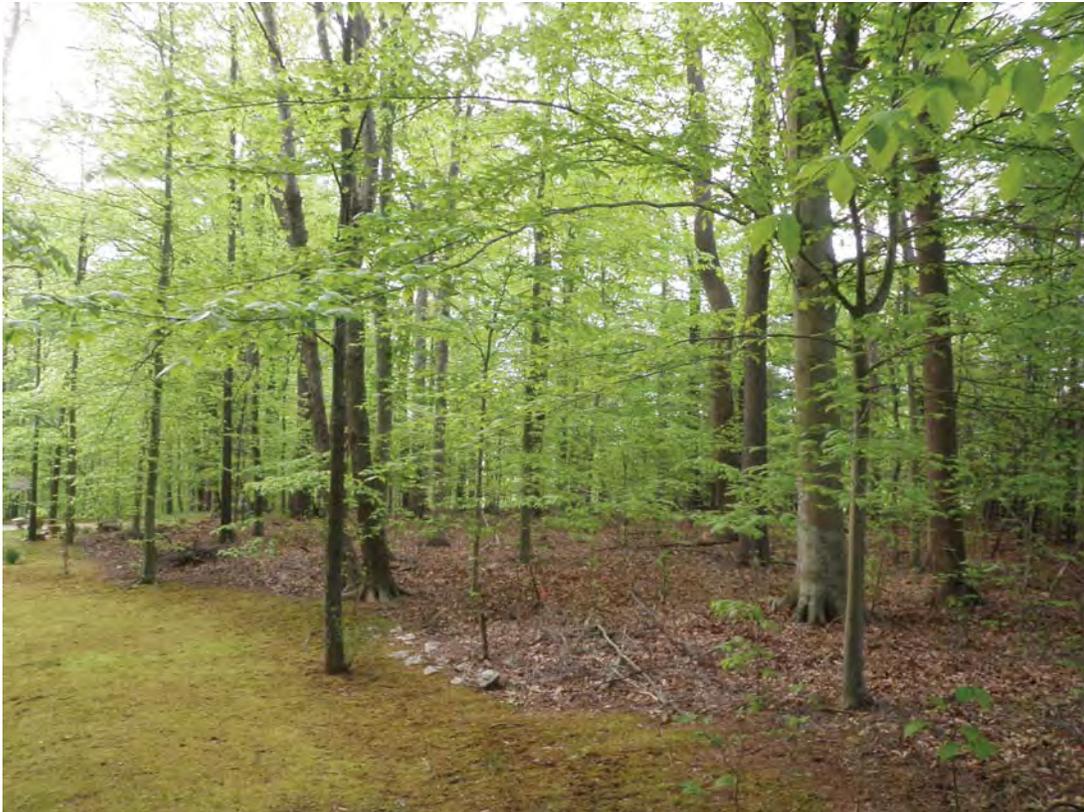
Figure 30. Overview of Site 44FX2305, showing wooded area to the north of Nomes Court, with paved driveway visible on the far left, facing south.

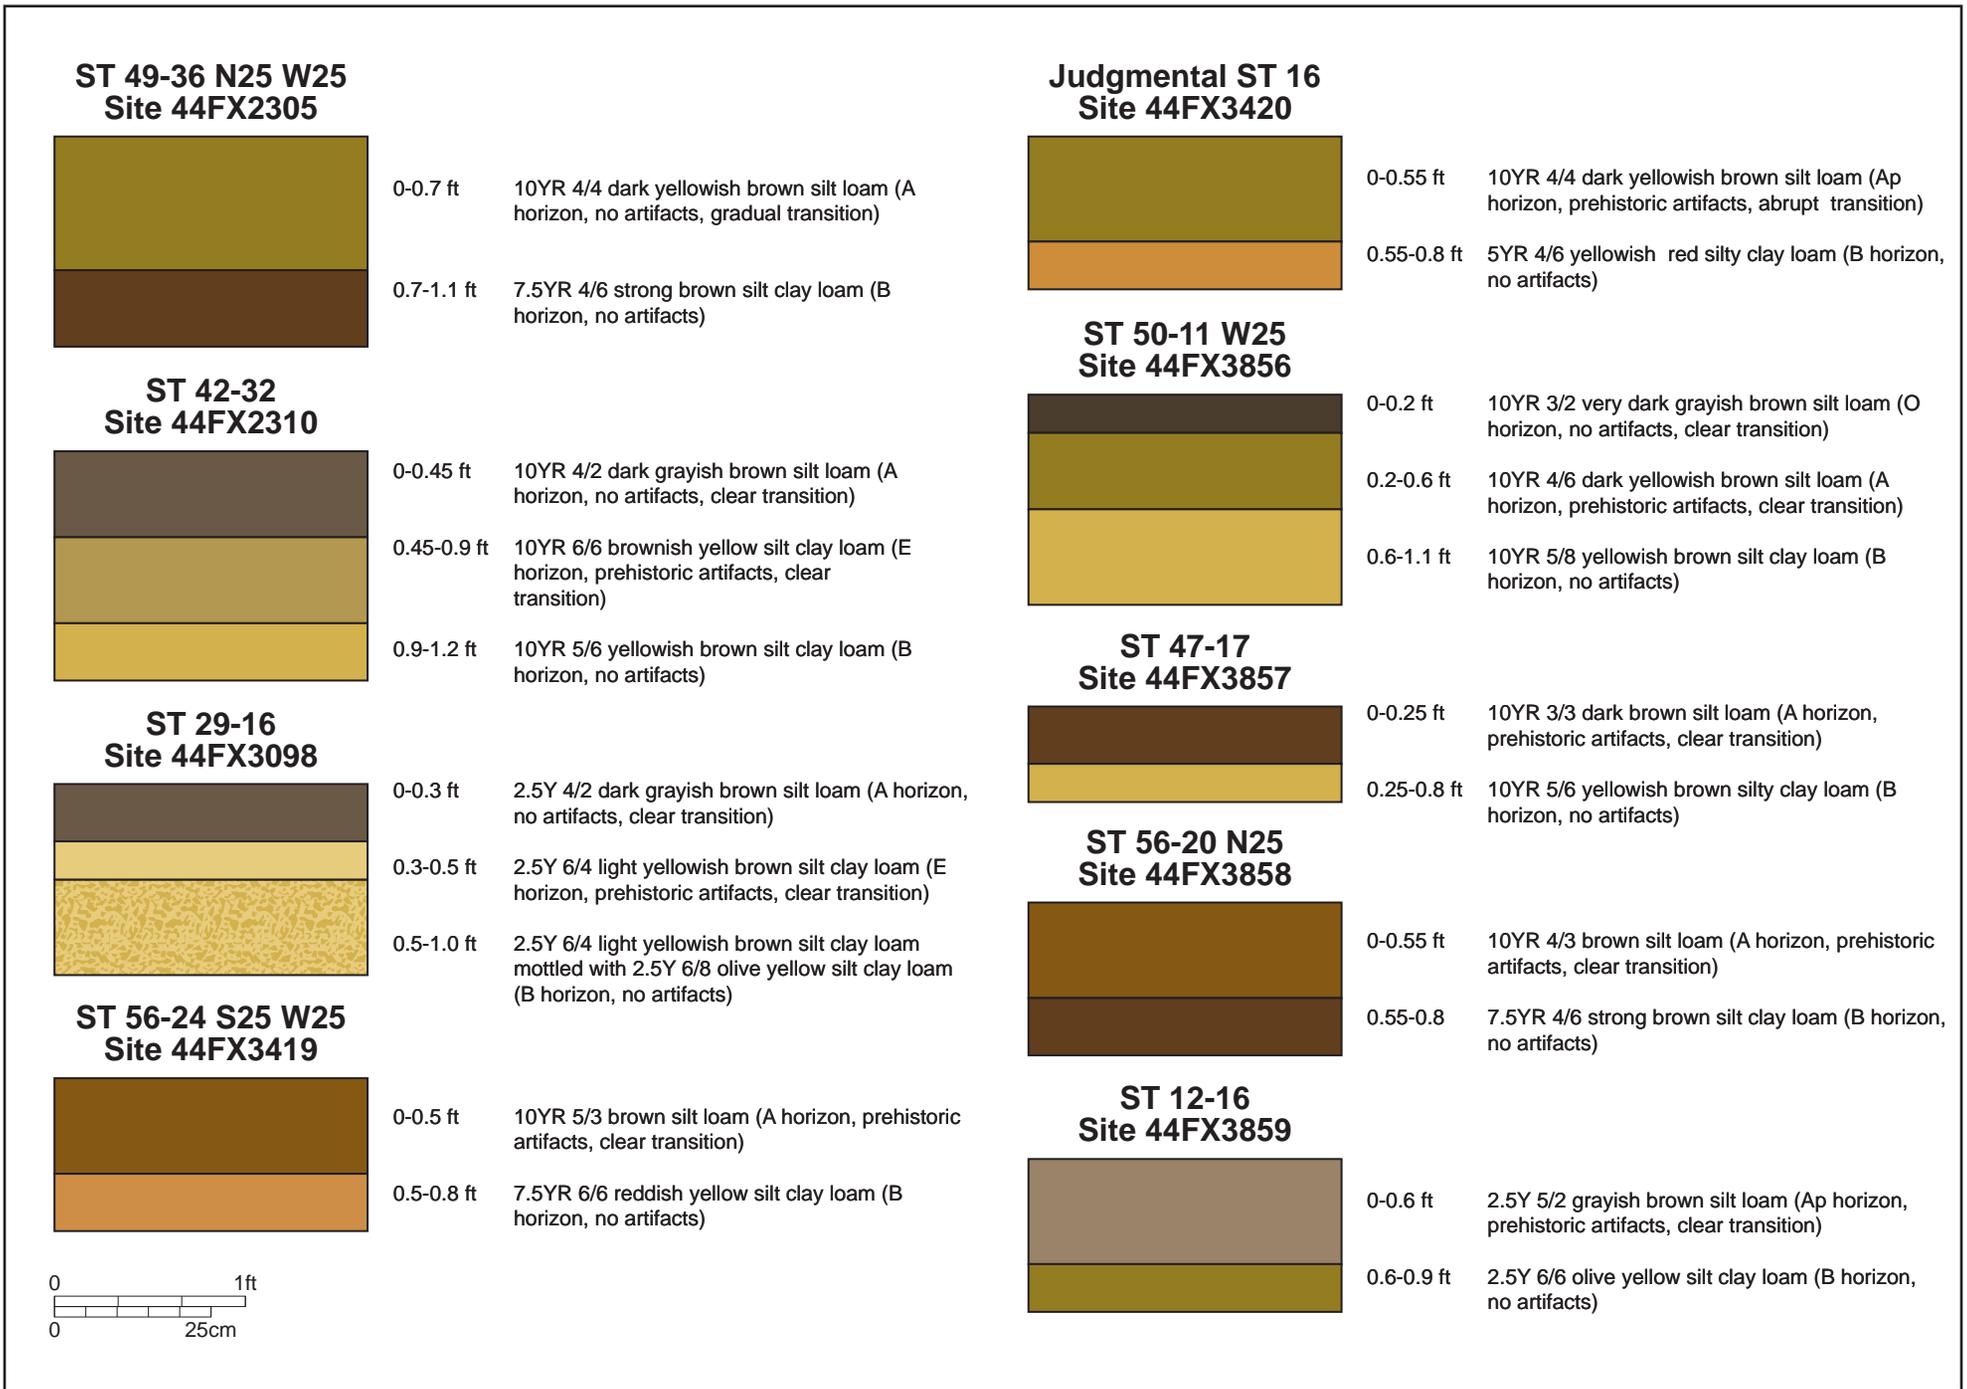
Figure 31. Representative shovel test profiles from Sites 44FX2305, 44FX2310, 44FX3098, 44FX3419, 44FX3420, 44FX3856, 44FX3857, 44FX3858, 44FX3859.

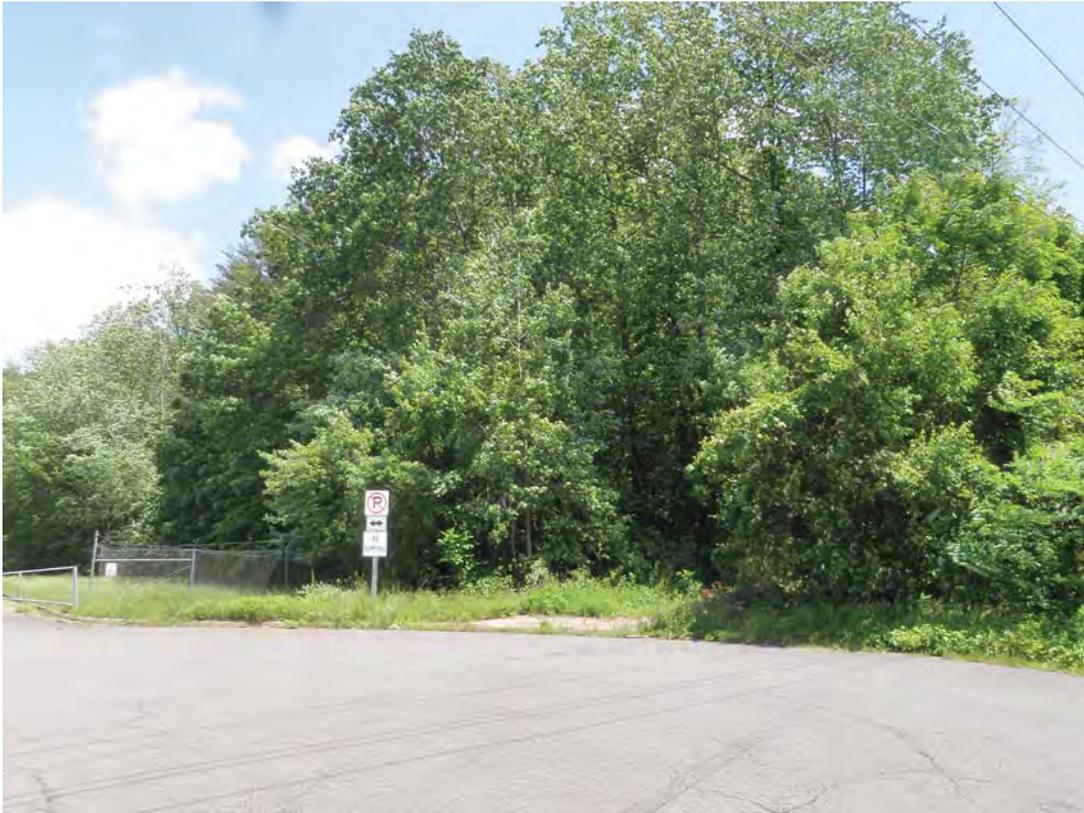
Figure 32. Overview of southwest portion of Site 44FX2755 showing wooded area adjacent to storage facility, facing east.

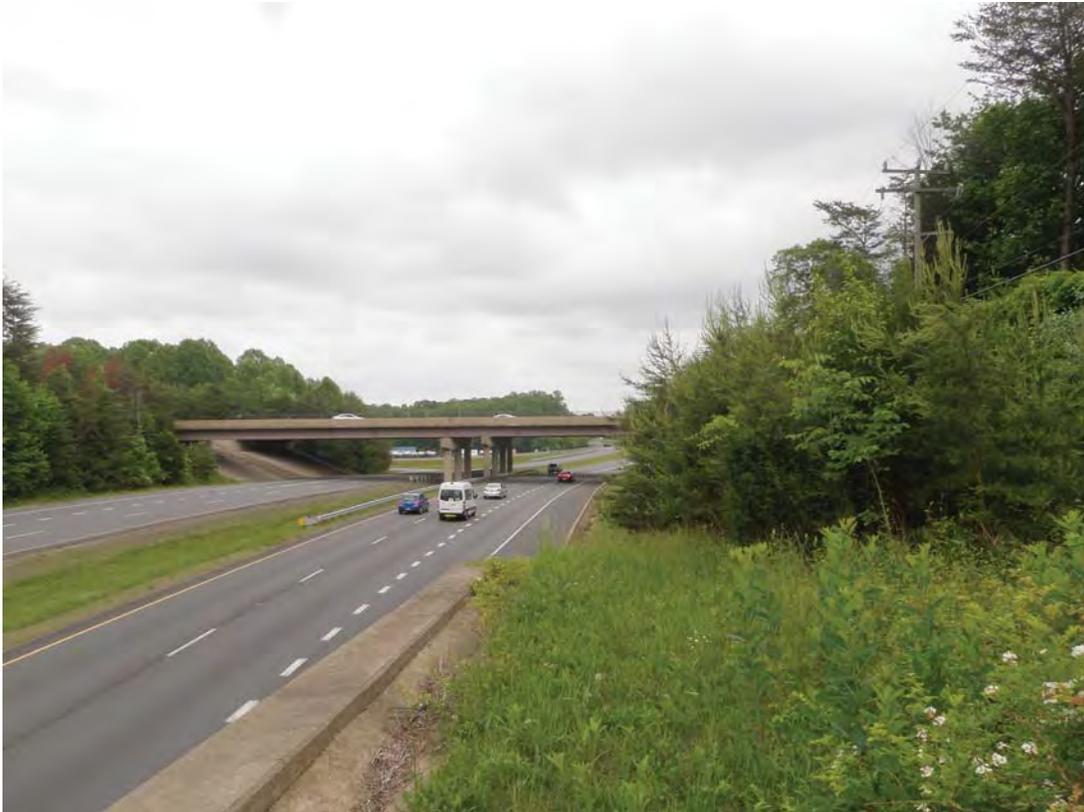
Figure 33. Overview of location of Site 44FX3417, showing area disturbed by the construction of Fairfax County Parkway, facing east.

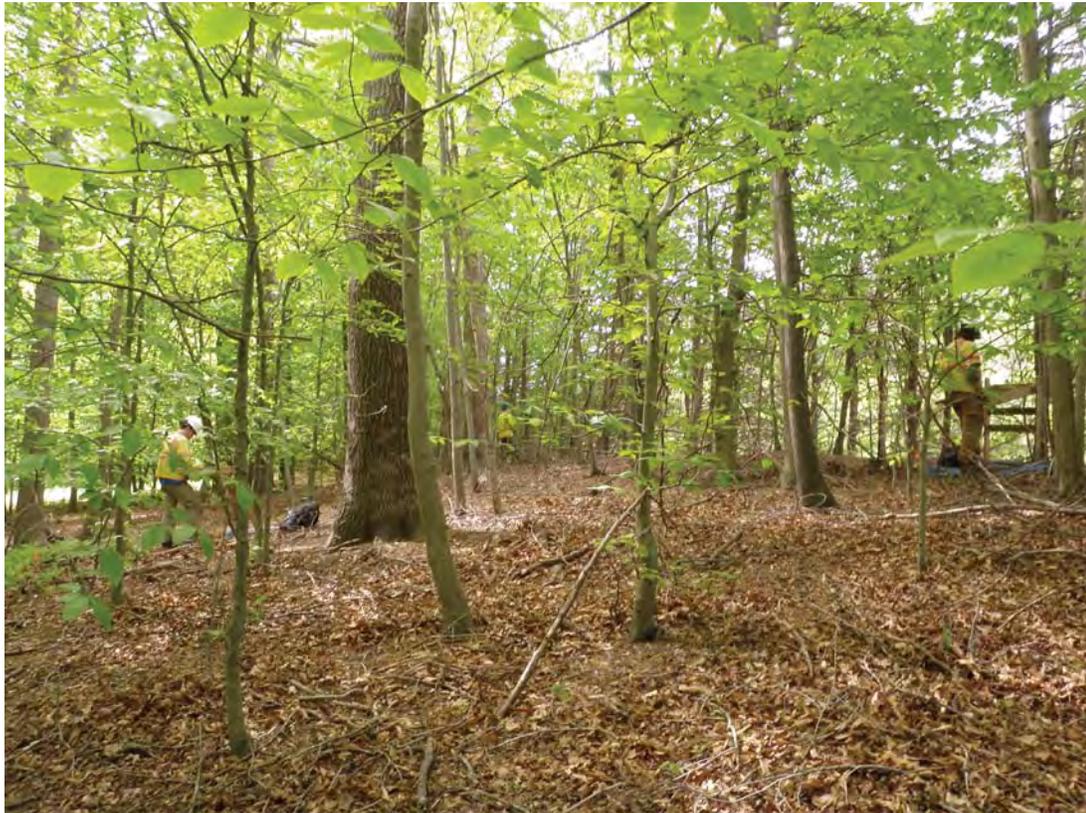
Site 44FX3856 is located on the west side of Fairfax County Parkway approximately 800 ft south of where it crosses Popes Head Creek (Figure 16). This site was identified during the current survey with two positive STs and one positive radial ST (Figure 34). The site is located on top of a ridge surrounded by steep slopes on all sides. Soils in this area consisted of Glenelg

Figure 34. Overview of work in progress at Site 44FX3856, facing northeast.

silt loam, with slopes ranging from 7 to 15 percent. Steep slopes and disturbances were noted within the Archaeology APE including areas with built up roadside berms. A typical ST showed a shallow O horizon of 10YR 3/2 very dark grayish brown silt loam over an A horizon of 10YR 4/6 dark yellowish brown silt loam that covered a B horizon of 10YR 5/8 yellowish brown silty clay loam (Figure 31, ST 50.11 W25). Three STs were positive for prehistoric artifacts, including two quartz flakes and two pieces of quartz shatter (Table 13). Portions of this site have been destroyed by the construction of Fairfax County Parkway and the installation of a roadside berm.

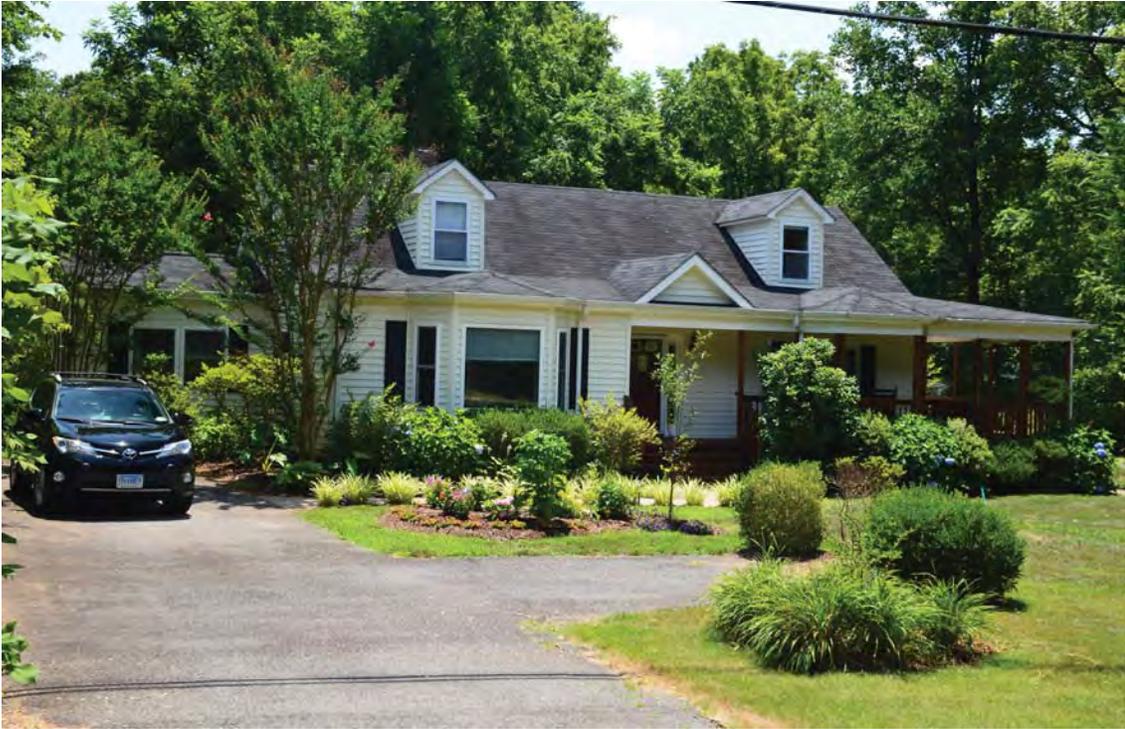
This one-and-one-half story tall frame dwelling has a rectangular core that measures three bays wide and two bays deep (Figure 55). It has a vinyl sided exterior. The side gabled roof is covered with asphalt shingles and features two gabled dormers on the front roof slope. A hipped roof porch wraps around the façade and west elevation of the house. A cross-gable on this porch marks the location of the front entry. The porch is supported by square wood posts and has a wood matchstick railing. This porch is partially enclosed. A one-bay wide, side-gabled ell extends from the east gable end. The windows are mostly one-over-one, double-hung vinyl sash, with a bay window on the enclosed portion of the front porch. A brick chimney rises through the center of the roof ridge.

According to Fairfax County property assessment records, this dwelling was built in 1939. It is an example of the Cape Cod variation of the Colonial Revival style with a one-and-one-half story, rectangular form with gabled dormers on the front roof slope. This house has lost integrity of design and materials through the application of vinyl siding and changes to the fenestration pattern.

Figure 55. 11607 Popes Head Road (029-6315), house, façade.

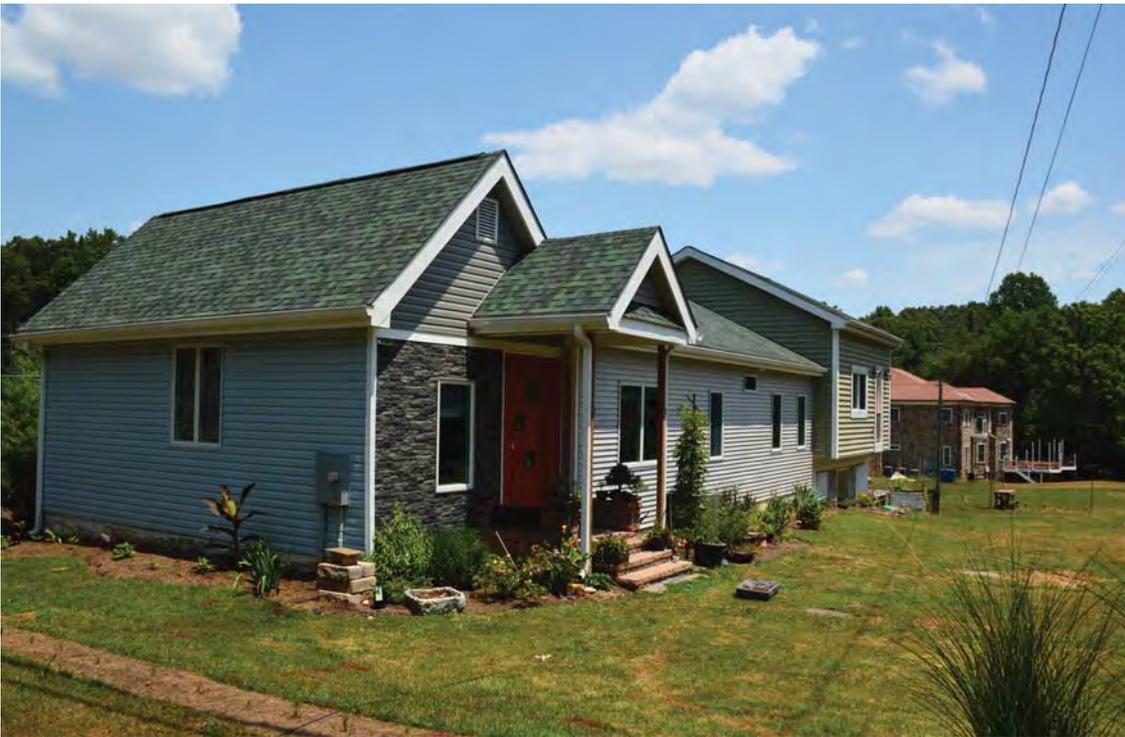
This one-story tall frame dwelling has a rectangular core that measures five bays wide with a side-gabled roof (Figure 58). There is a two-bay wide, front-gabled addition on the west elevation of this core. Another two-bay wide, side-gabled addition is on the east elevation of the core. The exterior of the house is vinyl siding and the roof is covered with asphalt shingles. The south elevation of the western addition has stone veneer. A gabled entry porch with square wood posts shelters the main entry into this addition. The windows are casement windows, with some hung in pairs. A projecting bay window is on the north elevation of the core. A stone veneer chimney rises through the north roof slope.

Figure 58. 11801 Popes Head Road (029-6318), house, view to northeast.
