# CULTURAL RESOURCES SURVEY FOR THE FAIRFAX COUNTY PARKWAY (ROUTE 286) WIDENING PROJECT FAIRFAX COUNTY, VIRGINIA

VDOT PROJECT: 0286-029-259, B619, B620, B621,  
B622, B623, B624, B625, B627, B628, B629,  
B630, B631, B632, D604, D605, P101  
IPM/UPC/CSC No: 107937  
VDHR FILE No: 2018-0073

**FINAL REPORT  
AUGUST 2018**

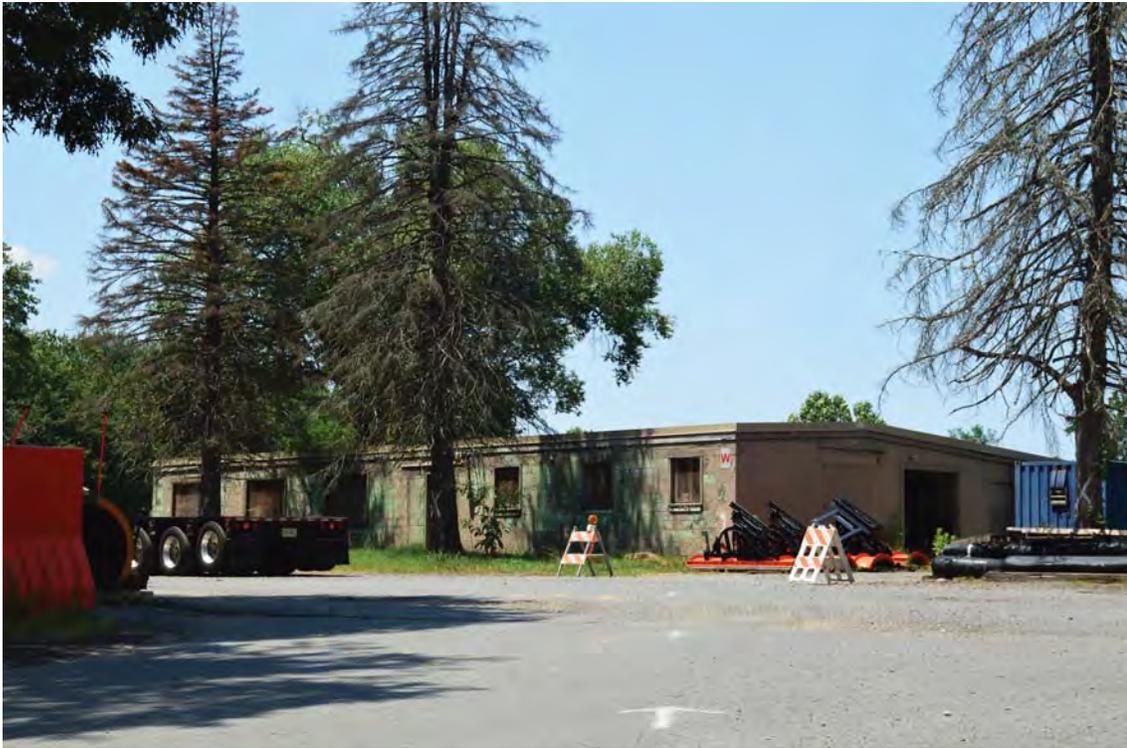
The 12-acre parcel includes three buildings, a warehouses and two storage barns (Figure 59). These buildings are linked by wide gravel driveways. There are also several machinery and materials storage areas around the property.

Figure 59. 5414 Ladue Lane (029-6322), former Popes Head Road Nike Missile site, warehouse, view to northwest.

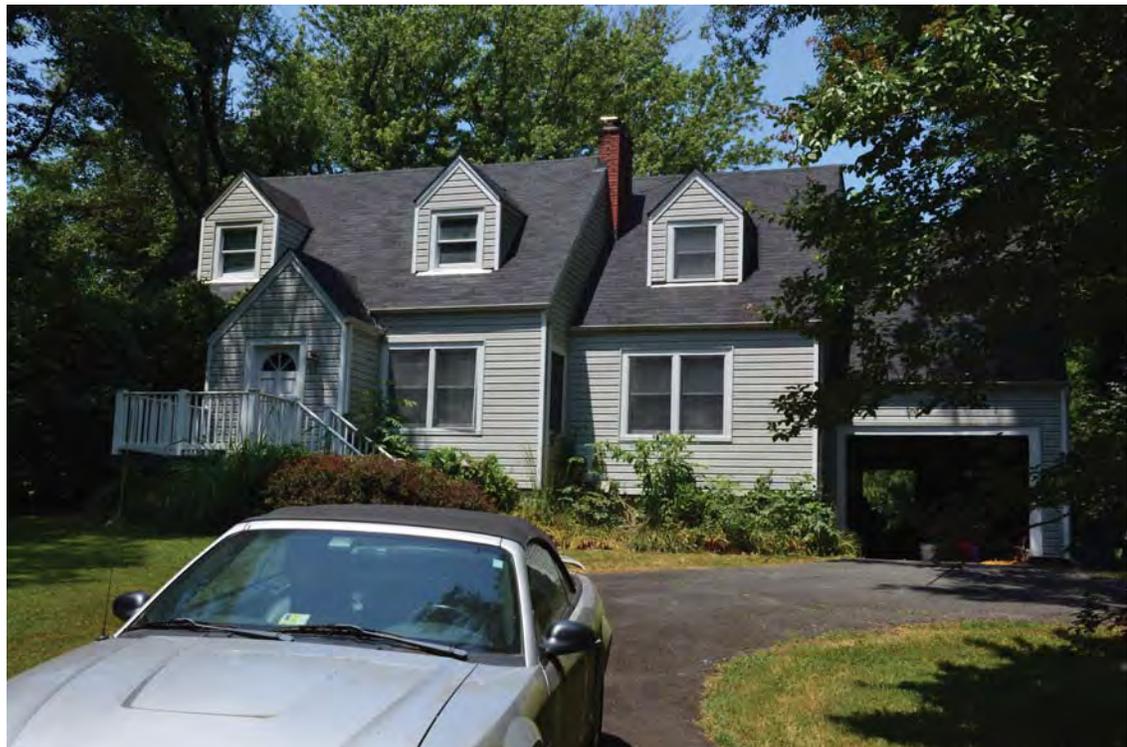
This one-and-one-half story tall frame dwelling has a rectangular core that measures three bays wide and two bays deep (Figure 60). A one-bay wide, side-gabled ell is set back from the façade on the east gable end. A one-car garage, also with a side-gabled roof, extends from the east elevation of this ell. The exterior of the house is clad with vinyl siding and the side gabled roof is covered with asphalt shingles. There are two gabled dormers on the front roof slope of the core, and one dormer on the front roof slope of the east wing. A stretcher bond brick chimney rises up the east gable end of the core. A wooden deck leads to the front door, which is within a gabled vestibule. The windows are one-over-one, double-hung vinyl sash with some hung in pairs.

Figure 60. 5444 Ladue Lane (029-6321), house, façade.

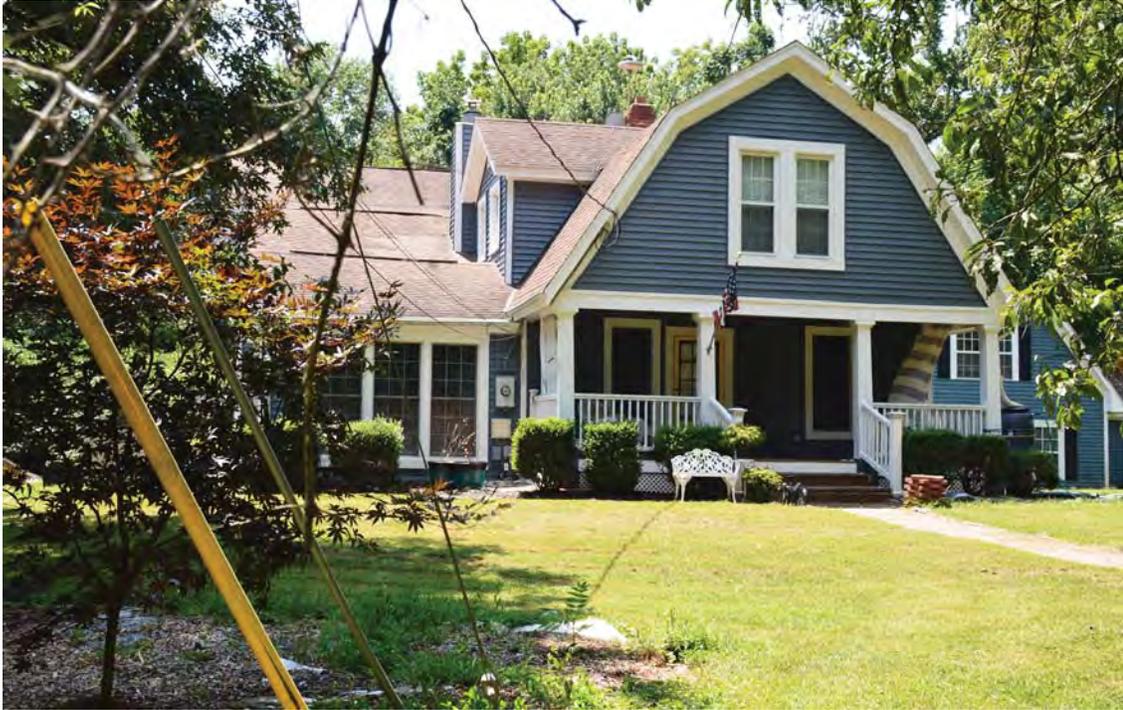
This two-story tall frame dwelling has a rectangular core that measures three bays wide and three bays wide (Figure 61). The house is clad with weatherboard and the roof is covered with asphalt shingles. The core has a front gambrel roof and a full-width inset porch on the façade. This porch is supported by square wood columns and has a wooden matchstick railing. Gabled dormers are

Figure 61. 5445 Ladue Lane (029-6320), house, façade.

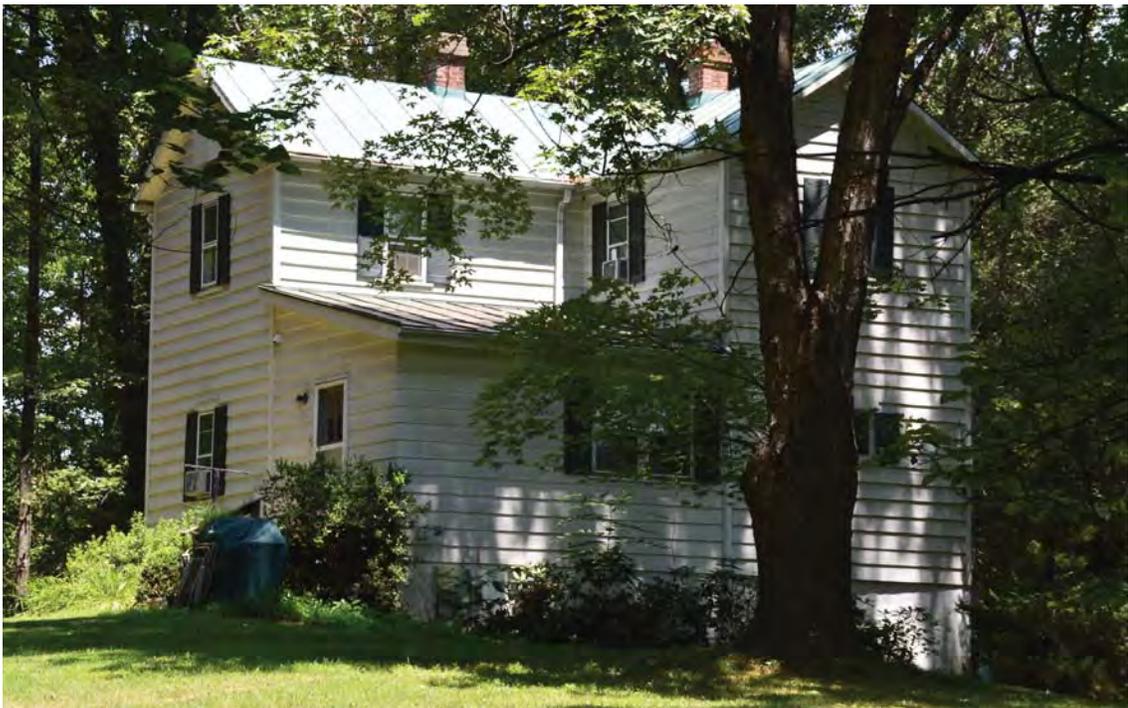
This two-story tall, T-plan frame dwelling stands on a parged foundation (Figure 62). The house measures three bays wide and two bays deep. The land around the house slopes down to the south, leaving the foundation exposed on the southwest corner of the house. The exterior of the house is clad with aluminum siding. The cross gabled roof is covered with standing seam metal. There are two corbelled cap chimneys rising through the roof ridge. The windows are one-over-one, double-hung vinyl sash, some of which are hung in pairs. The shed roof porch within the ell on the northwest corner of the house has been enclosed.

Figure 62. 5464 Ladues End Lane (029-6319), house, view to southeast.

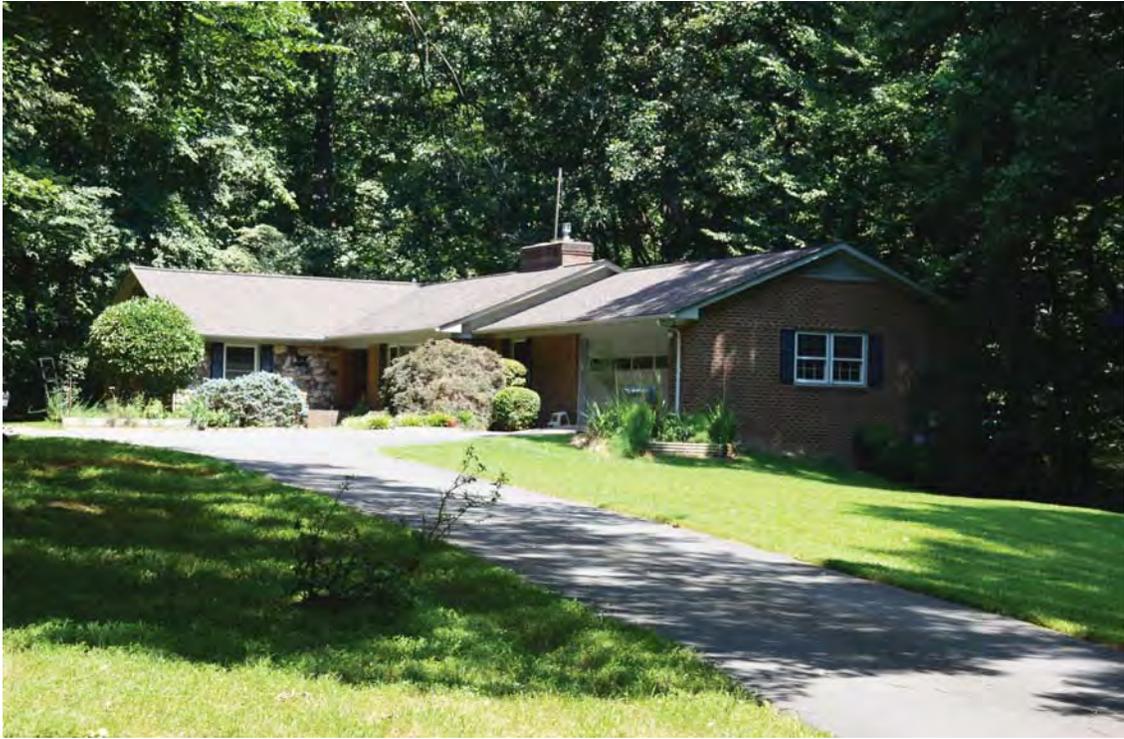
This one-story tall house has an L-plan that measures three bays wide and five bays deep (Figure 63). The south elevation of the west wing is faces with rubble stone veneer and the remainder of the exterior is clad with stretcher bond brick. The cross gabled roof is covered with asphalt shingles. A wide, stretcher bond chimney rises through the ridge of the south wing. The windows are one-over-one, double-hung sash with rowlock sills. The windows abut the eaves, and some are hung in pairs. The southern two bays of the south wing are recessed and include a one car garage.

Figure 63. 11506 Four Penny Lane (029-6324), house, view to northeast.

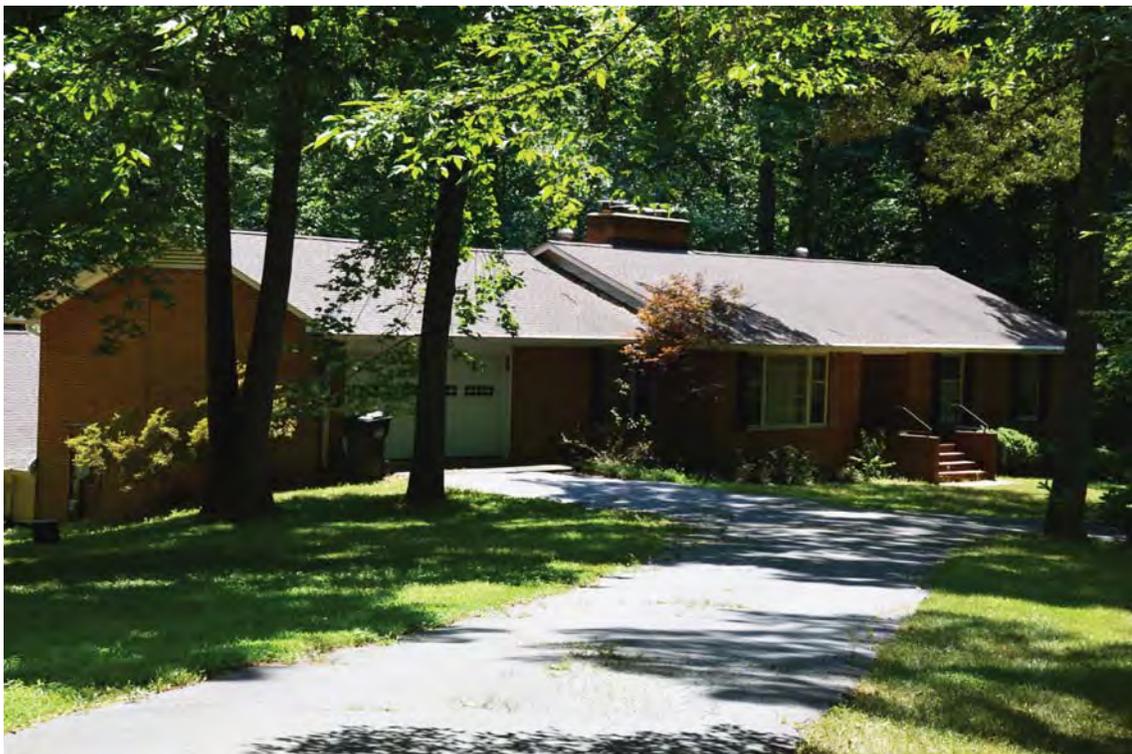
This one-story tall house has a rectangular plan that measures six bays wide and two bays deep (Figure 64). The northern two bays of the façade are recessed and includes a one-car garage. The

Figure 64. 11505 Four Penny Lane (029-6325), house, façade.

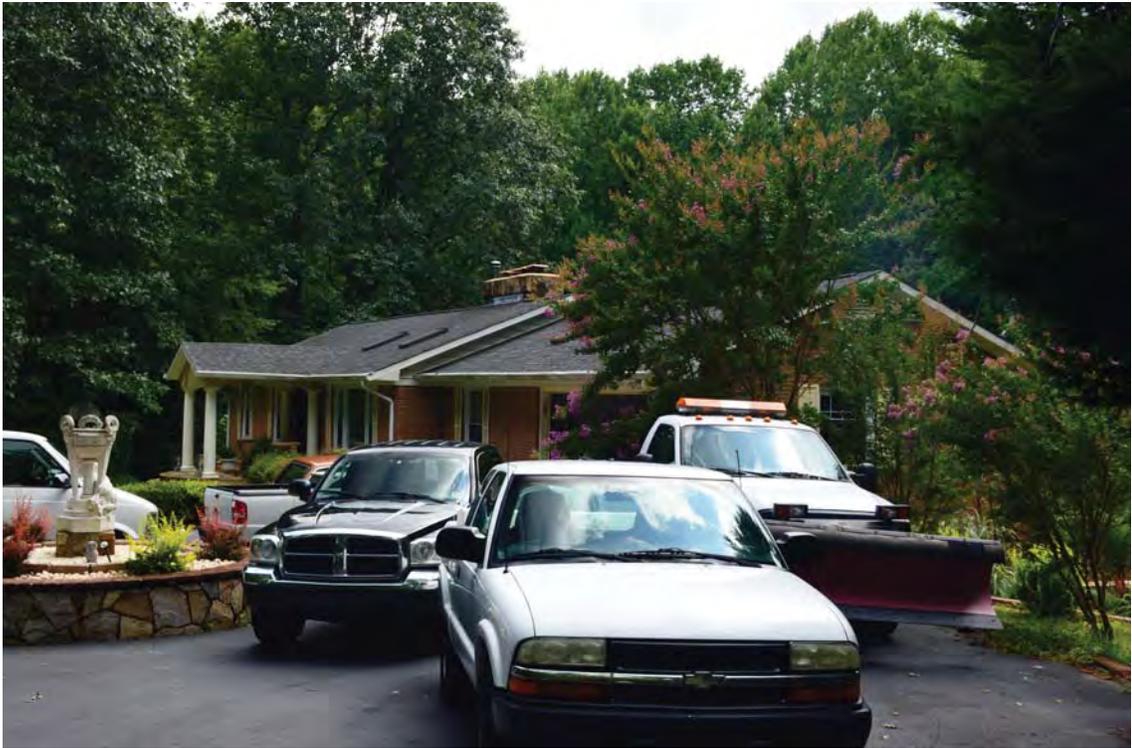
This one-story tall house has a rectangular plan that measures six bays wide and two bays deep (Figure 65). The northern two bays of the façade are recessed and includes a one-car garage. The exterior is stretcher bond brick. The side-gabled roof is covered with asphalt shingles. A wide, stone veneer chimney rises through the roof ridge. A gabled entry porch with encased columns shelters the front entry. The ground slopes down to the west and lower level of rear elevation is exposed. The windows are one-over-one, double-hung sash with rowlock sills. A picture window is also on the façade. The windows about the eaves.

Figure 65. 11511 Four Penny Lane (029-6326), house, view to southwest.

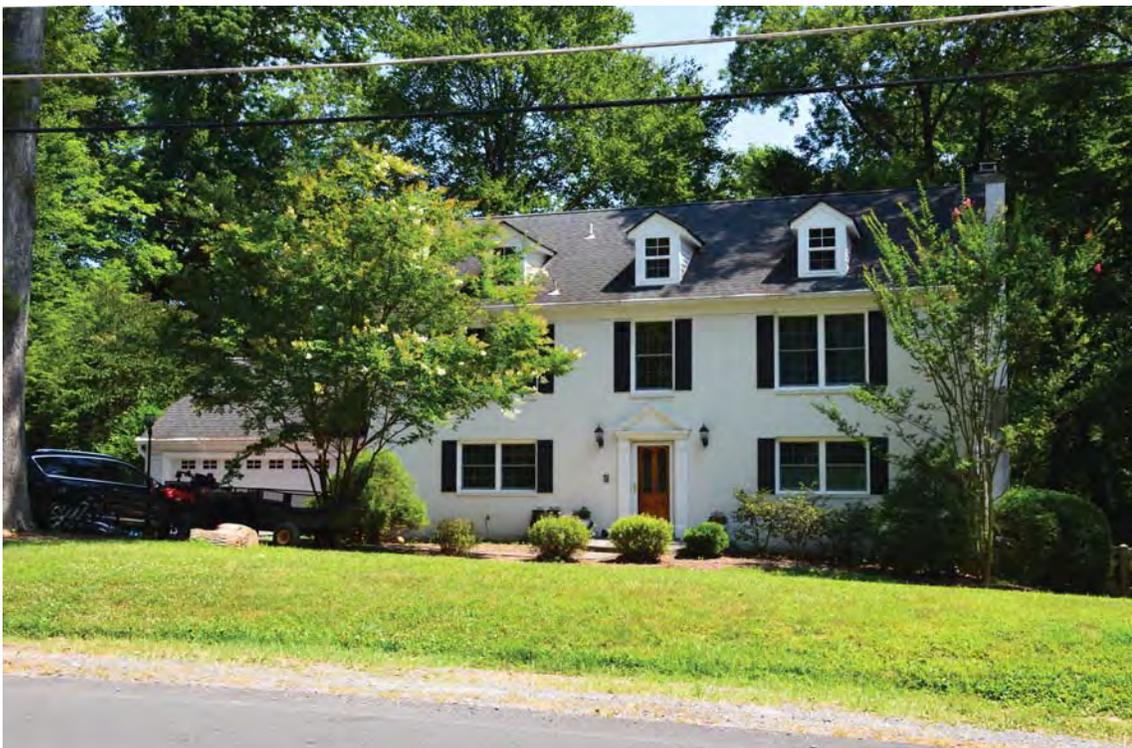
This two-story tall house has a rectangular plan that measures three bays wide and two bays deep (Figure 66). A two-car garage is attached to the northern gable end. The exterior is stretcher bond brick. The side-gabled roof is covered with asphalt shingles and features gabled dormers on the front roof slope. The roof on the garage features a central, decorative cupola. A stretcher bond chimney rises up the south gable end. The windows are one-over-one, double-hung sash with rowlock sills. The windows have applied muntins and some are hung in pairs. The front door is flanked by pilasters and is topped with a triangular pediment. The ground slopes down to the east and lower level of rear elevation is exposed.

According to Fairfax County property assessment records, this dwelling was built in 1968. It is an example of a Colonial Revival house. It has features typical of this style such as a symmetrical two-story tall façade, stretcher bond brick exterior, and triangular pediment over the front door. This house is not a significant example of a Colonial Revival dwelling.

Figure 66. 5923 One Penny Lane (029-6327), house, façade.

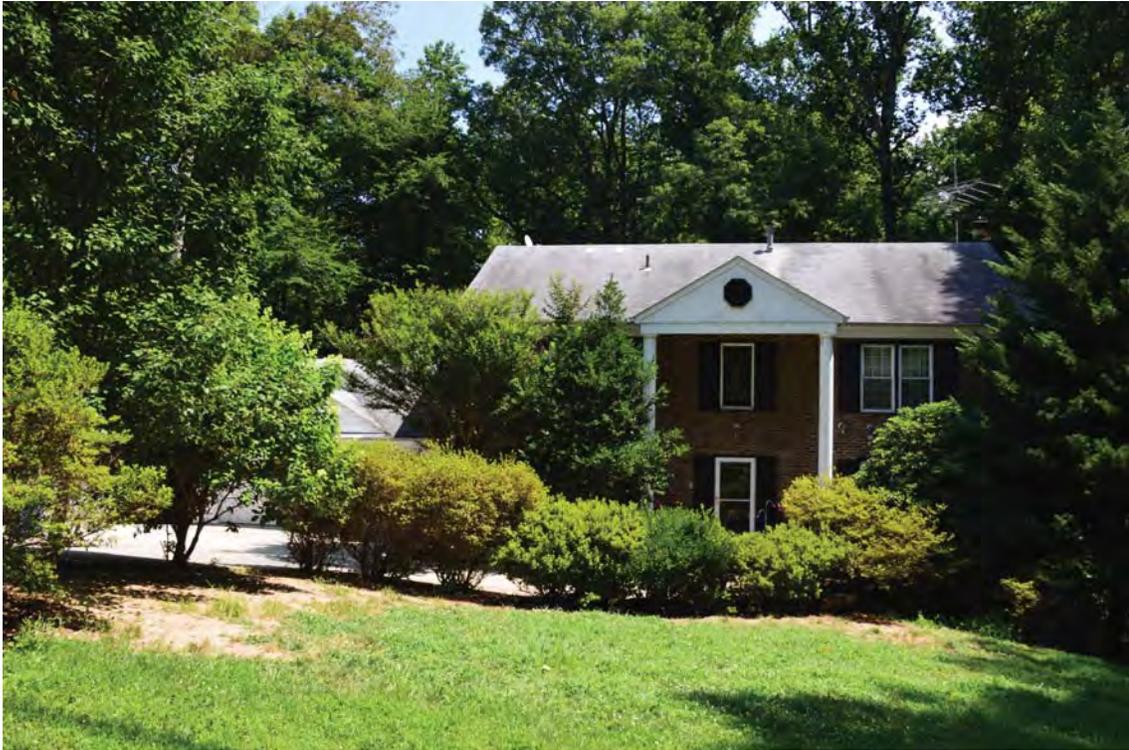
This two-story tall house has a rectangular plan that measures three bays wide and two bays deep (Figure 67). A two-car garage is attached to the northern gable end. The exterior is stretcher bond brick. The side-gabled roof is covered with asphalt shingles. The roof on the garage features a central cross gable. A stretcher bond chimney rises up the south gable end. The windows are one-over-one, double-hung sash with rowlock sills. The windows have applied muntins and some are hung in pairs. A two-story tall portico, supported on encased columns, is centered on the façade. The ground slopes down to the east and lower level of rear elevation is exposed.

Figure 67. 5925 One Penny Lane (029-6328), house, façade.

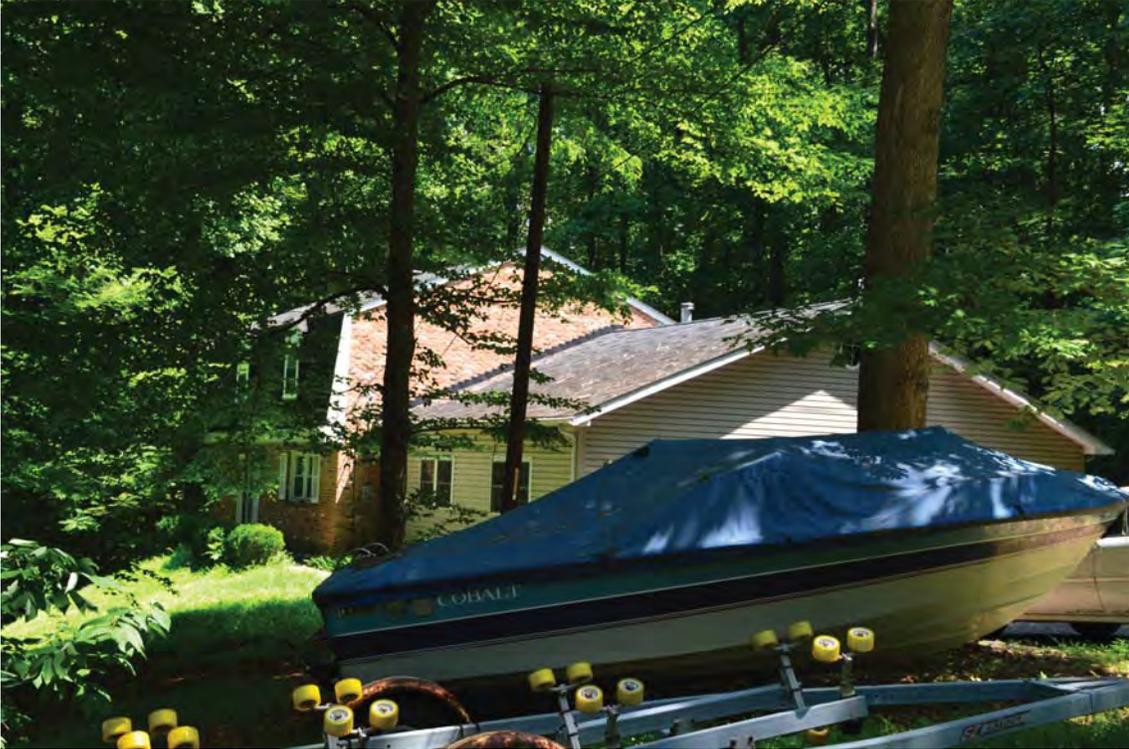
This two-story tall house has a rectangular plan that measures three bays wide and two bays deep (Figure 68). A three-car garage is attached to the southern elevation. The exterior is stretcher bond brick. The gambrel roof is covered with asphalt shingles and features gabled dormers on the lower roof slopes. The garage is of frame construction and has a vinyl sided exterior. Its side gabled roof is covered with asphalt shingles. The windows are one-over-one, double-hung sash with rowlock sills. The windows have applied muntins and some are hung in pairs.

Figure 68. 11510 Two Penny Lane (029-6329), house, view to northeast.

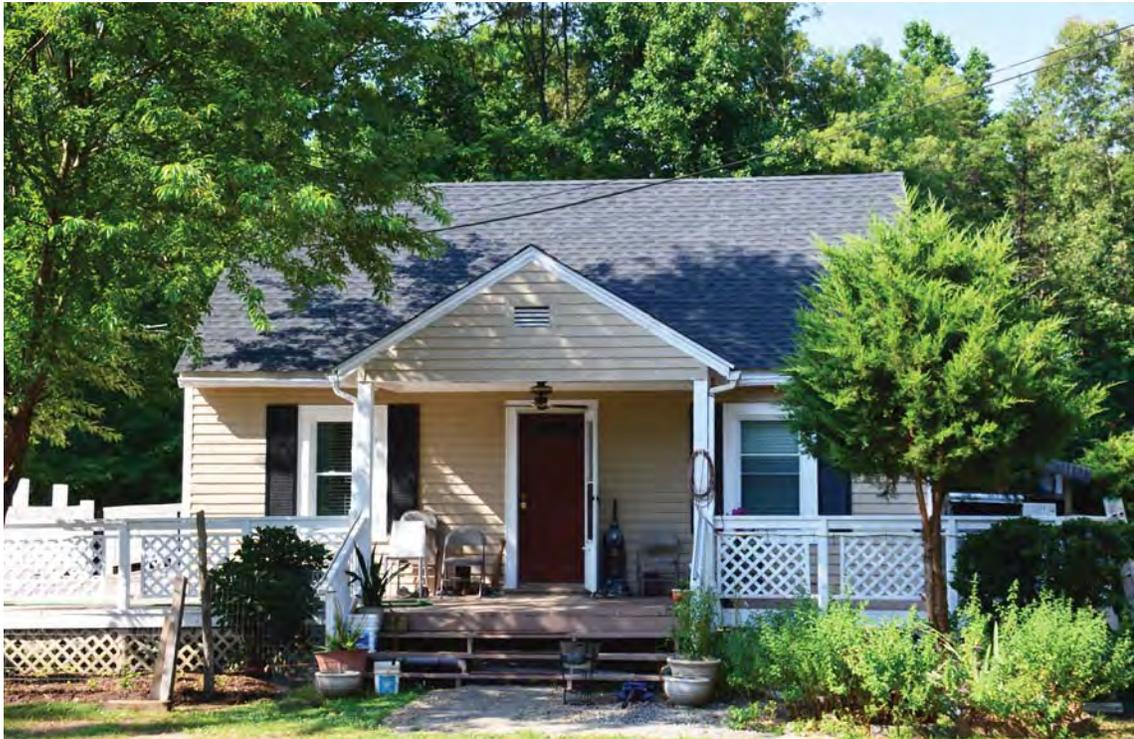
This one-and-one-half story tall house has a rectangular plan that measures three bays wide and two bays deep (Figure 76). The house stands on a parged foundation that is exposed on the southwest corner of the house due to the sloping lot. The exterior is clad with vinyl siding. The side-gabled roof is covered with asphalt shingles. A gabled porch, with square wooden posts, shelters the front entry. This porch has been expanded into a wooden deck, with lattice railing, that wraps around the east, north, and west elevations of the house. The windows are one-over-one, double-hung sash. A one-story, one-bay deep shed roof ell extends from the rear elevation of the house.

Figure 76. 11111 Chapel Road (029-6336), house, façade.

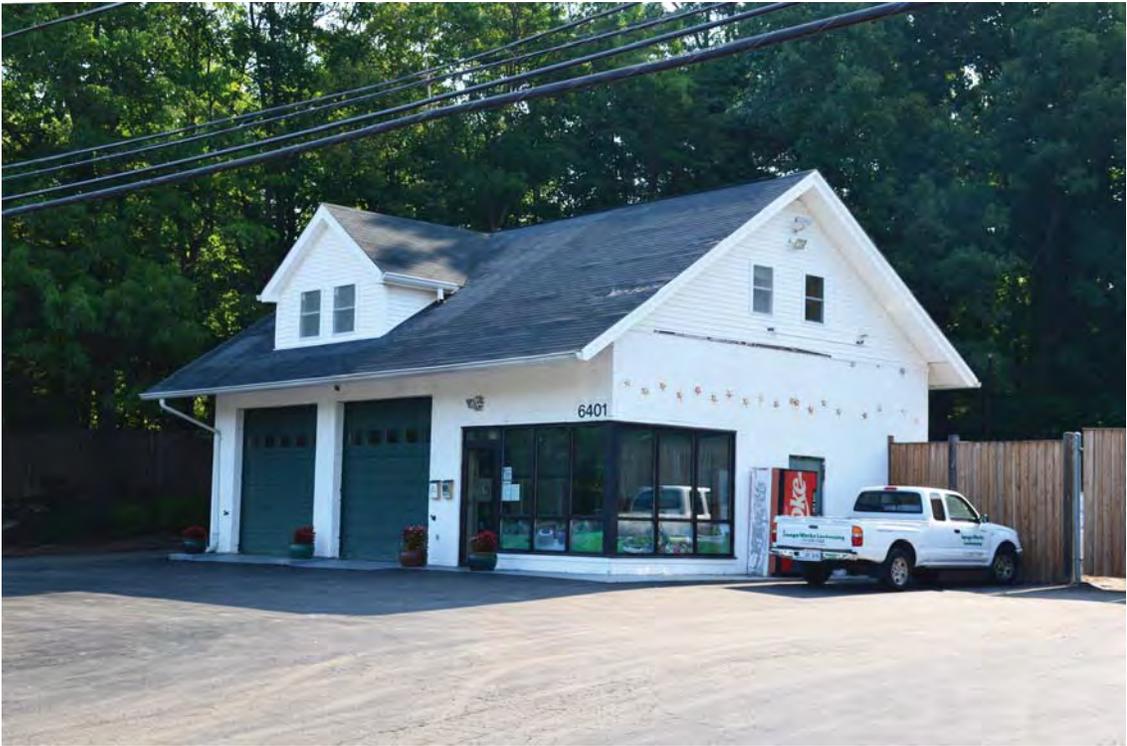
This one-and-one-half story tall building has a rectangular plan (Figure 77). The exterior is stretcher bond brick with vinyl siding in the gable ends. The side-gabled roof is covered with asphalt shingles and features a large, gabled dormer on the front roof slope. The northern two bays of the façade have tall, metal, overhead vehicular doors. The south bay of the façade is a band of plate glass windows and entry door that wraps around the southwest corner of the building. The windows on in the attic are one-over-one, double-hung vinyl sash.

Figure 77. 6401 Little Ox Road (029-6337), commercial building, view to northeast.

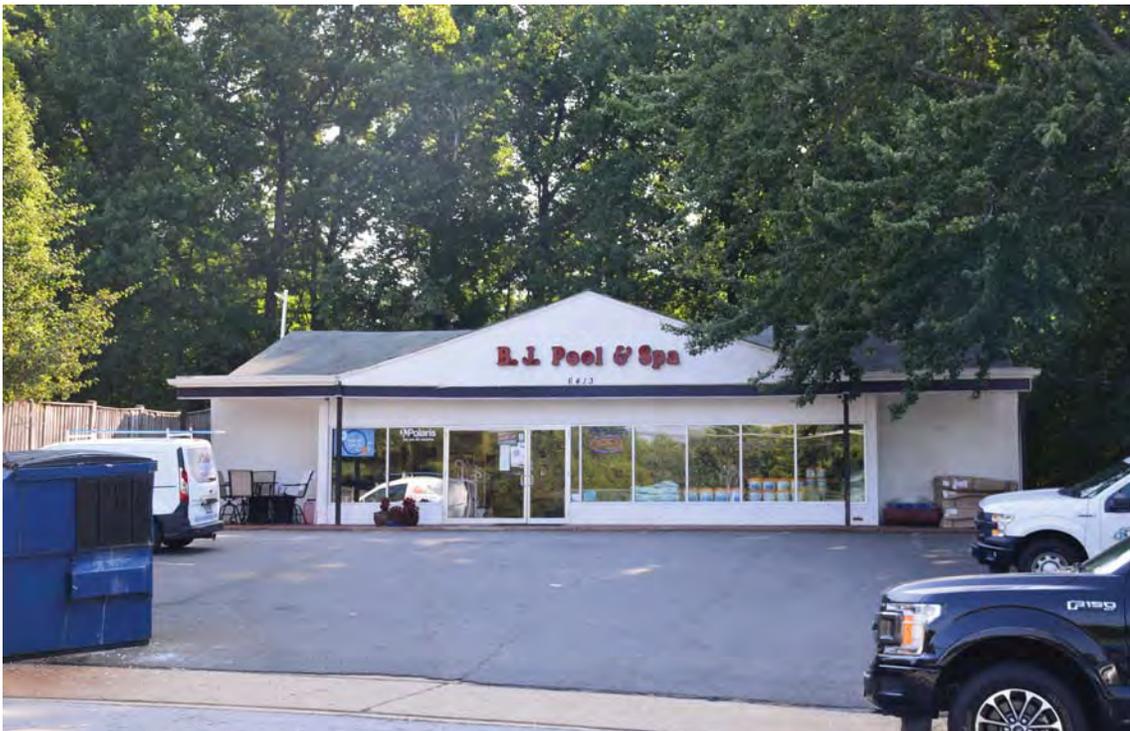
This one story tall house has a rectangular plan (Figure 78). The exterior is stretcher bond brick. The cross gabled roof is covered with asphalt shingles. There are small, inset porches on the north and south corners of the façade. There is a band of metal-framed plate glass windows, with double-leaf plate glass doors, stretching across the façade.

Figure 78. 6413 Little Ox Road (029-6338), commercial building, façade.

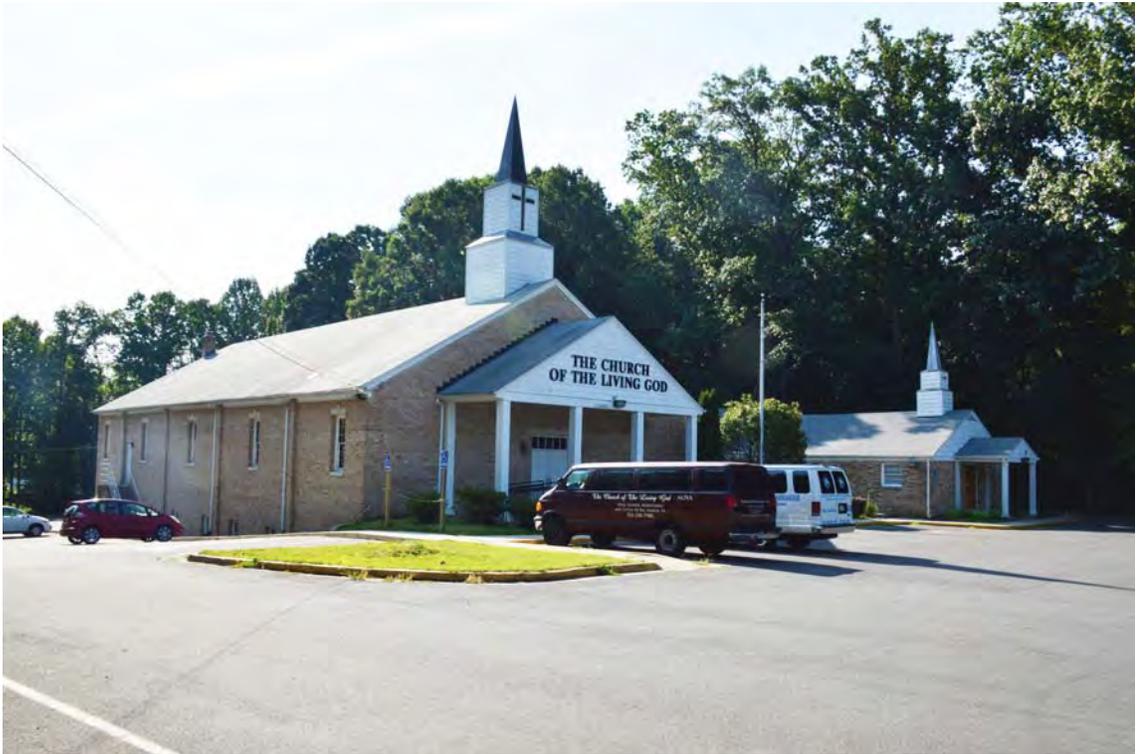
This church has two main components: the sanctuary and an educational wing adjoining it to the south (Figure 79). Both components are gable front in form and are connected by a gabled hyphen. The church shares exterior details including stretcher bond brick exterior, asphalt shingled roof, and gabled entry porches with square, aluminum-encased posts. The sanctuary wing is five bays deep, with each bay divided by brick wall buttresses. The windows in the sanctuary wing are multi-light, double-hung sash with keystone lintels. The main entry is through a pair of double doors, topped with a multi-light transom with a keystone lintel. An aluminum siding clad steeple rises from the west end of the roof and diminishes in size in two stages. A brick chimney rises up the rear gable end.

Figure 79. 6415 Little Ox Road (029-6339), Church of the Living God, view to southeast.

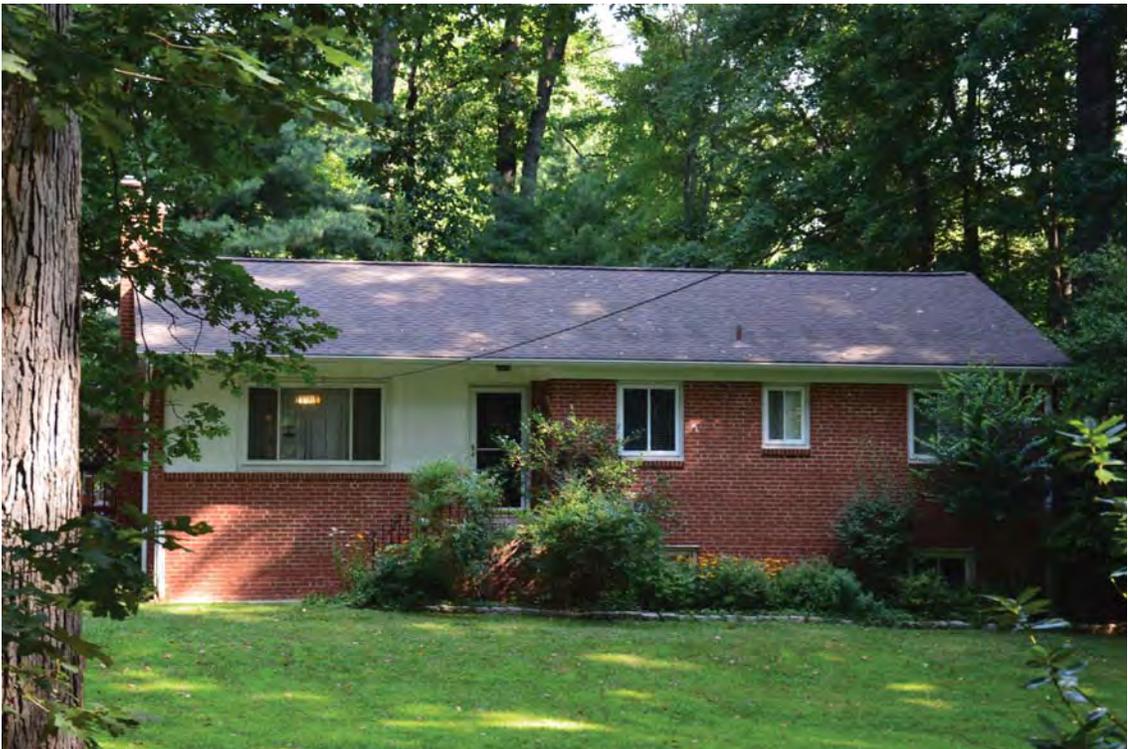
This one-and-one-half story tall house has a rectangular plan that measures five bays wide and three bays deep (Figure 80). The exterior is stretcher bond brick with a vertical board panel on the upper portion of the western section of the façade. A flight of brick-clad stairs with cast metal railing leads to the front door. A stretcher bond brick exterior chimney rises up the west gable end. The windows are sliding sash with rowlock sills.

Figure 80. 10950 Woodfair Road (029-6340), house, façade.

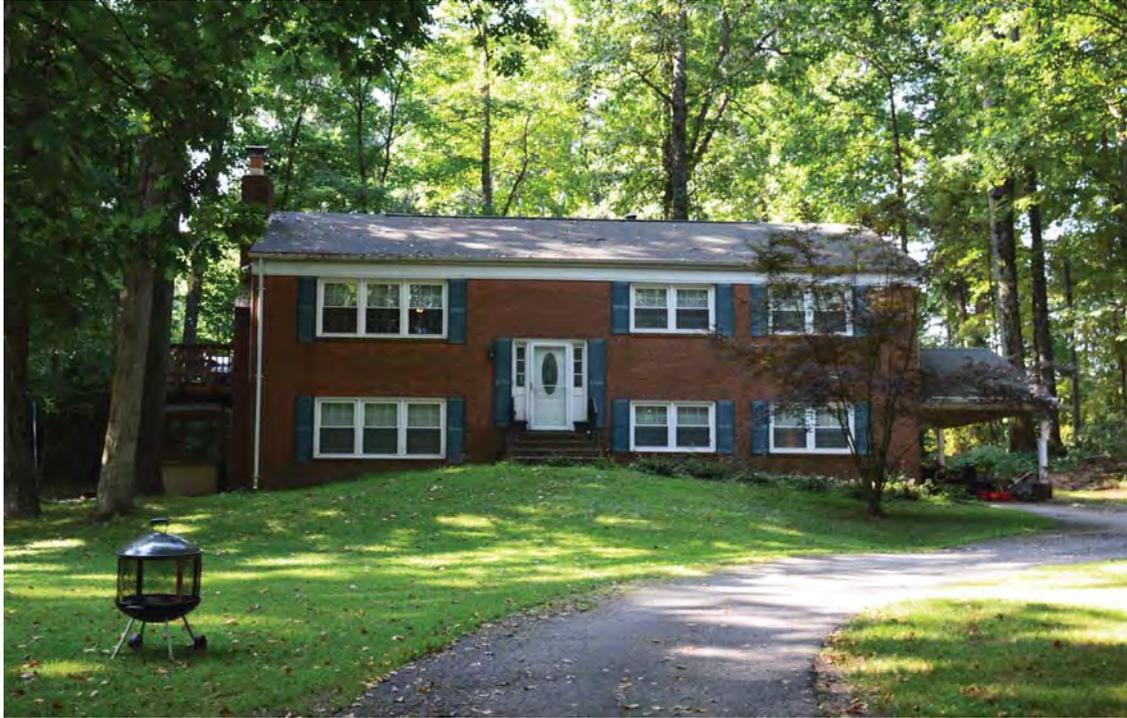
This two-story tall house has a rectangular plan that measures four bays wide and two bays deep (Figure 81). The façade and lower level are stretcher bond brick, the west, south, and east elevations of the second floor are clad with vinyl siding. The side gable roof has close eaves and is covered with asphalt shingles. A stretcher bond brick chimney rises up the east gable end. A side-gabled carport, supported by square wooden posts, is on the west gable end. A flight of concrete steps with cast metal railing leads to the front door. The windows are one-over-one, double-hung vinyl sash with applied muntins and rowlock sills. Some of the windows are hung in pairs.

Figure 81. 10951 Woodfair Road (029-6341), house, façade.

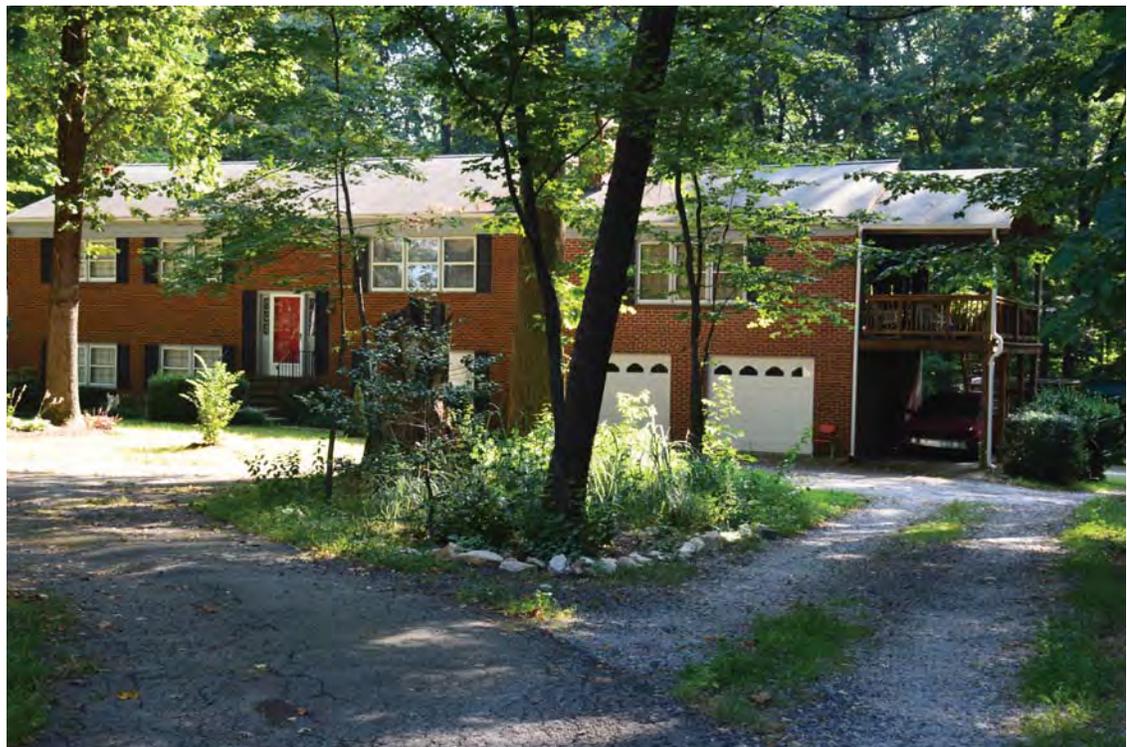
This two-story tall house has a rectangular plan that measures four bays wide and two bays deep (Figure 82). The exterior is stretcher bond brick. The side gable roof has close eaves and is covered with asphalt shingles. A stretcher bond brick chimney rises up the south gable end. A flight of concrete steps with cast metal railing leads to the front door. The windows are one-over-one, double-hung vinyl sash with applied muntins and rowlock sills. Some of the windows are hung in pairs and triples. A side-gabled, two story tall addition is on the south gable end. The lower level of this addition has a two car garage, while the upper level is living space. A two-story frame porch is on the south elevation of this addition. This porch features square wooden supports and a wooden matchstick railing. A side-gabled carport, supported by square wooden posts, is on the west gable end. A side-gabled carport, with square posts, is on the north gable end of the core.

Figure 82. 6431 Little Ox Road (029-6342), house, view to northeast.

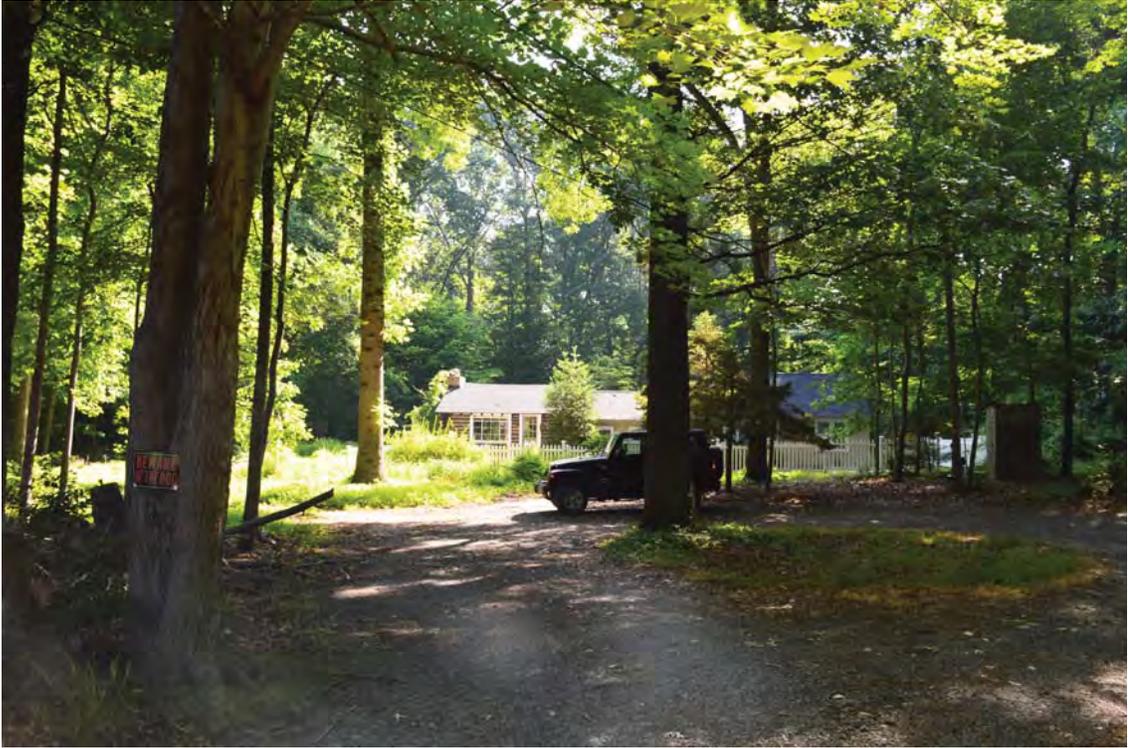
This one story tall house is comprised of three sections, each two bays wide (Figure 83). The north section is exposed log with saddle notches and chinking between the logs. This section has a side-gabled roof with asphalt shingles and exposed rafter ends. The middle section of the house is two bays wide and has a weatherboard exterior. This section's side-gable roof is covered with asphalt shingles. The southern section is also one story tall and measures three bays wide. The section has a vinyl sided exterior and a side-gabled, asphalt shingled roof. The windows of the house are one-over-one, double-hung sash. There is a fixed, multilight window on the north section, and some of the windows on the south section are hung in pairs. A concrete block chimney rises up the north gable end.

Figure 83. 6435 Little Ox Road (029-6343), house, façade.
