APPENDIX F - Multimodal Analysis Report

Multi Modal Analysis

I. INTRODUCTION

I-395 & Shirlington Rd Interchange Safety & Operations Phase II Study

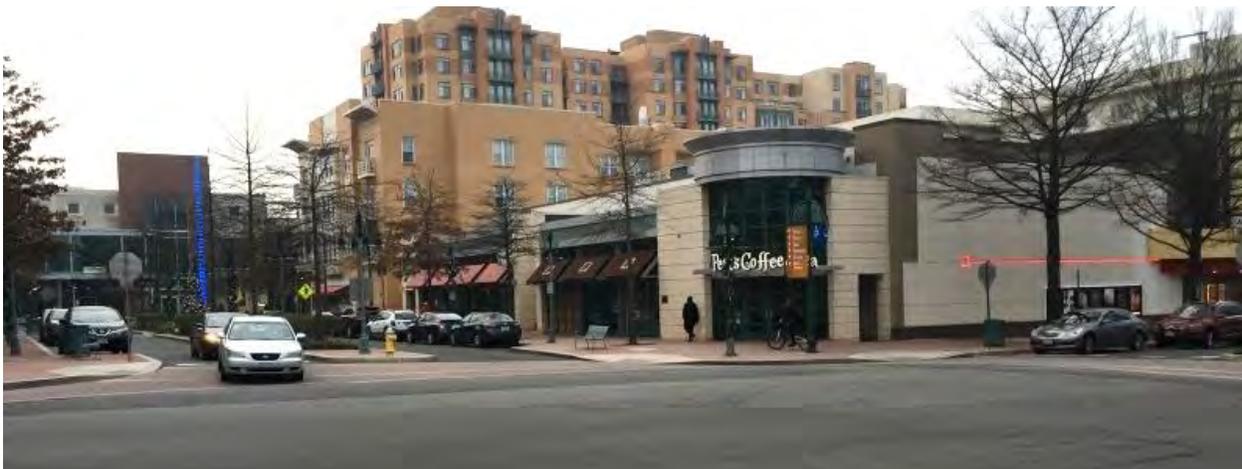
Figure 1: Typical Shirlington Streetscape with Personal Vehicles, Bicycles, and Pedestrians

Personal vehicles, buses, bicycles, and pedestrians can be found in the Shirlington area. The Shirlington Station serves many transit routes and Capital Bikeshare is represented in the area with multiple stations. There are no Metro stations in the vicinity. The following photographs (Figures 1, 2, and 3) show each of the modes of transportation represented in the Shirlington area.

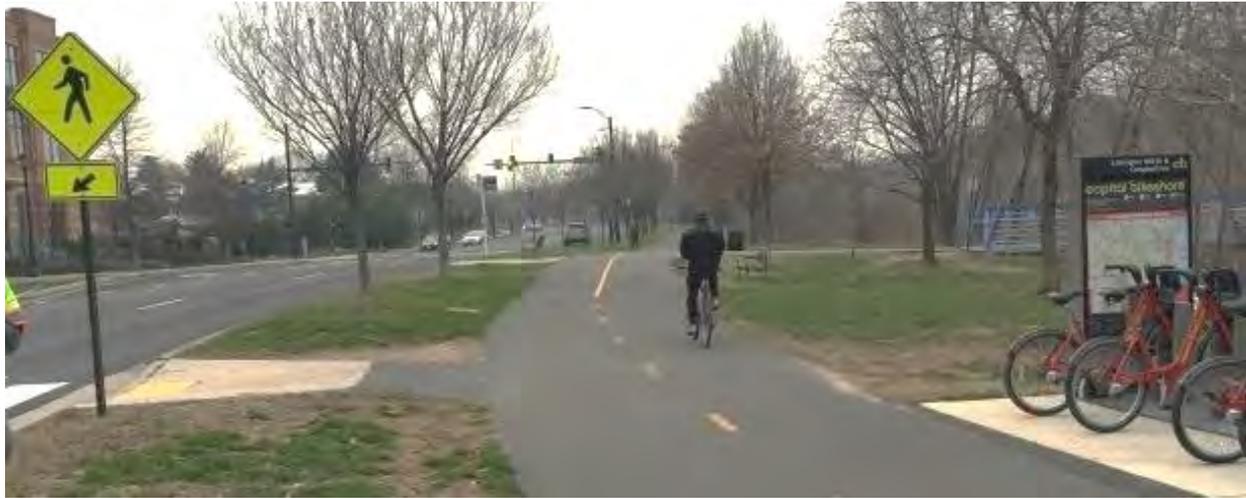
Figure 2: Four Mile Run Trail with Capital Bikeshare Station on South Arlington Mill Drive at Campbell Avenue

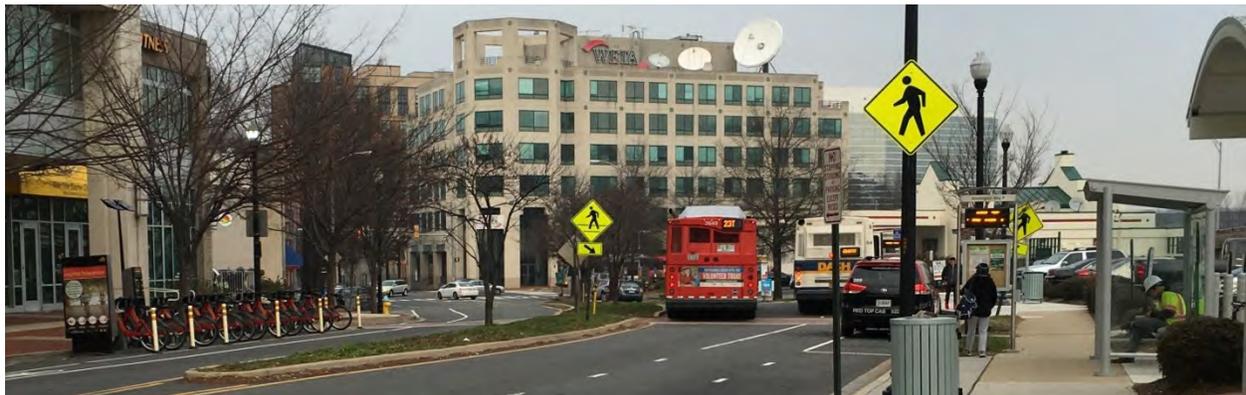
Figure 3: Buses, Cars, Bicycles, and Pedestrians at Shirlington Station Transit Center on South Quincy Street

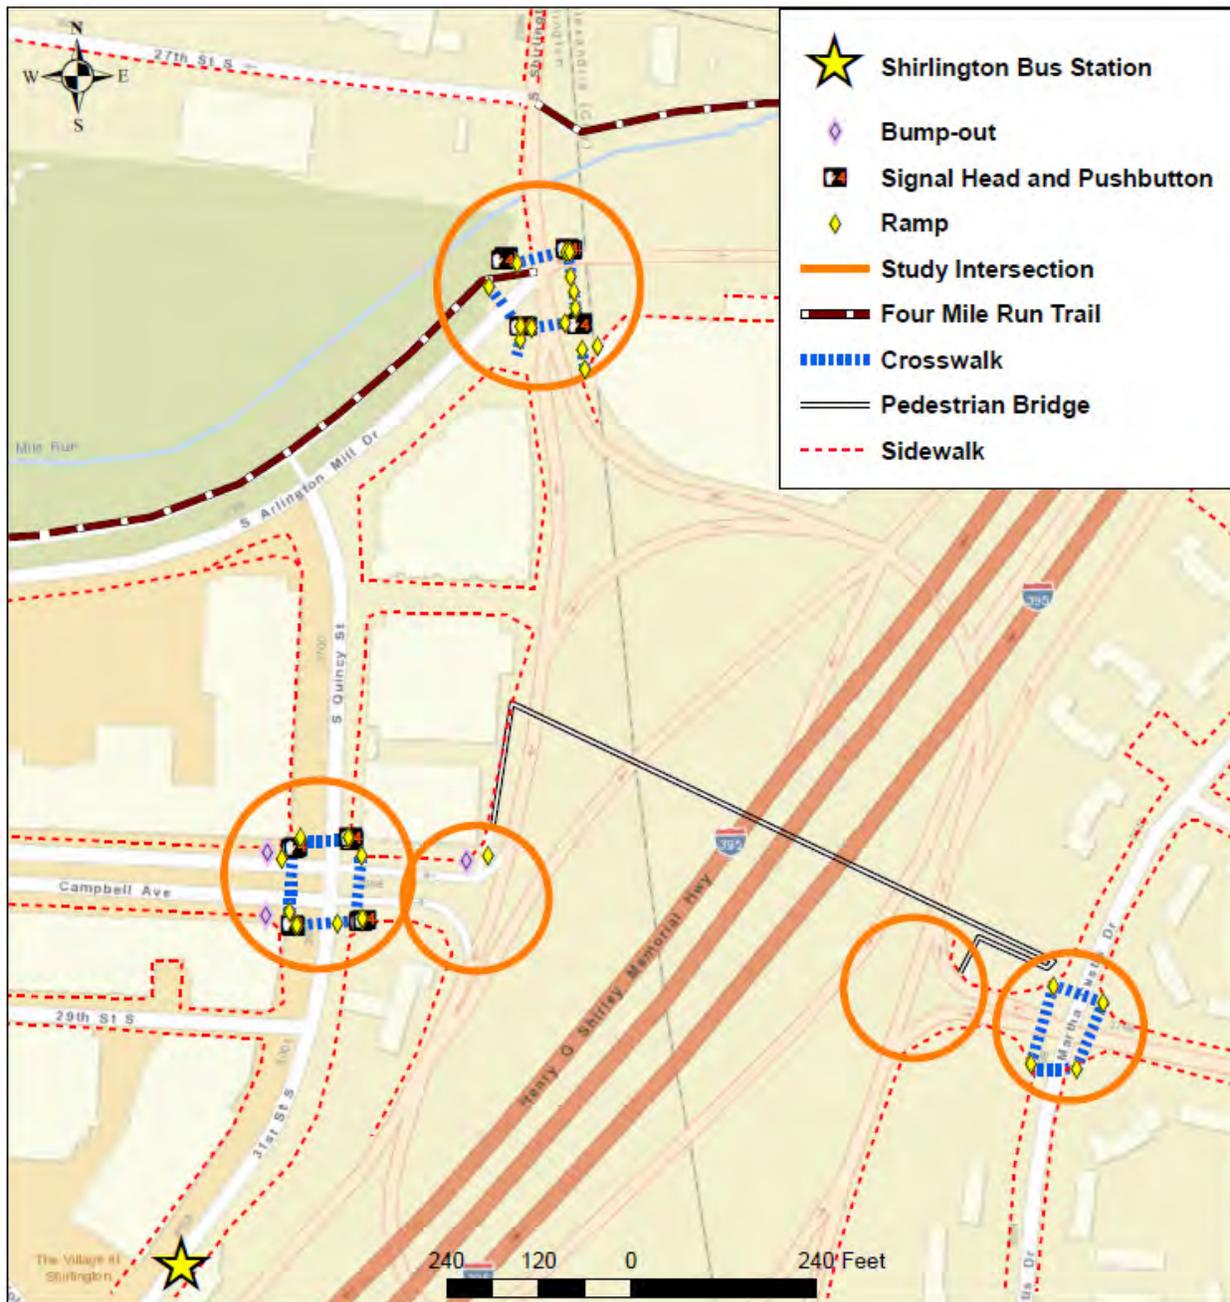
Figure 4: Pedestrian Amenities

Existing pedestrian and bicycle amenities are shown in Figures 4 and 5, respectively, and a discussion of each study intersection is included in the following paragraphs. **Appendix B** provides existing conditions diagrams and **Appendix C** provides the proposed concept diagrams, as discussed in the following paragraphs.

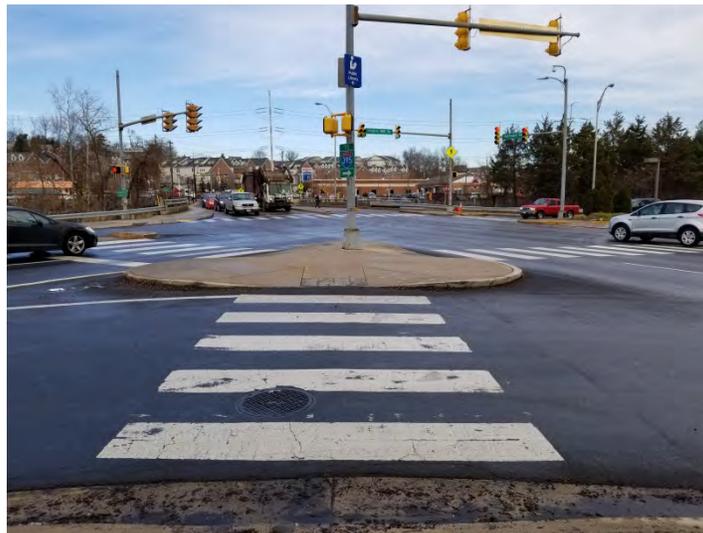
Figure 7: View of Shirlington Road and Arlington Mill Drive Intersection from Southwest Corner

Sidewalk or trail is present on both sides of Arlington Mill Road, on the west side of southbound Shirlington Road, and on the islands on the east side of the intersection. Ramp detectable warning surfaces are missing on the southeast island and the east leg median, and the slopes are too steep to meet ADA compliance. The other ramps have acceptable slopes. Figure 7 shows two photographs of the study intersection from the southwest corner.

The northbound channelized right turn into Shirlington Gateway increases the number of conflict points with pedestrians, and the sidewalk has no destination. If the channelized right turn is closed, pedestrians walking between the garage and the crosswalk can use the closed area while access to the garage is maintained for drivers via the main driveway.

- Eliminate the northbound channelized right turn into Shirlington Gateway.
- Install ADA-compliant curb ramps on the east leg on the median and the southern island.
- Restripe the eastern crosswalk with continental crosswalk pavement markings.
- Remove the existing pedestrian warning signs on the northeast mast arm signal pole.
- Upgrade Pushbutton signs to show the crossing direction.

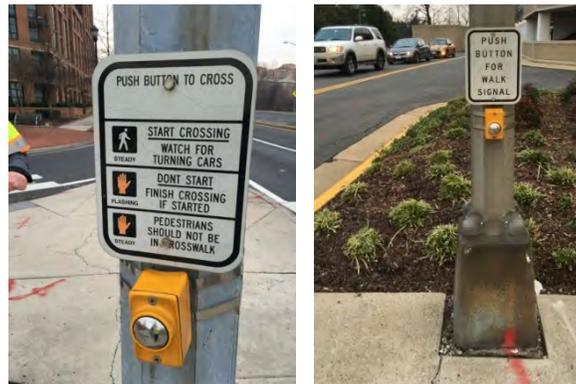
Loop detectors are located along Arlington Mill Drive, the I-395 exit, and the Shirlington Gateway office building exit. Pedestrian signals are present for all crossings. Pushbuttons are provided only to cross Shirlington Road in all four corners and work. Pedestrian signals for Four-Mile Run Road are on recall. Pushbutton signs for Shirlington Road does not indicate the crossing direction, as shown in the following photographs (Figures 8 and 9).

Figure 8 (Left): Pushbutton on Southwest Corner

Figure 9 (Right): Pushbutton on Southeast Corner

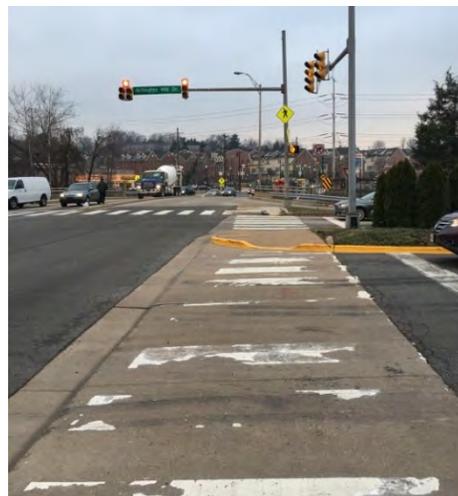
Figure 10: Northbound View of Crosswalk across Shirlington Gateway Office Building Driveway

Continental pavement markings are striped for each crosswalk. Skip lines and double yellow lines along Shirlington Road northbound and southbound were recently repainted. Crosswalks and stop bars for the north, south, and I-395 exit ramp legs were also recently repainted. The west leg crosswalks remain in good condition while the crosswalk at the Shirlington Gateway office building exit is in poor condition, as shown in the following photograph.

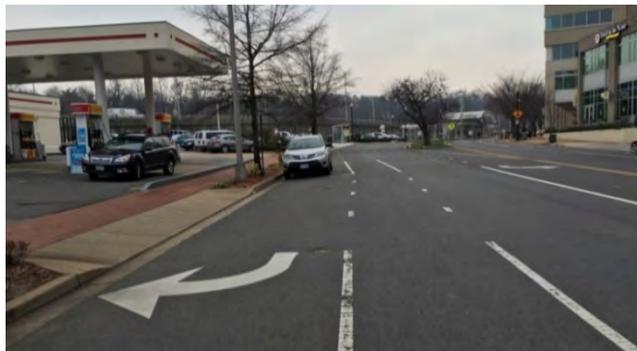
Figure 14: Northbound South Quincy Street Approach

Exclusive bicycle lanes are striped along Quincy Avenue, as shown in Figure 14. Bicycle pavement markings along northbound and southbound Quincy Street do not meet VA MUTCD, Section 9C.04 standards. The Helmeted Bicyclist Symbol should be used, and the bike lane arrow markings are missing. The skip lines currently installed are at an incorrect spacing of 3-foot line, 9-foot skip instead of the required 2-foot line, 4-foot skip per figure 9C-6(VA).

Vehicles including buses were observed queueing along northbound South Quincy Street to turn right. The queue extended across the bicycle lane, thereby blocking it. No impeded bicyclists were observed. Only 75 feet are available for the right-turn lane before a 36-foot parking strip is present. The bike lane and right-turn lane are shown in Figure 14. While there are no pavement markings or signs that clearly identify bicycle routes along Campbell Avenue, there are several bicycle racks on both sides of the street.

- Replace the overhead “Turning Vehicles Yield to Pedestrians in Crosswalk” signs with MUTCD R10-15 image signs.
- Install MUTCD R4-4 “Begin Right Turn Lane Yield to Bikes” sign on northbound approach
- Install new Bike Route sign on northbound Quincy Street.
- Remove existing left arrow under the southbound bike route sign since the sign below shows through and left-turn options.
- Install ADA-compliant curb ramps on southwest, southeast, and northwest corners.
- Remove detectible warning surface on north median since it is too narrow.
- Restripe bike lanes and pavement markings to match VA MUTCD requirements.
- Extend northbound right-turn lane to provide additional storage.

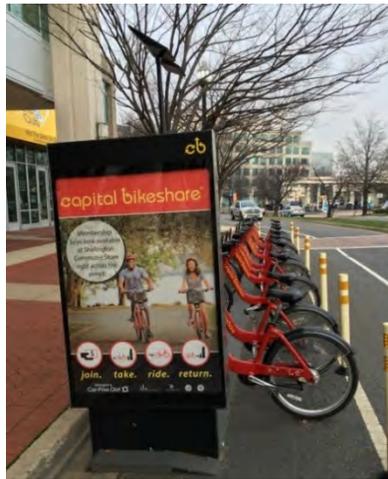
The Shirlington Transit Center/S Quincy & Randolph St Capital Bikeshare station is located approximately 300 feet south of Campbell Avenue along South Quincy Avenue across from Shirlington Station and is shown in Figure 15.

Figure 15: Shirlington Transit Center Capital Bikeshare Station

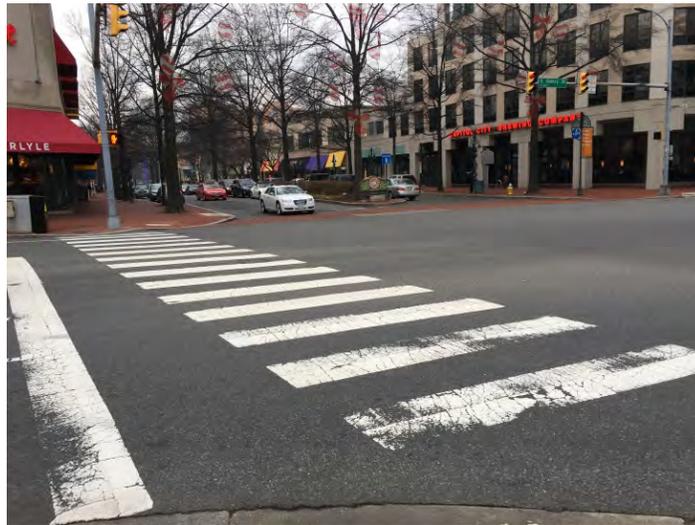
Figure 13: View from Southeast Corner of Campbell Avenue and South Quincy Street

Pavement markings are in fair condition. Continental pedestrian pavement markings are used across all crossings except the west leg of Campbell Avenue where decorative red brick is used to delineate the pedestrian crossing, as shown Figure 13.

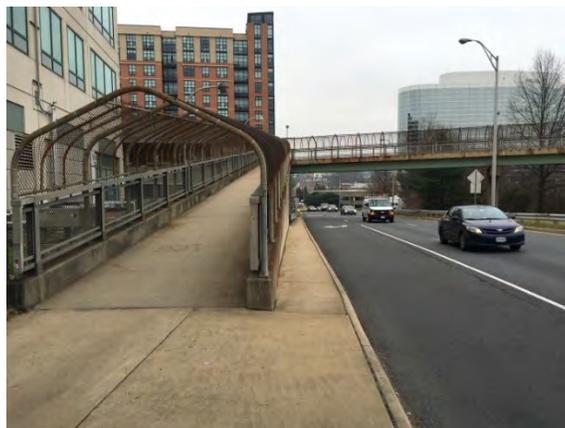
Figure 18: Pedestrian Bridge Connecting Fairlington and Shirlington

Sidewalk is present on the southwest corner, but there are no destinations for pedestrians east of South Quincy Street. Access to the pedestrian bridge overpass crossing I-395 (shown in Figure 13) is present on the northwest corner. No crosswalks are present, but a ramp is located on the northwest corner.

Street lighting is present at the intersection. While no lights are located directly on the northwest corner near the pedestrian overpass, there is lighting on the overpass and street lighting on both roadways.

- Eliminate the ramp on the northwest corner and rebuild the curb and sidewalk.
- Install signs indicating pedestrians should use the crosswalk at Quincy Street (R9-3 and R9-3bP assembly.)
- Install pedestrian lighting in the northwest corner at the start of the pedestrian overpass entrance.

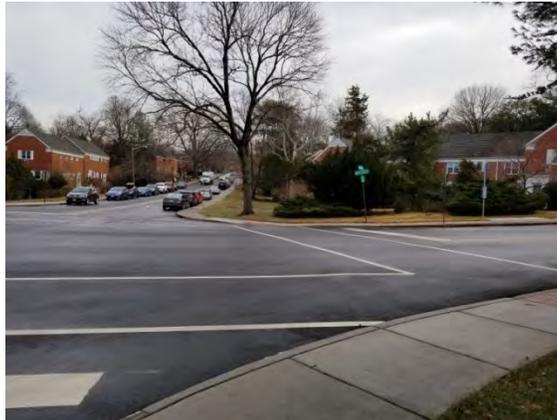
Figure 21: Intersection of Gunston Road and Martha Custis Drive

The crosswalks and stop bars for all four approaches were recently repainted. Standard parallel line pedestrian crossing markings were clearly striped on each approach. The southern crosswalk is striped at an angle as is shown in Figure 21. Low volume pedestrian activity was observed.

- Realign the southern crosswalk and stop bar on Martha Custis Drive to shorten the crossing distance, and rebuild the southeast ramp to match.
- Restrict northbound parking and install/relocate bus signs for the northbound Martha Custis Drive near side bus stop.
- Relocate stop signs to be closer to the stop lines.

- Install sharrows on north leg for consistency.
- Install new sidewalk to pave the footpath to provide more direct access to the pedestrian bridge.
- Remove the curb abutted sidewalk in the northwest corner.

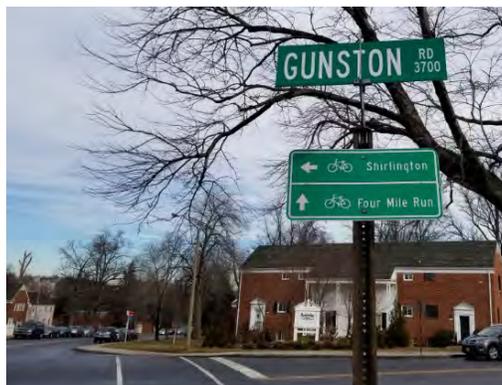
Figure 23: Bicycle Signs on Northbound Martha Custis Drive at Gunston Road

There are sharrow pavement markings south of the intersection along Martha Custis Drive and east on Gunston Drive and in new condition. Bicycle signs are present at the intersection, such as the ones shown in Figure 23. No bicyclists were observed during the field visit.

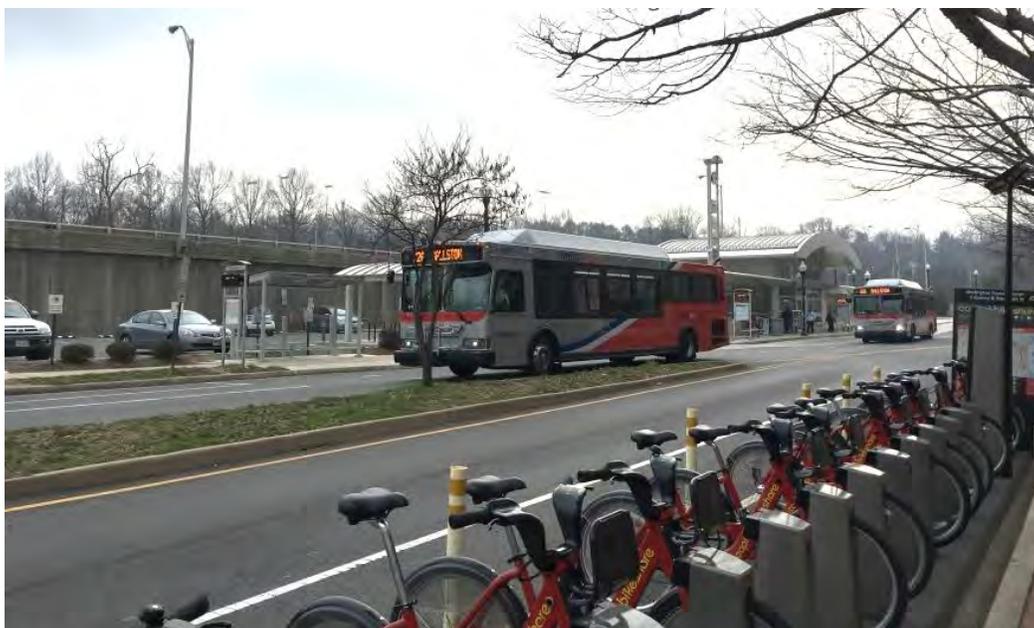
Figure 25: Capital BikeShare Station and Buses Departing Shirlington Station Transit Center

Three different agencies have multiple bus routes traversing the Shirlington area, including Washington Metropolitan Area Transit Authority (WMATA), Arlington Transit (ART), and Alexandria Transit Company’s DASH. Shirlington Station is located south of downtown Shirlington along South Quincy Street with five bus bays, an indoor waiting area, a staffed commuter store offering transit information, and audible schedule devices. The station, shown in Figure 25, serves over 2,000 commuters daily.

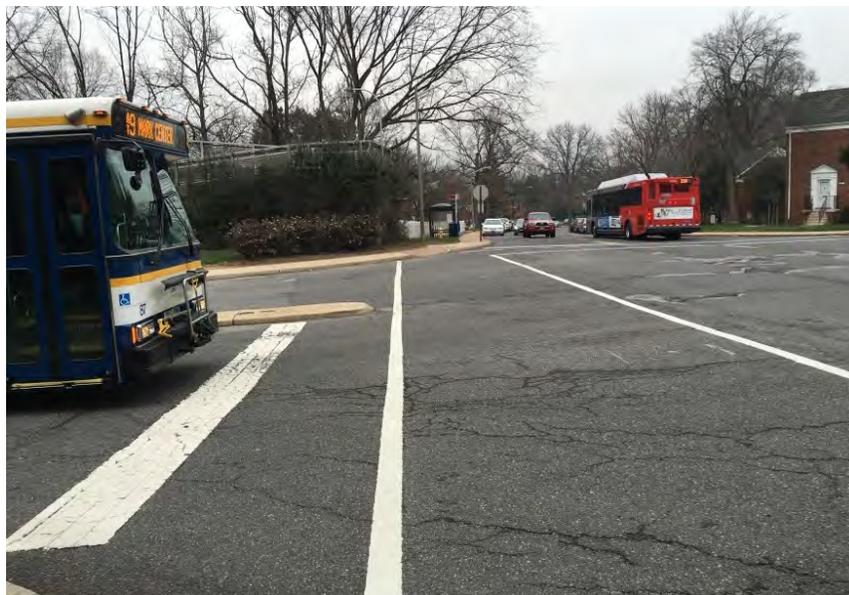
Figure 26: DASH and WMATA Buses at Intersection of Gunston Road and Martha Custis Drive

DASH and WMATA buses are shown in Figure 26 at the intersection of Gunston Road and Martha Custis Drive.

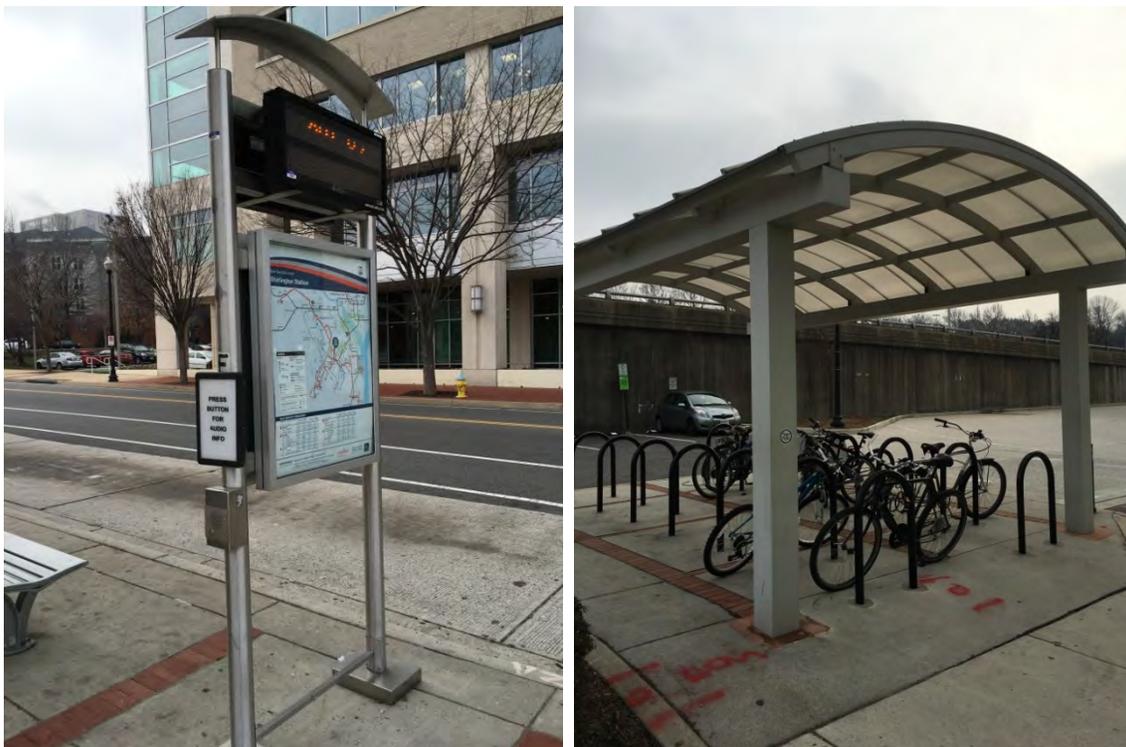
Shirlington Station is Arlington County's only enclosed public bus station; it is located at 2975 South Quincy Street, adjacent to I-395. Over 2,000 commuters use the station daily. The building is staffed with employees providing route and travel information for all transit options. There are five bus bays for WMATA and ART public buses. Each bus bay is equipped with route information, electronic signing with next bus arrival time, and audible scheduling devices, as shown Figure 27. There is an additional bus stop for Alexandria's DASH route AT9 located 100 feet north of the station along South Quincy Street. Aside from Shirlington Transit Center, bus stops are located throughout the area. While not all have bus shelters, all are well marked and clearly visible. There are no Park & Ride facilities in the immediate vicinity. A covered bicycle rack shelter is located directly north of the station and is shown in Figure 28.

Figure 27 (Left): Bus Bay Featuring Route Information and Audible Schedule Devices

Figure 28 (Right): Covered Bicycle Parking at Shirlington Transit Center

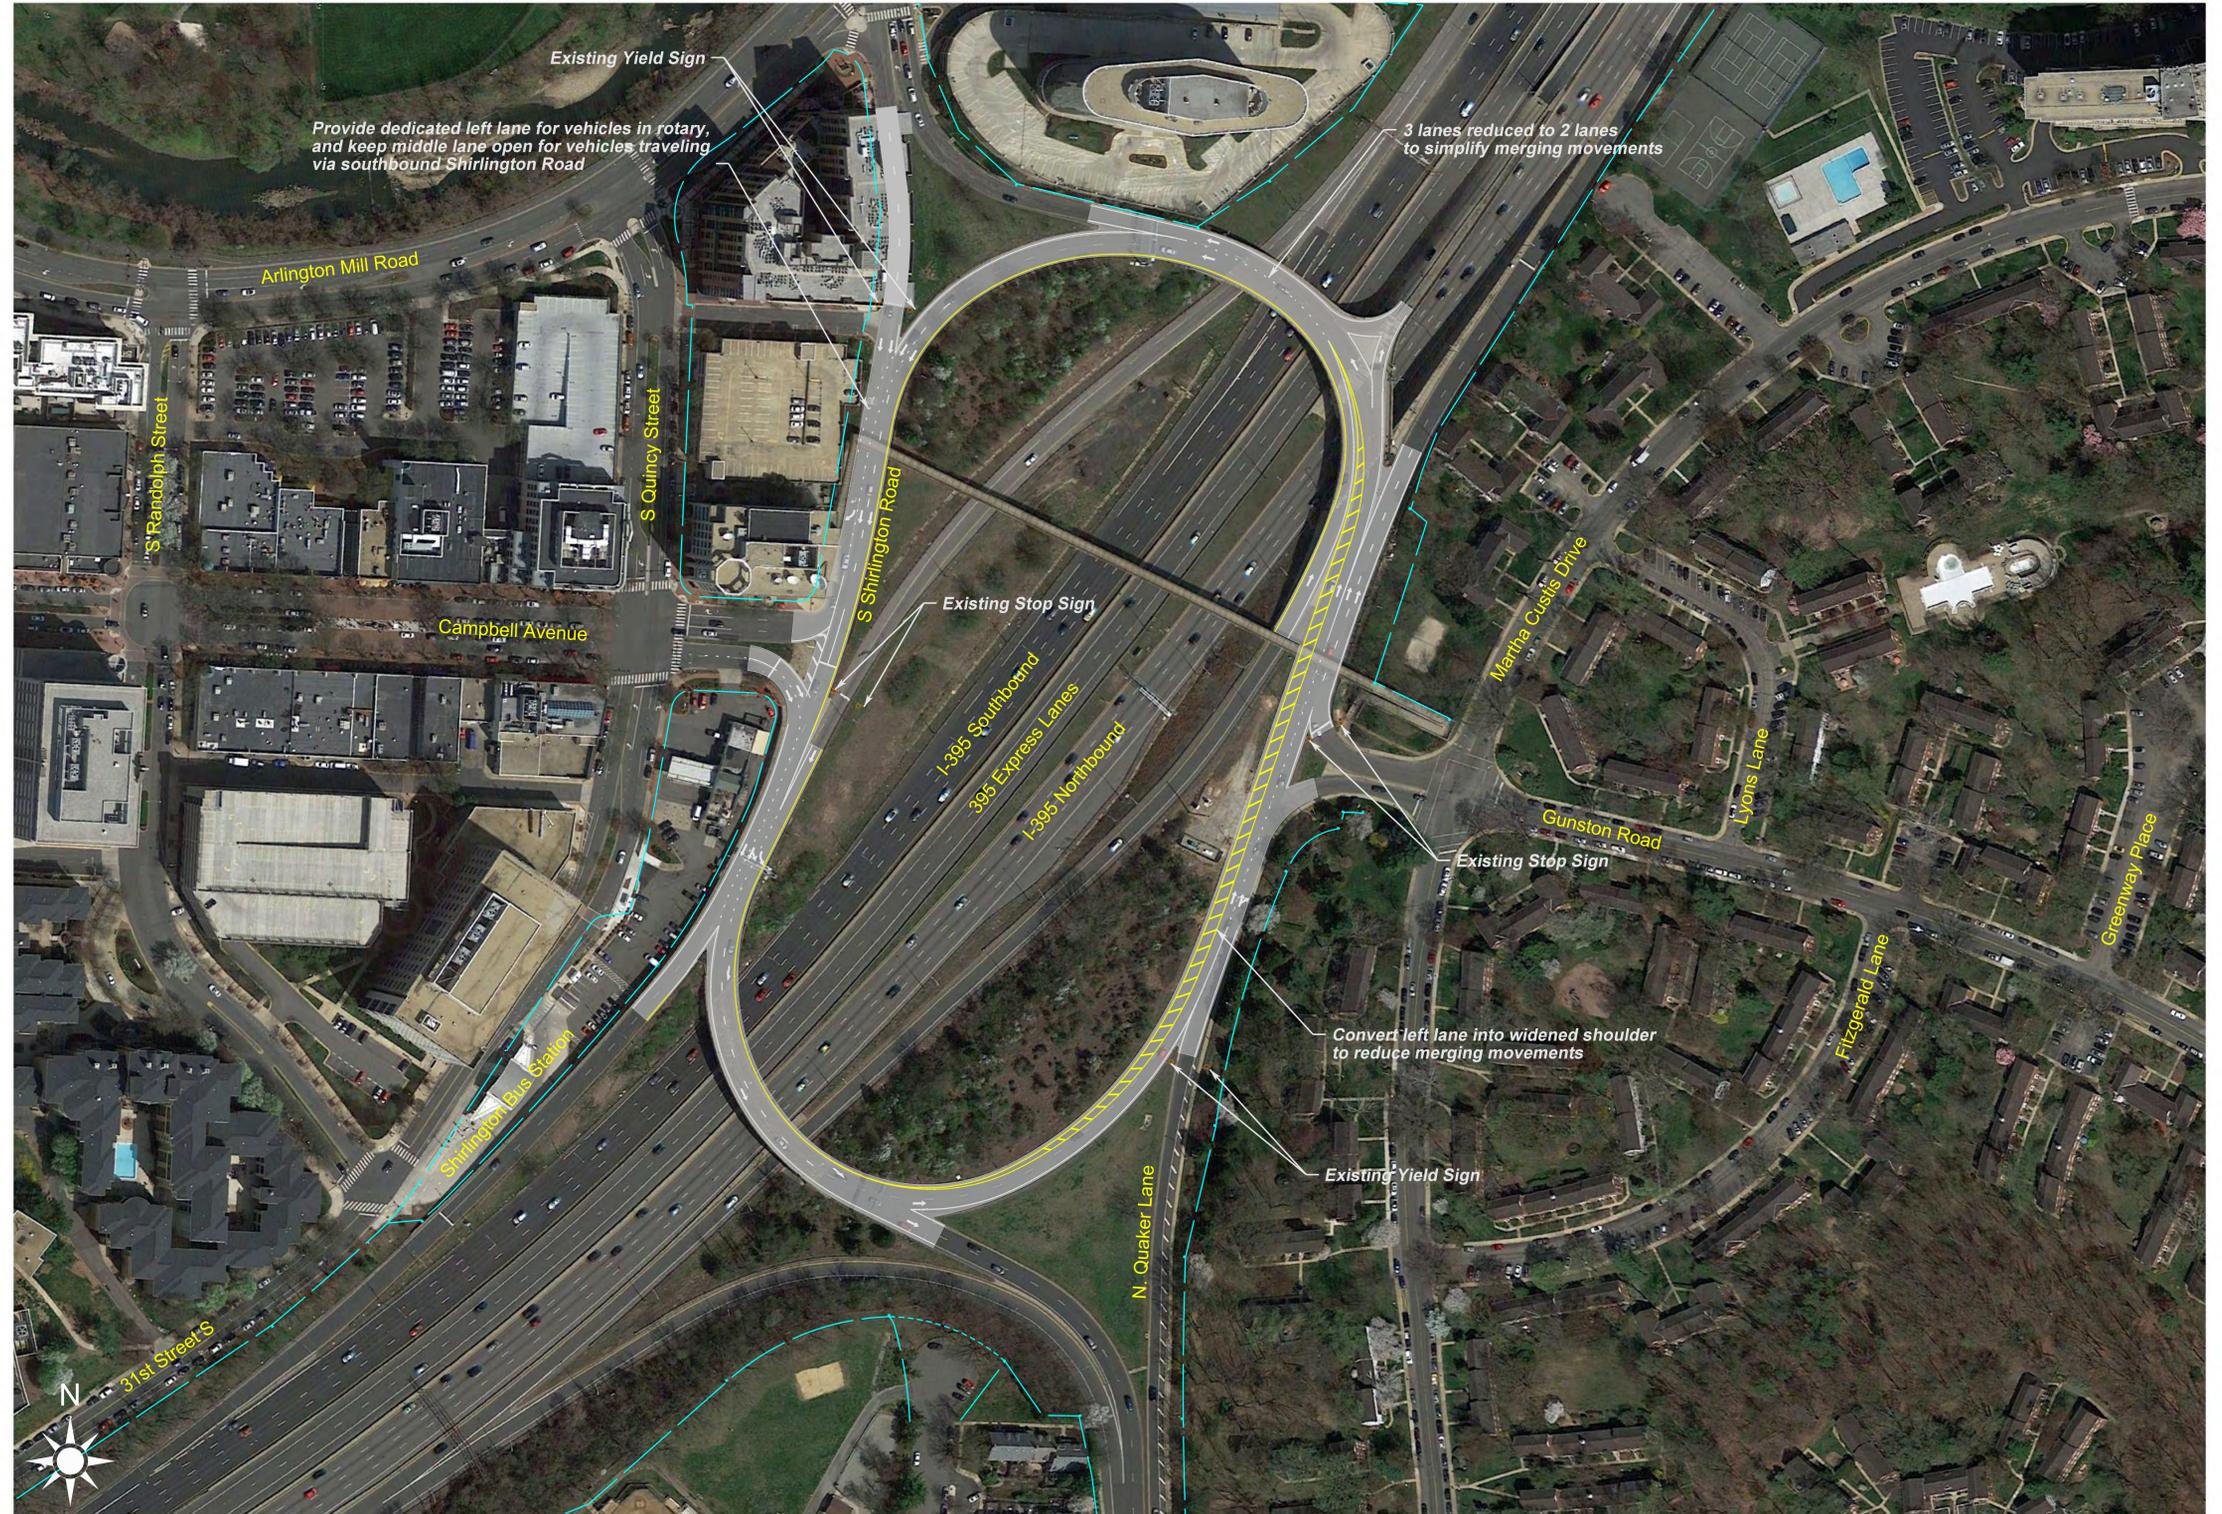
S1: Reduce Required Weaves; Reduce and Repurpose Existing Lanes

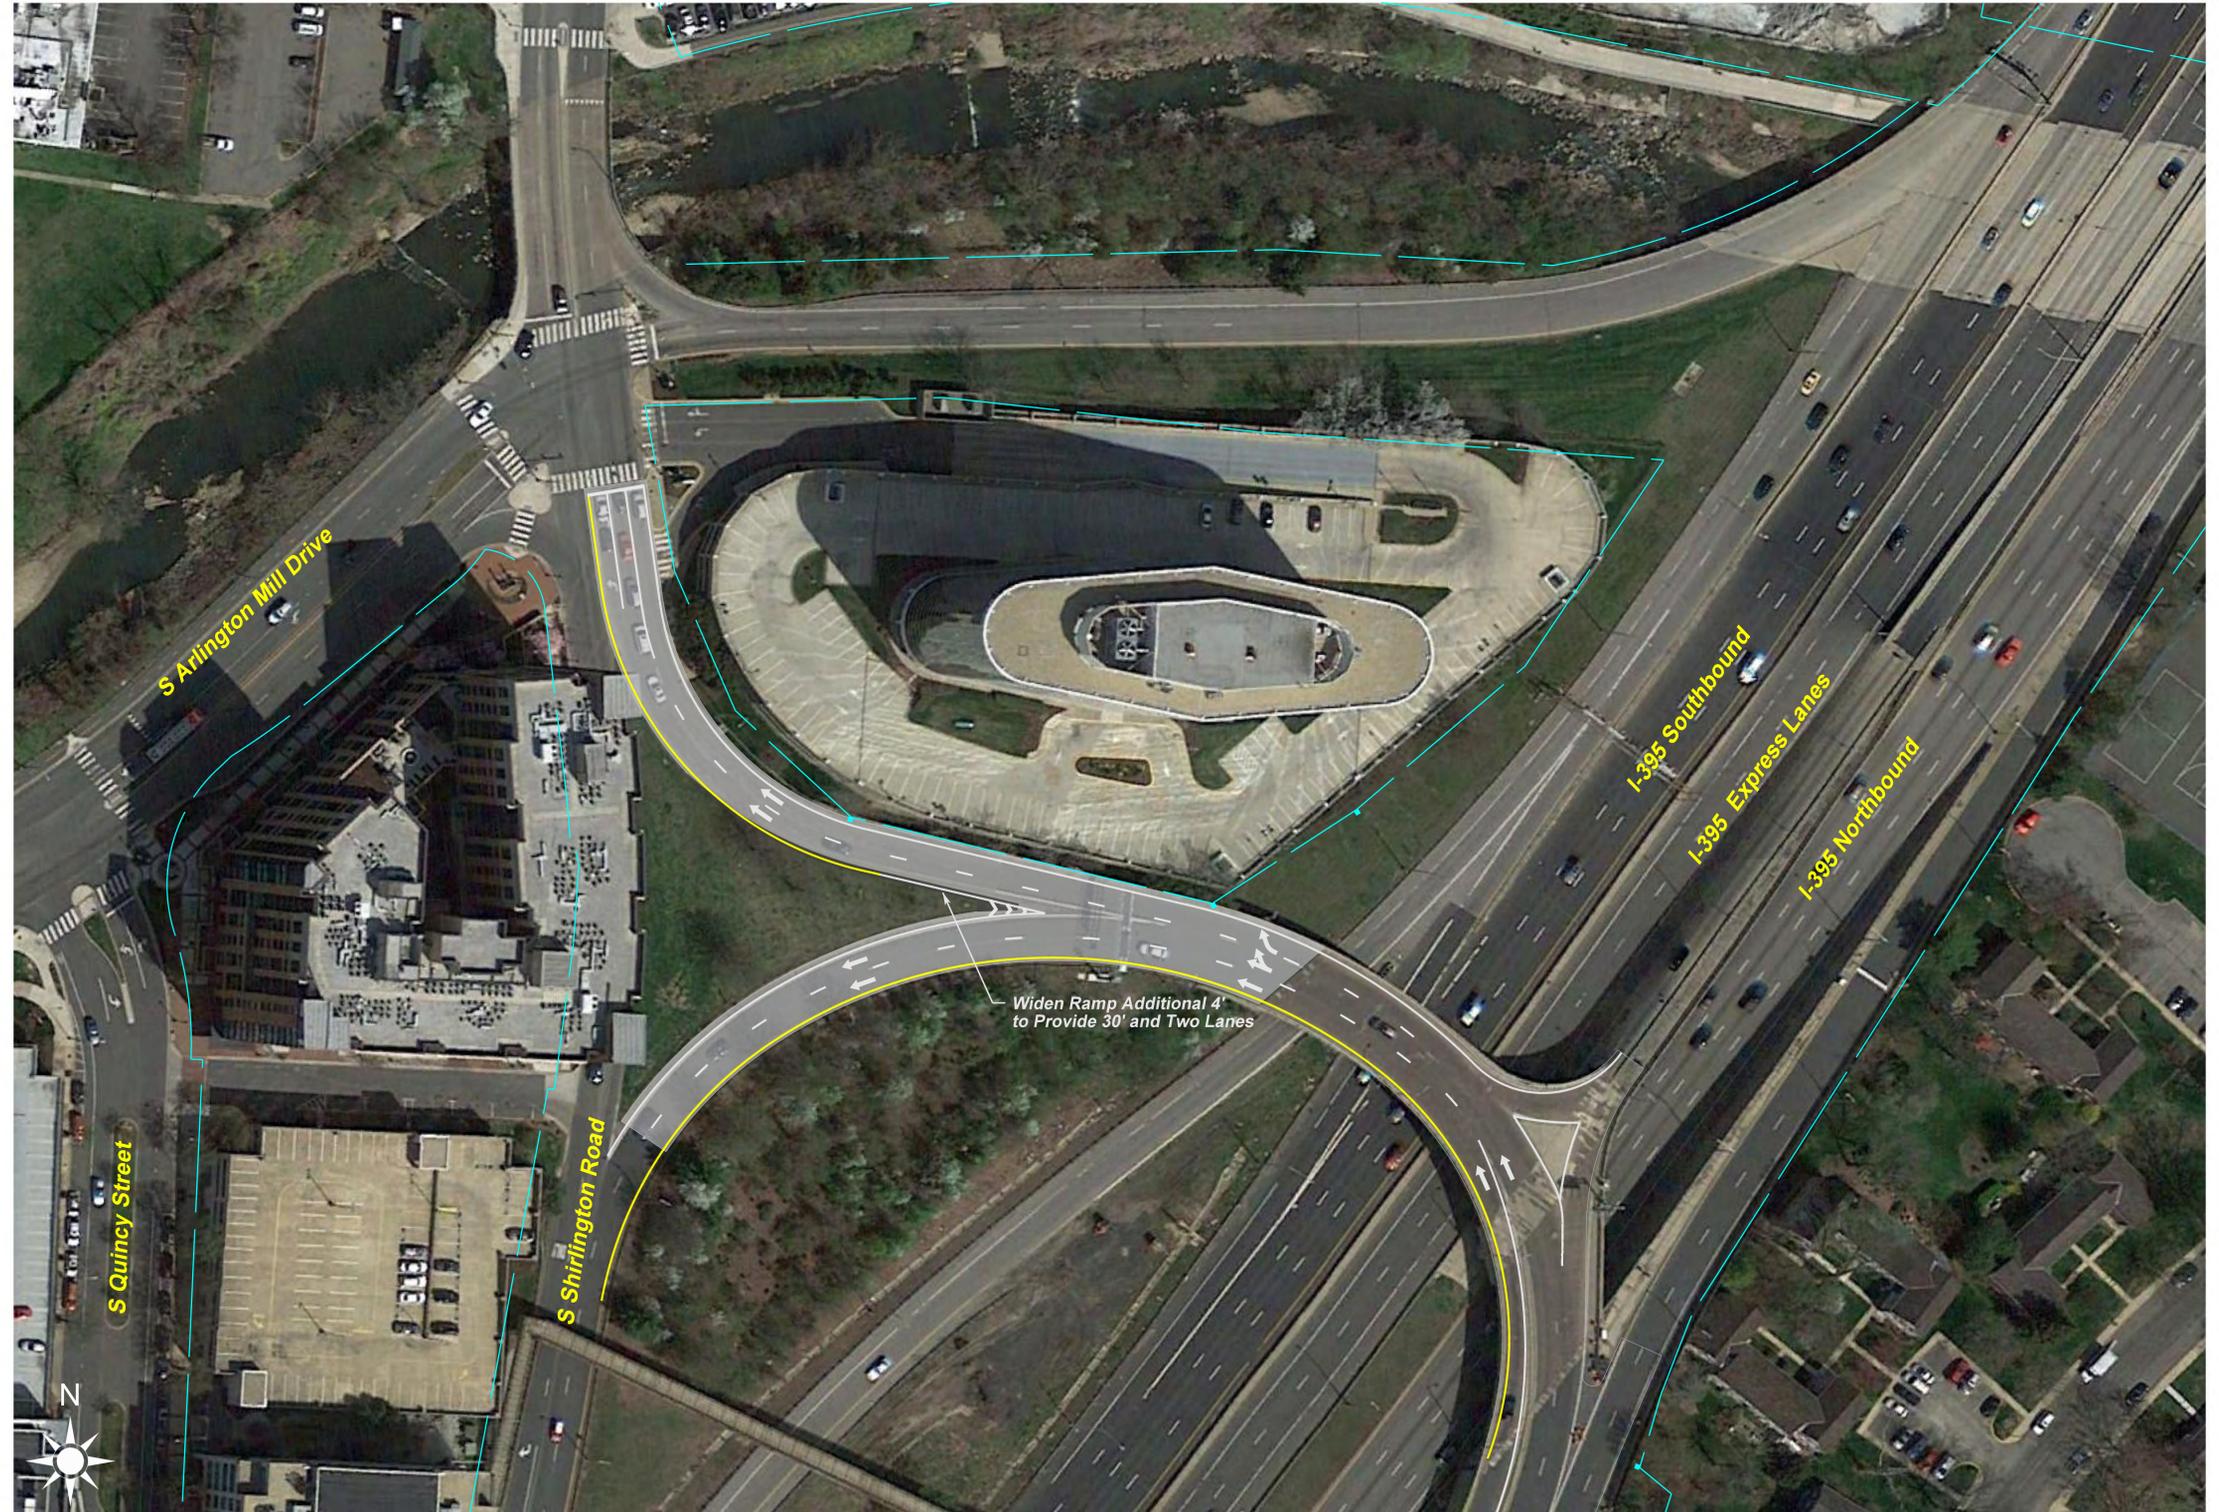
S7: Add Full Lane to Arlington Mill Road On-Ramp

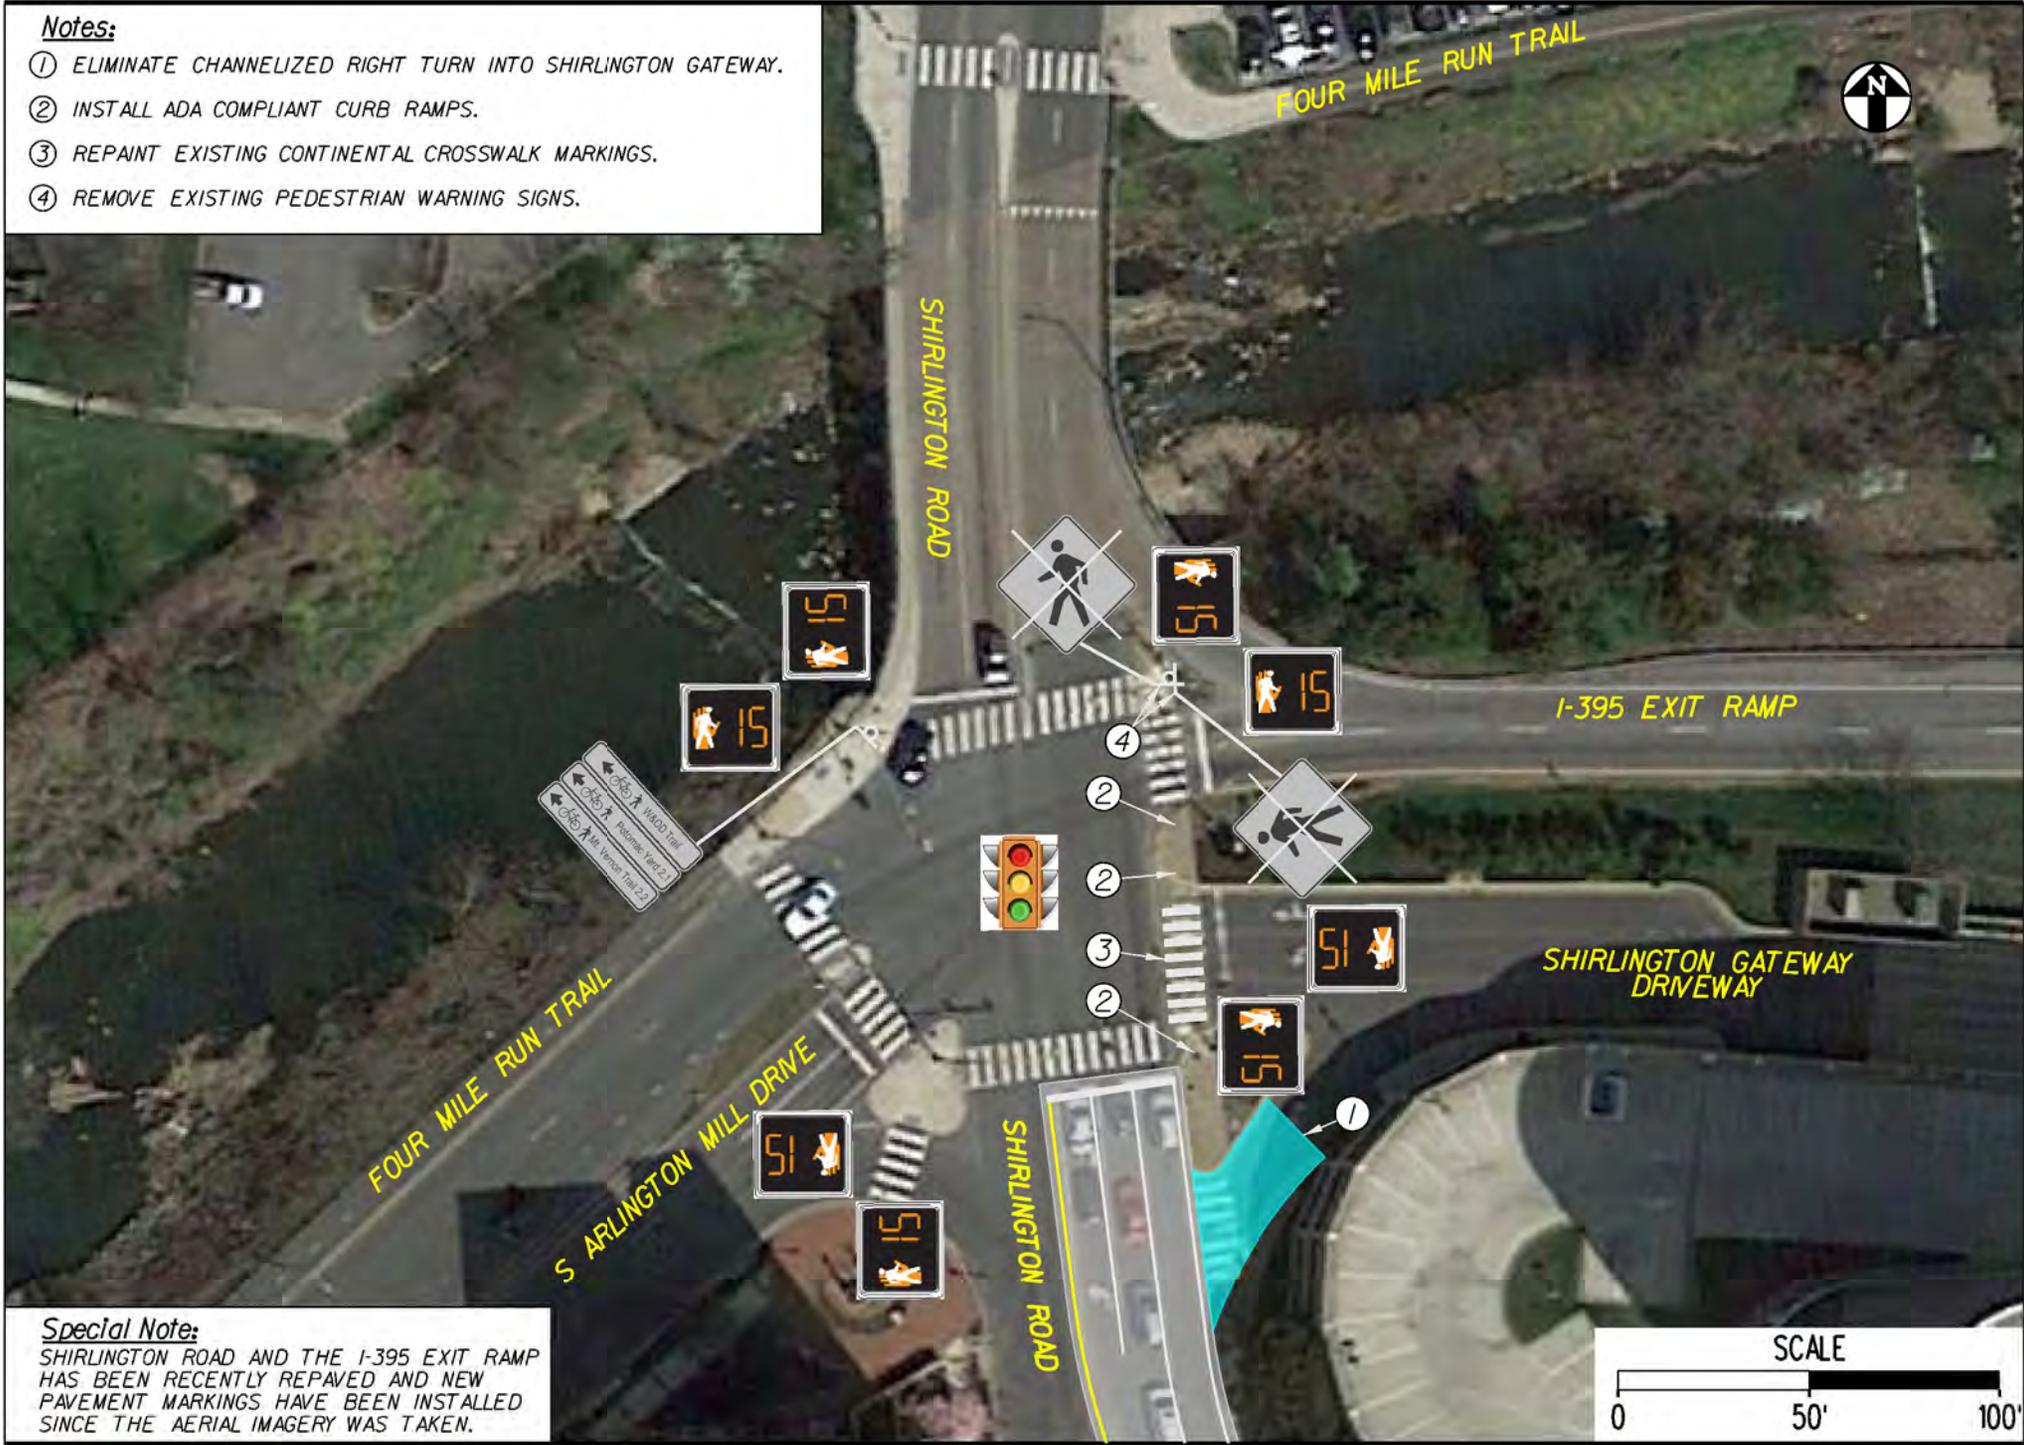
- ① ELIMINATE CHANNELIZED RIGHT TURN INTO SHIRLINGTON GATEWAY.
- ② INSTALL ADA COMPLIANT CURB RAMP.
- ③ REPAINT EXISTING CONTINENTAL CROSSWALK MARKINGS.
- ④ REMOVE EXISTING PEDESTRIAN WARNING SIGNS.
