APPENDIX F - Multimodal Analysis Report

Multi Modal Analysis

I. INTRODUCTION

I-395 & Shirlington Rd Interchange Safety & Operations Phase II Study

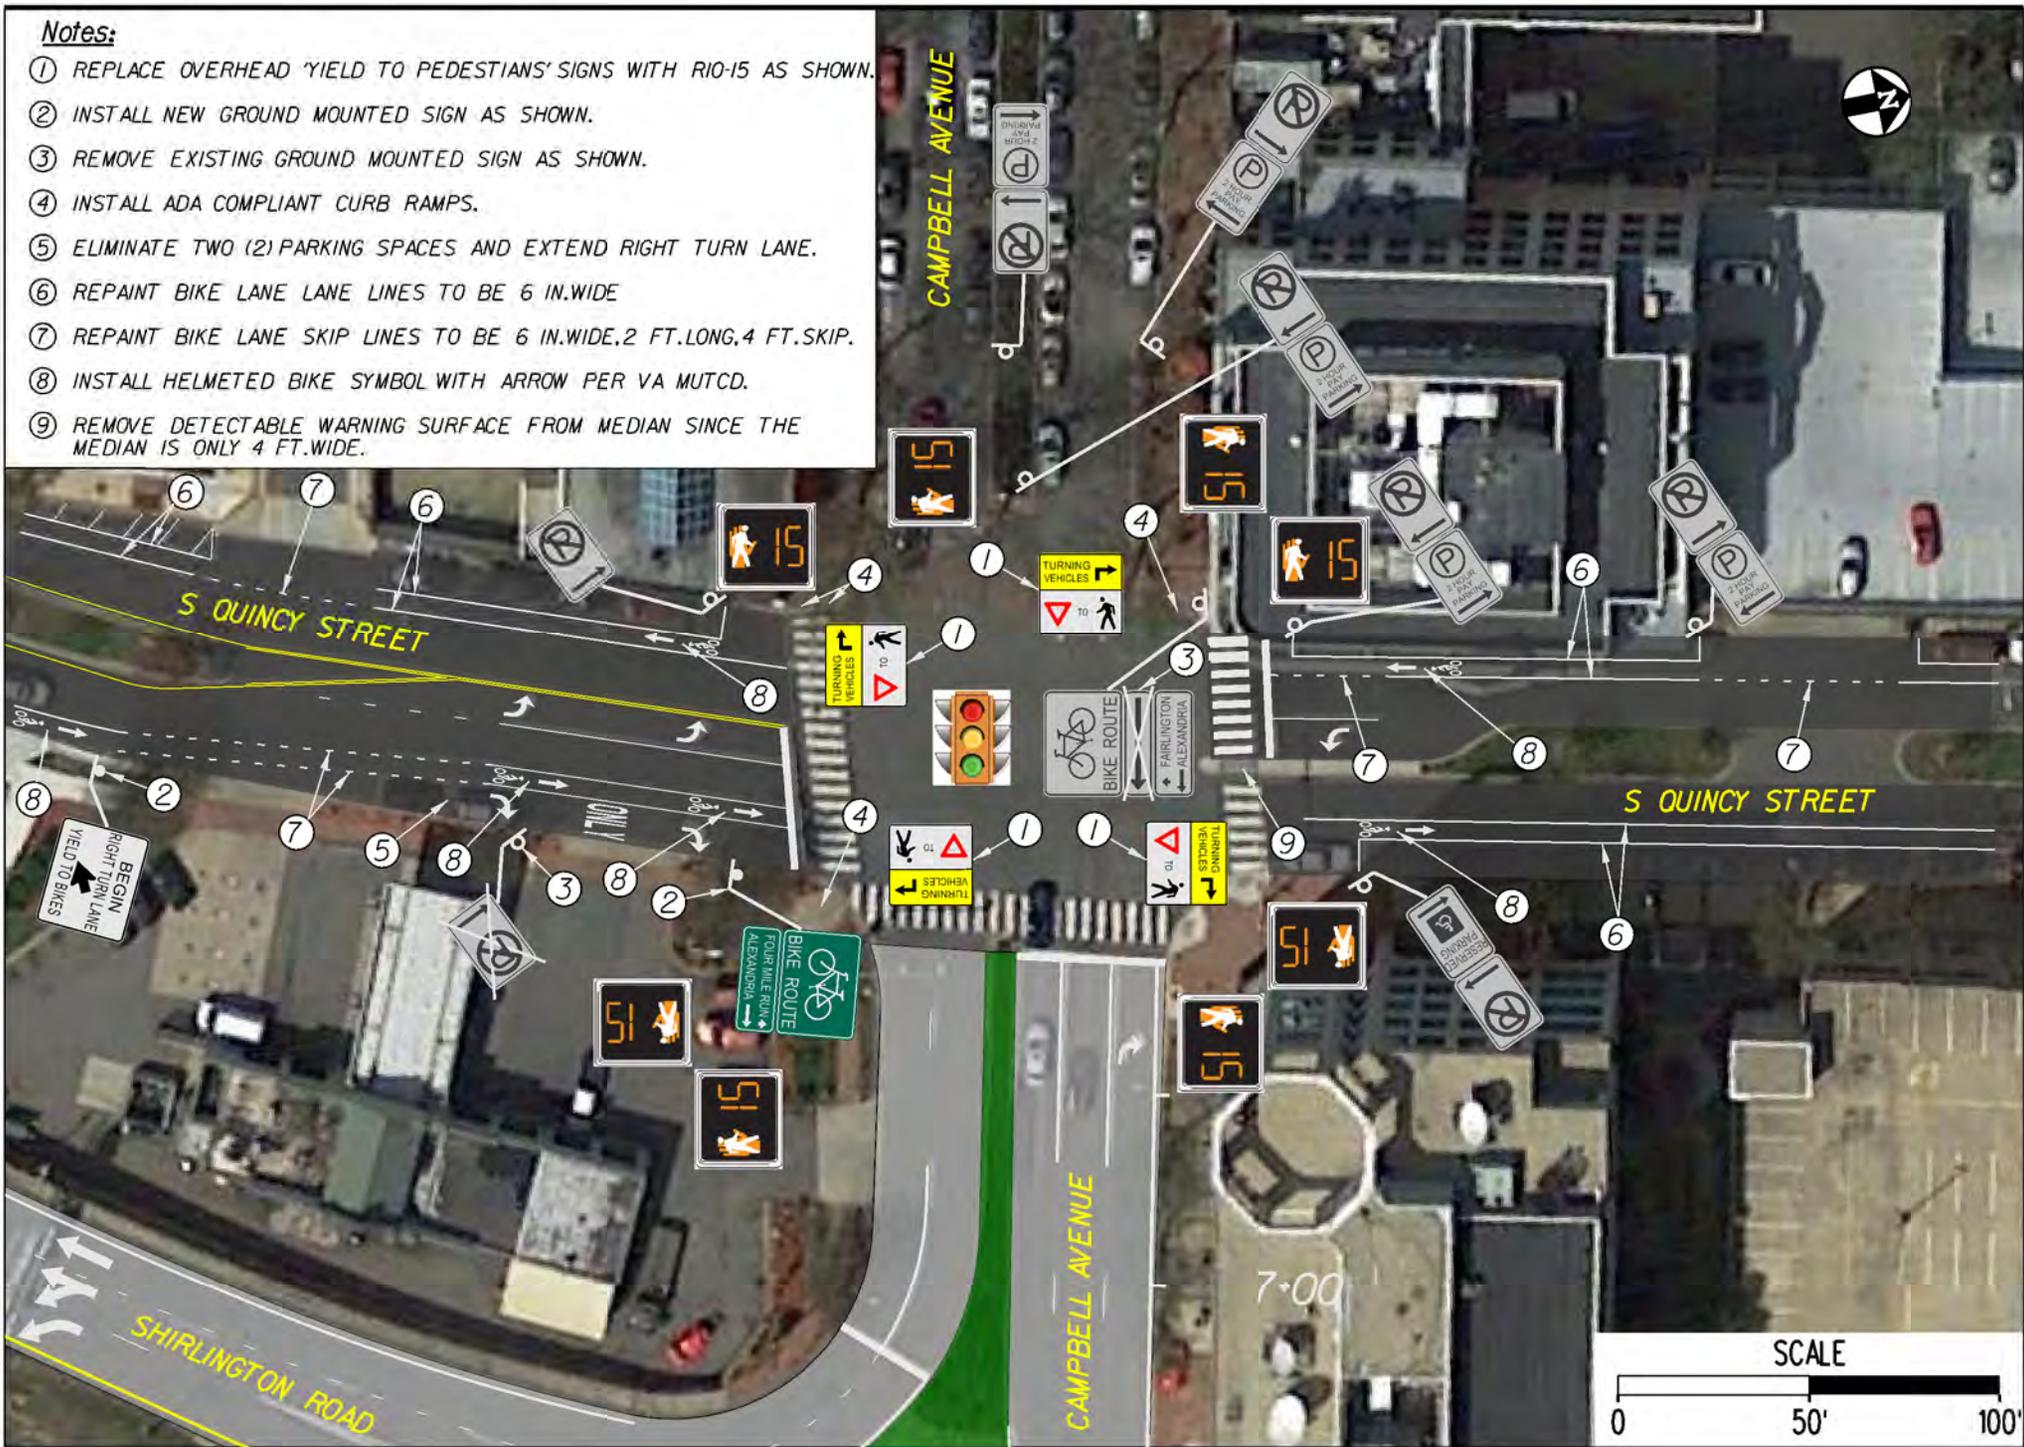
- ① REPLACE OVERHEAD 'YIELD TO PEDESTIANS' SIGNS WITH RIO-15 AS SHOWN.
- ② INSTALL NEW GROUND MOUNTED SIGN AS SHOWN.
- ③ REMOVE EXISTING GROUND MOUNTED SIGN AS SHOWN.
- ④ INSTALL ADA COMPLIANT CURB RAMP.
- ⑤ ELIMINATE TWO (2) PARKING SPACES AND EXTEND RIGHT TURN LANE.
- ⑥ REPAINT BIKE LANE LANE LINES TO BE 6 IN.WIDE
- ⑦ REPAINT BIKE LANE SKIP LINES TO BE 6 IN.WIDE, 2 FT.LONG, 4 FT.SKIP.
- ⑧ INSTALL HELMETED BIKE SYMBOL WITH ARROW PER VA MUTCD.
- ⑨ REMOVE DETECTABLE WARNING SURFACE FROM MEDIAN SINCE THE MEDIAN IS ONLY 4 FT.WIDE.

- Replace the overhead “Turning Vehicles Yield to Pedestrians in Crosswalk” signs with MUTCD R10-15 image signs.
- Install MUTCD R4-4 “Begin Right Turn Lane Yield to Bikes” sign on northbound approach
- Install new Bike Route sign on northbound Quincy Street.
- Remove existing left arrow under the southbound bike route sign since the sign below shows through and left-turn options.
- Install ADA-compliant curb ramps on southwest, southeast, and northwest corners.
- Remove detectible warning surface on north median since it is too narrow.
- Restripe bike lanes and pavement markings to match VA MUTCD requirements.
- Extend northbound right-turn lane to provide additional storage.

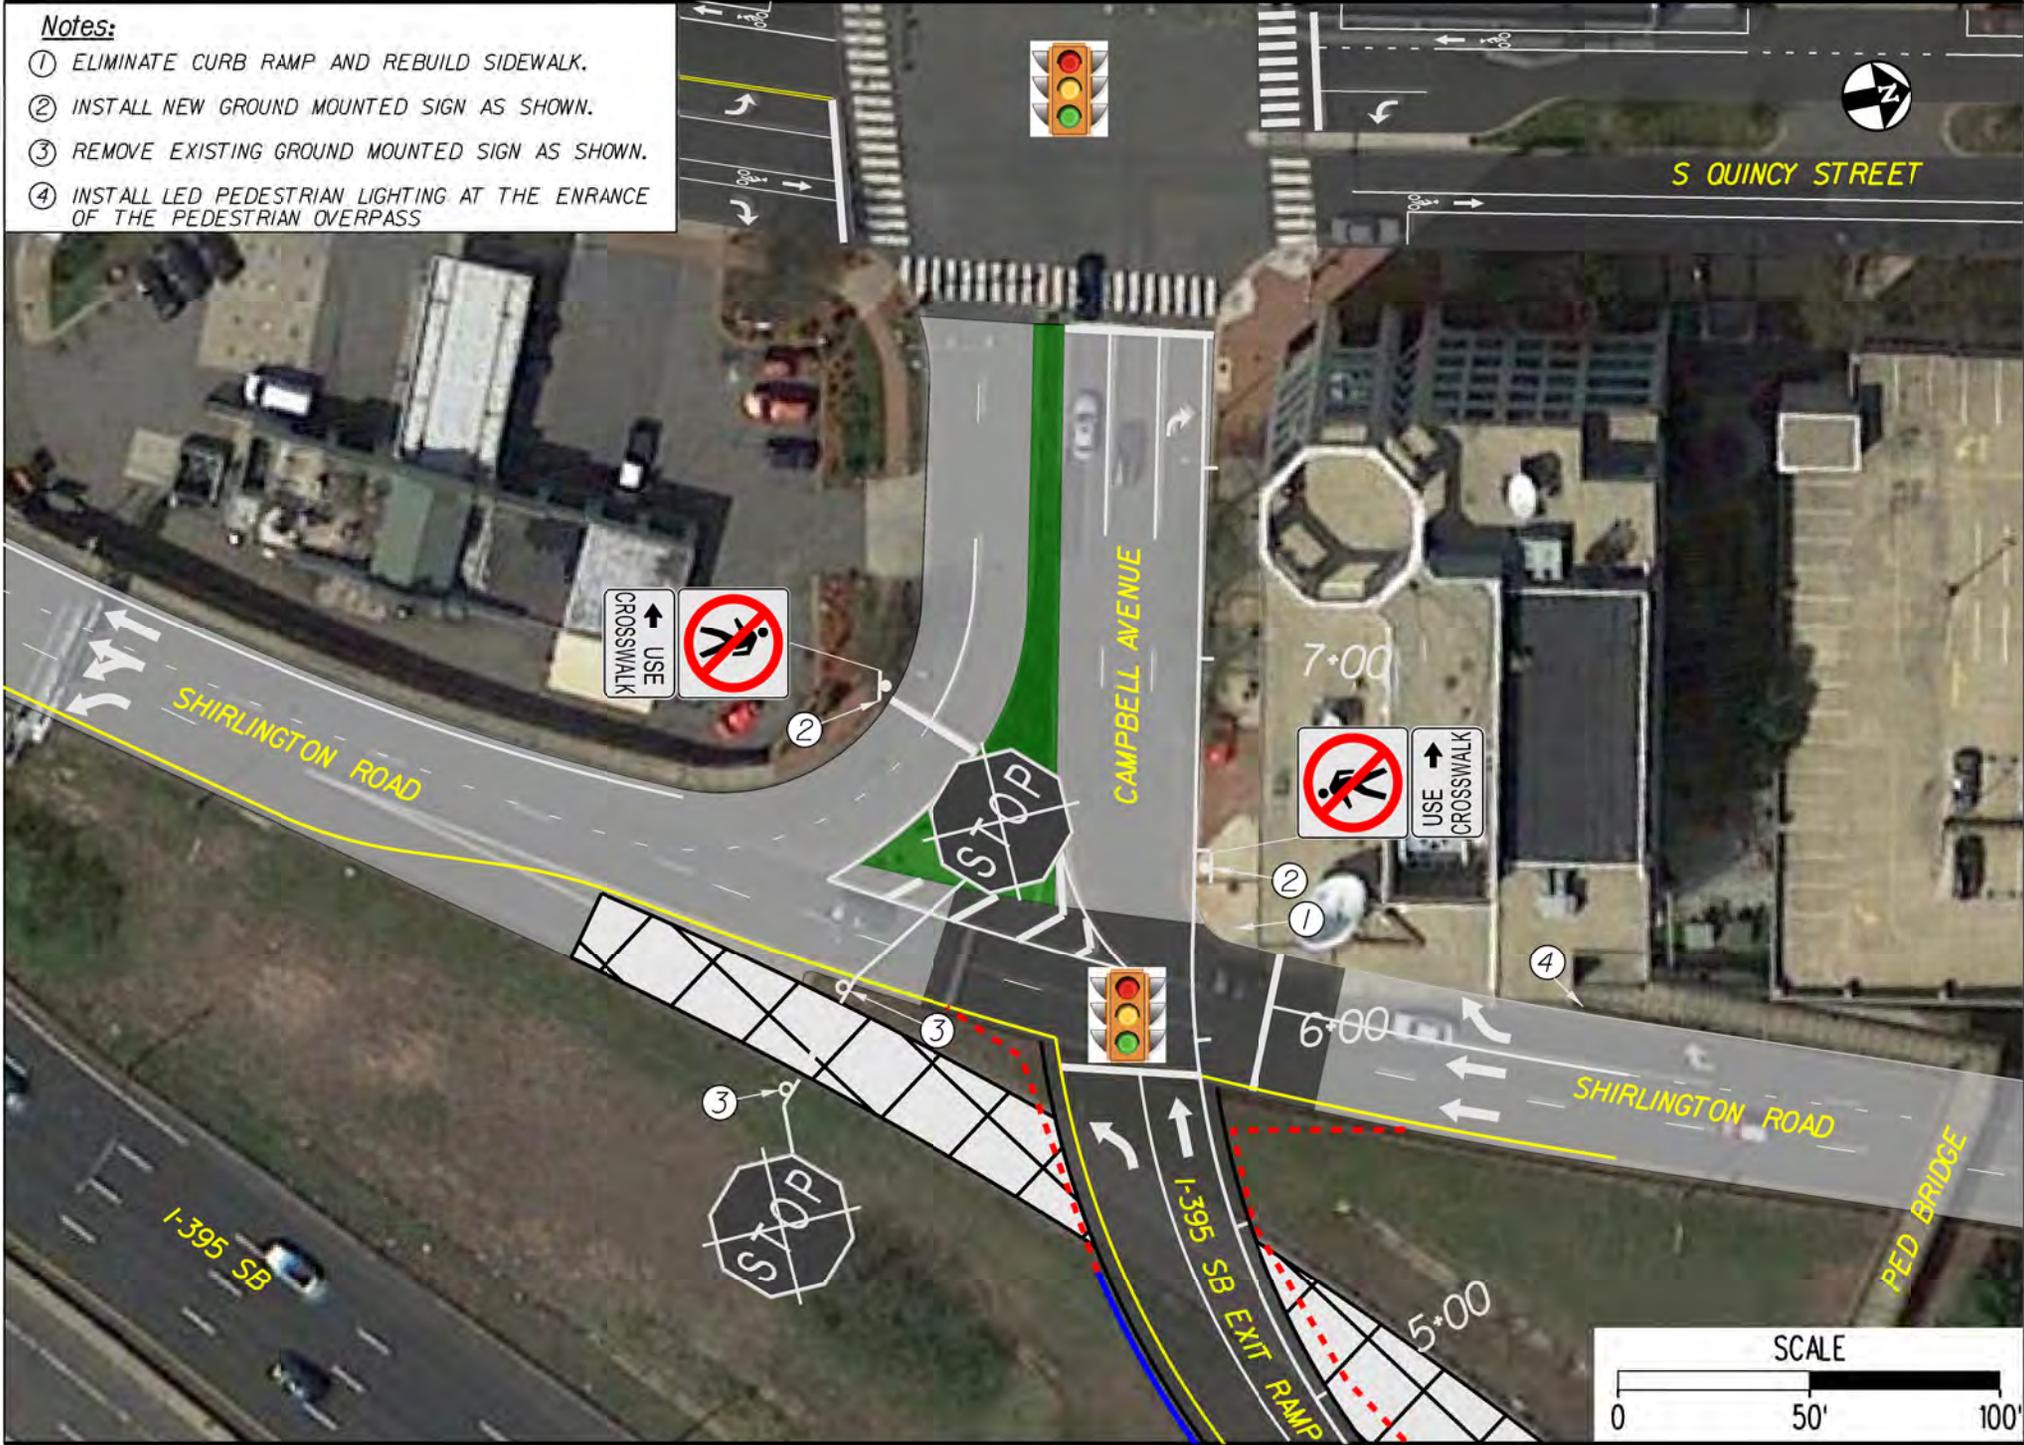
- ① ELIMINATE CURB RAMP AND REBUILD SIDEWALK.
- ② INSTALL NEW GROUND MOUNTED SIGN AS SHOWN.
- ③ REMOVE EXISTING GROUND MOUNTED SIGN AS SHOWN.
- ④ INSTALL LED PEDESTRIAN LIGHTING AT THE ENTRANCE OF THE PEDESTRIAN OVERPASS

- Eliminate the ramp on the northwest corner and rebuild the curb and sidewalk.
- Install signs indicating pedestrians should use the crosswalk at Quincy Street (R9-3 and R9-3bP assembly.)
- Install pedestrian lighting in the northwest corner at the start of the pedestrian overpass entrance.

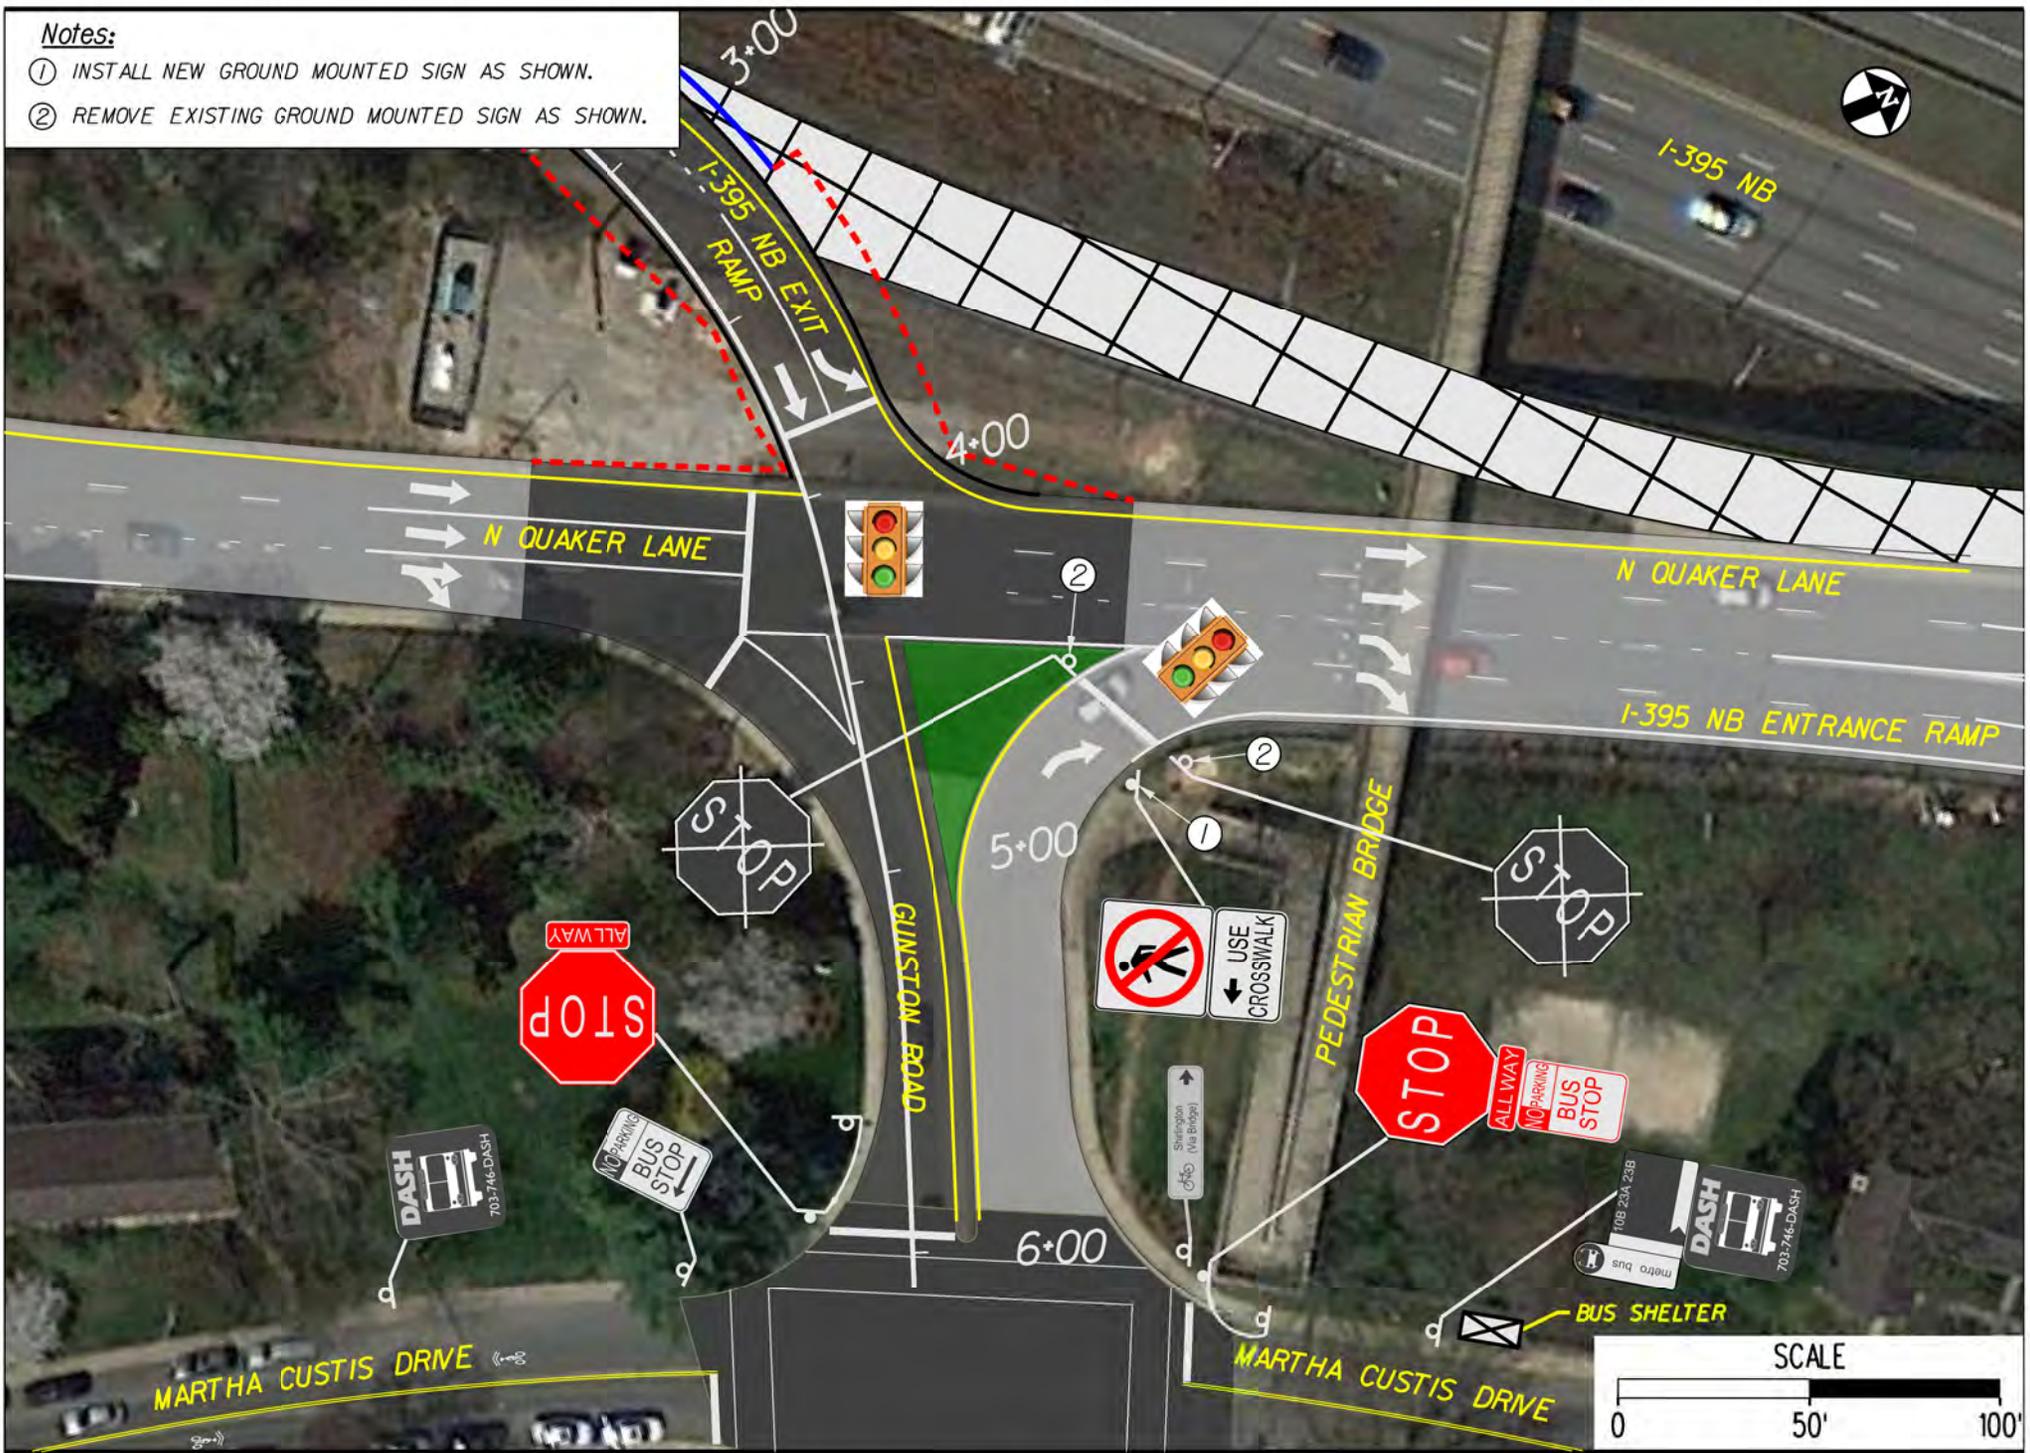
- ① INSTALL NEW GROUND MOUNTED SIGN AS SHOWN.
- ② REMOVE EXISTING GROUND MOUNTED SIGN AS SHOWN.

- Install signs indicating pedestrians should use the crosswalk at Martha Custis Drive (R9-3 and R9-3bP assembly) for pedestrians coming off the pedestrian bridge.
- Install new sidewalk to pave the footpath to provide more direct access to the pedestrian bridge.
- Provide pedestrian-level lighting for the new footpath.

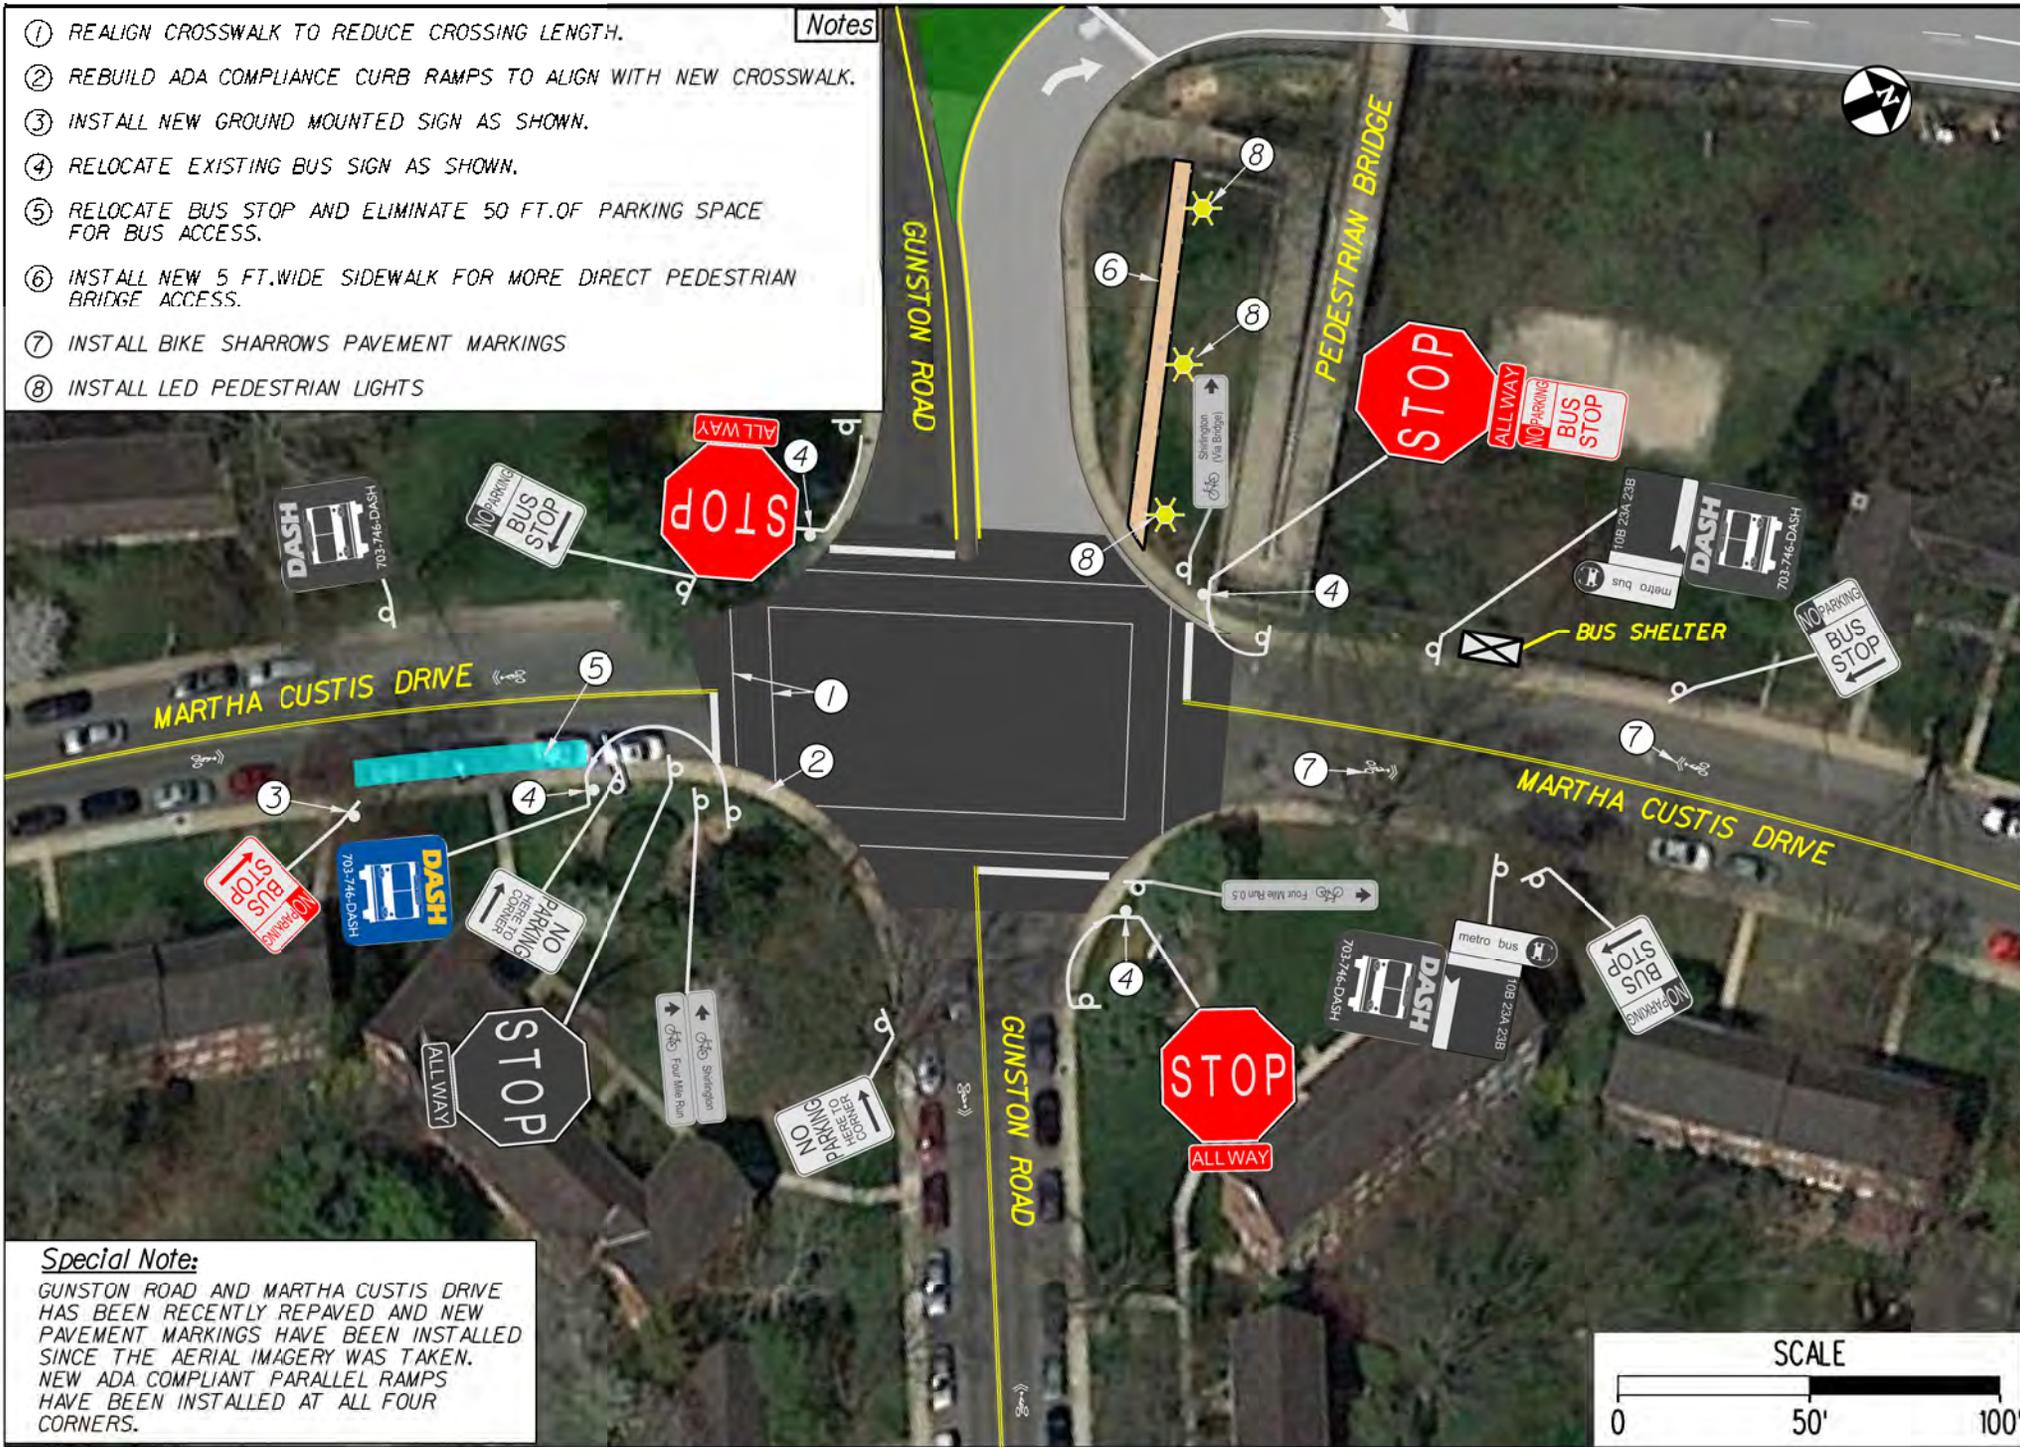
- Notes**
- ① REALIGN CROSSWALK TO REDUCE CROSSING LENGTH.
 - ② REBUILD ADA COMPLIANCE CURB RAMP TO ALIGN WITH NEW CROSSWALK.
 - ③ INSTALL NEW GROUND MOUNTED SIGN AS SHOWN.
 - ④ RELOCATE EXISTING BUS SIGN AS SHOWN.
 - ⑤ RELOCATE BUS STOP AND ELIMINATE 50 FT. OF PARKING SPACE FOR BUS ACCESS.
 - ⑥ INSTALL NEW 5 FT. WIDE SIDEWALK FOR MORE DIRECT PEDESTRIAN BRIDGE ACCESS.
 - ⑦ INSTALL BIKE SHARROWS PAVEMENT MARKINGS
 - ⑧ INSTALL LED PEDESTRIAN LIGHTS

- Realign the southern crosswalk and stop bar on Martha Custis Drive to shorten the crossing distance, and rebuild the southeast ramp to match.
- Restrict northbound parking and install/relocate bus signs for the northbound Martha Custis Drive near side bus stop.
- Relocate stop signs to be closer to the stop lines.

- Install sharrows on north leg for consistency.
- Install new sidewalk to pave the footpath to provide more direct access to the pedestrian bridge.
- Remove the curb abutted sidewalk in the northwest corner.
