**ARCHITECTURAL IDENTIFICATION SURVEY  
BRIDGEWATER BYPASS LOCATION STUDY  
ROCKINGHAM COUNTY AND  
TOWN OF BRIDGEWATER, VIRGINIA**

**VDOT PROJECT NO. 0257-176-101, PE-101; UPC 17541  
VDHR FILE # 2007-1264**

**MANAGEMENT SUMMARY**

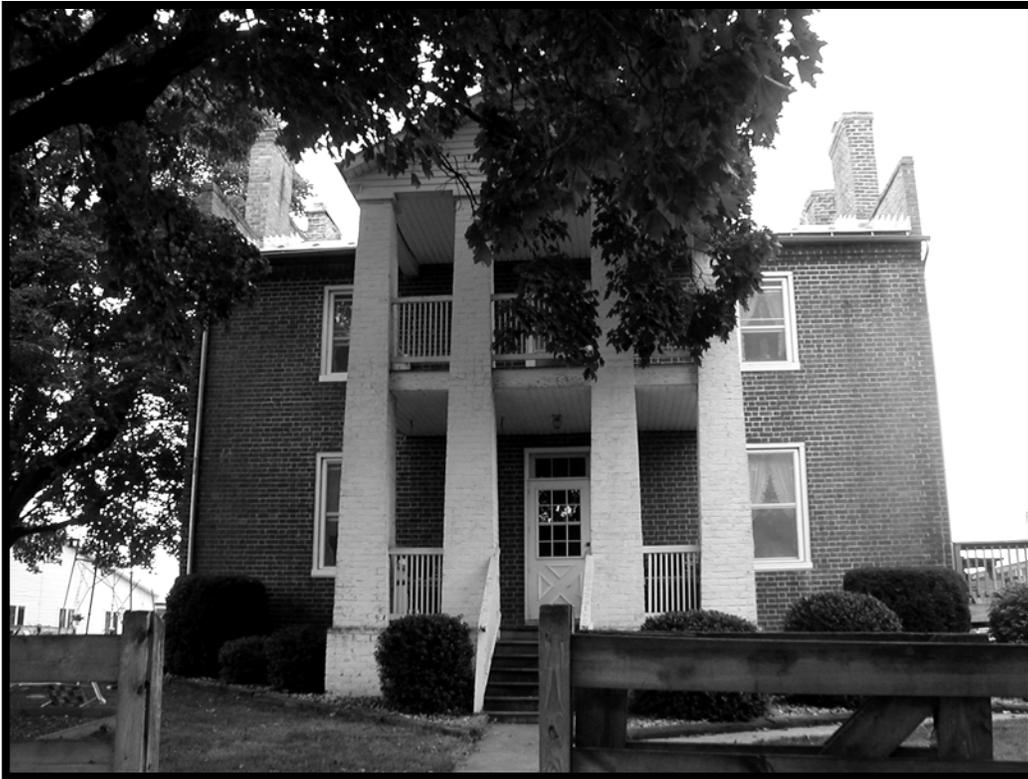
Figure 4: Mary Miller House (VDHR #082-0316), Front Elevation.

***Mary Miller House*** (VDHR #082-0316). Built c. 1850, this house is a Masonry Vernacular style home with Greek Revival-style detailing that features a brick structural system and rests on a solid foundation of coursed limestone. The house is three-bays wide and three-bays deep. The front façade of this house displays a stately two-story, one-bay entry portico with a front gabled roof supported by large square brick columns that are slightly tapered and painted white (Figure 4). Square wooden balusters are the

railing for the porch. The front façade of the house was constructed in Flemish bond, while the sides and back were laid in American bond. The front and back elevations also feature a corbelled brick cornice. The side-gabled roof is clad in standing-seam metal. Each side (Figure 5) of the house displays parapeted gables with paired interior end chimneys. The windows were replaced c. 1920 by the Layman family. The one-story back porch was enclosed with brick by the Wenger family in the 1990s. The enclosed porch features brick exterior walls and a gabled roof covered in standing-seam metal similar to the rest of the house.

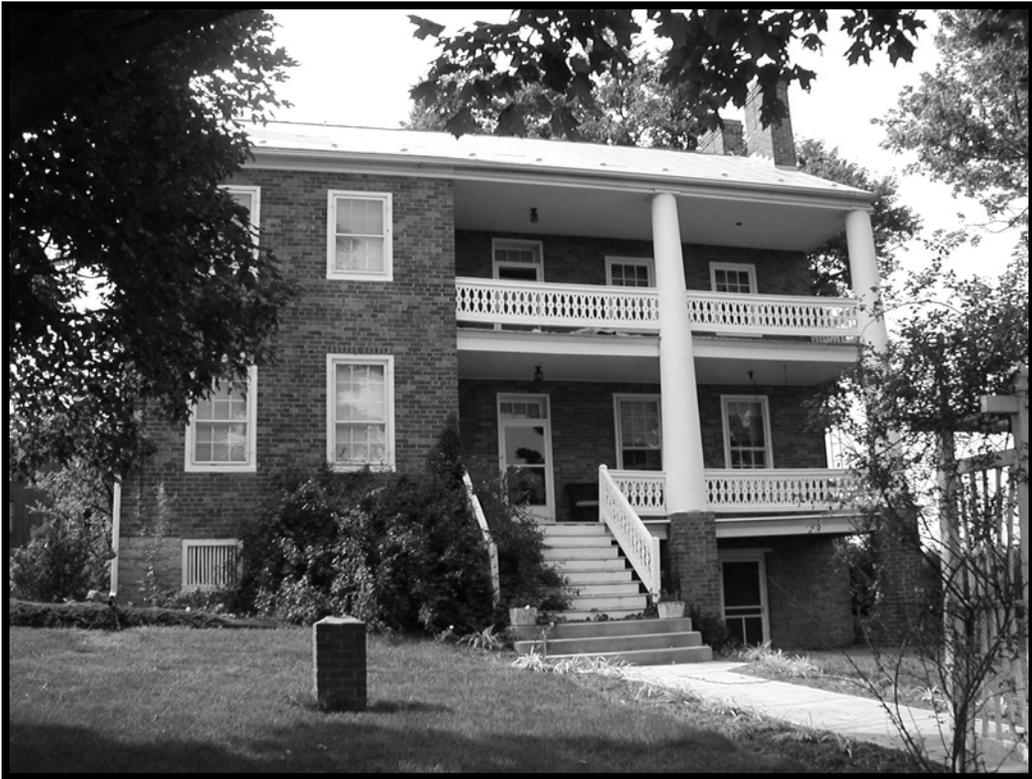
Figure 6: Sundial Dairy (VDHR #082-5120), Front Elevation.

*Sundial Dairy* (VDHR #082-5120). Built c. 1840, this two-story Masonry Vernacular-style dwelling with Greek Revival (Figure 6) detailing features a solid limestone foundation. The exterior walls of the house are clad in brick, and the gabled roof is covered in standing-seam metal. The house was constructed by the Pence family. The Lathrop and Griffing Atlas of Rockingham County (1995[1885]) indicates that the property was owned by the Pence family in 1885. The front façade is characterized by a two-story inset porch with scroll sawn balustrades and two large Doric columns that rest on brick piers. The front façade is five bays wide and displays a central entry door with a simple transom window. The door to the second floor balcony is also in the center bay and displays a simple transom. The house rests on a solid limestone foundation with the original wooden vents. There is a door to the basement on the front façade of the house. The first floor features nine-over-six wooden double-hung sash windows, while the second floor windows are six-over-six wooden double-hung sash. Aluminum awning windows are located on the rear one-story kitchen addition. Each end of the house is characterized by paired interior-end corbelled chimneys. The rear one-story kitchen was added to the house in 1980. There was a rear two-story ell that was clad in weatherboard, but it has been removed from the house and replaced with the modern kitchen (Figure 7).

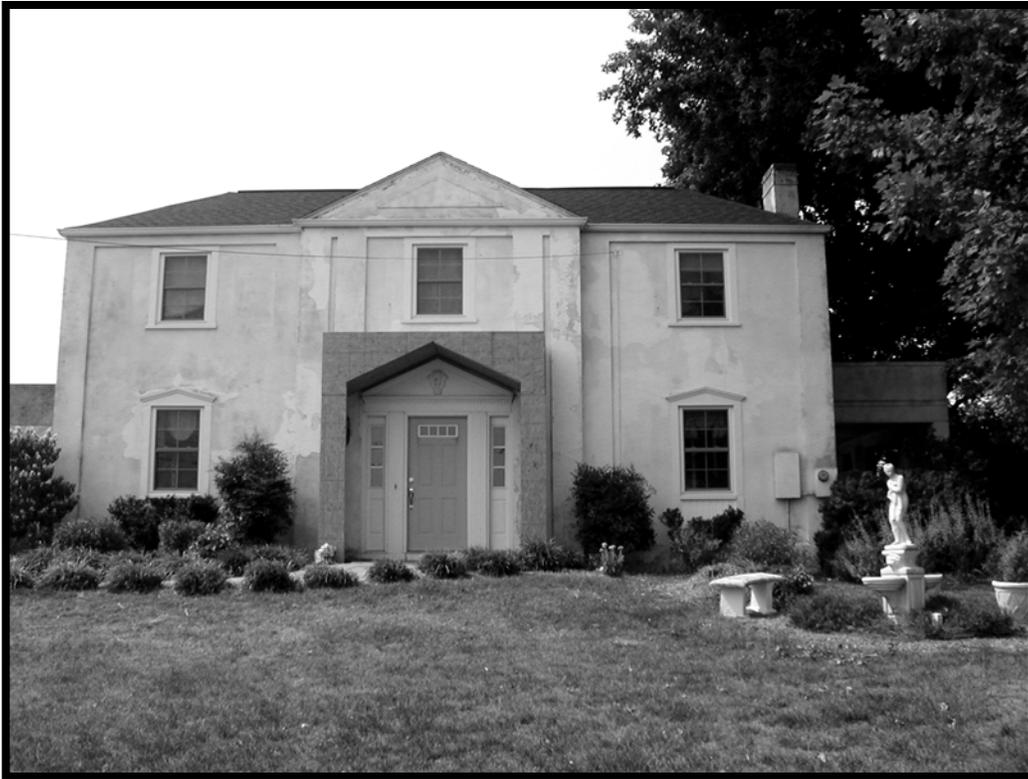
Figure 8: Logan House (VDHR #082-5459), Front Elevation.

**DESCRIPTION:** This two-story Masonry Vernacular-style house (Figure 8) displays some Colonial Revival detailing and rests on a solid foundation covered in stucco. The exterior walls of the house are covered in stucco, and the hipped roof is clad in asphalt shingles. The front façade is three-bays wide. The central bay features two-story double pilasters on each side of the entrance in low-relief topped by a front gable that forms a pediment. The actual door frame also displays a pediment with a lion head in the center. The house is currently under construction for renovations. The front entry is being altered, and a side gabled addition is being added. A chimney clad in stucco is located on the northeast elevation as is a one-story porch with a flat roof and stucco-clad square columns.

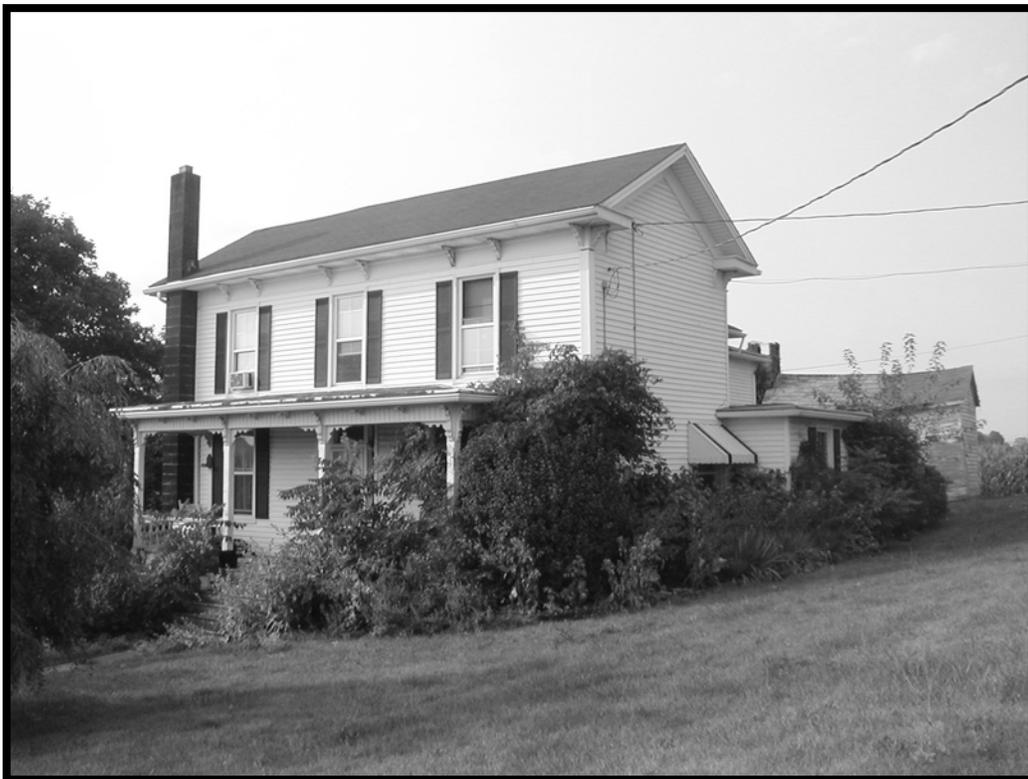
Figure 9: Frank Wenger House (VDHR #082-5461), Front Elevation.

**DESCRIPTION:** This two-story Frame Vernacular I-House (Figure 9) with Italianate detailing was built c. 1880 by John S. Sanger and can be seen on the 1885 Lathrop and Griffing Atlas of Rockingham County (1995[1885]). This house features a wooden frame structural system that rests on a solid limestone foundation. The exterior walls of the house are clad in vinyl siding, and the side-gabled roof is covered in asphalt shingles. Decorative paired Italianate brackets are located along the cornice on the house. A brick chimney is located in the center of the rear two-story ell, and a concrete flue was added to the exterior wall of the front elevation. The front porch is a one-story three-bay porch with decorative brackets under the eaves and along the tops of the turned wooden posts. The front door features a broken transom light and sidelights. The windows are two-over-two wooden double-hung sash with decorative shutters.
