**ARCHITECTURAL IDENTIFICATION SURVEY  
I-81 CORRIDOR IMPROVEMENT STUDY  
TIER 2 I-77/I-81 OVERLAP  
WYTHE COUNTY AND  
TOWN OF WYTHEVILLE, VIRGINIA  
VDOT PROJECT NO. 0077-098-104, P100, UPC: 51441  
VDHR FILE # 2001-0626**

**CBA 7 AND EXPANDED INTERCHANGES**

**JUNE 2009**

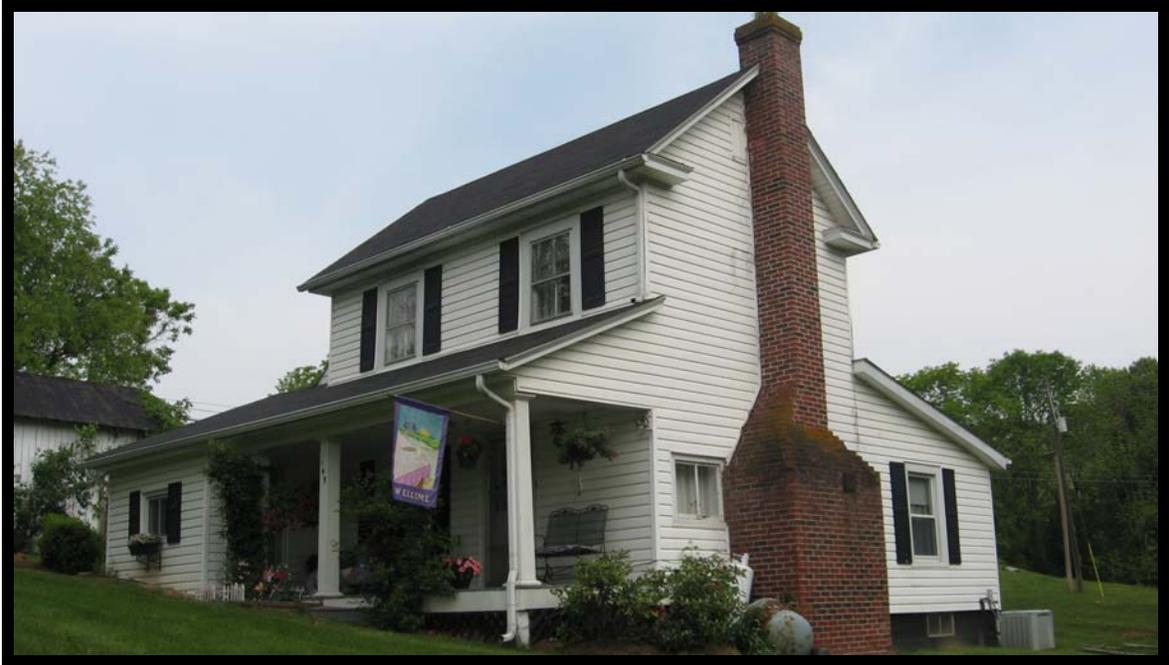
Figure 4: George Keesling House (VDHR #098-5153).

**DESCRIPTION:** George Keesling constructed this house c. 1860. The house (Figure 4) is currently owned by Mary Keesling Hancock, the great-granddaughter of George Keesling. The land to the east of the house (Carter Wayside) was originally owned by the Keesling family and operated as a campground in the mid-twentieth-century by Charlie Keesling. This two-story timber frame I-house features exterior walls that are covered in

vinyl siding, and a side-gabled roof with gable returns is clad in asphalt shingles. Ms. Hancock stated during the course of an interview that the house was not originally of log construction (Mary Keesling Hancock, personal communication 2009). A brick chimney is located on the east exterior end, and a concrete flue is located on the north wall of the house. The house rests on a foundation of solid stone, but the additions are built on concrete block. The house displays a one-story, two-bay front entry that consists of a shed roof supported by square wooden columns. The roof of the porch has been extended to the west to cover a one-story gabled addition on the west elevation. An addition has been appended to the rear of the house and a one-story enclosed porch with a hipped roof has been added to the west elevation of the gabled addition. The windows are one-over-one vinyl and two-over-two wooden double-hung sash windows with decorative shutters. A brick patio has been built into the hillside to the west of the house. The patio was built c. 1990.

***RECOMMENDATIONS FOR NRHP ELIGIBILITY:*** This resource has no apparent association with any event or person important in our nation's history, lacks architectural significance, and does not appear to have the ability to yield important information. The

house has been altered with the addition of vinyl siding, new windows, decorative shutters, the construction of several additions, and the addition of new roofing material. This resource is recommended as not eligible for the NRHP under Criteria A, B, C, or D.

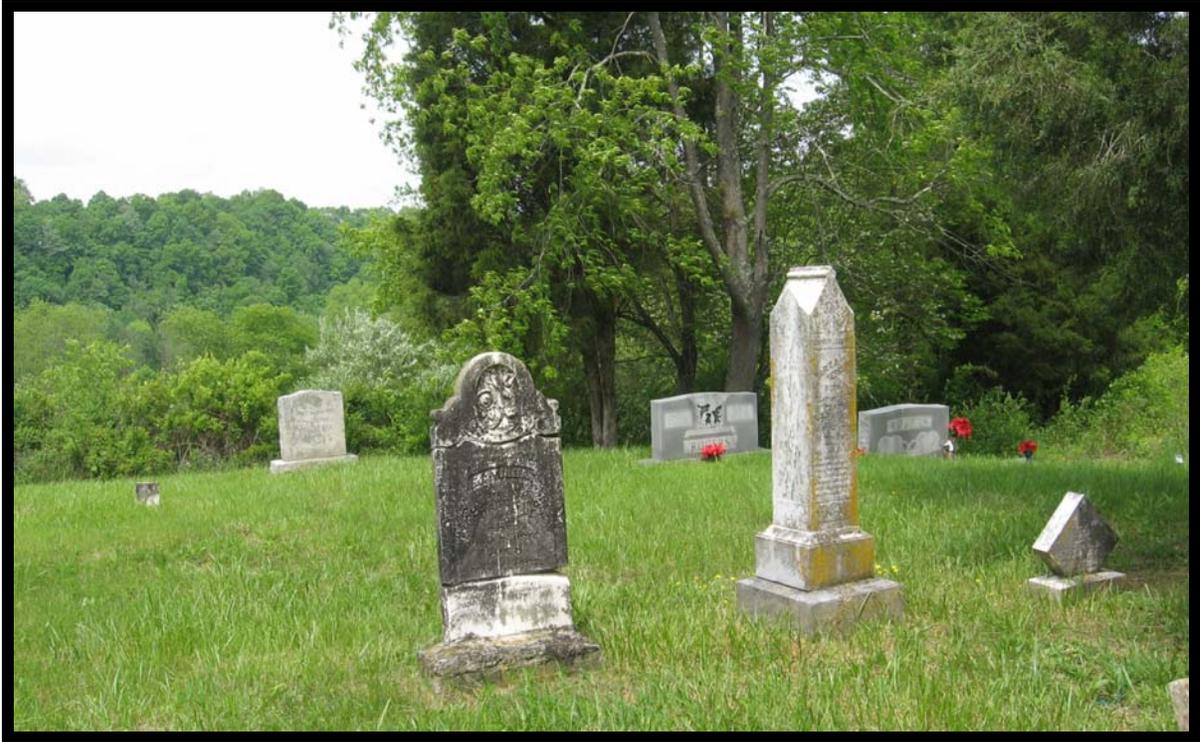
Figure 6: Keesling Cemetery (VDHR #098-5158).

**RECOMMENDATIONS FOR NRHP ELIGIBILITY:** This cemetery does not lend itself to comparative archaeological or physical anthropological studies. The cemetery is recommended as not eligible for the NRHP under Criteria A, B, C, or D. It is also recommended as not eligible under Criteria Consideration C for association with important persons or Criteria Consideration D, as it contains no graves of important persons, is not of great age, contains no special design elements, and is not associated with significant events. However, relevant local and state statutes regarding the protection and relocation of cemeteries must be followed.

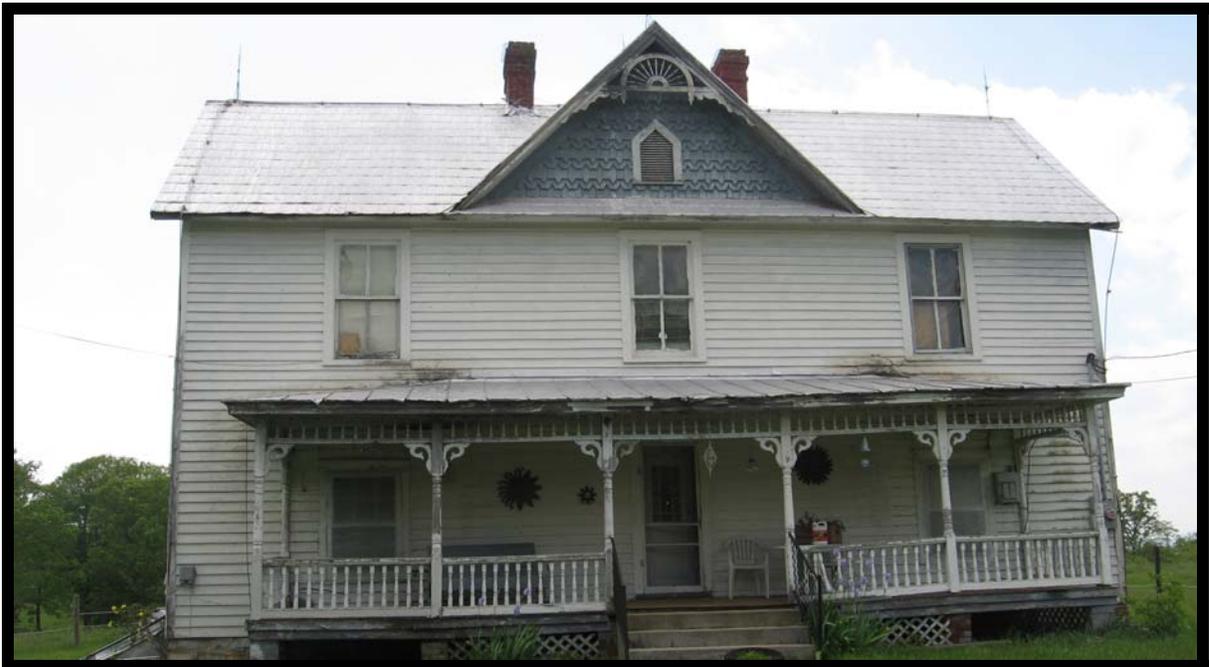
Figure 7: Armentrout House (VDHR #098-5160).

**DESCRIPTION:** Built c. 1910, this two-story wooden frame Victorian-style I-House rests on a limestone foundation (Figure 7). The exterior walls are covered in weatherboard, and the side-gabled roof is clad in pressed tin shingles. The front elevation displays a front facing gable with decorative shingles, a vent with a pointed arch, and decorative spindlework. The front porch is three bays wide with a hipped roof, a spindlework frieze, decorative brackets, and turned posts and railing. There is decorative spindlework in each gable end on the house. The windows are two-over-two and six-over-six wooden sash windows with wooden surrounds. There are two corbelled brick chimneys located in the center of the main roof, a corbelled brick chimney in the center of the rear two-story ell, and a brick chimney on the west exterior end of the ell. The rear ell features an integral two-tier porch with decorative brackets on the south elevation. A one-story hipped addition has been appended to the west elevation of the main house. A basement door is located on the south elevation. Northwest of the house is a barn/corncrib constructed c. 1910. The exterior of the barn is covered in weatherboard, and the gabled roof is clad in standing-seam metal. West of the house are two c. 1920 sheds. Shed (A) is clad in vertical boards and has a gabled roof covered in standing-seam metal. Shed (B) is clad in weatherboard and has a gabled roof covered in standing-seam metal. A wire fence encloses the yard around the house.

**RECOMMENDATIONS FOR NRHP ELIGIBILITY:** This structure exhibits a design common for the period. This resource has no apparent association with any event or person important in our nation's history, lacks architectural significance, and does not appear to have the ability to yield important information. This resource is recommended as not eligible for the NRHP under Criteria A, B, C, or D.

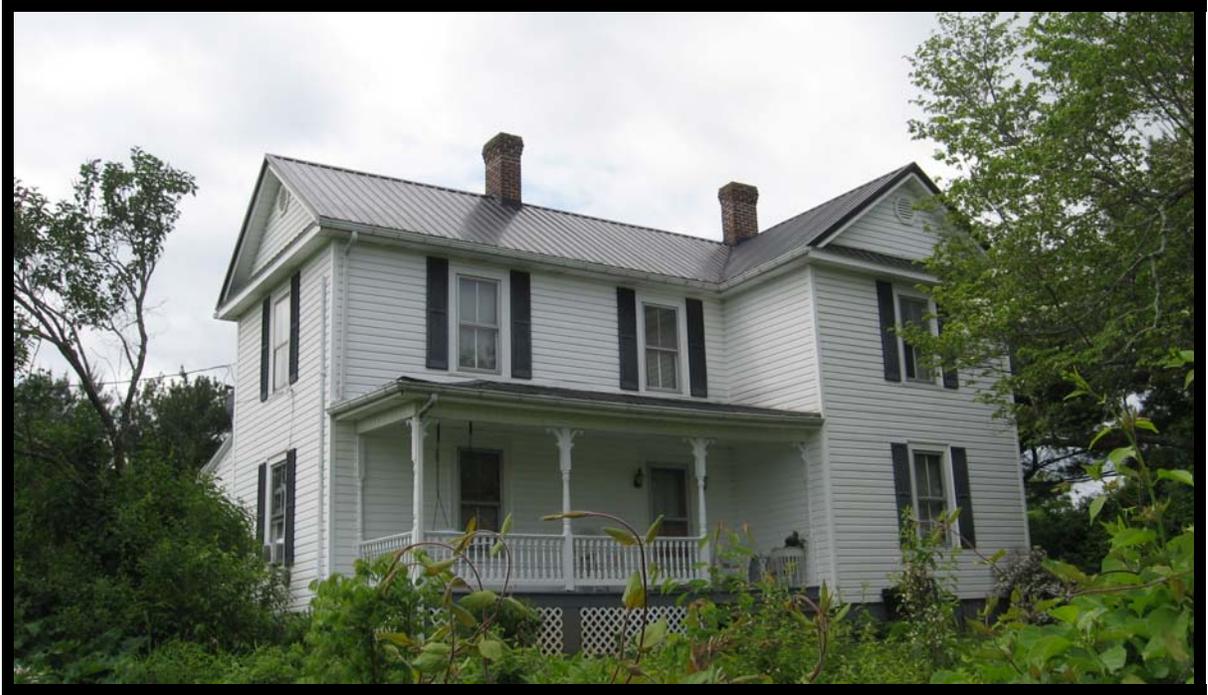
Figure 9: Reardon House (VDHR #139-5082) Located at 235 Walnut Road.

**DESCRIPTION:** Built c. 1910, this two-story house with a “T” shape plan features a wooden frame structural system that rests on a solid foundation of limestone (Figure 9). The exterior walls are covered in vinyl siding, and the cross-gabled roof is clad in 5-V crimped metal. There are two brick chimneys located in the center of the roof. The front porch is two bays wide and features a hipped roof that is supported by turned wooden posts with decorative brackets. The windows are two-over-two wooden double-hung sash with decorative shutters. A one-story addition with a hipped roof has been added to the south elevation, and an enclosed one-story porch was added later that is located in the rear of the house along the south and east elevations. To the southeast of the house is a c. 1910 chicken house. The chicken house is clad in board and batten siding and displays a shed roof covered in corrugated metal. In addition, also to the southeast of the house is a c. 1910 shed covered in board and batten siding and has a gabled roof covered in standing-seam metal. To the south of the house is a c. 1910 smoke house clad in vertical boards and has a gabled roof covered in standing-seam metal. Southwest of the house is a c. 1930 animal shelter that features exterior walls covered in vertical boards and a shed roof clad in corrugated metal. To the southwest of the house in a field are the ruins of an old wooden frame barn. The c. 1910 barn is covered in vertical boards and features a gabled roof covered in corrugated metal.

**RECOMMENDATIONS FOR NRHP ELIGIBILITY:** This dwelling exhibits a design common for the period. This resource has no apparent association with any event or person important in our nation’s history, lacks architectural significance, and does not appear to have the ability to yield important information. This resource is recommended as not eligible for the NRHP under Criteria A, B, C, or D.

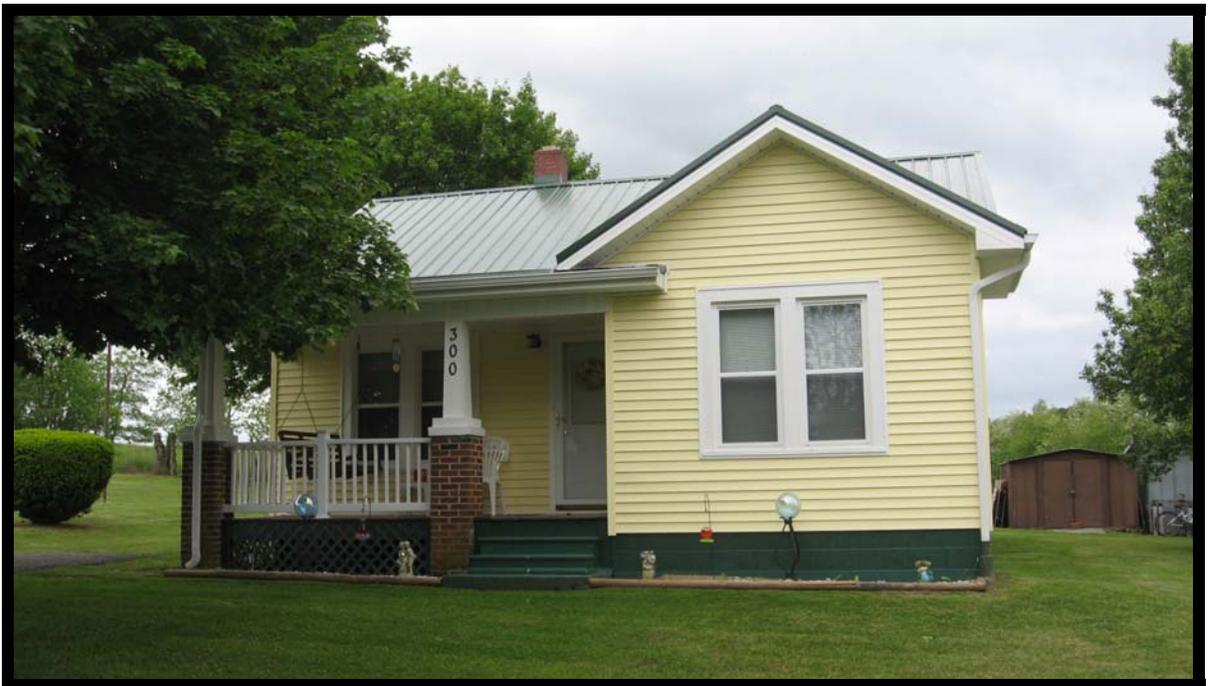
Figure 10: Dwelling (VDHR #139-5084) Located at 300 Locust Lane.

**DESCRIPTION:** Built c. 1945, this one-story wooden frame house rests on a solid foundation of concrete block. This gable-front-and-wing house (Figure 10) is an example inspired by the Minimal Traditional style of the 1940s (McAlester and McAlester 1998). The exterior walls are covered in vinyl siding, and the cross-gabled roof is clad in 5-V crimped metal. A shed-roofed addition has been appended to the rear façade. A shed-roofed porch is located in the L formed by the two wings and features square wooden posts. The windows are one-over-one aluminum double-hung sash windows with wooden surrounds.

**RECOMMENDATIONS FOR NRHP ELIGIBILITY:** This structure exhibits a design common for the period. This resource has no apparent association with any event or person important in our nation's history, lacks architectural significance, and does not appear to have the ability to yield important information. This resource is recommended as not eligible for the NRHP under Criteria A, B, C, or D.

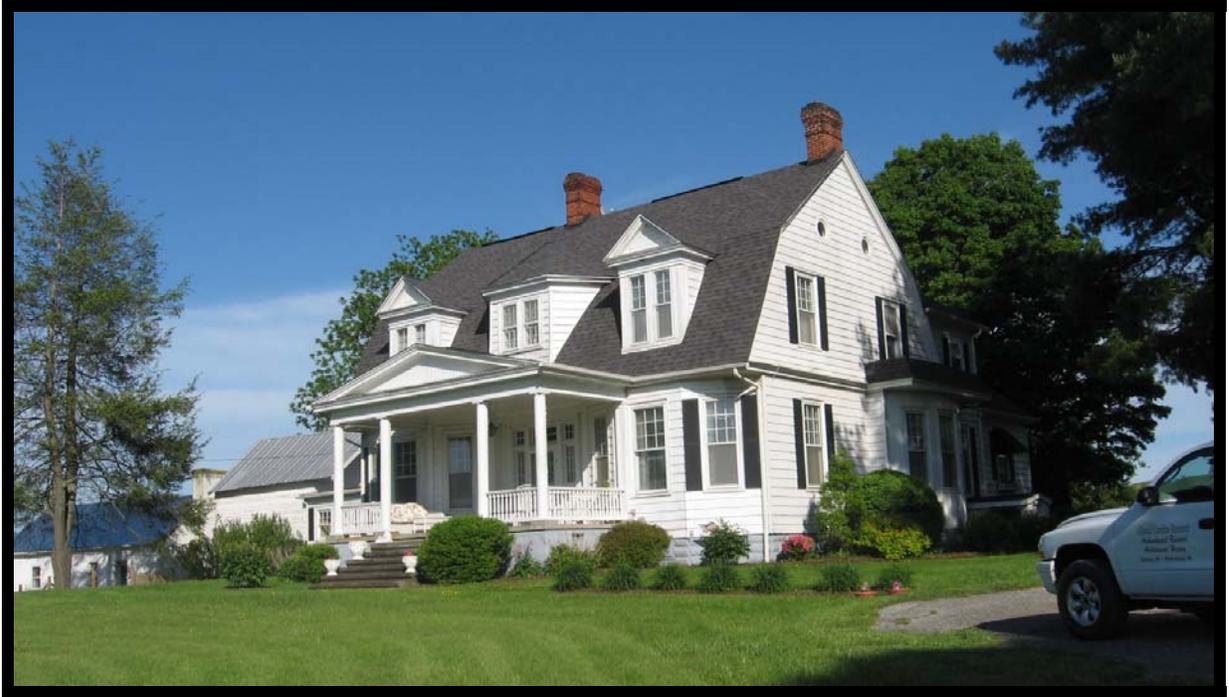
Figure 13: Sanders Farm House (VDHR #098-5168).

**DESCRIPTION:** Built c. 1905, this two-story Dutch Colonial Revival-style, a sub-type of the Colonial Revival style, house (Figure 13) rests on a solid foundation of rusticated stone blocks. This is a nice example of a Dutch Colonial Revival-style dwelling featuring a side-gambrel roof with flared eaves. The roof is covered in asphalt shingles, and the exterior walls have been clad in aluminum siding. The symmetrical front elevation is three bays wide and features a large porch with a front-gabled roof that has an exaggerated pediment supported by fluted Doric Columns. The front door features an Adamesque-style door surround with transom and sidelights. A large bay window is located on each side of the front porch. The front façade of the roof displays a polygonal dormer with two windows (six-over-one wooden double-hung sash) that is flanked to each side by a gabled dormer with an exaggerated pediment and two six-over-one windows. A corbelled brick chimney is located in the center of the roof, and a second corbelled brick chimney is located on the west interior end of the roof. Two round windows are in the west gambrel end. Other windows on the house are nine-over-one and three-over-one wooden double-hung sash, some with decorative shutters. The rear portion of the west elevation features a rounded bay window with pent roof. The rear of the house displays a two-story hipped addition with a front-facing gable in the roof that has an oval window. The use of varying window styles is seen in Colonial Revival style homes as influenced from the preceding Shingle style of architecture. A one-story gabled addition has been appended to the south elevation of the rear of the house, and next to it is a one-story hipped roof porch that has been enclosed with windows. Appended to the east of the house is a two-bay carport that is open to the south and has a hipped roof. The carport is enclosed to the north with six-over-one windows.

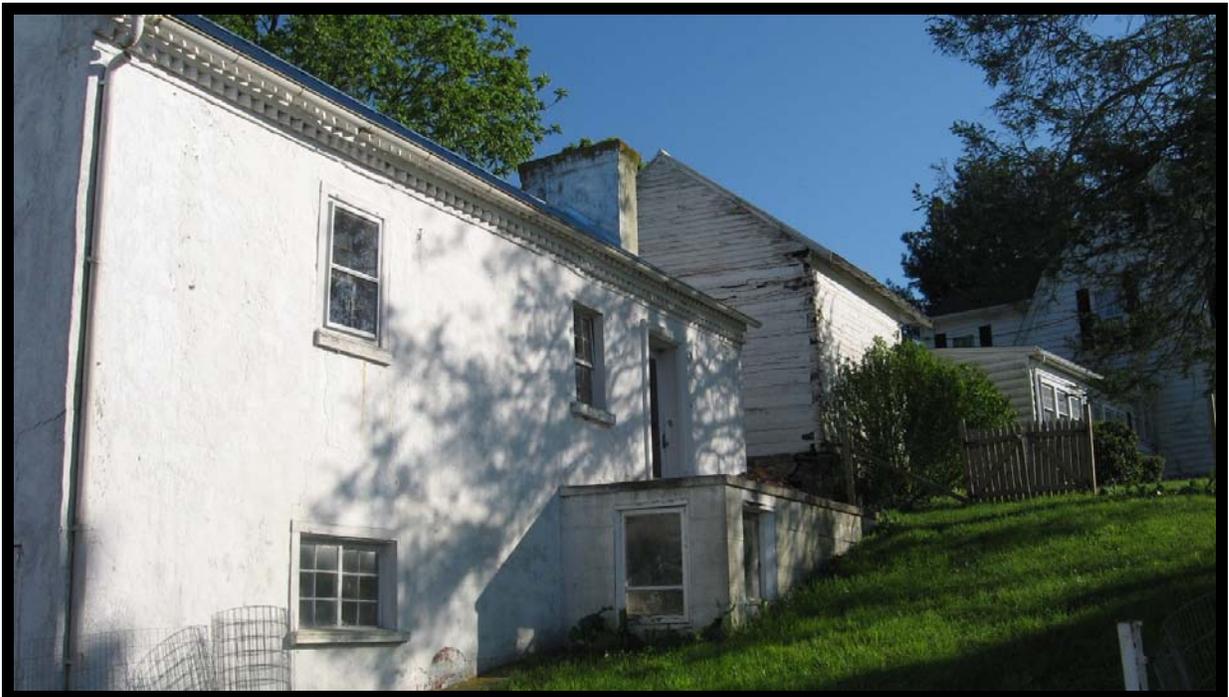
Figure 14: Secondary Dwelling and Smoke House on Sanders Farm (VDHR #098-5168).

To the south of the house is a twentieth century shed (A) clad in board and batten siding, and has a gabled roof covered in standing-seam-metal. Directly to the east of the house is a c. 1850 two-story log smoke house that rests on a limestone foundation. The smoke house features an extended roofline over the entrance on the west elevation. North of the smoke house is a c. 1950 shed (B) constructed of concrete block with a gabled roof covered in standing-seam metal. East of the smoke house is a c. 1850 secondary dwelling (Figure 14) that is one-story in height, but due to the slope terrain features a lower level on the east end of the building. The building displays a stuccoed

chimney on the west exterior end wall, and a second chimney on the east interior end. The entrance features a recessed door that demonstrates the thickness of the walls. A two-story shed addition has been appended to the rear of the building, and a set of double doors is located on the ground level of the east elevation. The windows are six-over-six wooden double-hung sash. A brick saw-tooth cornice is located beneath the eaves. North of the secondary dwelling is a c. 1905 dairy house constructed of brick and rests on a limestone foundation. There is weatherboard in the gable ends and the gabled roof is covered in standing-seam metal. To the east is a compound of three outbuildings connected together. The northern most building is a c. 1950 equipment shed constructed of concrete block and features a shed roof covered in standing-seam metal. The next structure is a long section of the barn covered in vertical boards, and has a gabled roof covered in standing-seam metal. There are various bays on the west elevation of the central part of the building. The last section of the structure is a three-story barn that dates to the early twentieth century and is clad in weatherboard with a gambrel roof covered in corrugated metal. A large open shed-roofed addition has been appended to the south elevation of the barn and the southern most part of the barn addition contains a wooden corncrib. The farm is situated on rolling fields that overlook the Fort Chiswell Manor property (VDHR #098-0005).
